# Aboriginal Cultural Heritage Due Diligence Assessment Crackenback Ridge Water Supply Upgrade

Report Prepared for Kosciuszko Thredbo Pty Ltd

18 November 2024

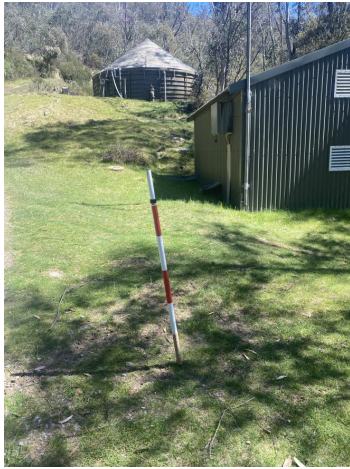
The current water tank is located adjacent to the main fire trail leading from Cascade Close and ascending the middle to upper slopes. The water tank and current pump house are located within mid slopes with steep gradient slopes. Vegetation removal and soil displacement has occurred due to the previous works of tank and pipeline which is evident in mounds of displaced soils within the current footprint of the proposed additional tank (Plate 4) .

Plate 1. Current pumphouse and water tank – note benched areas for placement

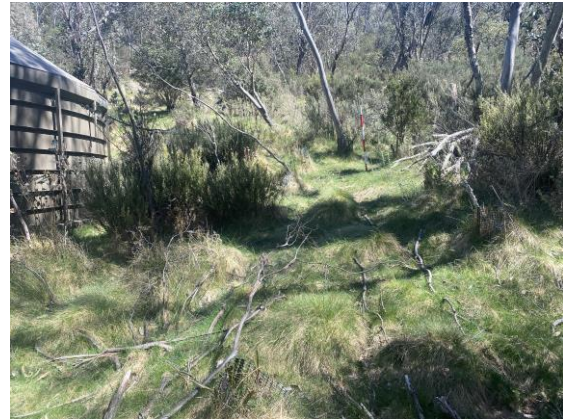
Plate 2. Proposed tank location amidst displaced soils from benching
