## Stage 1B Rehabilitation & Environmental Offsets Plan - Gunbarrel lift camera and trench

This plan relates to the *Rehabilitation and Environmental Offsets Plan, Stage 1B Mountain Bike Trails, Thredbo DA 6571, December 2015*, and has been prepared to detail the rehabilitation and monitoring required for the areas disturbed by the construction works associated with the installation of a camera and cable trench within the Stage 1B offset area within the Gunbarrel lift corridor.

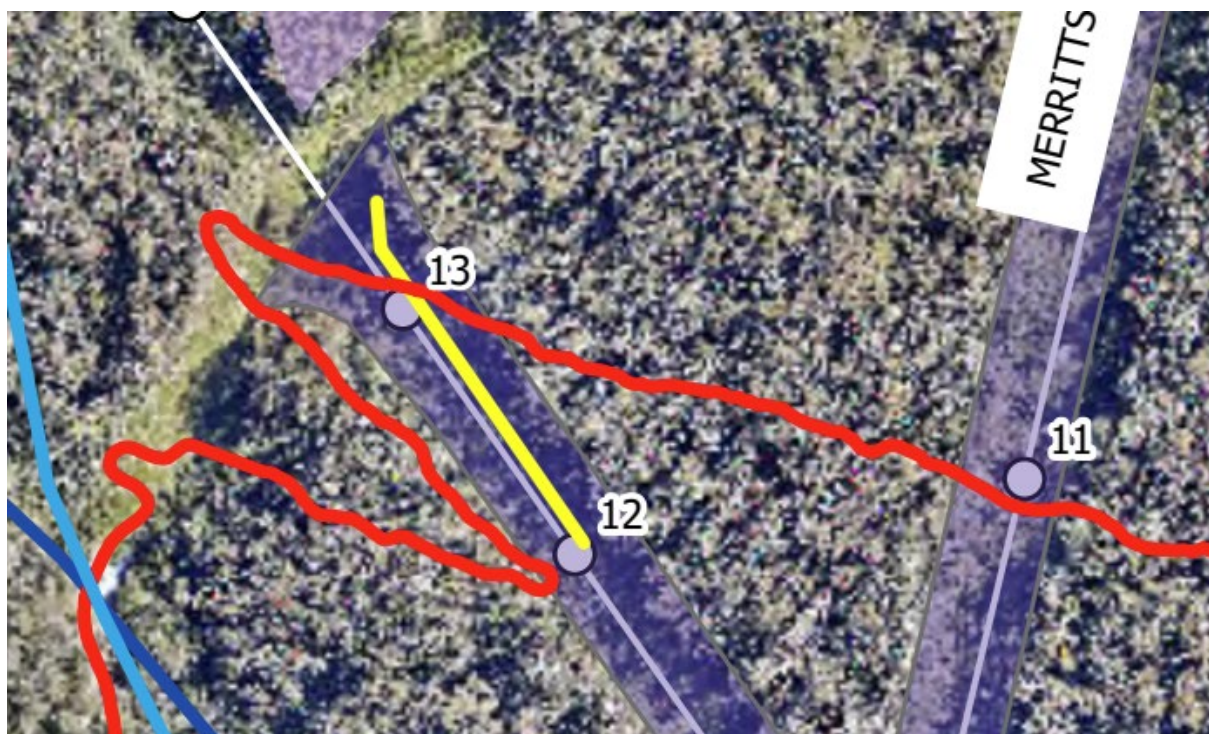
The proposed camera cable trench which forms part of the Merritts Intermediate Mountain Bike Trail and Associated Works development traverses a short section of the approved Stage 1B offset area, refer **Figure 1**. The trench disturbance is approximately 30 m<sup>2</sup> (100 m long x 300 mm wide).

Figure 1: Proposed camera trench (yellow line) within Stage 1B offset area

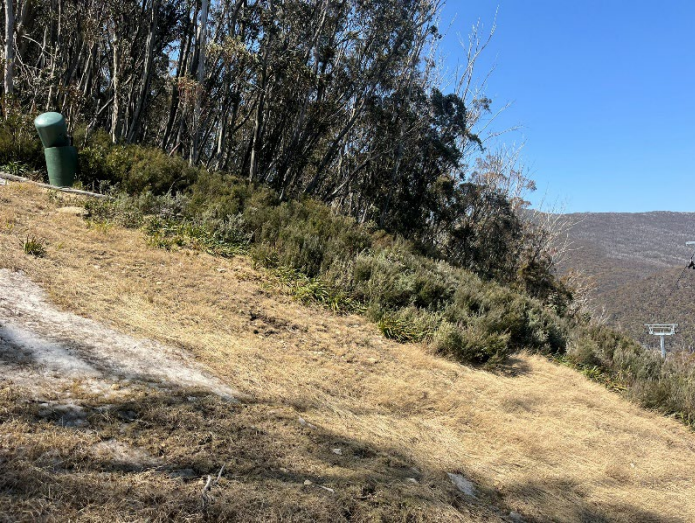
| Photo Point | Description | Coordinates | Photo |
|---|---|---|---|
| GBU PHPT4<br><br>Date:<br>10/09/24 | Looking at trenching site from Dream Run | 616,876<br>5,960,551 | |

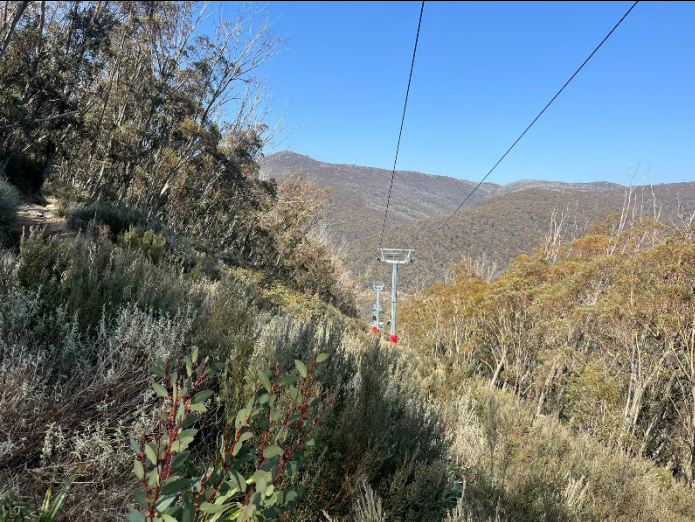
| Photo Point | Description | Coordinates | Photo |
|---|---|---|---|
| GBU PHPT3<br><br>Date:<br>10/09/24 | Looking down Gunbarrel lift line to T12 along trenching site | 616,883<br>5,960,539 | |

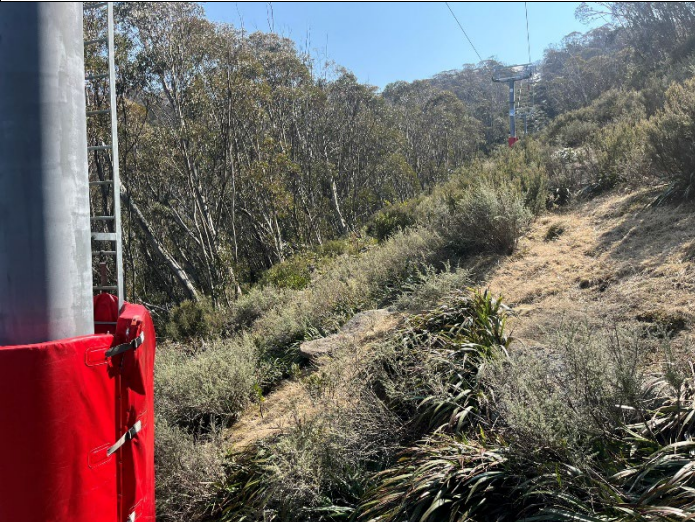
| Photo Point | Description | Coordinates | Photo |
|---|---|---|---|
| GBU PHPT2<br><br>Date:<br>10/09/24 | Looking up Gunbarrel lift line from T12 along trenching site | 616,937<br>5,960,460 | |
