ELOURA DEVELOPMENTS LAKEMBA

Hydrogeological Investigation

5-9 Croydon Street, Lakemba, NSW

E26227.G04_Rev1

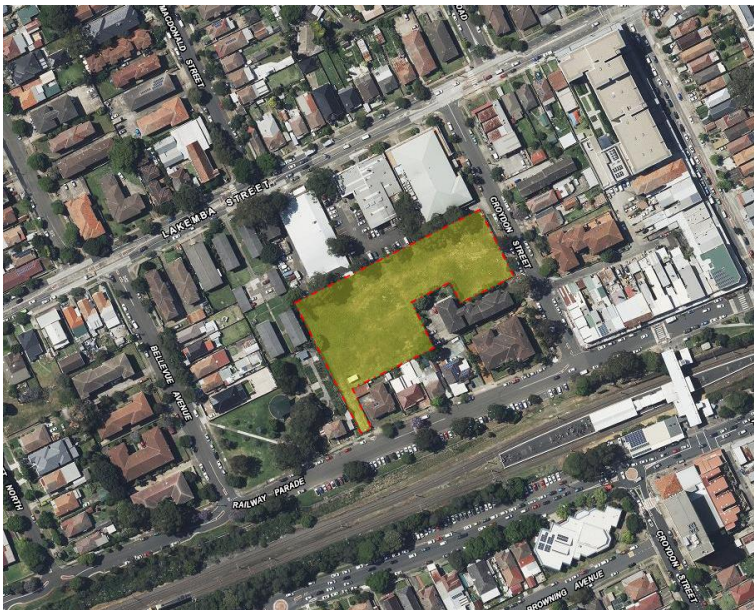
Plate 1: Aerial photograph of the site (source: SIX Maps, accessed 17/06/24)

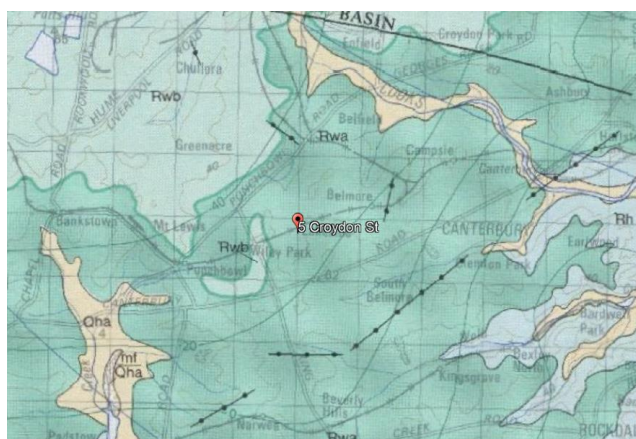
Plate 2: Excerpt of geological map showing location of site.

Attribute	Description
Topography	The site gently falls down from the eastern site boundary to the western site boundary at an angle of about 2-3°. The site level ranges from about RL 29.1m to 29.2m AHD along the eastern site boundary to RL 24.6m to 24.9m AHD along the western site boundary.
Regional Geology	Information on regional sub-surface conditions, referenced from the Department of Mineral Resources Geological Map Sydney 1:100,000 Geological Series Sheet 9130 (DMR 1983) indicates the site to be underlain by Ashfield Shale (Rwa), which consists of black to dark grey shale and laminite.

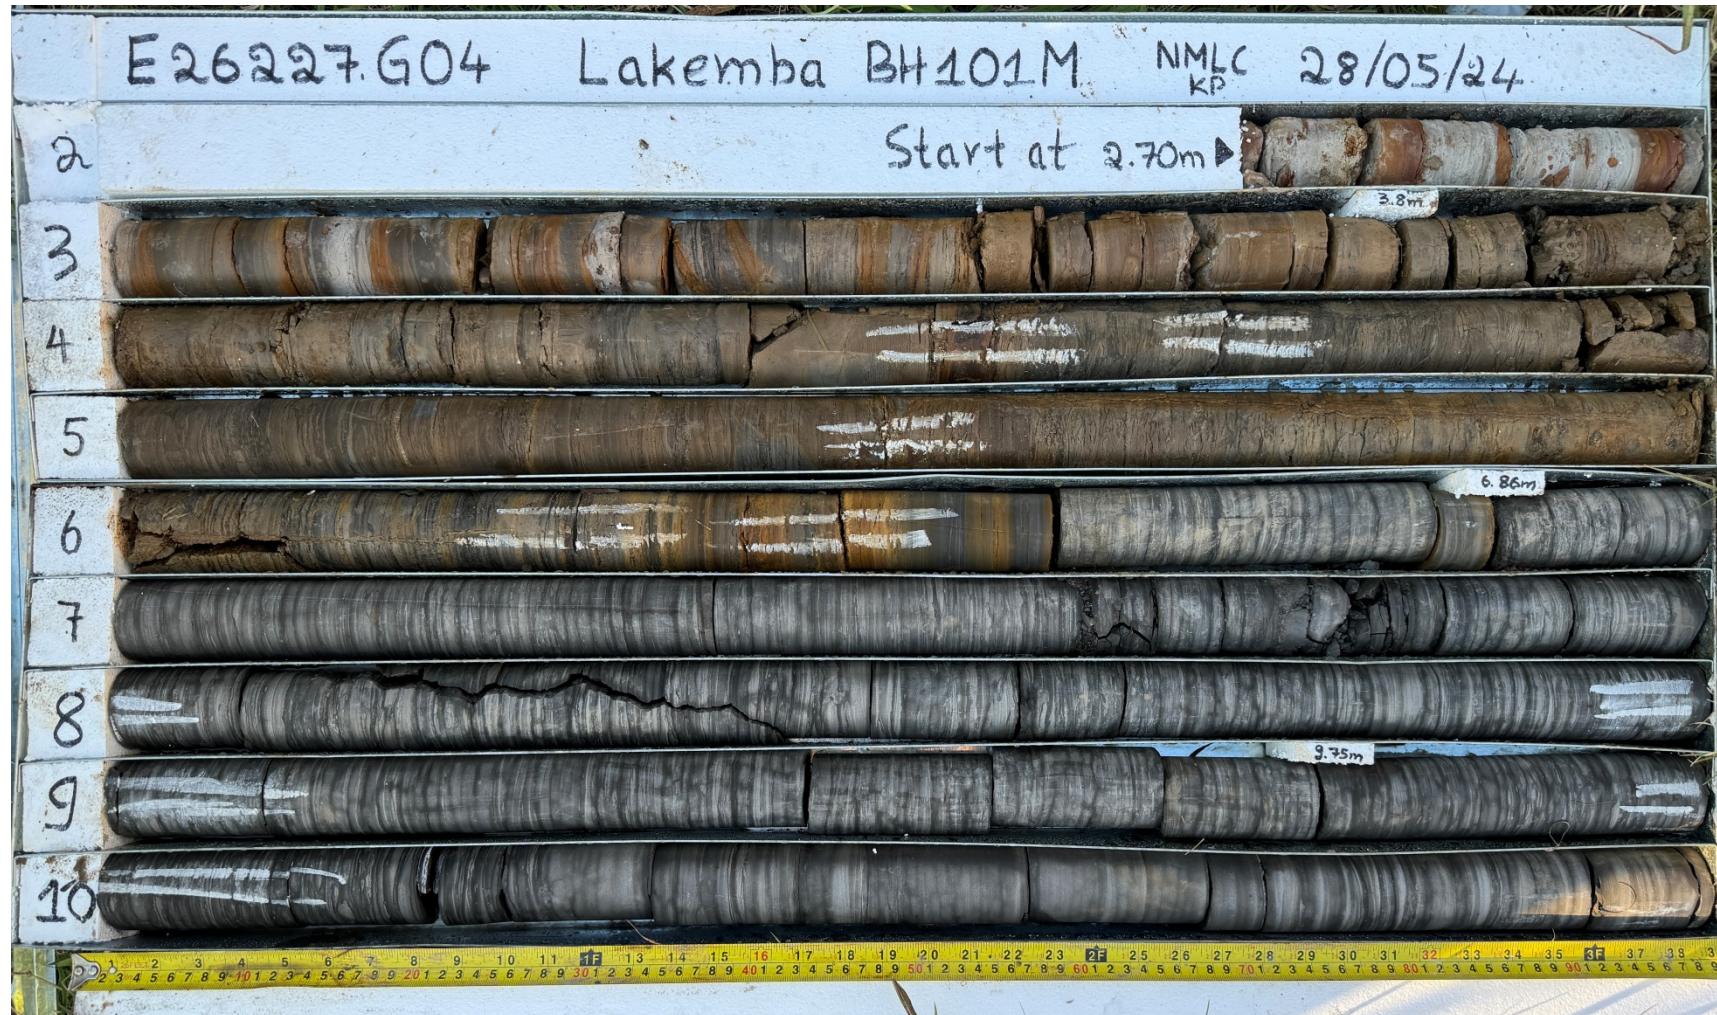
CORE PHOTOGRAPH OF BOREHOLE: BH101M

Project	Proposed Development	East	322060.8201	Depth Range	2.70m to 11.00m BEGL		
Location	5-9 Croydon Street, Lakemba NSW	North	6245114.7356	Contractor	GeoSense Drilling & Engineering Pty Ltd		
Position	See Figure 2	Surface RL	≈ 29.20m	Drill Rig	Comachhio Geo 205		
Job No.	E26227.G04	Inclination	-90°	Logged	KP	Date	29 / 5 / 2024
Client	Eloura Developments Pty Ltd	Box	1 & 2 of 5	Checked	SK	Date	5 / 7 / 2024

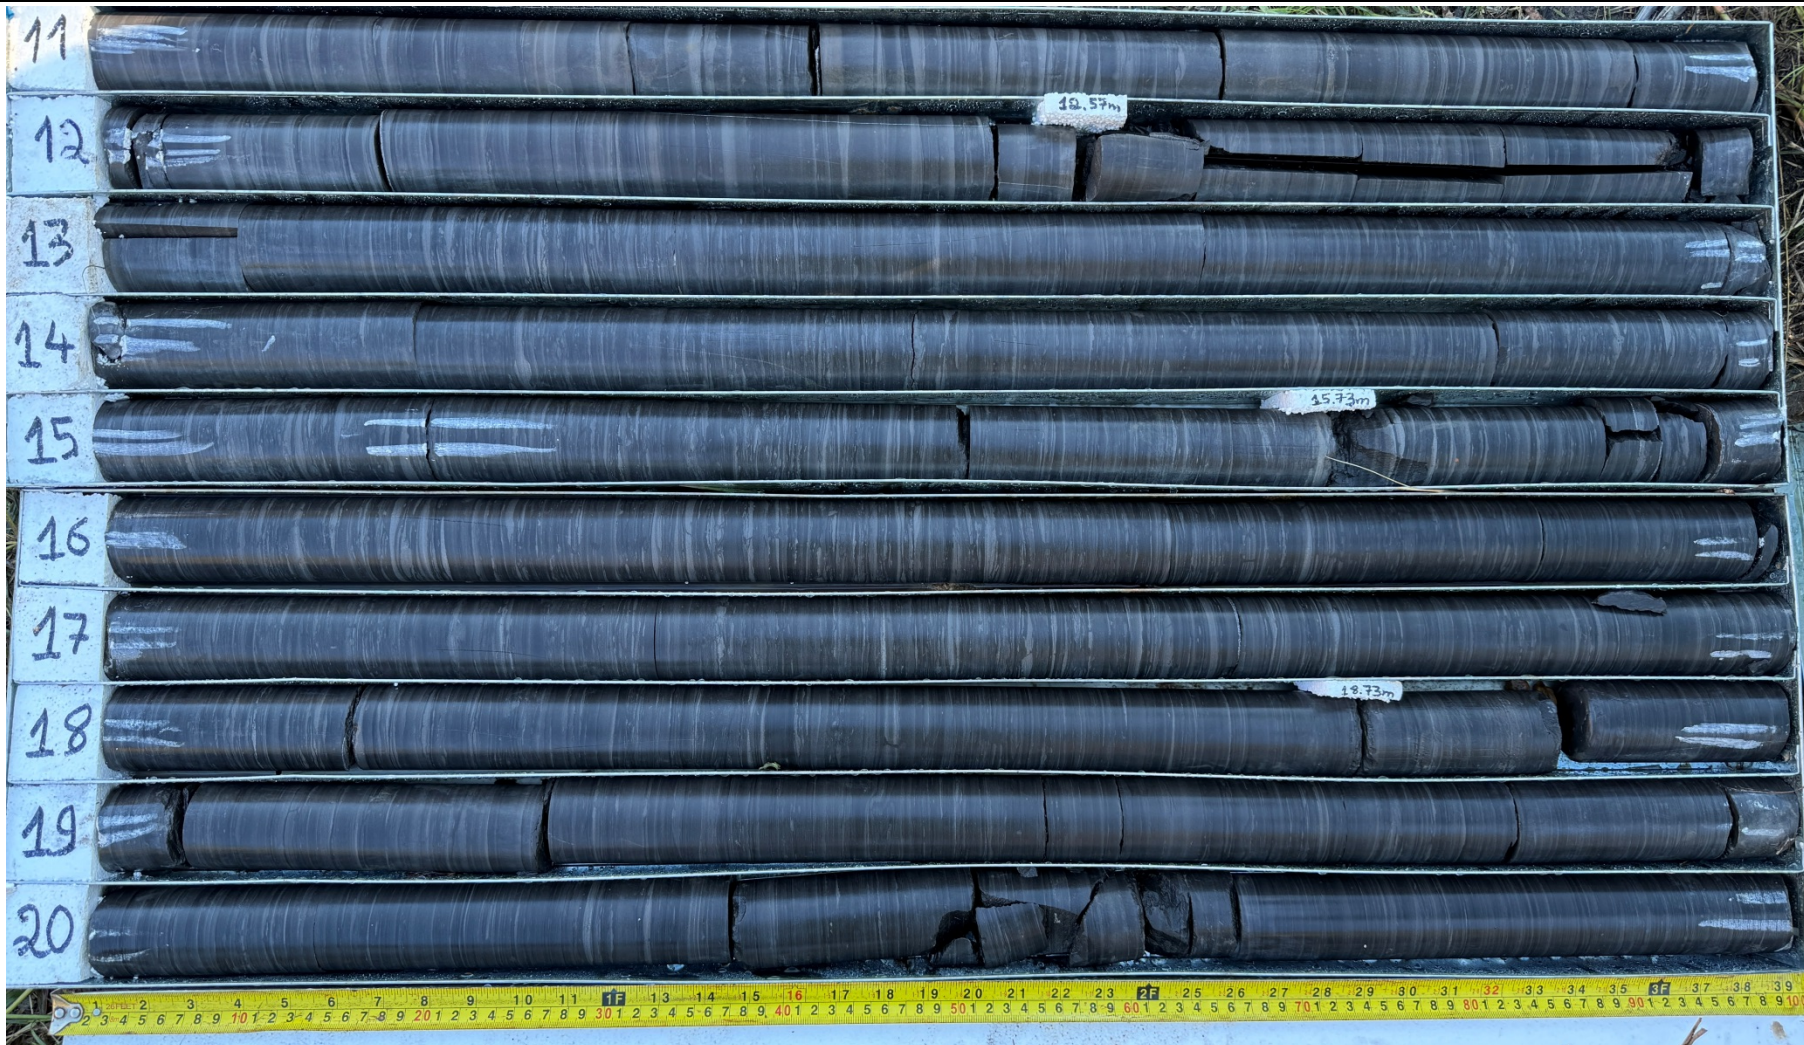
CORE PHOTOGRAPH OF BOREHOLE: BH101M

Project	Proposed Development	East	322060.8201	Depth Range	11.00m to 21.00m BEGL	
Location	5-9 Croydon Street, Lakemba NSW	North	6245114.7356	Contractor	GeoSense Drilling & Engineering Pty Ltd	
Position	See Figure 2	Surface RL	≈ 29.20m	Drill Rig	Comachhio Geo 205	
Job No.	E26227.G04	Inclination	-90°	Logged	KP	Date 29 / 5 / 2024
Client	Eloura Developments Pty Ltd	Box	3 & 4 of 5	Checked	SK	Date 5 / 7 / 2024

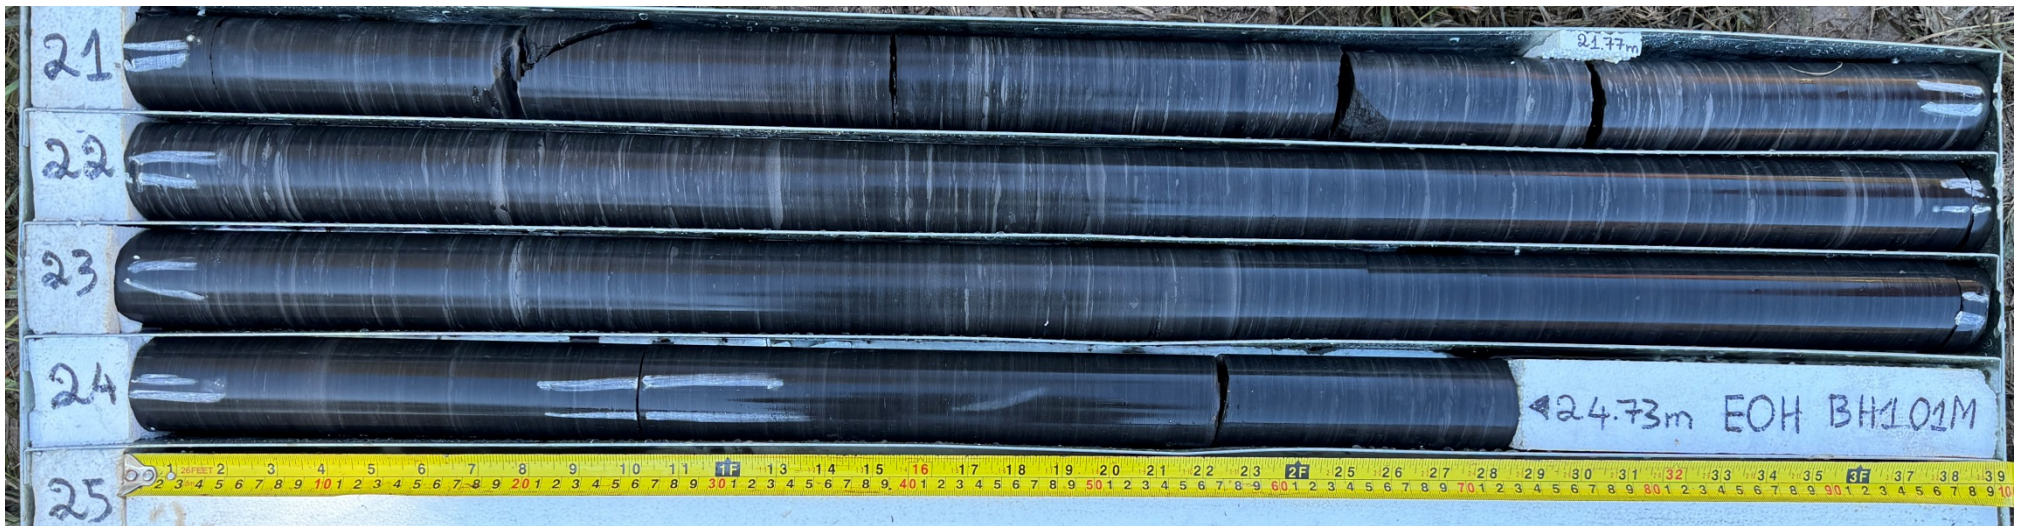
CORE PHOTOGRAPH OF BOREHOLE: BH101M

Project	Proposed Development	East	322060.8201	Depth Range	21.00m to 24.73m BEGL		
Location	5-9 Croydon Street, Lakemba NSW	North	6245114.7356	Contractor	GeoSense Drilling & Engineering Pty Ltd		
Position	See Figure 2	Surface RL	≈ 29.20m	Drill Rig	Comachio Geo 205		
Job No.	E26227.G04	Inclination	-90°	Logged	KP	Date	29 / 5 / 2024
Client	Eloura Developments Pty Ltd	Box	5 of 5	Checked	SK	Date	5 / 7 / 2024

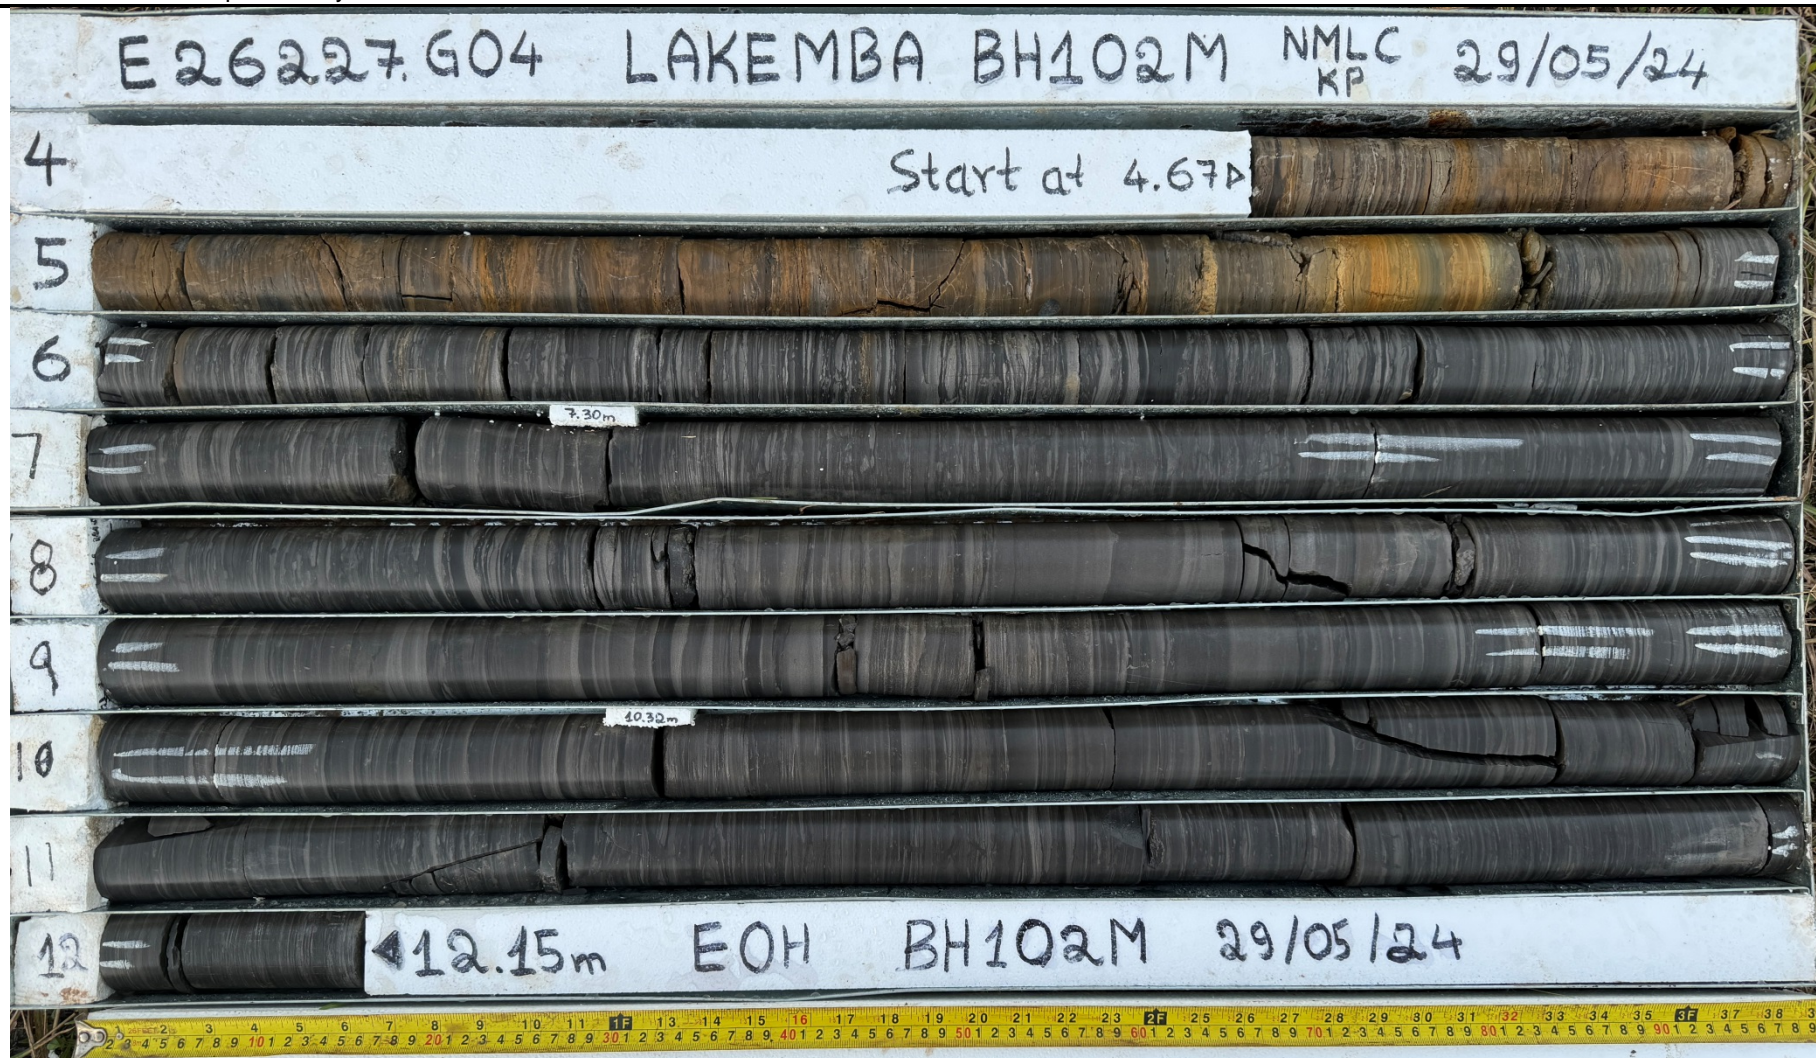
CORE PHOTOGRAPH OF BOREHOLE: BH102M

Project	Proposed Development	East	321991.0430	Depth Range	4.67m to 12.15m BEGL
Location	5-9 Croydon Street, Lakemba NSW	North	6245115.8197	Contractor	GeoSense Drilling & Engineering Pty Ltd
Position	See Figure 2	Surface RL	≈ 25.10m	Drill Rig	Comachhio Geo 205
Job No.	E26227.G04	Inclination	-90°	Logged	KP Date 29 / 5 / 2024
Client	Eloura Developments Pty Ltd	Box	1 & 2 of 2	Checked	SK Date 5 / 7 / 2024

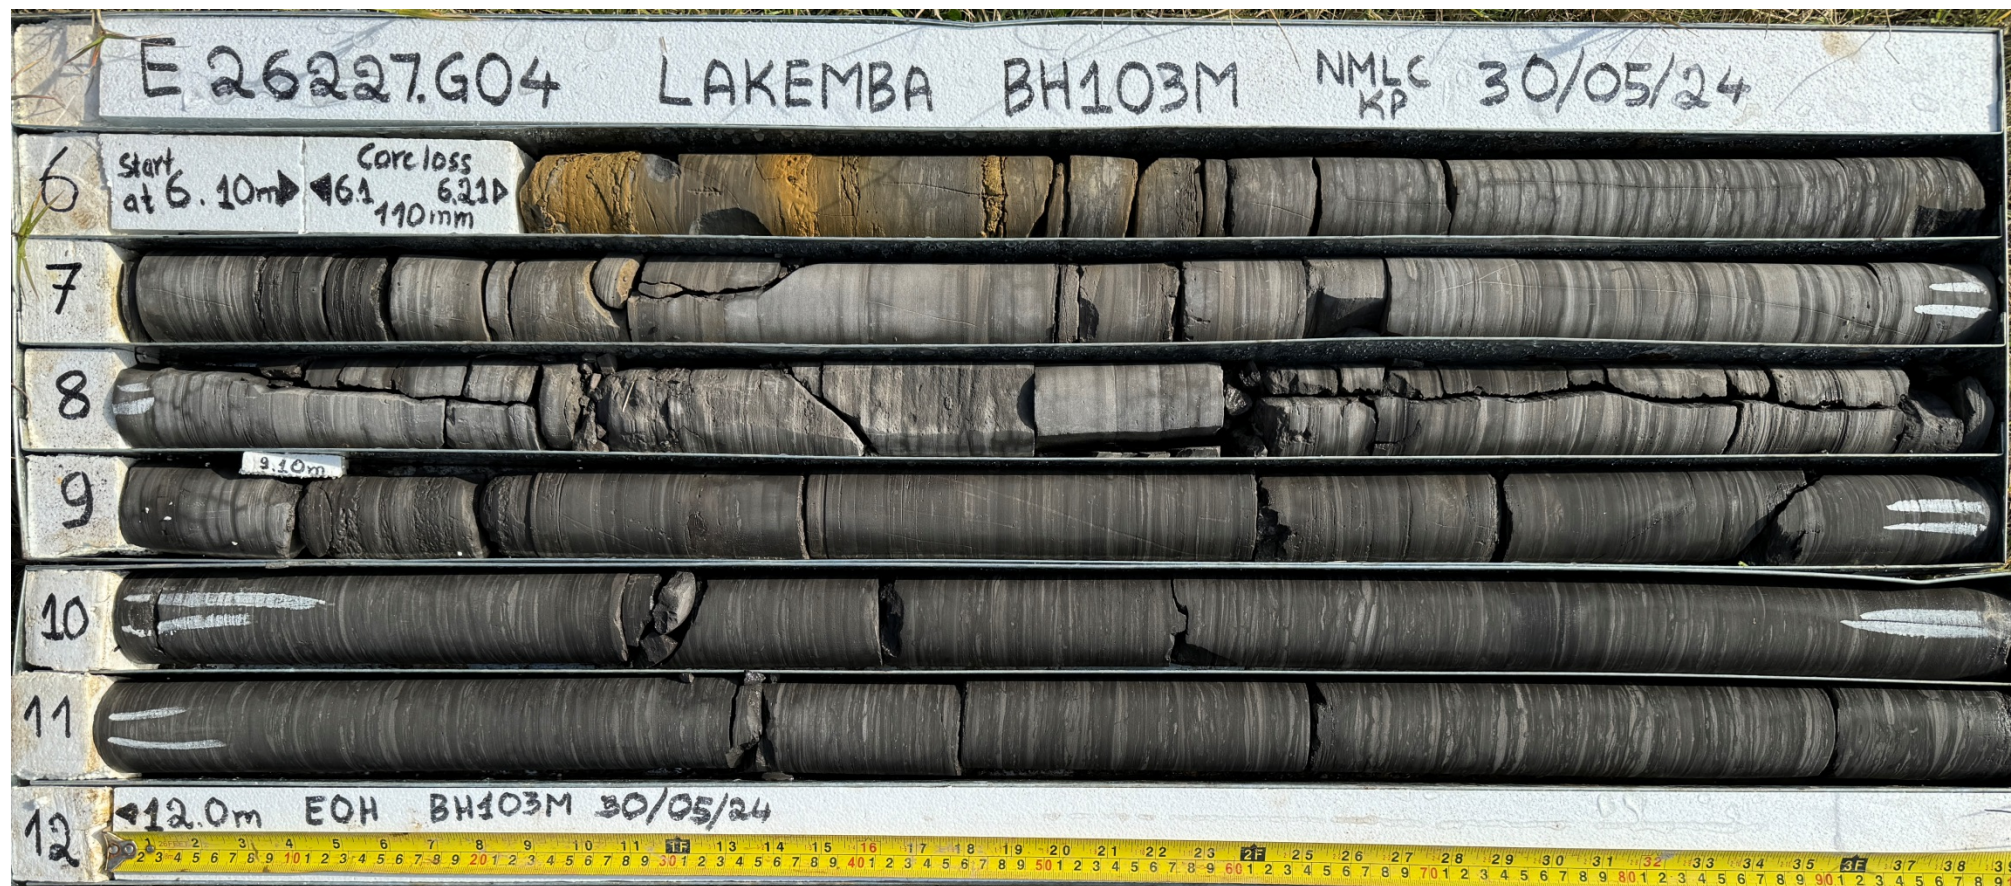
CORE PHOTOGRAPH OF BOREHOLE: BH103M

Project	Proposed Development	East	321966.1116	Depth Range	6.10m to 12.00m BEGL
Location	5-9 Croydon Street, Lakemba NSW	North	6245044.8211	Contractor	GeoSense Drilling & Engineering Pty Ltd
Position	See Figure 2	Surface RL	≈ 24.90m	Drill Rig	Comachio Geo 205
Job No.	E26227.G04	Inclination	-90°	Logged	KP Date 29 / 5 / 2024
Client	Eloura Developments Pty Ltd	Box	1 & 2 of 2	Checked	SK Date 5 / 7 / 2024

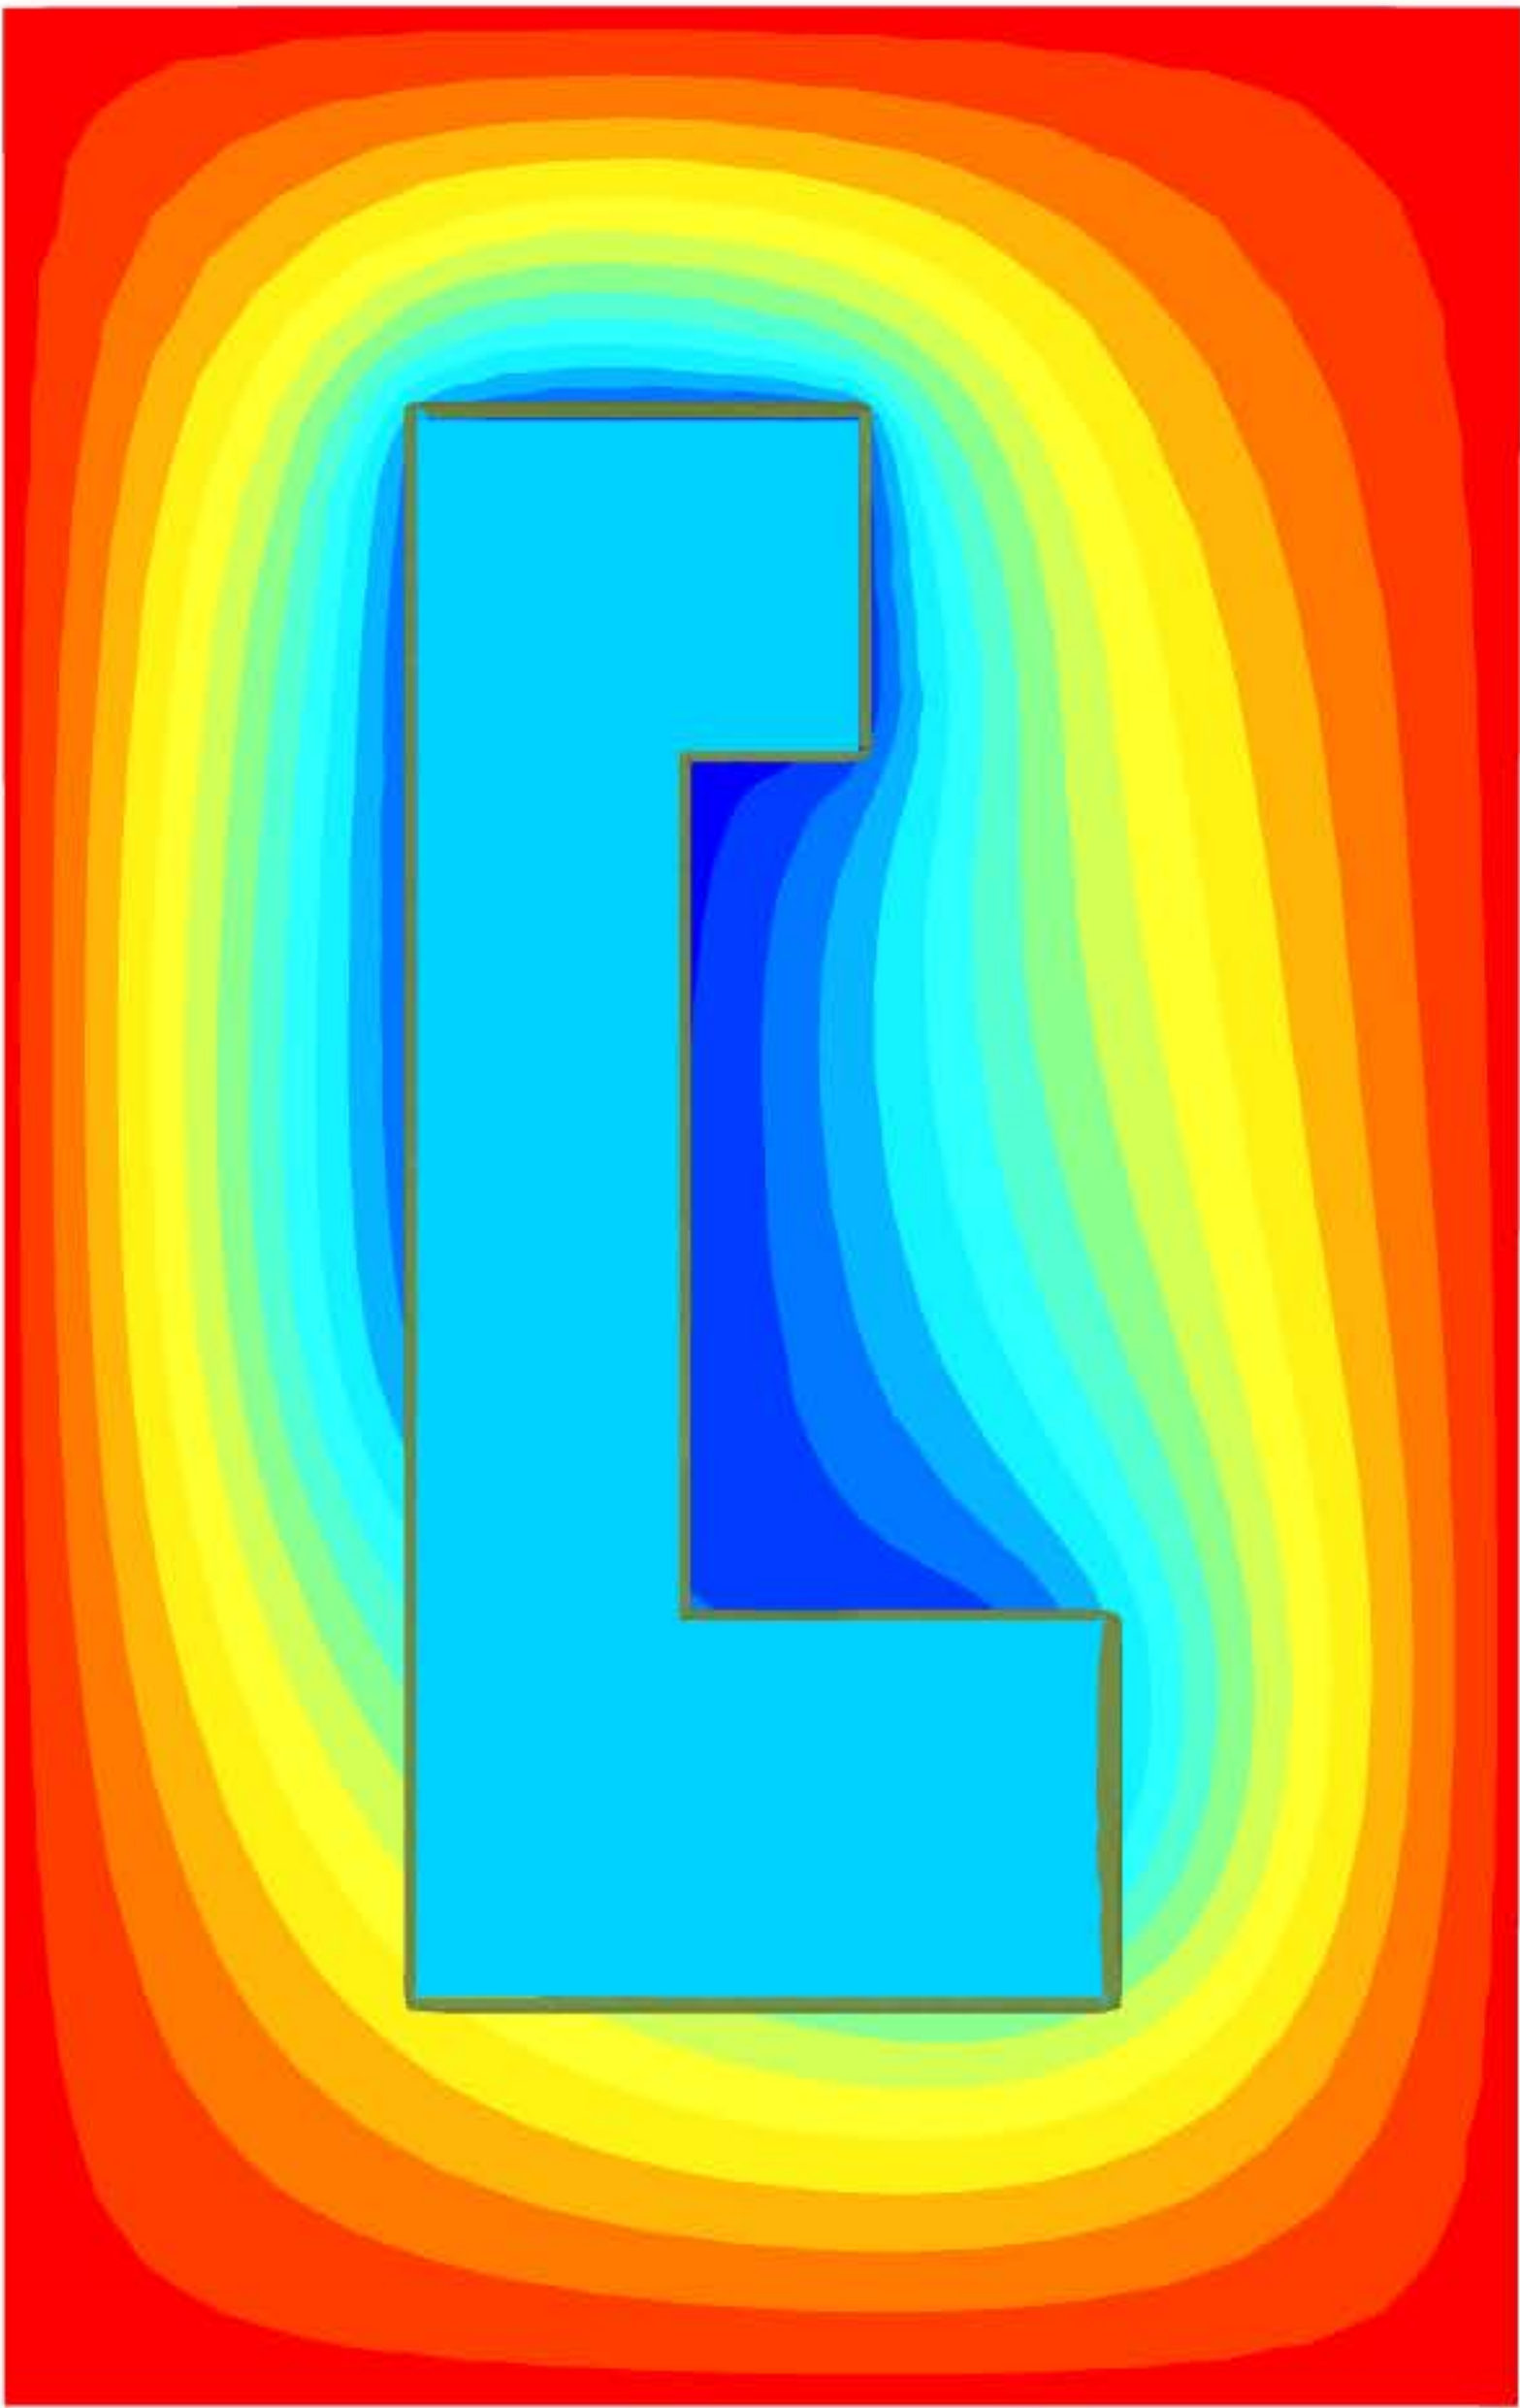
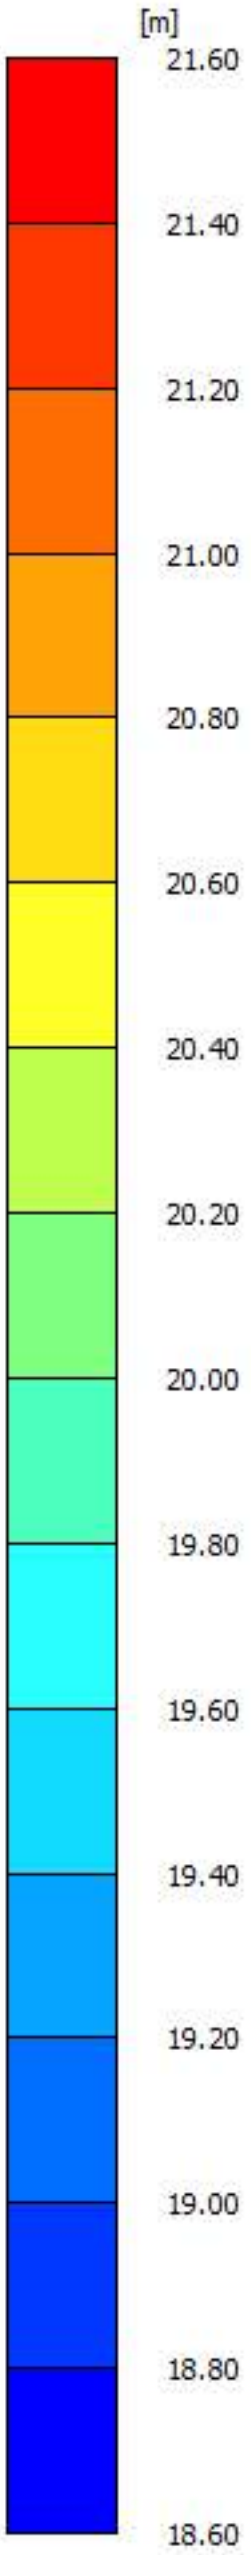
Groundwater head (scaled up 0.200 times)

Maximum value = 21.51 m (Element 37882 at Node 431)

Minimum value = 18.65 m (Element 39513 at Node 23147)

Groundwater seepage analysis for flow through and beneath the excavation wall system during construction has been undertaken using PLAXIS 3D, finite element analysis software with the capability of simulating hydrological conditions in construction sites. This model estimates the volume of water which will be required to be dewatered during the construction of the basement.

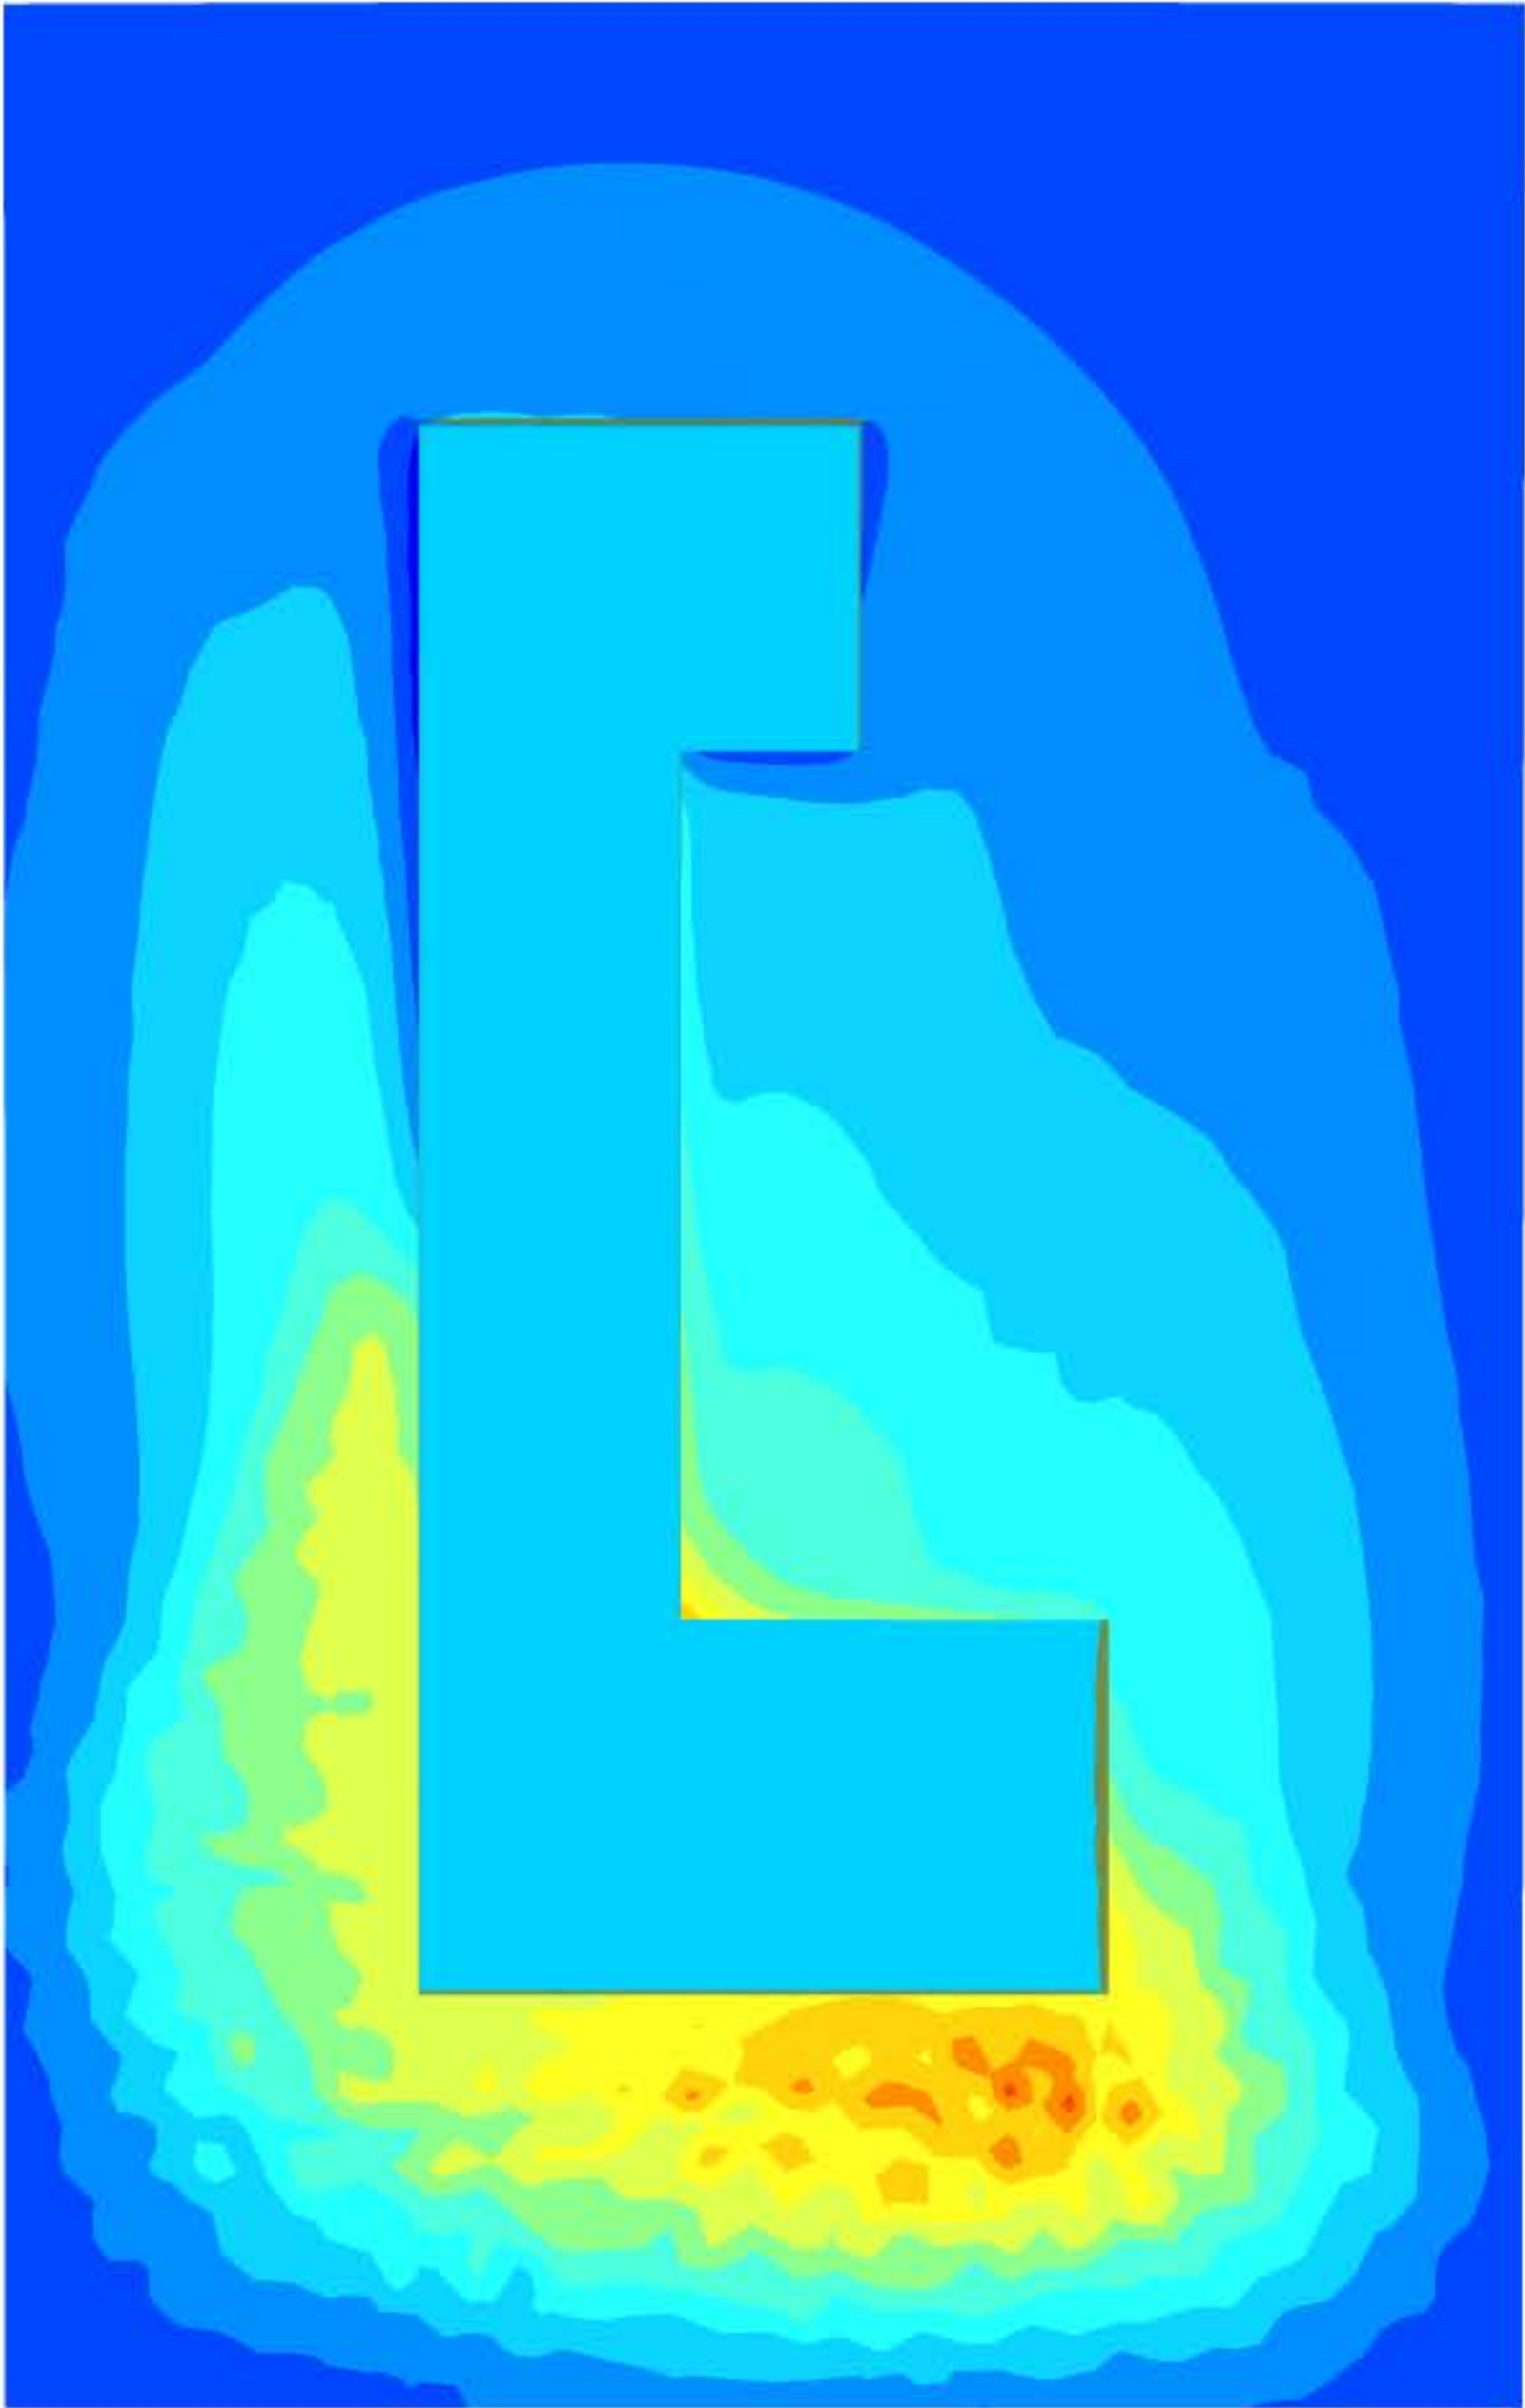
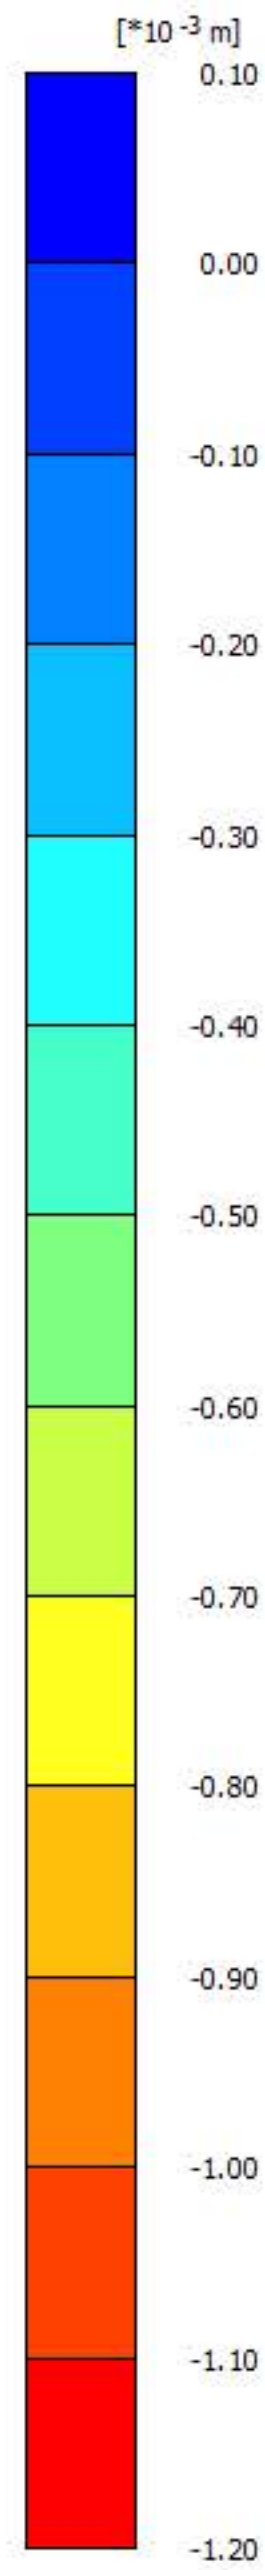
Total displacements u_z (scaled up $5.00 \cdot 10^{-3}$ times)

Maximum value = $0.07174 \cdot 10^{-3}$ m (Element 2620 at Node 6354)
