ELOURA DEVELOPMENTS LAKEMBA

Hydrogeological Investigation

5-9 Croydon Street, Lakemba, NSW

E26227.G04_Rev1

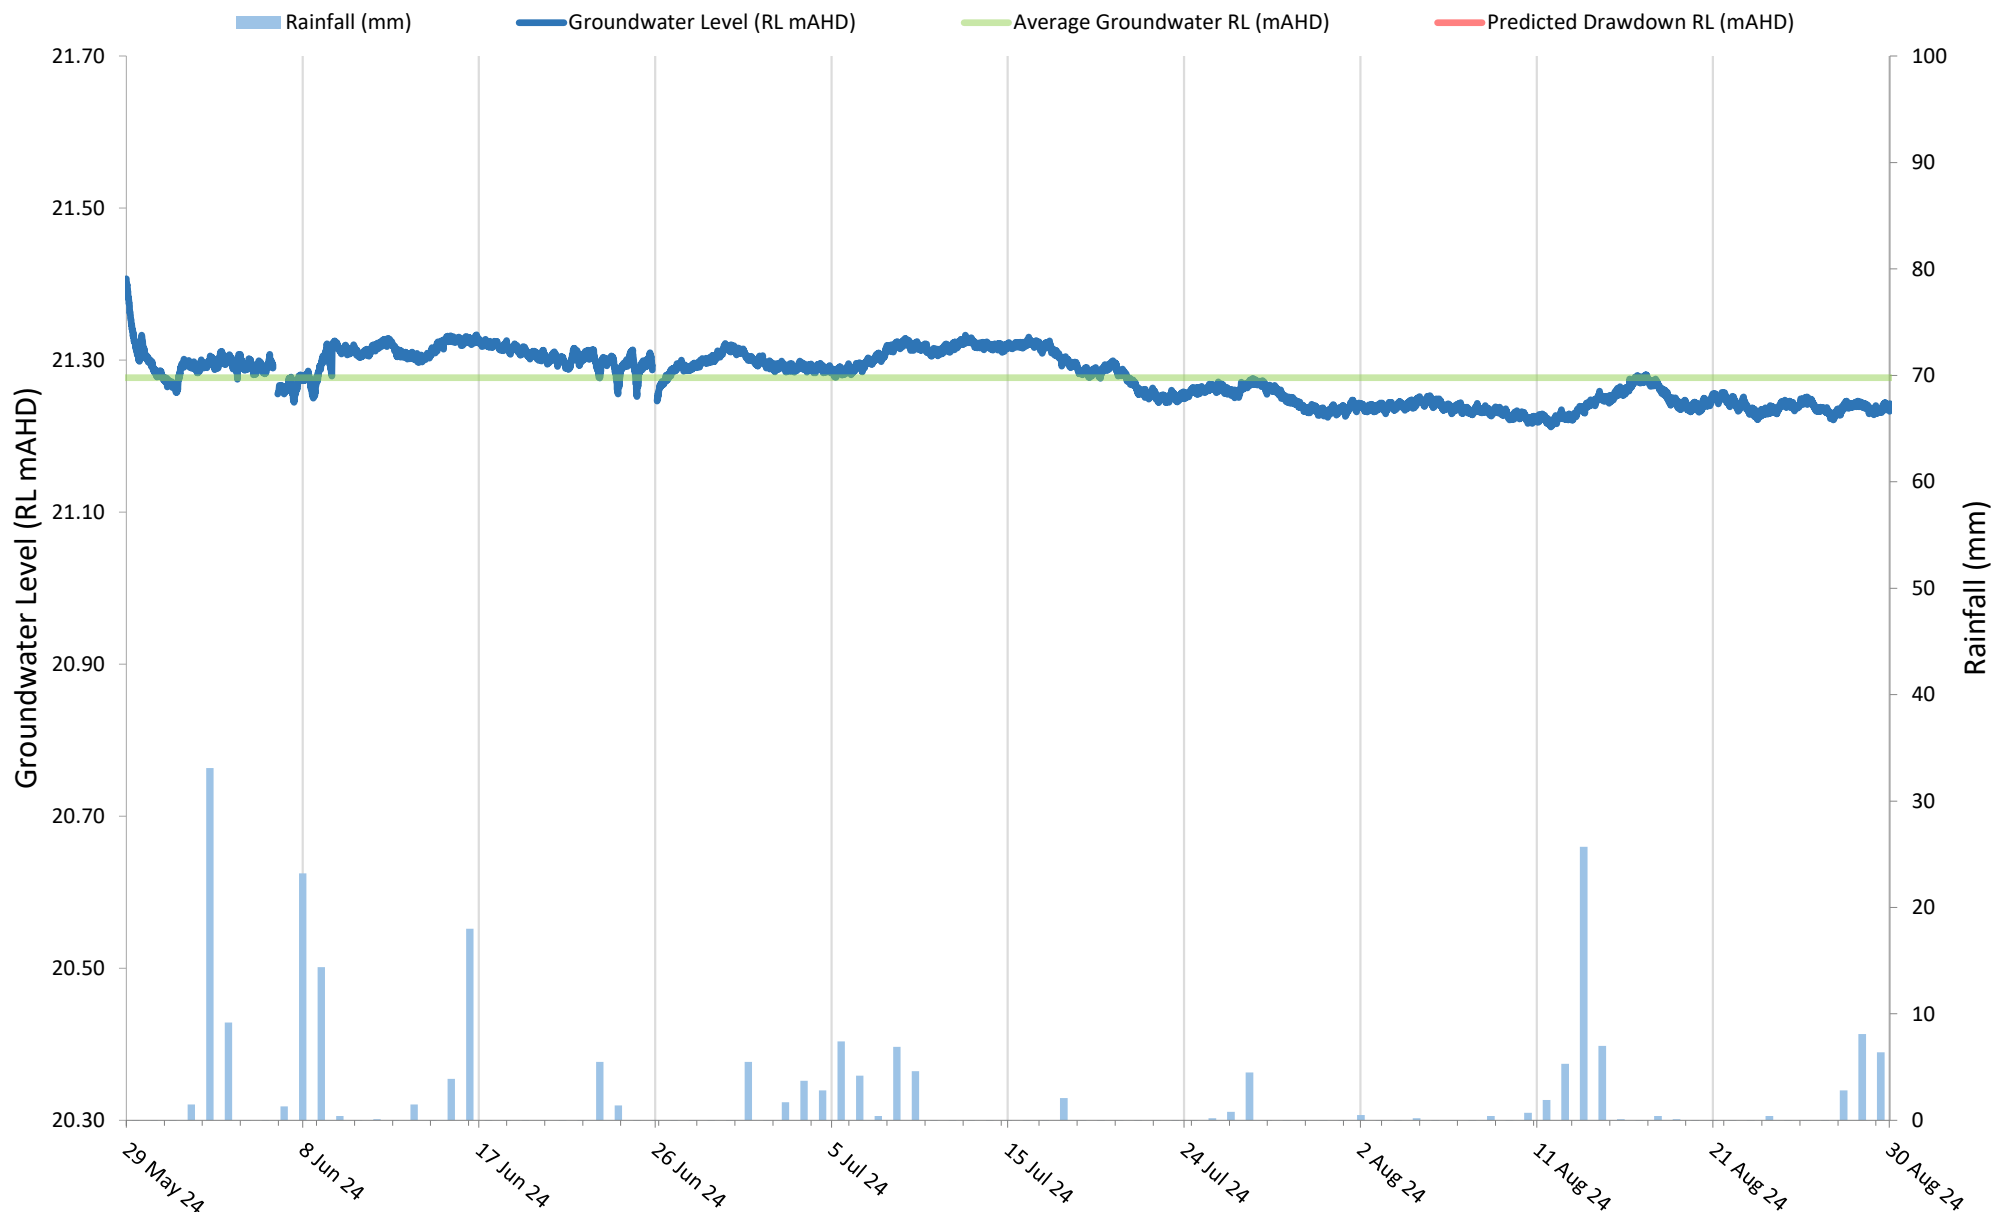
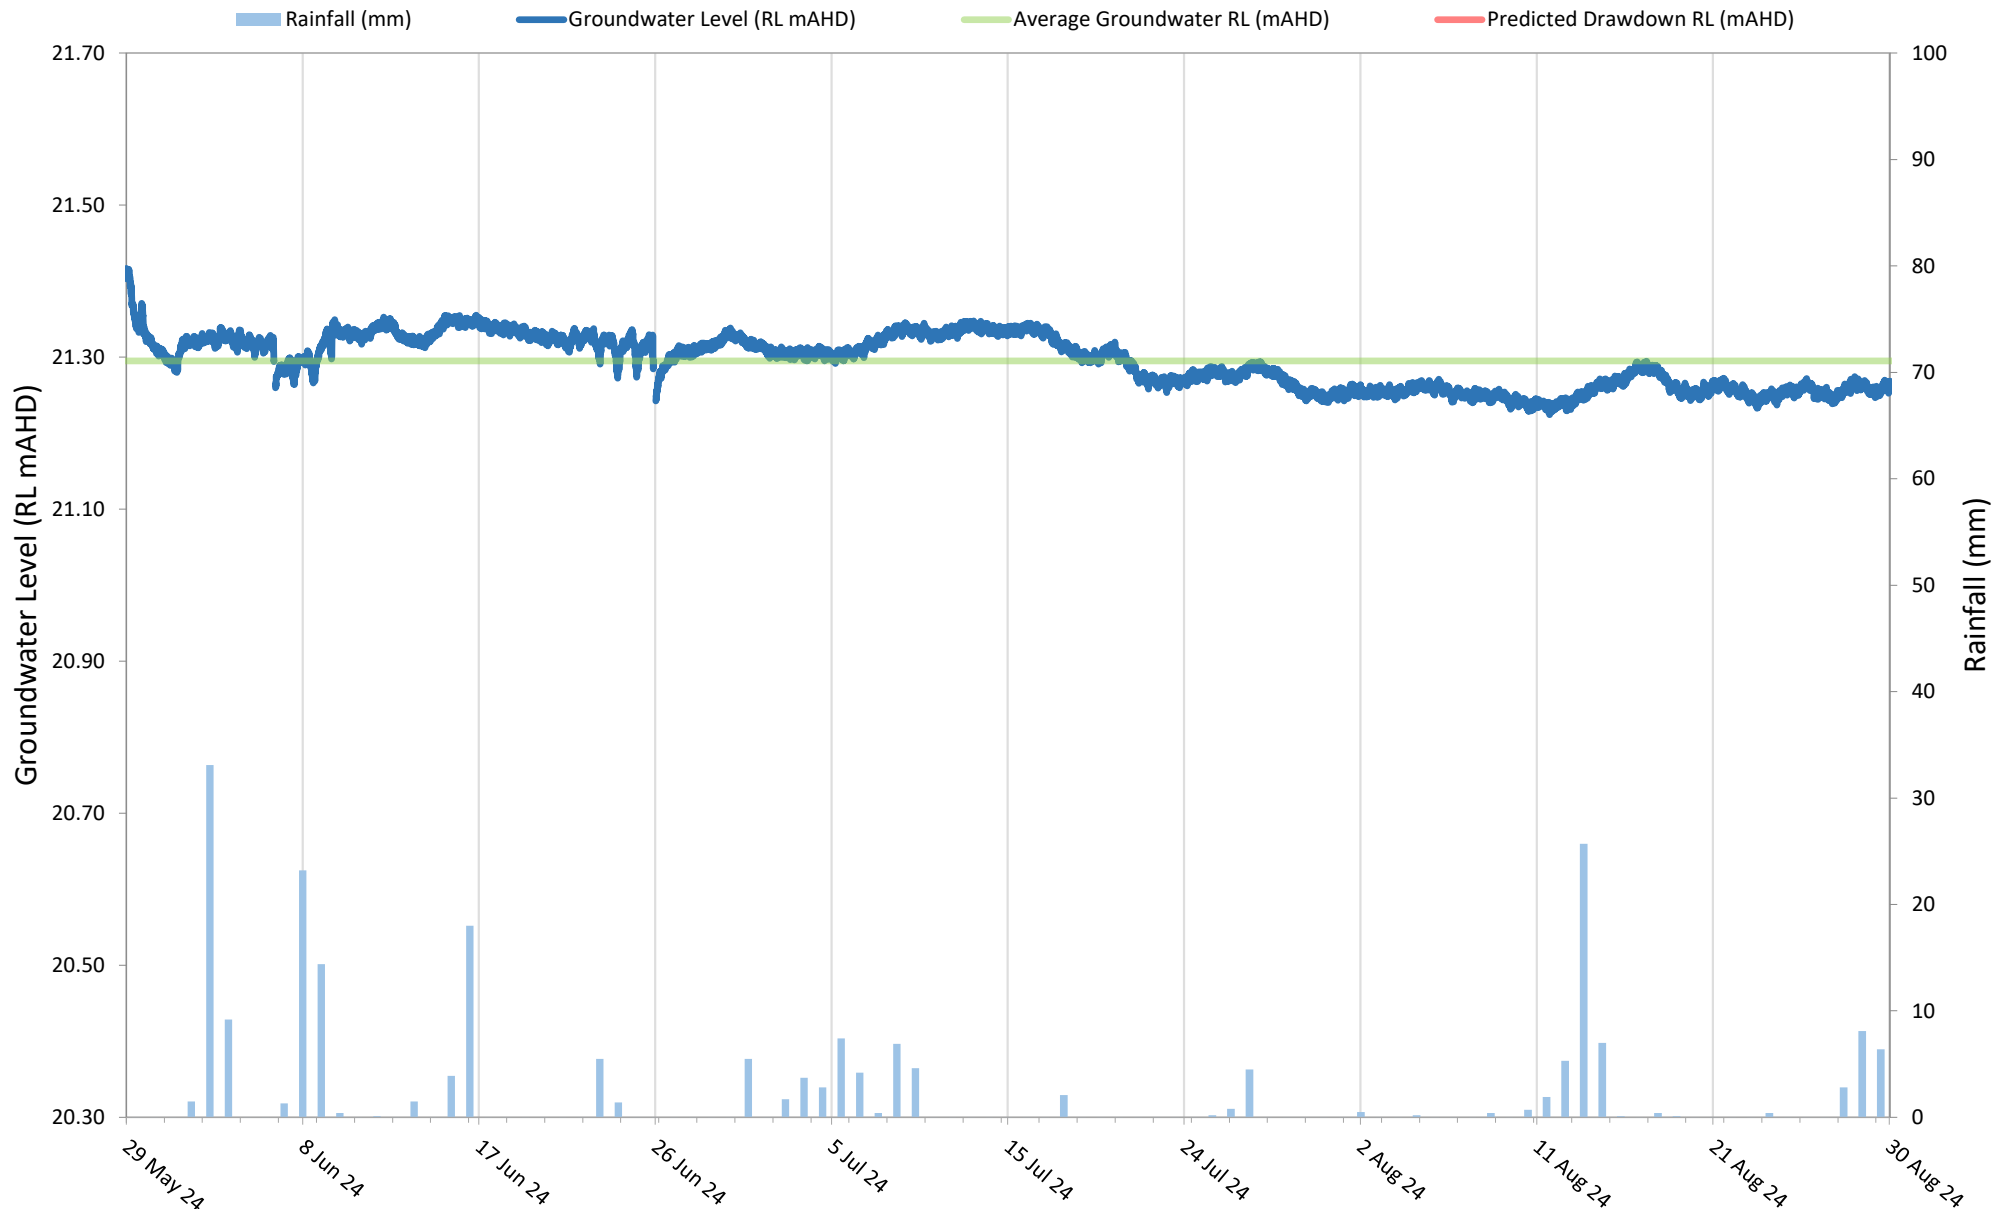
Data Logger Location Plan
Groundwater Level, Daily Rainfall vs. Time From 29 May 2024 to 30 August 2024

Groundwater was observed in all monitoring wells as detailed in **Table 3-3**.
