# The Homestead, Georges Hall

## Conservation Management Plan

February 2024

Prepared for Hope Point School

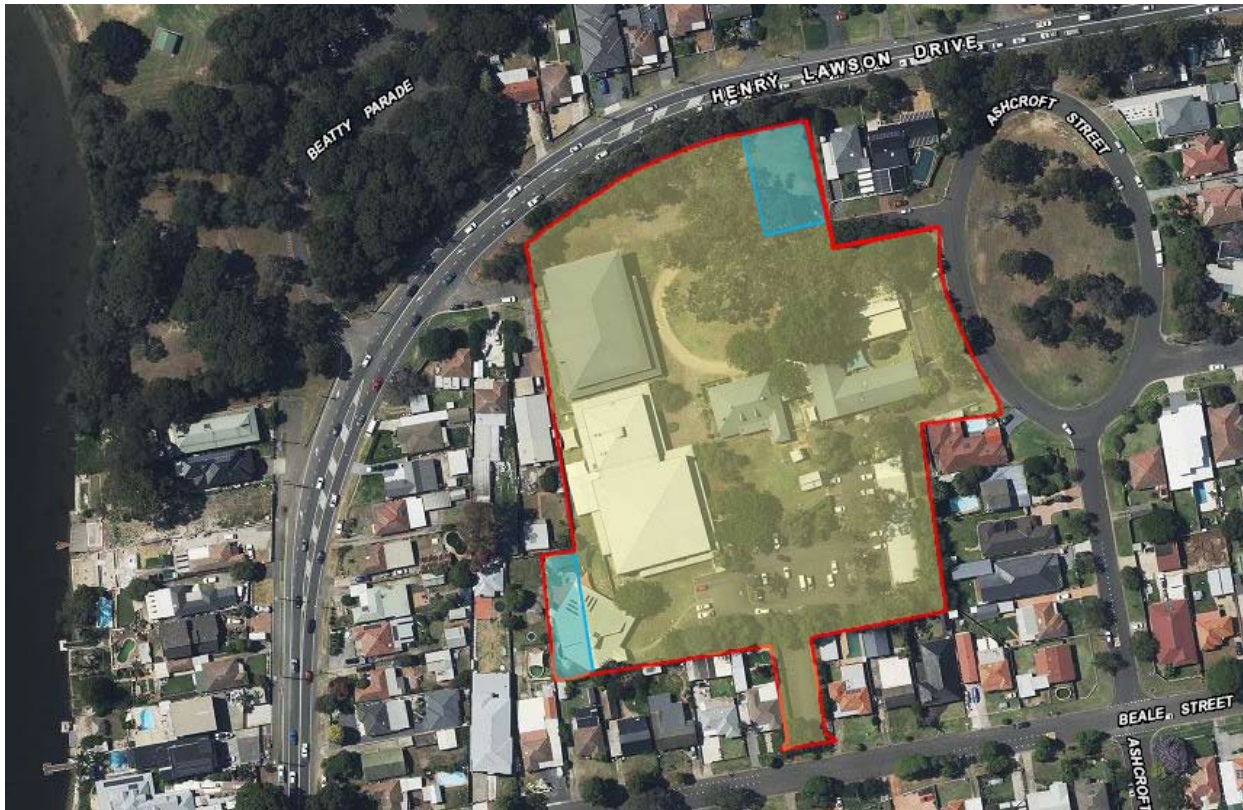
*Figure 3: Aerial View. Subject site edged in red. Heritage curtilage shaded yellow and areas recently added shaded blue. (Sixmaps 2024 with edits by JPA&D)*

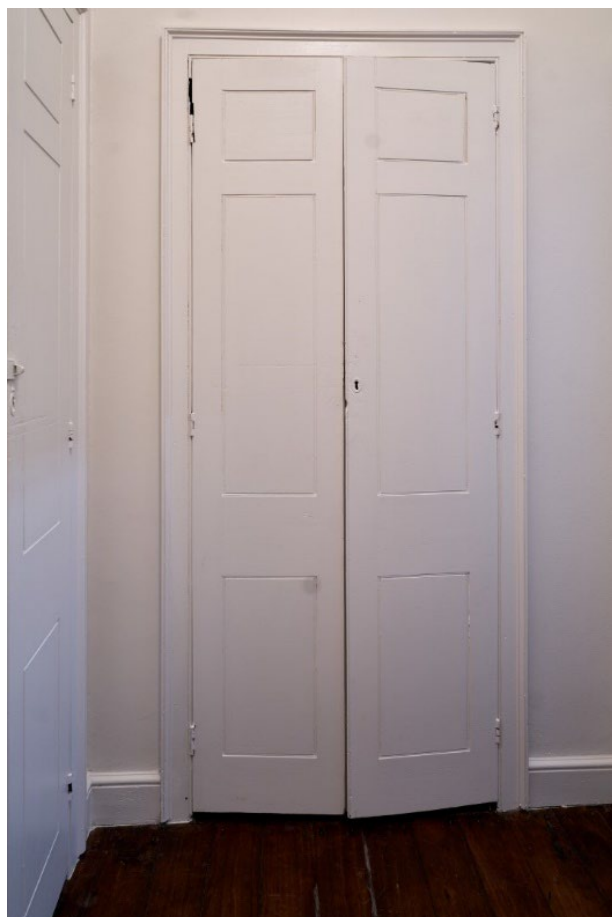
Figure 11: Exterior view of built in cupboard doors

The three fitted cupboards in the storeroom are unusual and appear to be original. The doors are panelled and although they have been painted white externally, the inside shows the original timber.

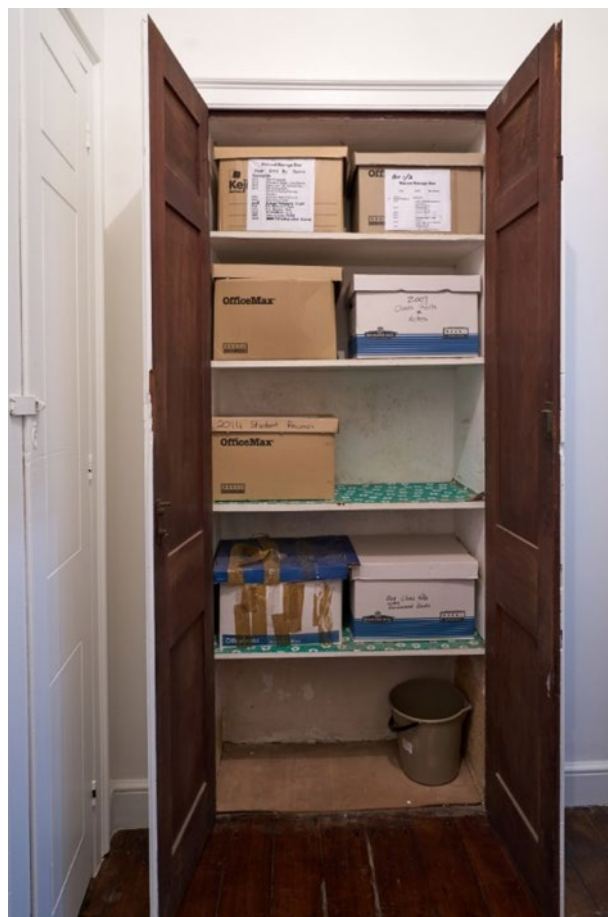
Figure 27: Interior of cupboard showing original timber

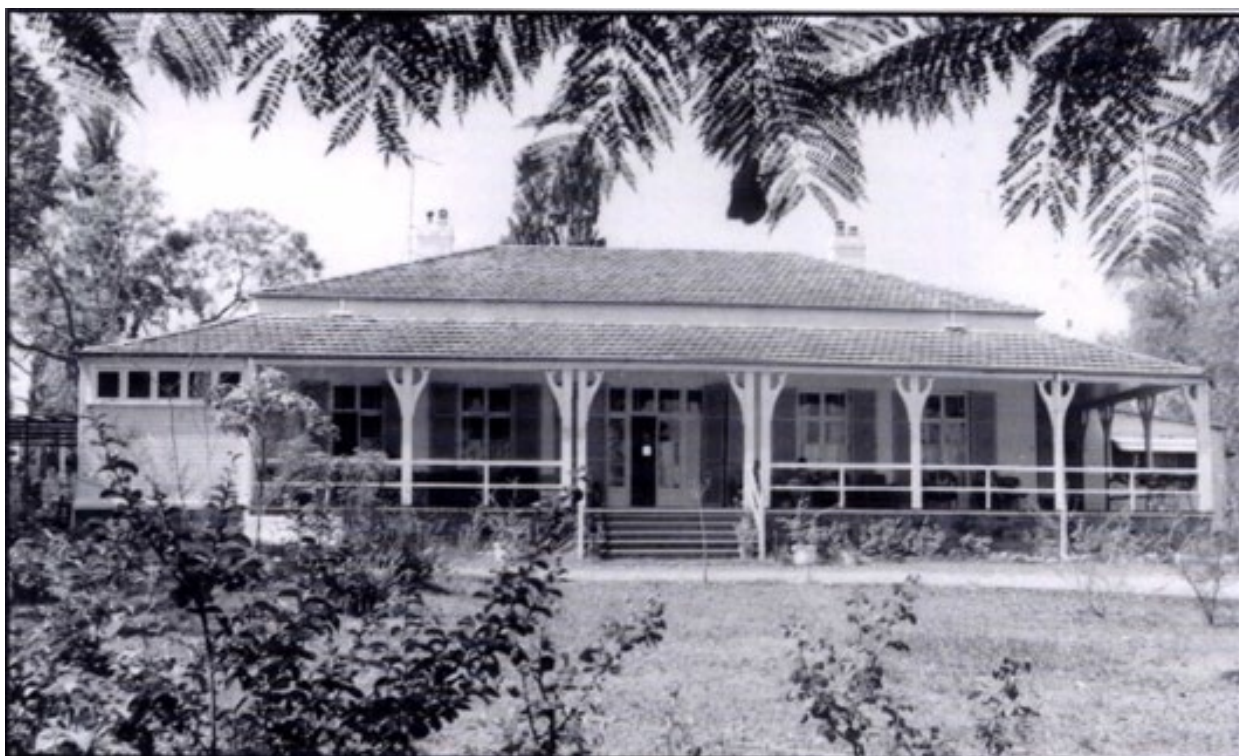
*Figure 28: The north elevation of the homestead c. 1960 showing the infill to the verandah, changes to the verandah and an extension to the west of the building.*

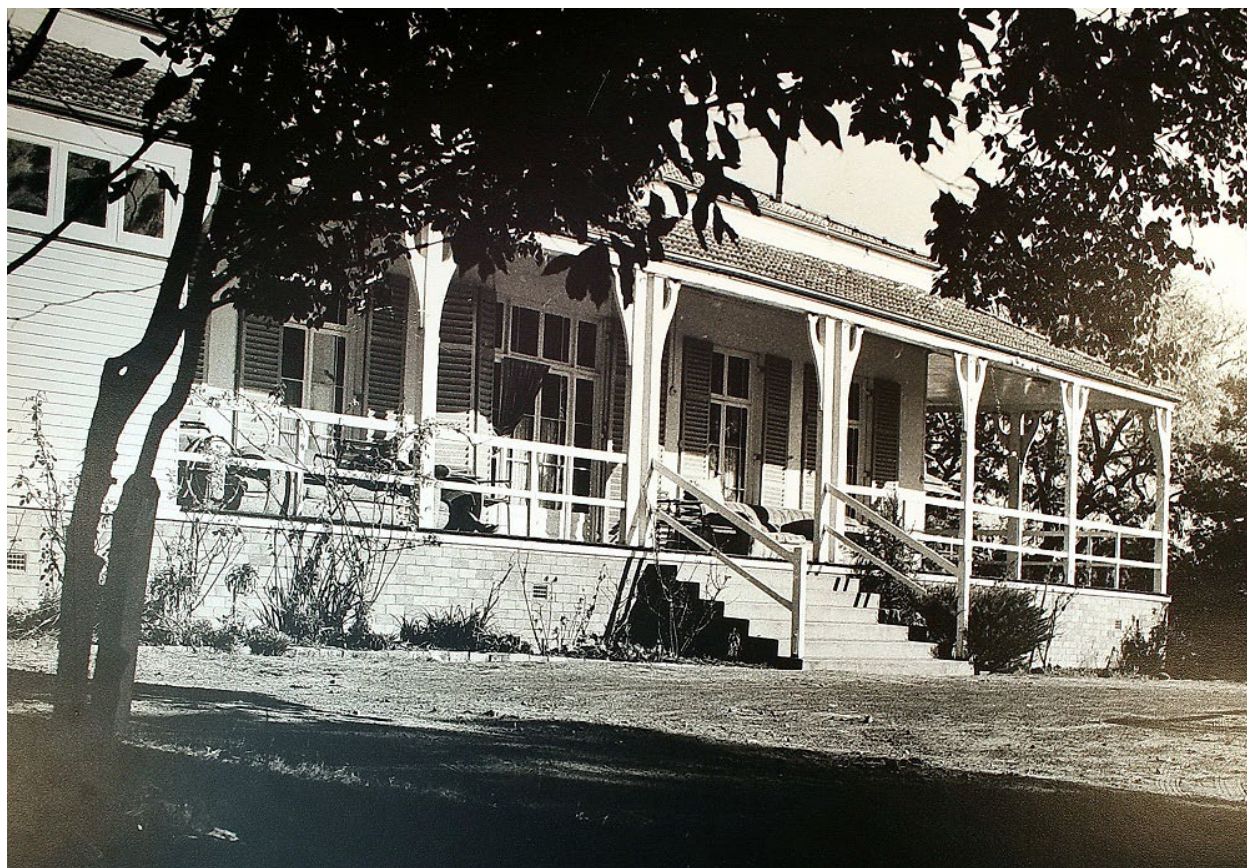
*Figure 12: View of the front verandah c1960. Note the brick wall to the verandah, concrete steps, horizontal balustrade and infill to the northeast corner. Canterbury Bankstown LibraryPH-0001940*

The original wall below the verandah was demolished c. 1959 and replaced with a brick wall below and a horizontal timber balustrade. The original balustrade design was reproduced from archival photographs and installed during the works in the 1990s. It is highly probable that the construction of the original verandah was a stone and brick wall structure with fill supporting the stone flagging of the verandah floor. The present verandah floor is timber. There is no obvious evidence of a damp-proof course and some areas of brick and stone in the cellars have been cement rendered in an attempt to repair damage caused by rising damp.

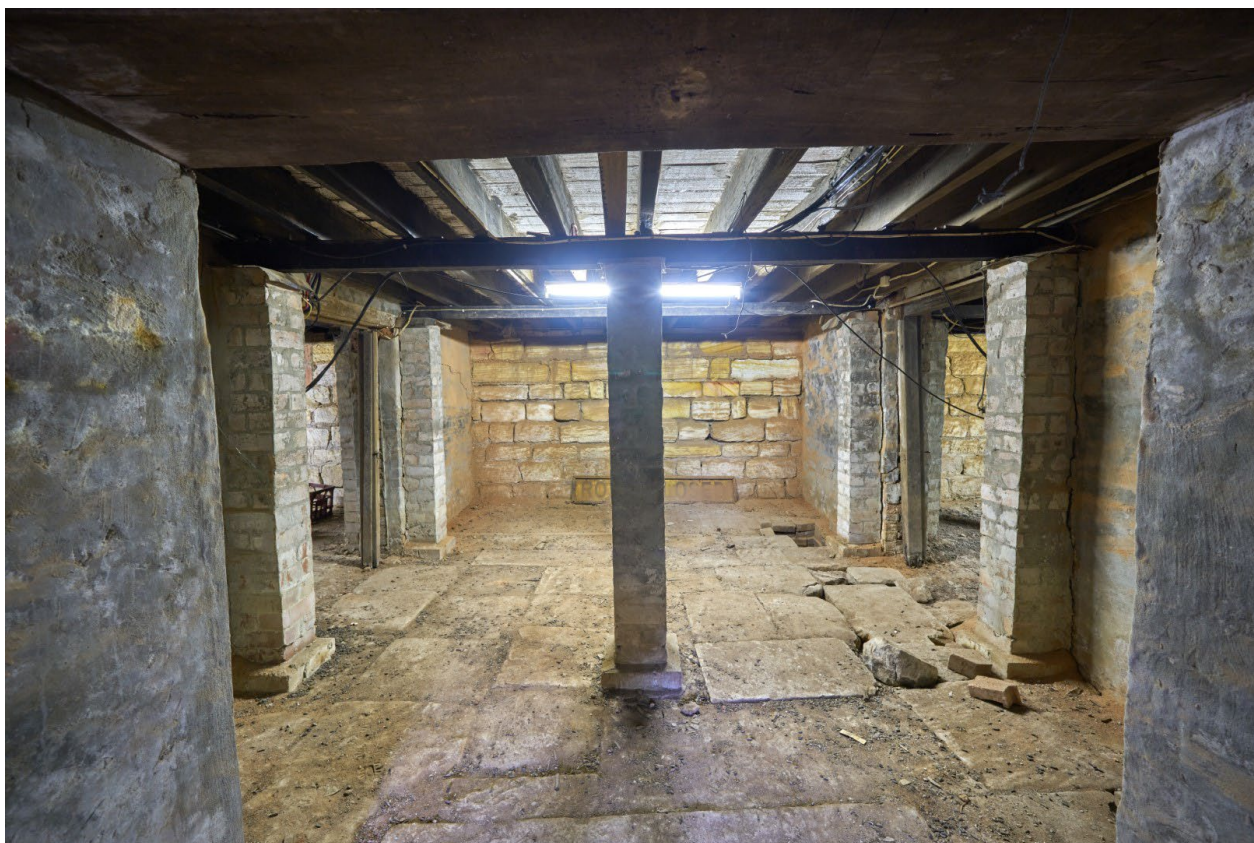
Figure 21: The Basement looking north from the entrance showing stone flagged floor and stone north wall.

The central floor of the cellar is flagged in sandstone whilst the side rooms were of rammed earth construction. The rammed earth floors were consolidated during the 1990s works but they have since deteriorated and now appear in large, cracked cakes. The ground level floor is of timber on pit sawn joists which are now supported on recent 230 x 230mm brick piers. The underside of the ground level floor can be viewed from the cellar below. The upper floor is similar to the ground floor. The verandahs were once stone flagged but are now timber.
