Our ref: 7237-G1 Rev1  
11 June 2025

## **Ski Slope above Guthega Nordic Centre, Guthega NSW Geotechnical Assessment**

This report presents the results of a geotechnical assessment for the proposed redevelopment of the Ski Slope above Guthega Nordic Centre at Guthega NSW (the Site). The assessment was commissioned on 10 November 2022 by Andrew Kennedy of Vail Resorts. The work was carried out in accordance with the email proposal by AssetGeoEnviro (Asset) dated 21 April 2023, reference 70237-P1.

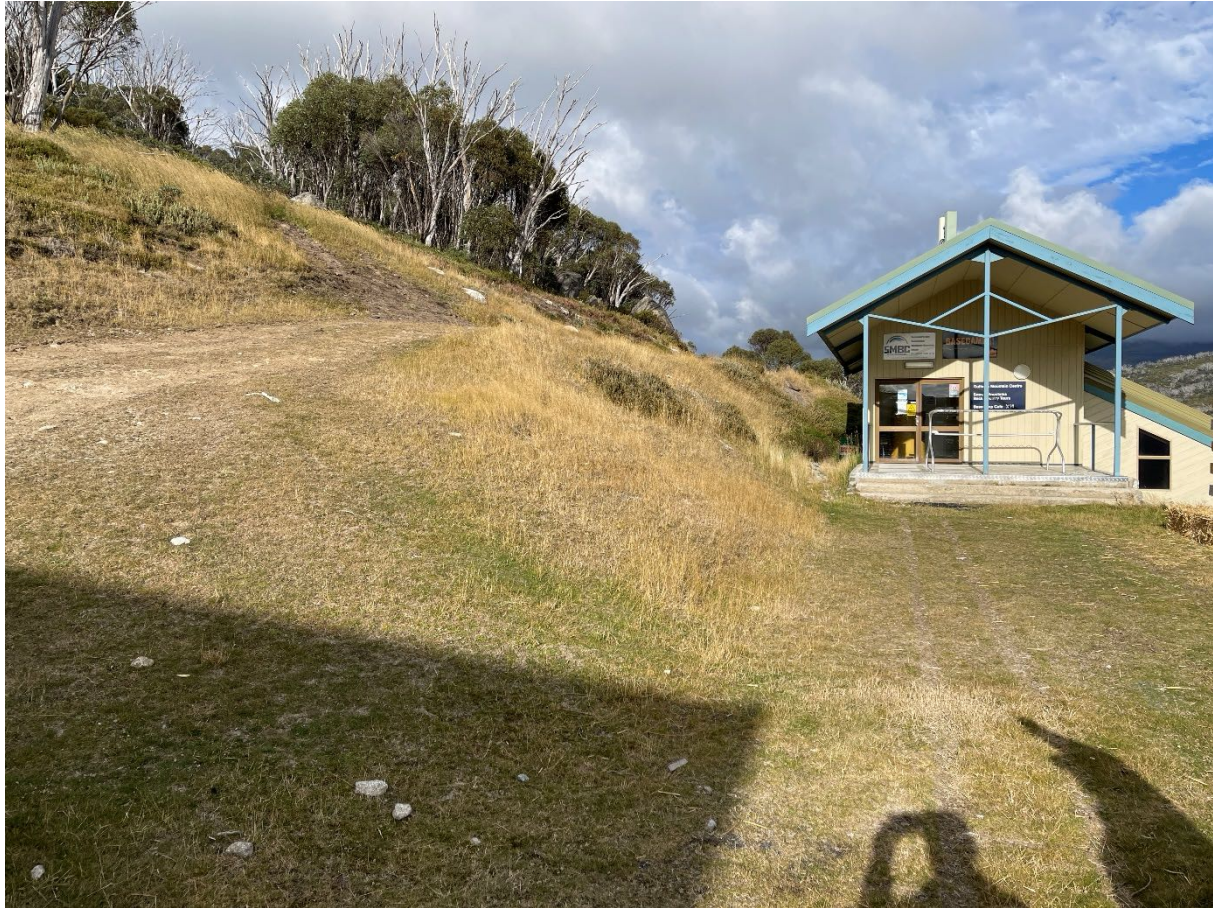
**Photo 1**

General view of slope at rear of Guthega Nordic Centre.

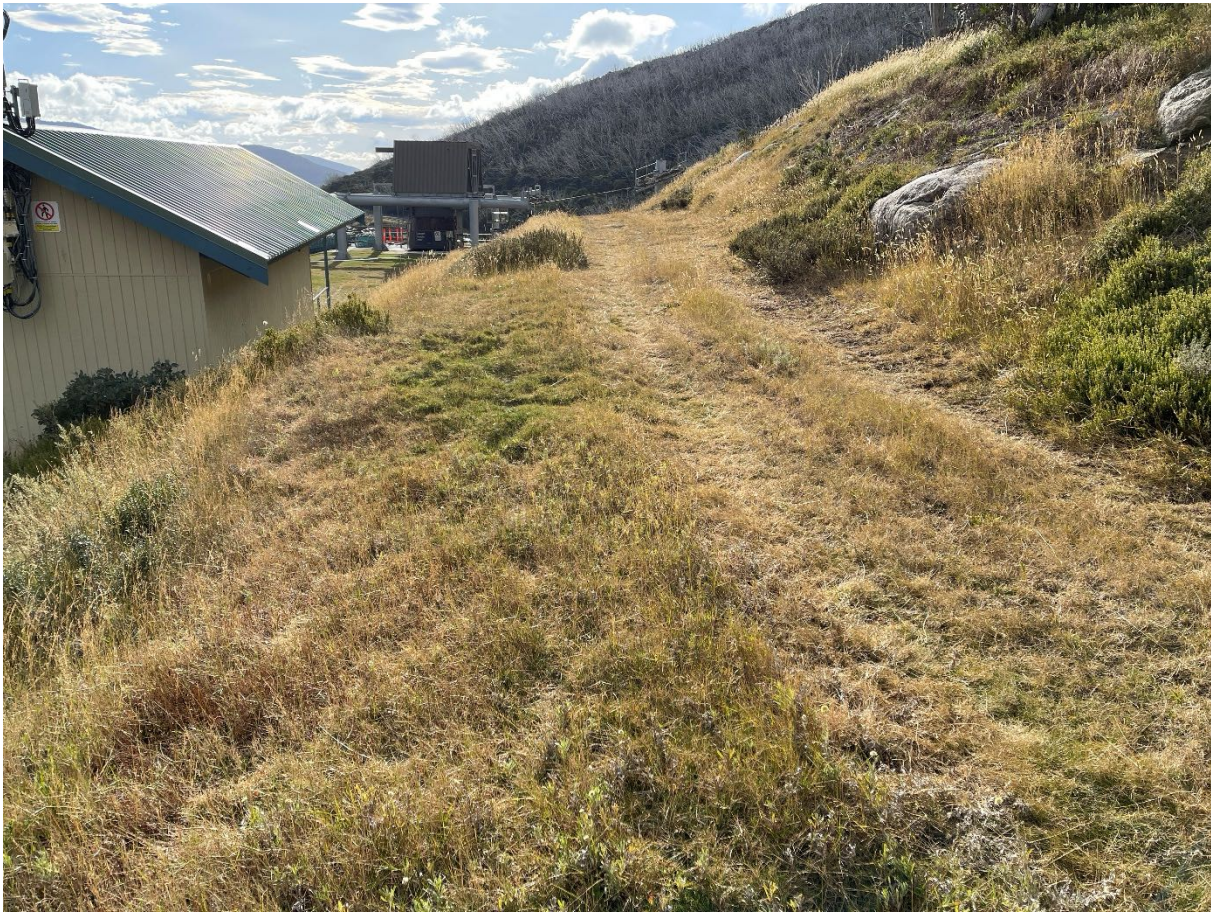
**Photo 2**

General view looking along track to be widened, Guthega Nordic Centre downslope.

Widening and lowering the existing track will require cutting of up to about 1.2m depth into the existing slope above the track. It will not be feasible to batter this slope due to the existing slope angle. It will therefore be necessary to construct a retaining wall to support the uphill slope where the cut exposes soil and extremely / highly weathered granite. If less weathered granite is exposed, no retaining would be required (subject to inspection by a geotechnical engineer).

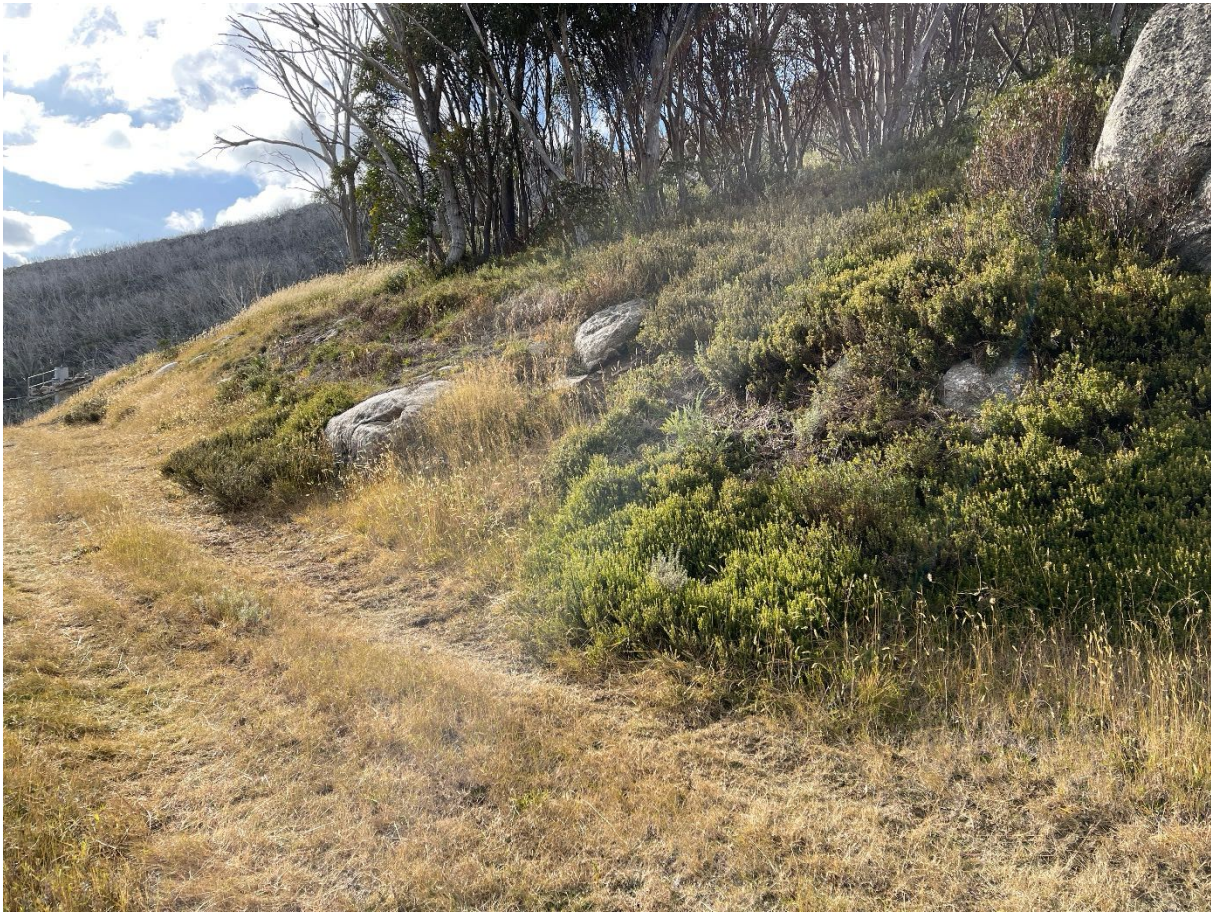
**Photo 3**

Granite rocks can be seen outcropping in the site vicinity and numerous granite boulders were observed within the slope above the track. It is expected that variably weathered granite is located at relatively shallow depth below the ground surface.

Continuation of Photo 2, note boulders exposed in slope above track.

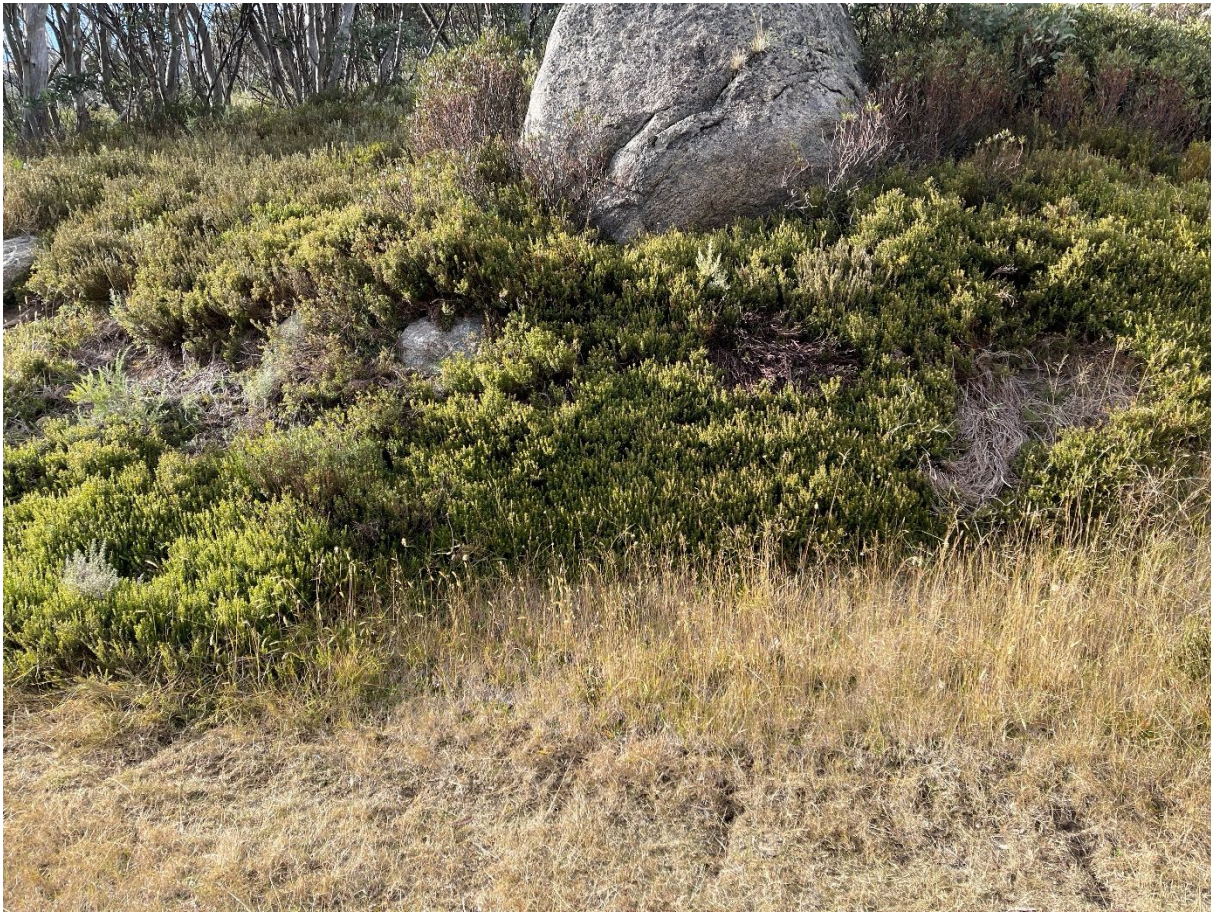
**Photo 4**

Continuation of Photo 3, note exposed boulders above track.

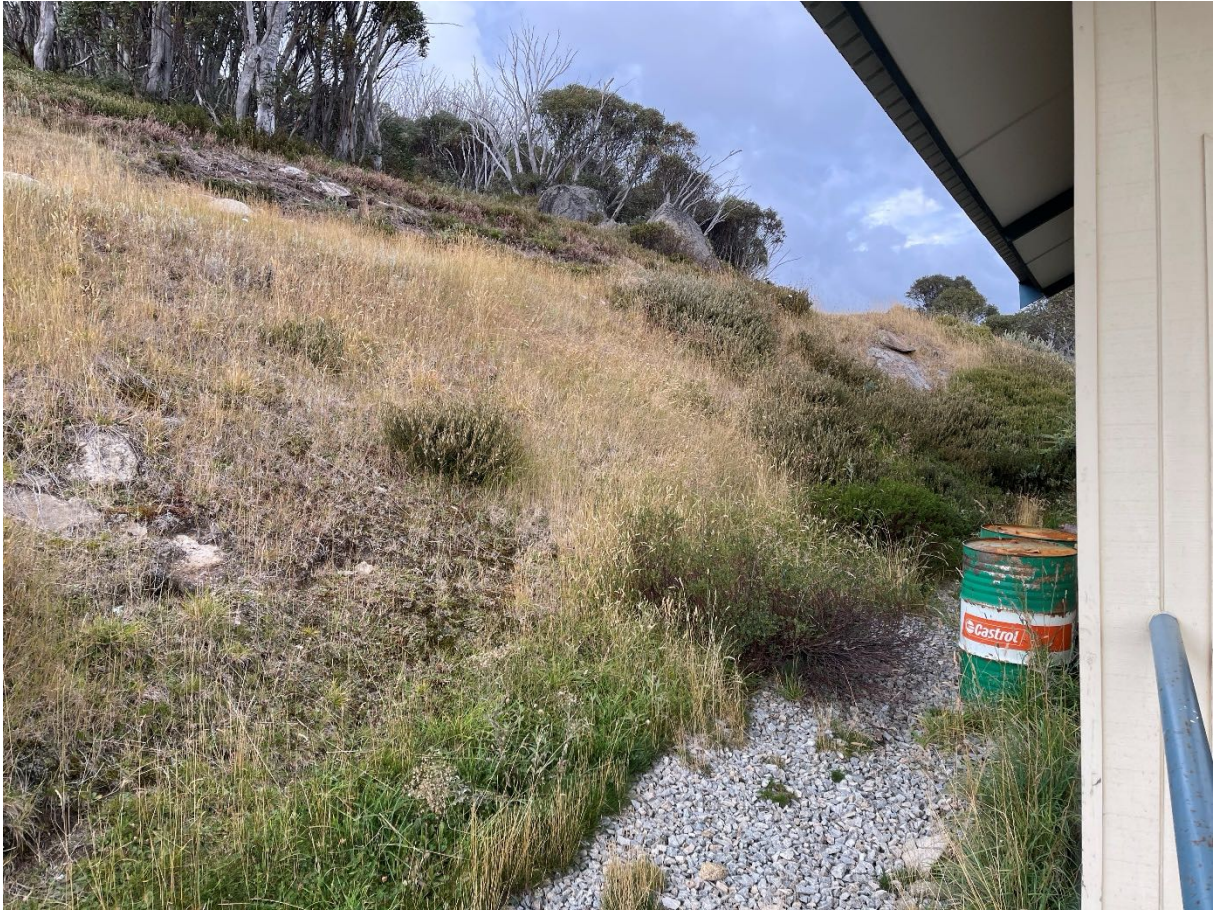
**Photo 5**

The slope below the track would not require modification as part of the development.

View of slope between track and Guthega Nordic Centre.
