Geotechnical Investigation Report

**29 Grey Street, Clarence Town,
NSW, 2321**

230855-PRJ1278804-GEO-REP-01

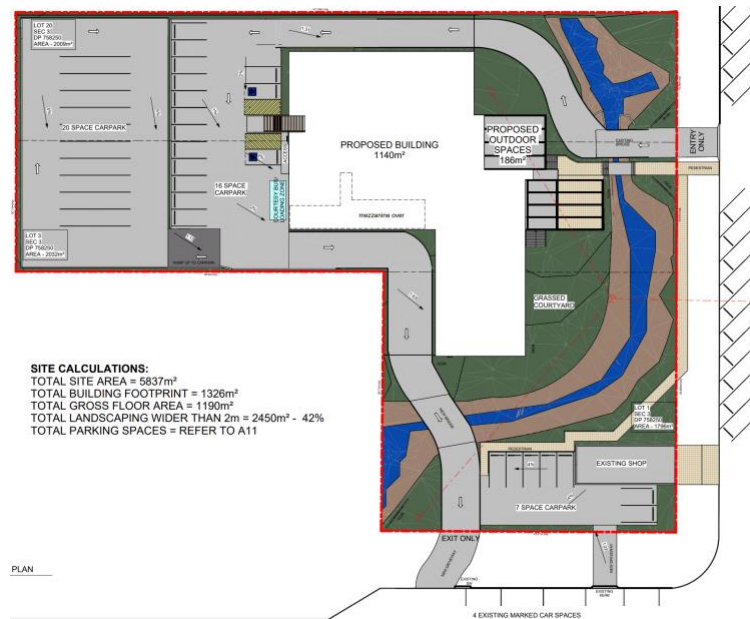
Based on the traffic loading, the road type of the site was defined in the figure as follow.

Figure 7-1 Pavement Areas

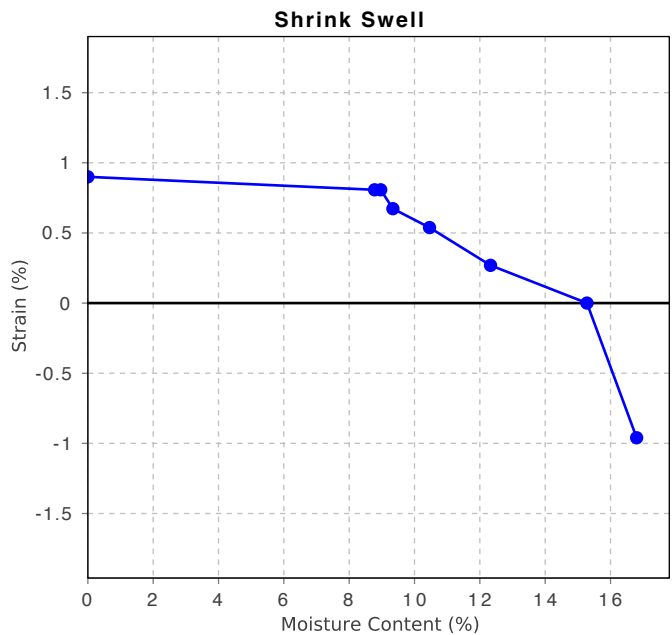
Shrink Swell Index (AS 1289 7.1.1 & 2.1.1)	
Iss (%)	0.8
Visual Description	Sandy CLAY, light brown, medium plasticity, soft
* Shrink Swell Index (Iss) reported as the percentage vertical strain per pF change in suction.	
Core Shrinkage Test	
Shrinkage Strain - Oven Dried (%)	0.9
Estimated % by volume of significant inert inclusions	0
Cracking	Moderately Cracked
Crumbling	No
Moisture Content (%)	15.3
Swell Test	
Initial Pocket Penetrometer (kPa)	350
Final Pocket Penetrometer (kPa)	
Initial Moisture Content (%)	15.3
Final Moisture Content (%)	16.8
Swell (%)	1.0
* NATA Accreditation does not cover the performance of pocket penetrometer readings.
