# Alera

PROJECT: Club Mount Lewis

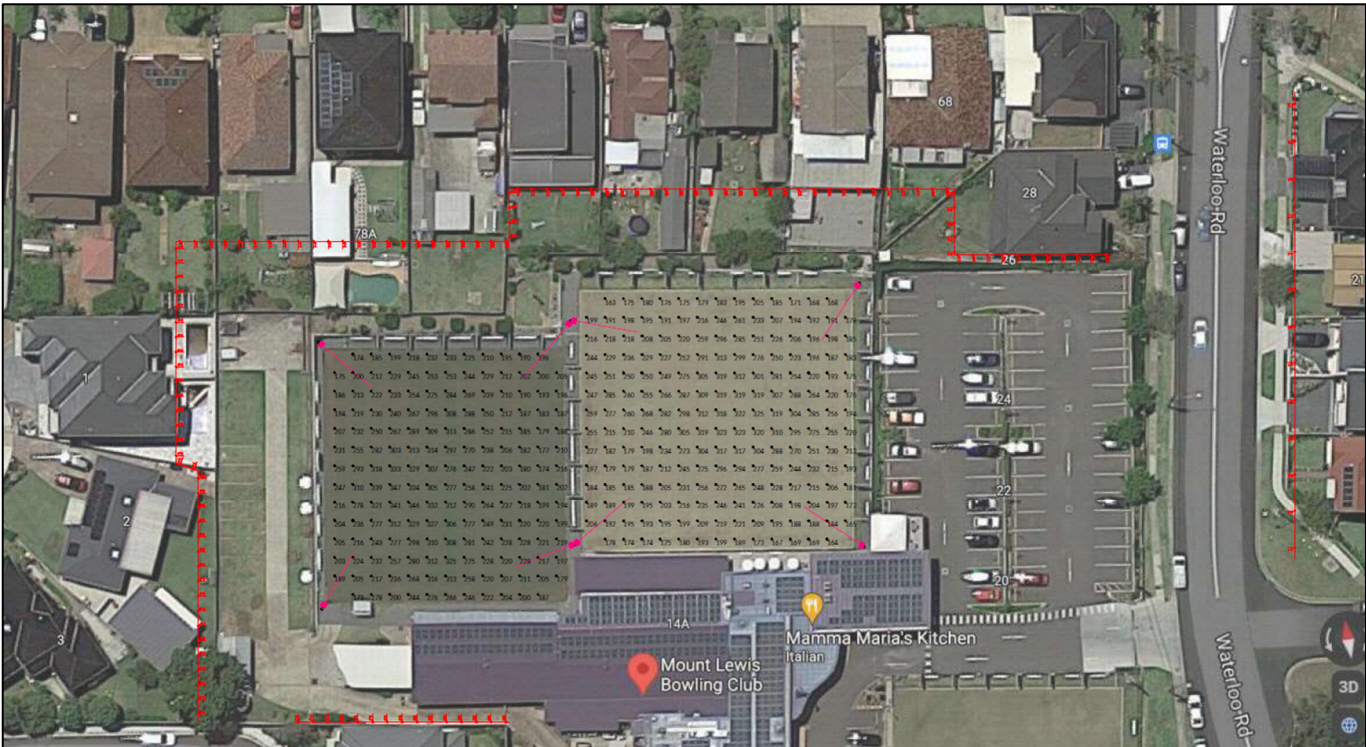
Figure 3. Proposed Lighting Plan (Source: Legacy Lighting, 2024)

The proposed Design Drawings including a specification sheet has been prepared by Legacy Lighting and are attached to **Appendix 2**. Extracts of the proposed lighting plan are provided in **Figure 3** below.

The Design Drawings also include a Light Spill Plan on page 3 which demonstrates that the proposal is compliant with AS4282:2023 *Control of the Obtrusive Effects of Outdoor Lighting*. In terms of operation the lights will be utilised semi-regularly and will not be used past 11pm.

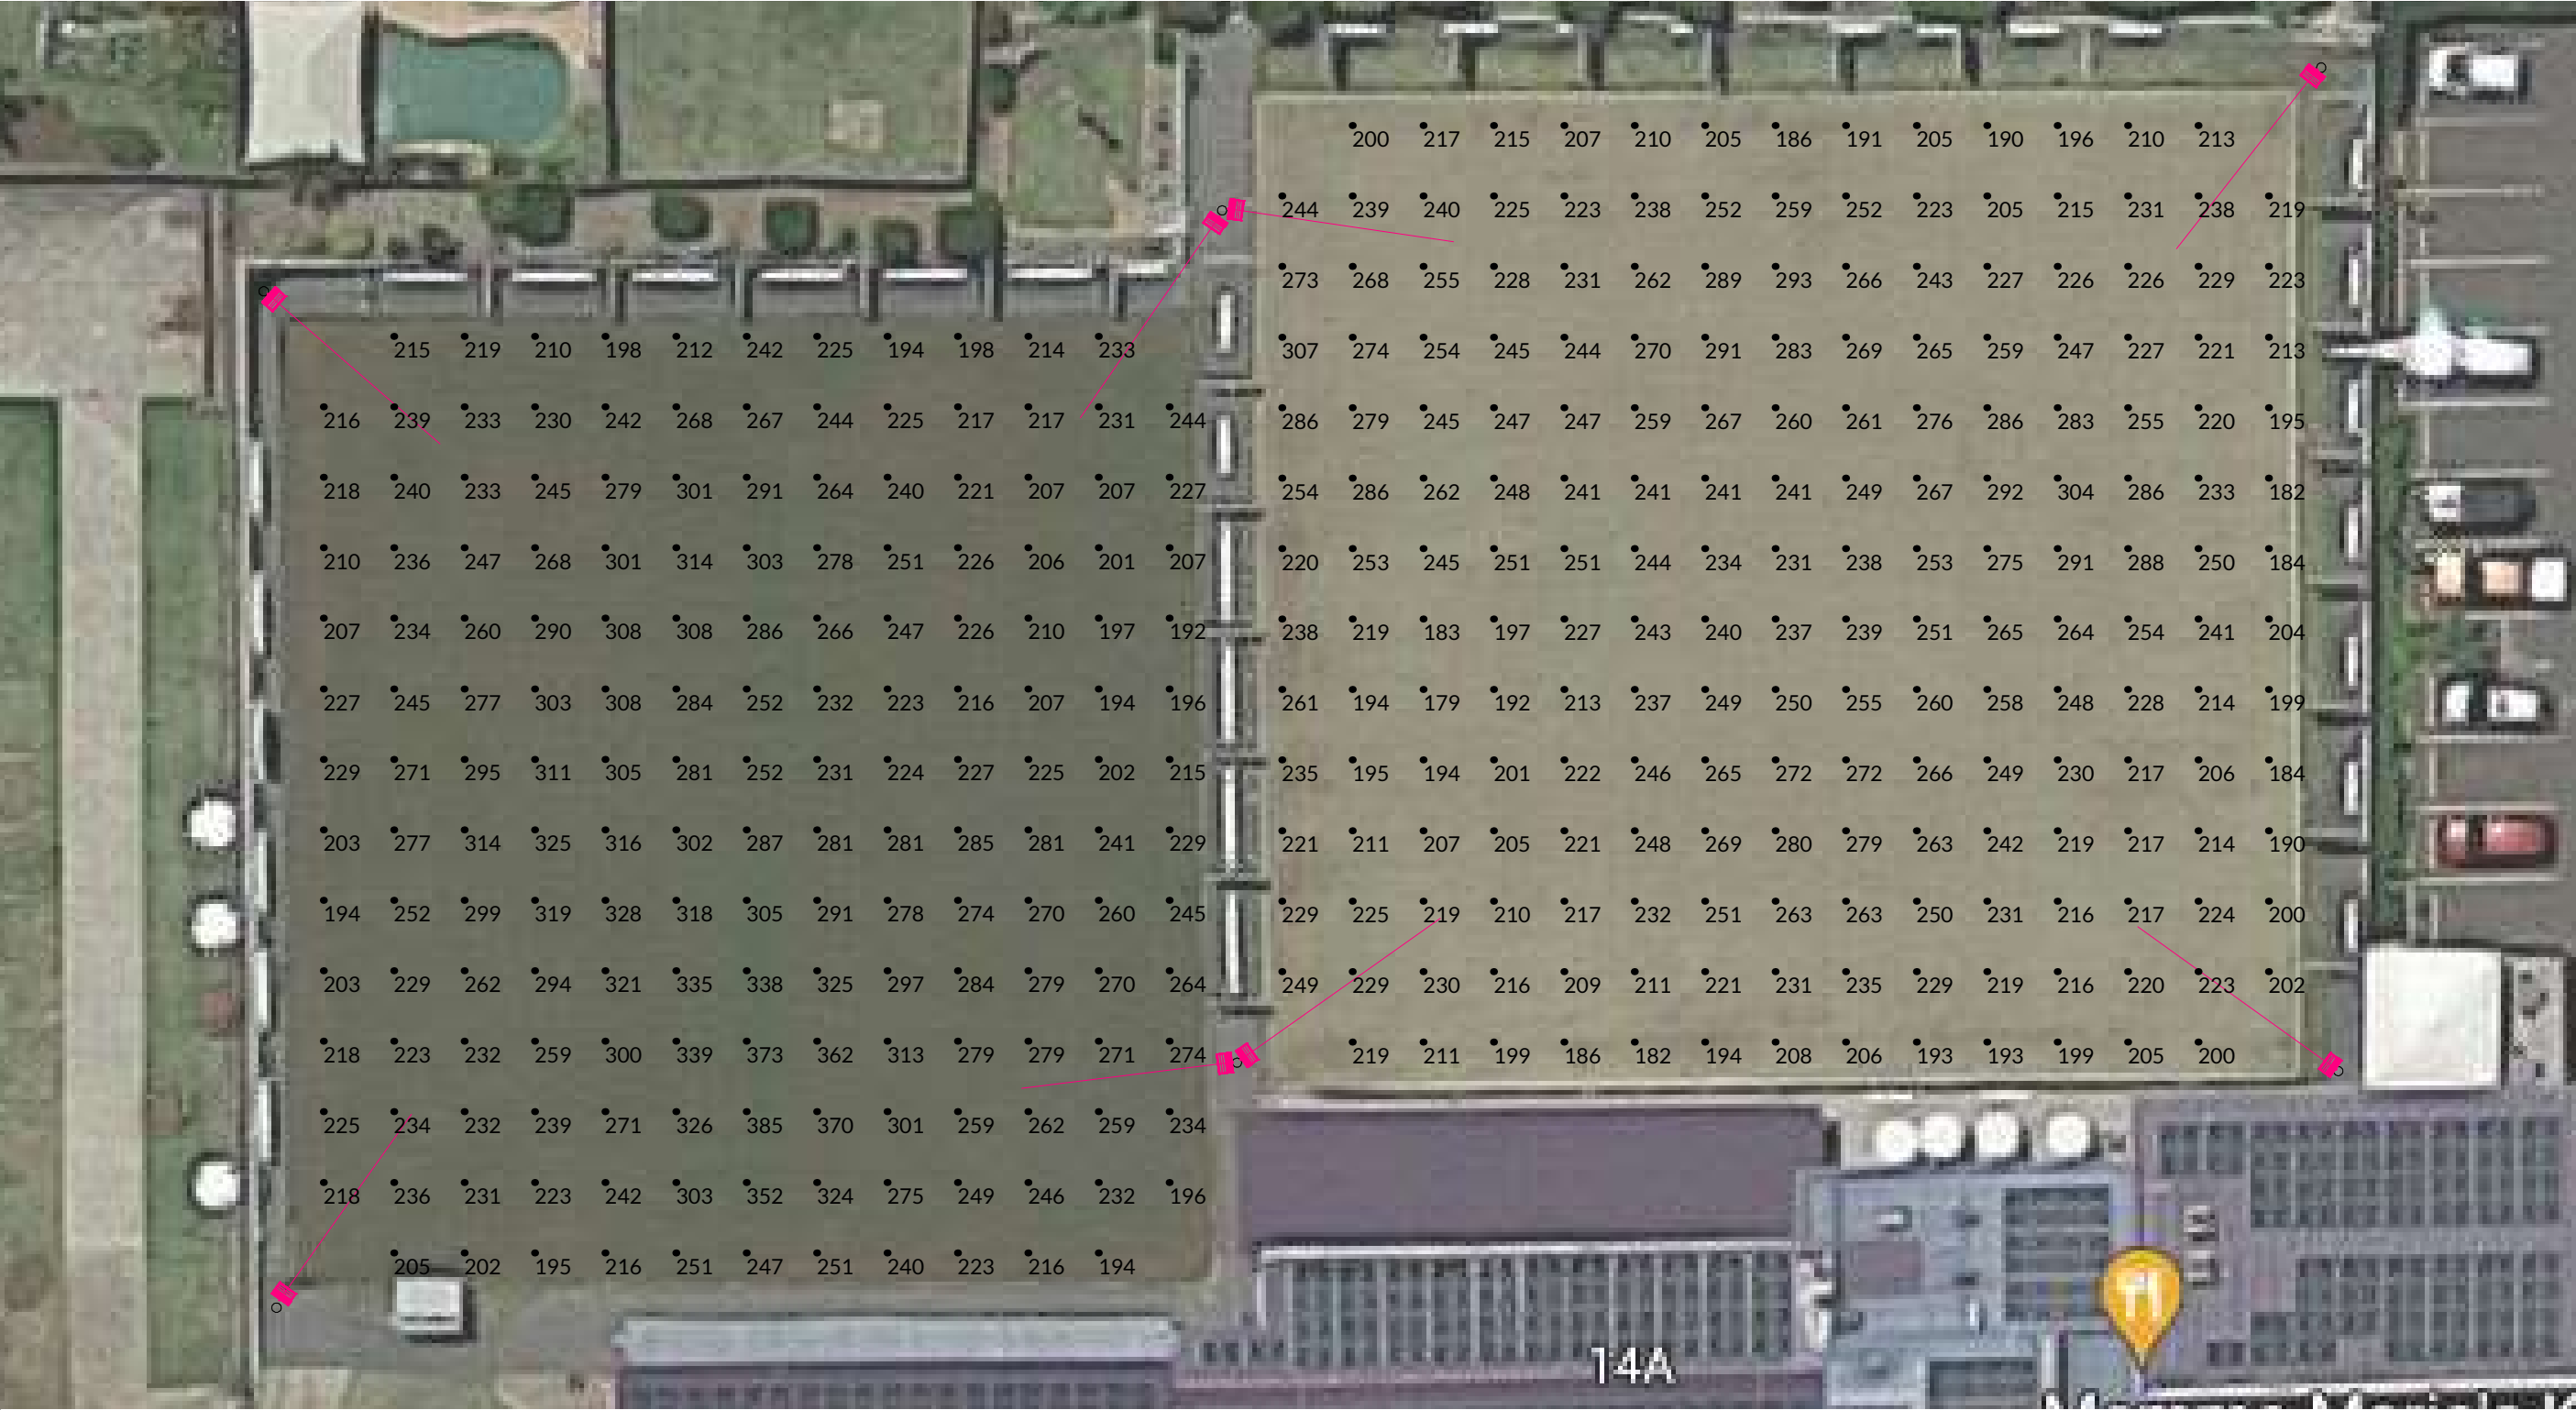
Lighting system performance meets the minimum lighting criteria of AS2560.2 Sports Lighting - 200 lux

Uses 9 metre poles  
Lights are mounted at 9 metres

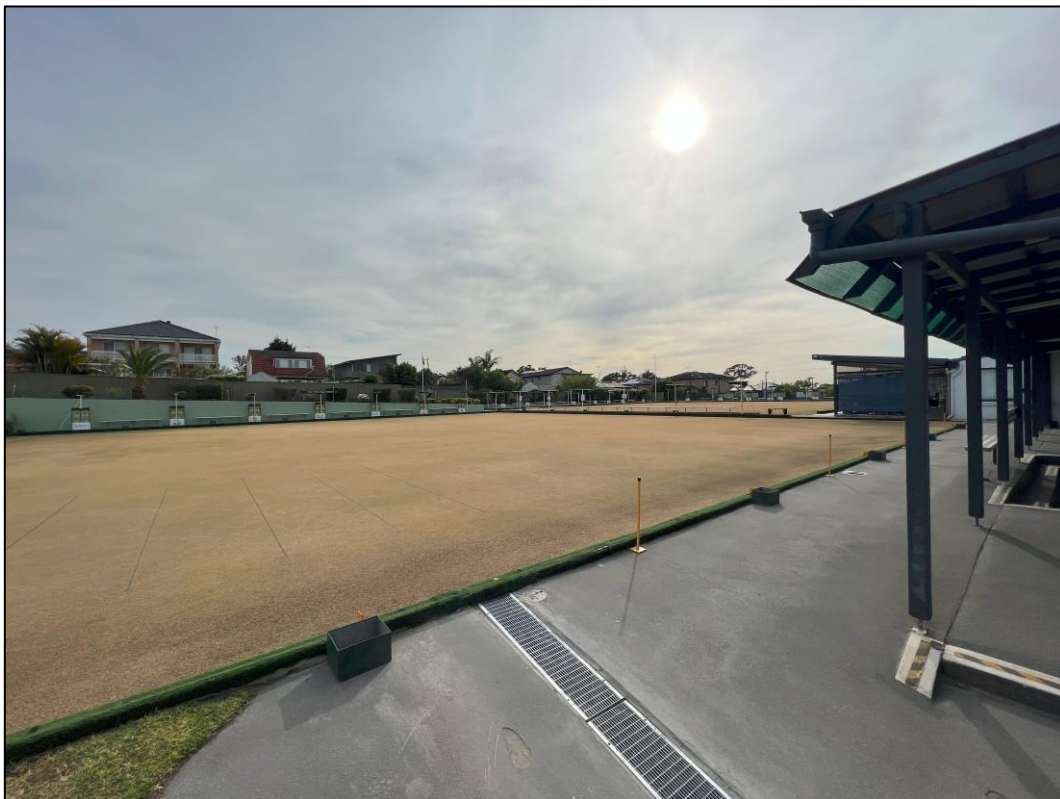
**Site Photograph 6.2.3** View of the two (2) northern bowling greens located within the northern portion of the site, as observed 24 September 2024, facing north-east.

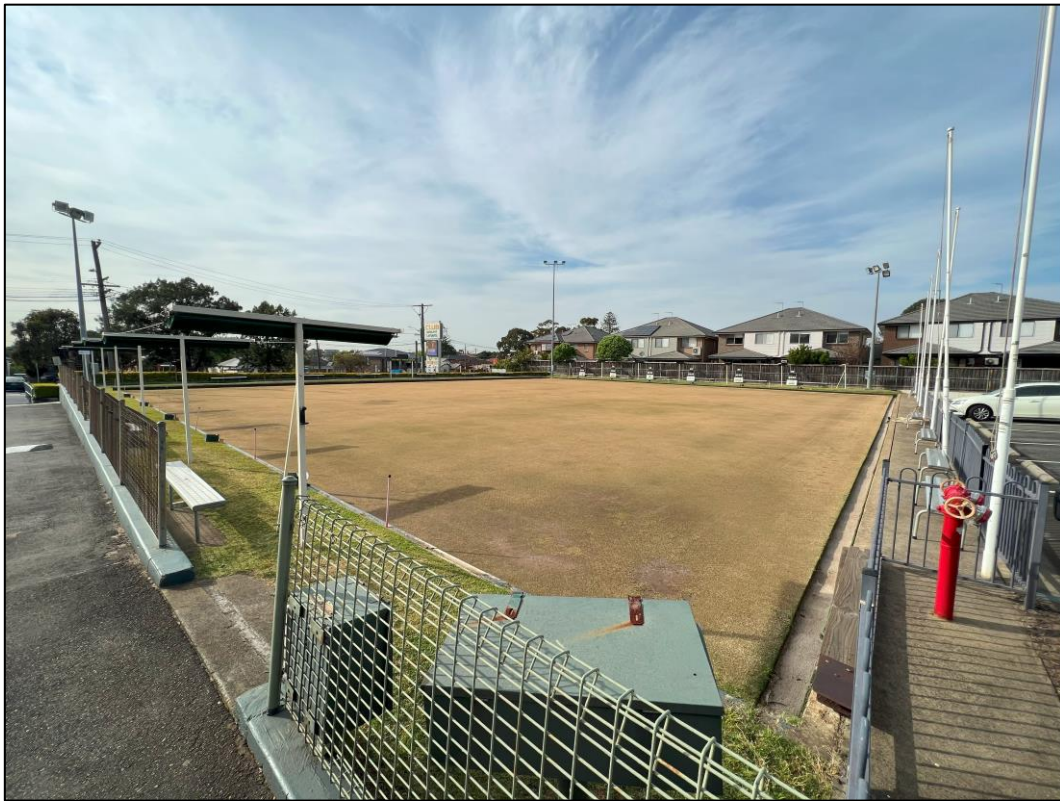
**Site Photograph 6.2.4** View of the single (1) bowling green located within the southeastern portion of the site, as observed on 24 September 2024, facing south-east.

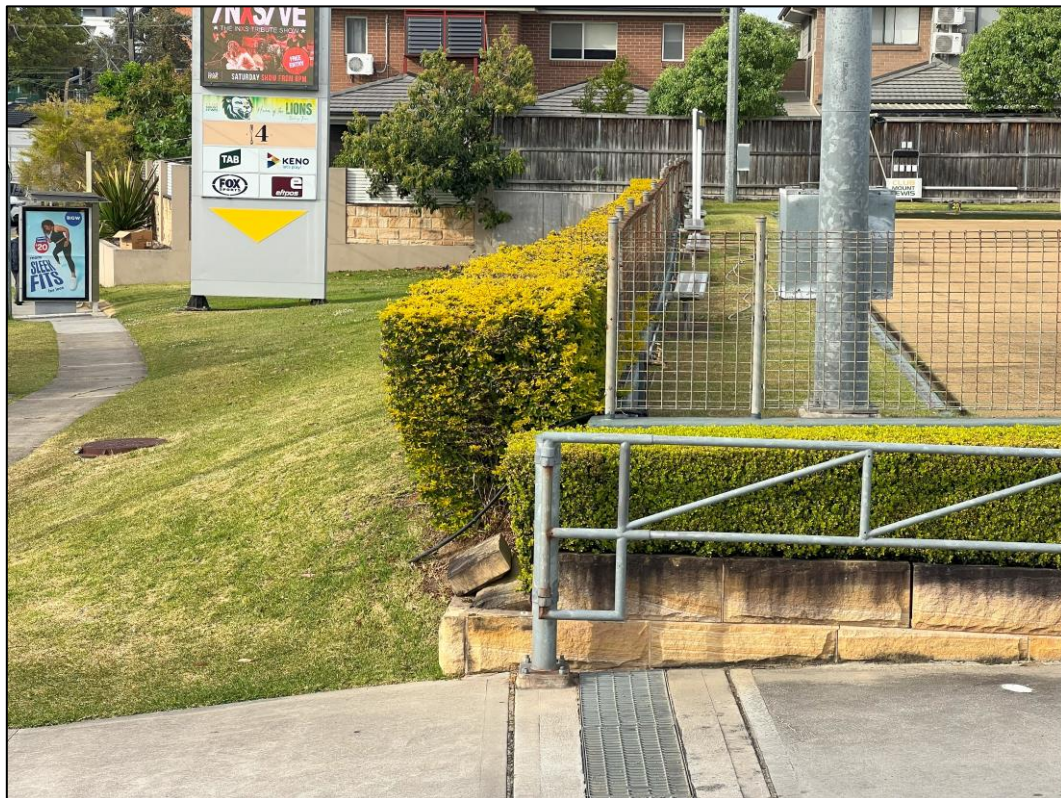
**Site Photograph 6.3.1** View of boundary fencing and gated access from Waterloo Road along the eastern boundary of the site, as observed 24 September 2024, facing south.

Boundary fencing was observed along the boundaries of the site during the site walkover. One (1) gate providing access to the site was observed along the eastern boundary.

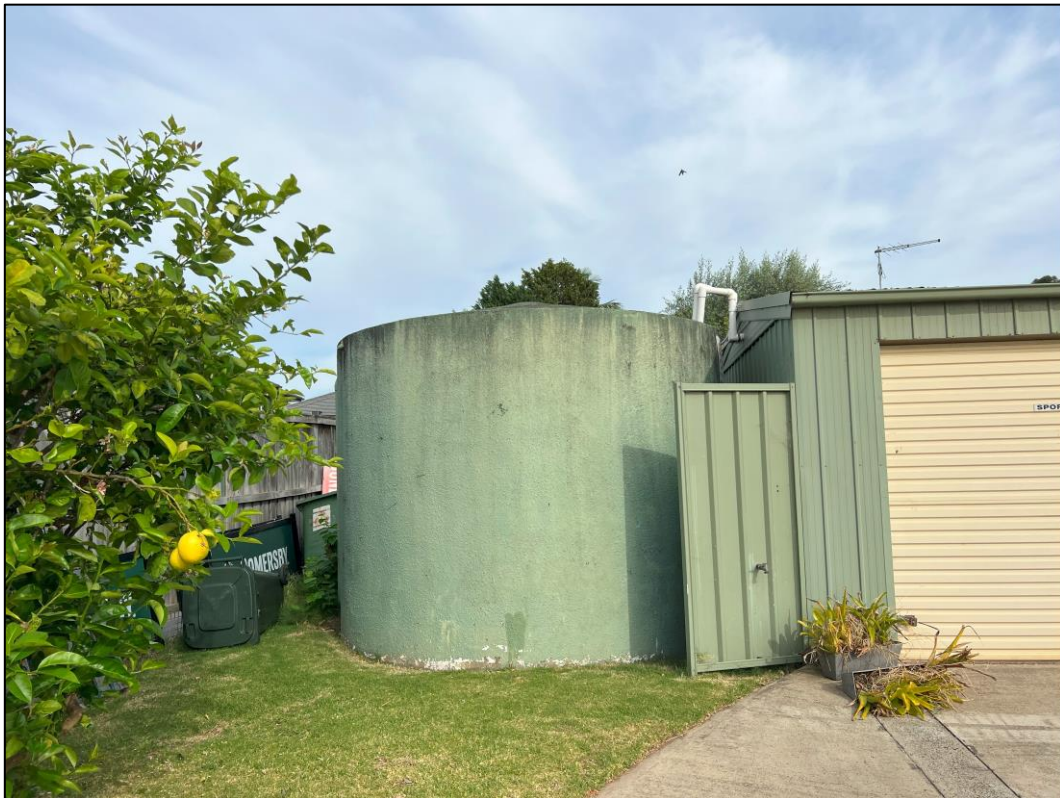
**Site Photograph 6.7.1** View of the concrete storage tank within the western portion of the site, as observed 24 September 2024.

One (1) large concrete storage tank was observed within the western portion of the site and was presumed to be filled with rainwater at the time of the site visit. No other tanks were observed within the site at the time of the inspection.

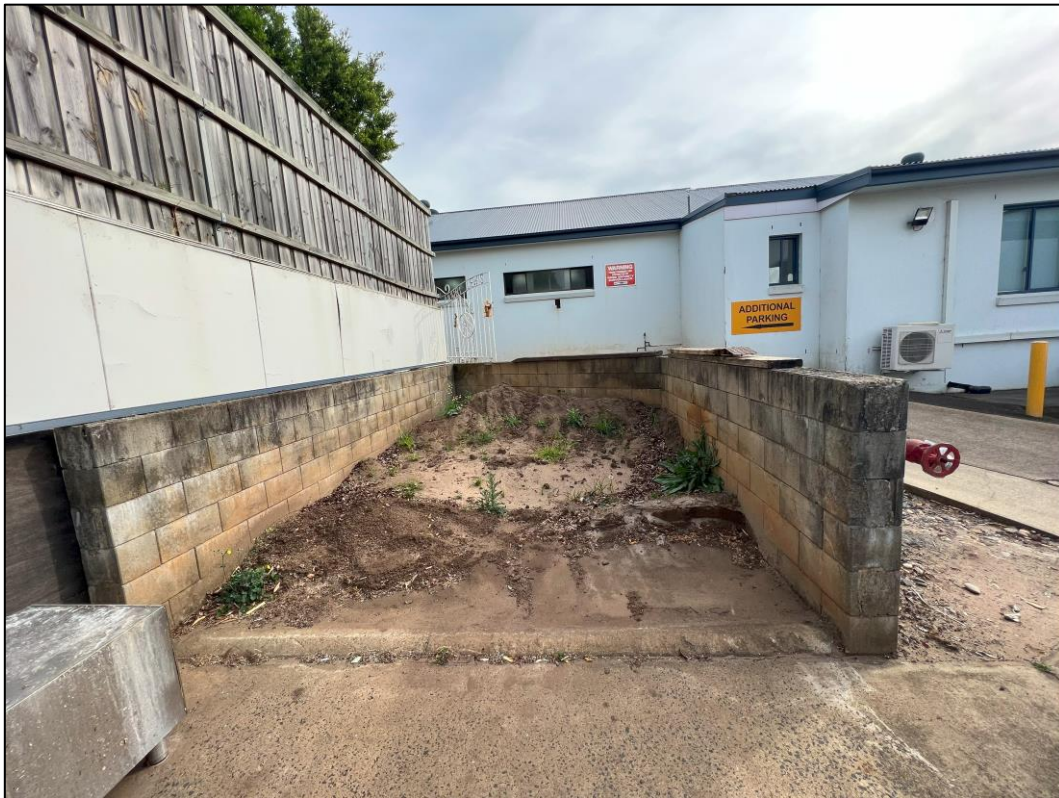
**Site Photograph 6.8.1** View of the sand and soil stockpile within central portion of the site, as observed 24 September 2024, facing north.

A small sand and soil stockpile was observed within the central portion of the site, south-west of the commercial building structure. These materials are presumably utilised for maintenance of the bowling greens and within the surrounding landscaping areas when required.

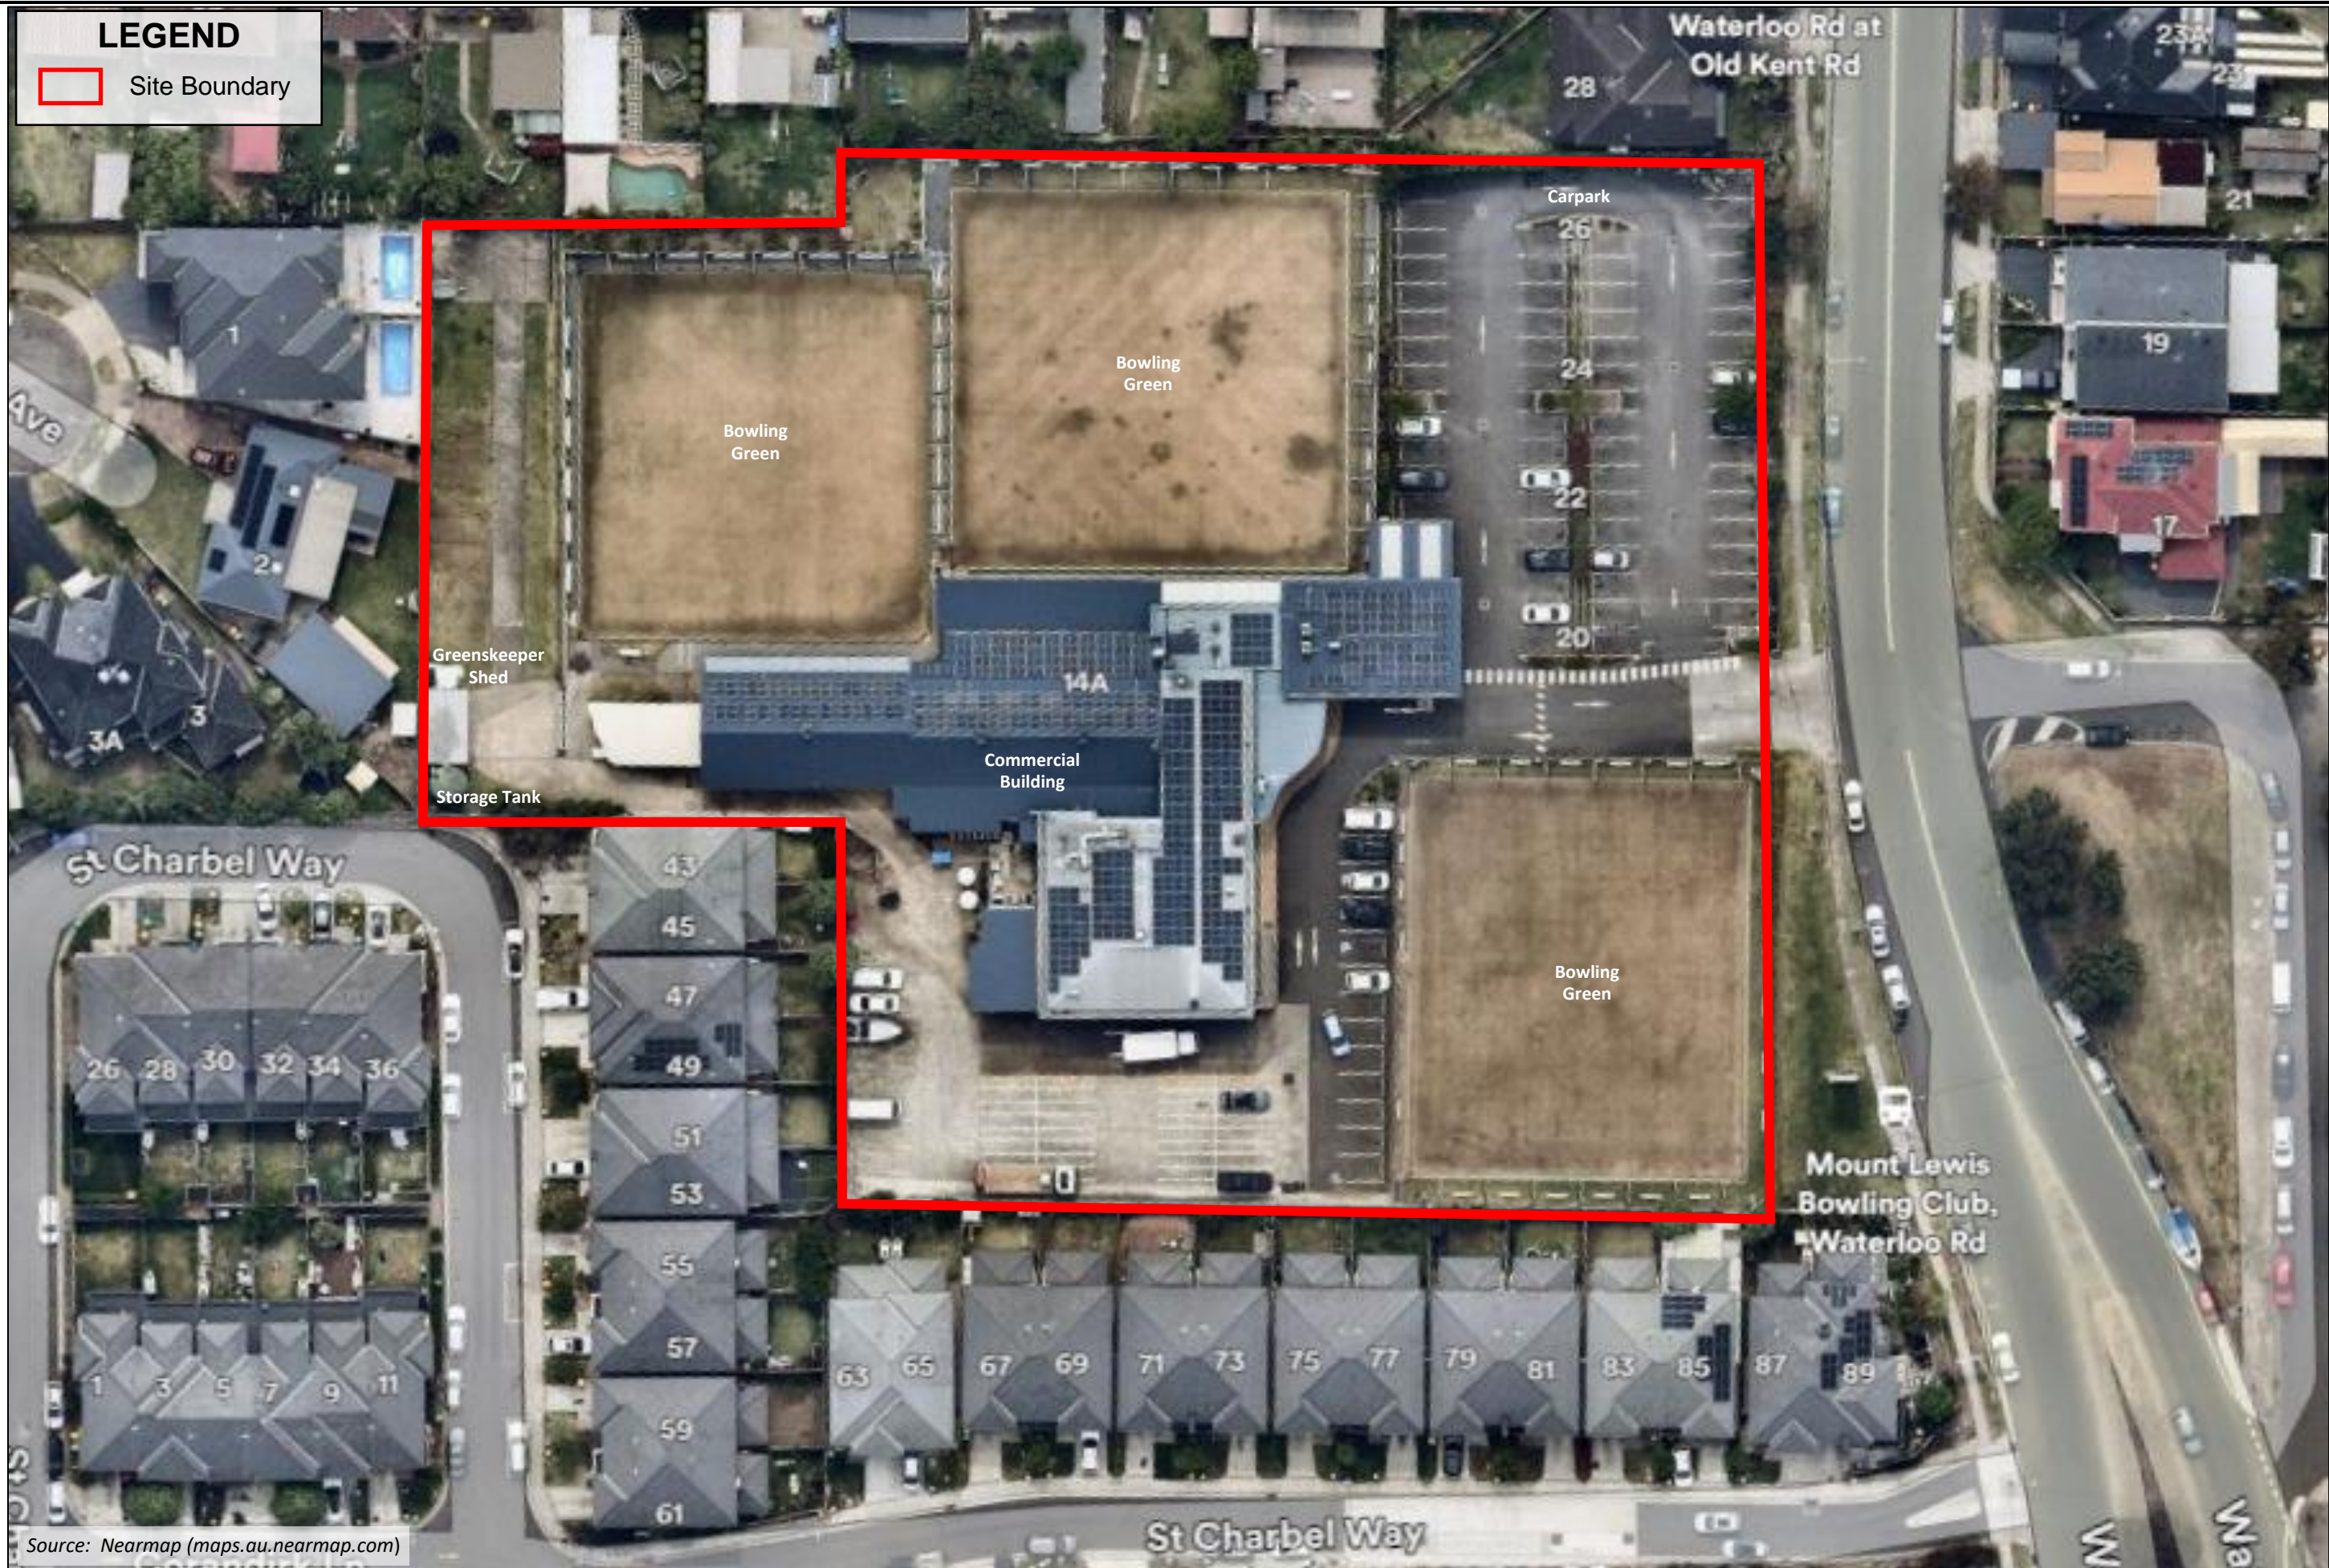
Figure Number: 1  
Figure Date: 10 October 2024  
Report Number: 2729-PSI-01-161024.v1f

Figure 1 - Site Locality

The locality of the site is set out in **Figure 1**.

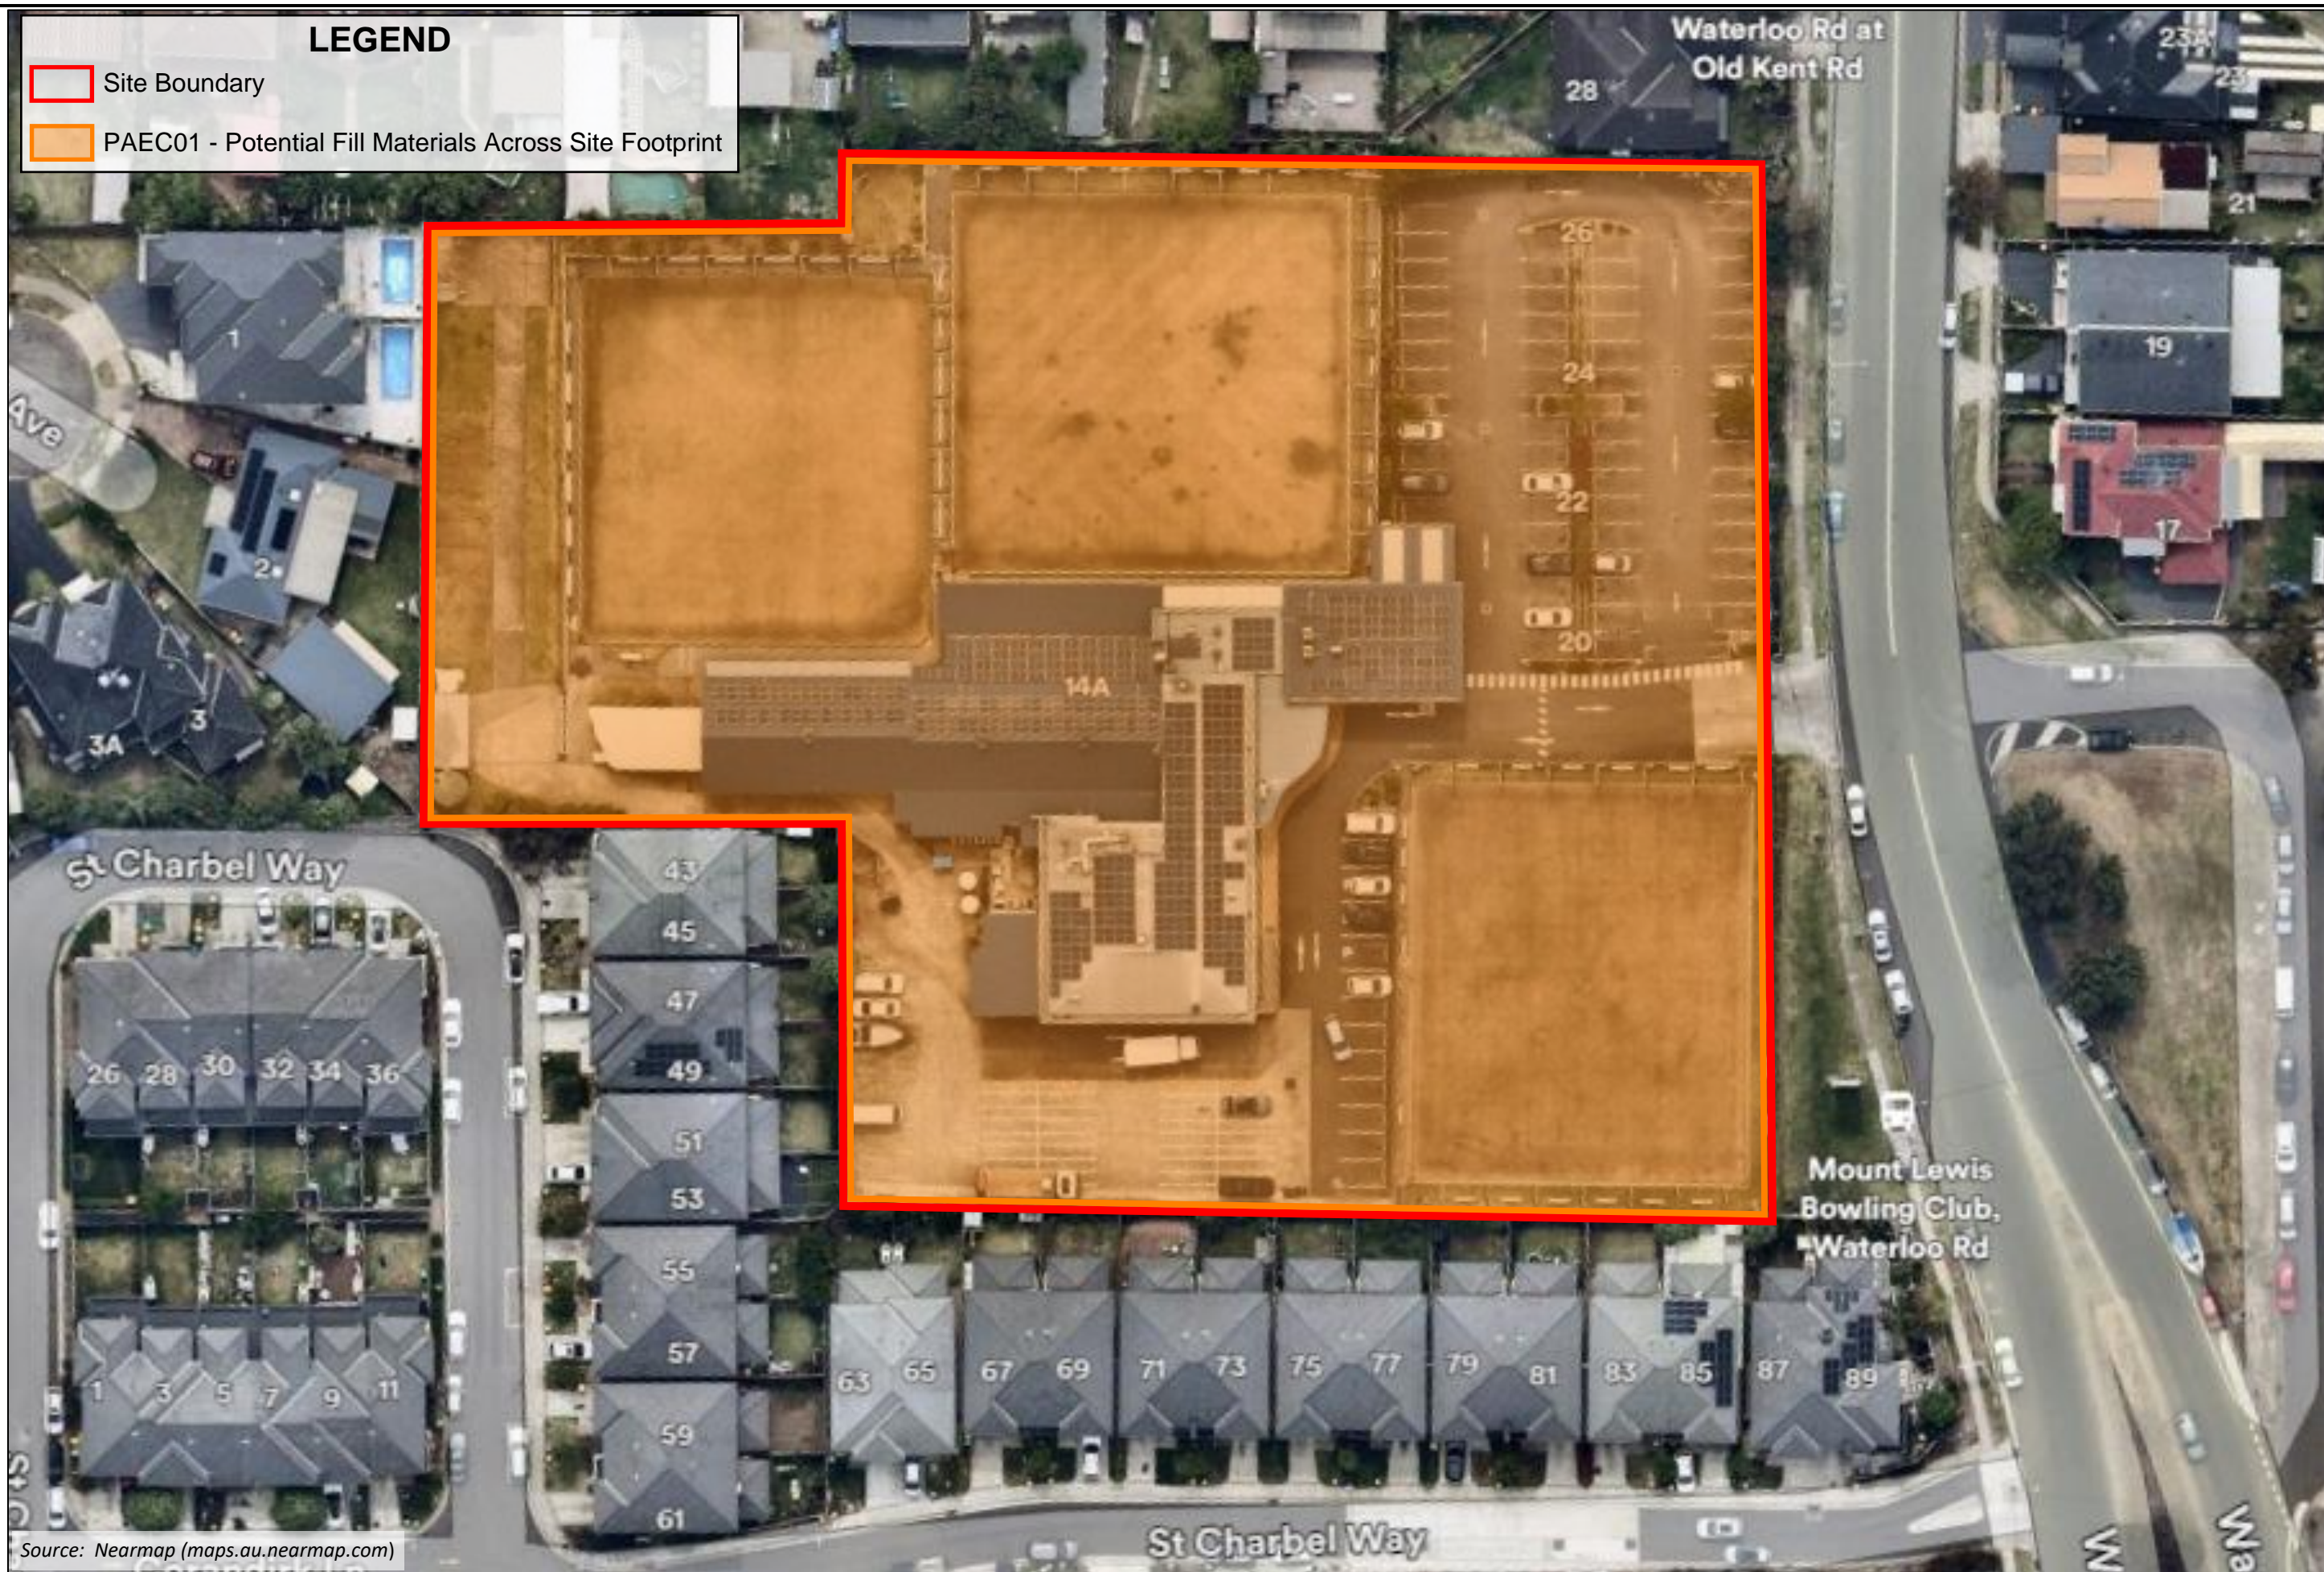
Figure Number:		2
	Project Name:	Stage 1 Preliminary Site Investigation		Figure Date:		10 October 2024
	Project Location:	Mount Lewis Bowling Club, Mount Lewis NSW		Report Number:		2729-PSI-01-161024.v1f

Figure 2 - Site Layout

The general layout and boundary of the site is set out in **Figure 2**.
