Geotechnical Consultants Australia

Geotechnical Investigation Report

Proposed Development at

190 Waterloo Road

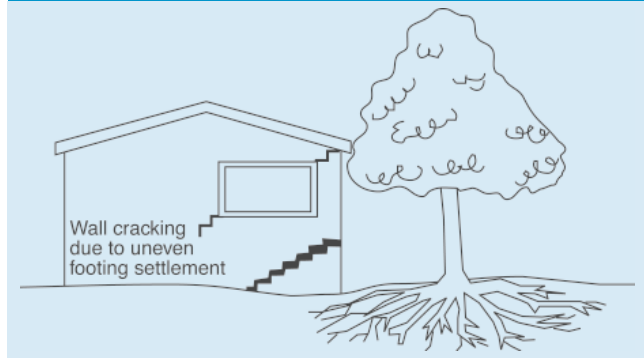
Trees can cause shrinkage and damage

As the weather pattern changes and the soil begins to dry out, the external footings will be first affected, beginning with the locations where the sun's effect is strongest. This has the effect of lowering the external footings. The doming is accentuated and cracking reduces or disappears where it occurred because of dishing, but other cracks open up. The roof lines may become convex.

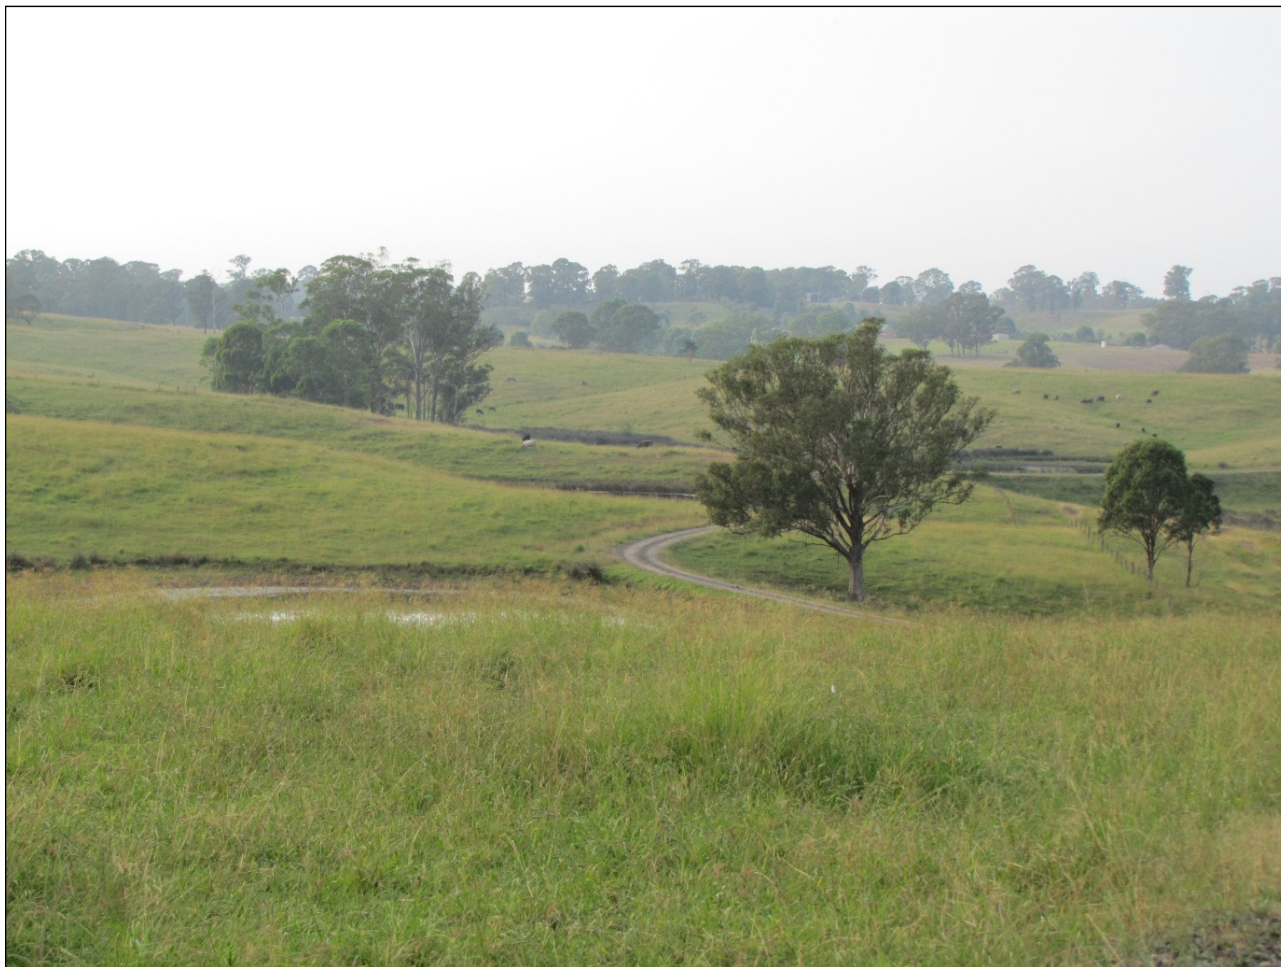
Source: Soil Landscapes of the Penrith 1:100,000 Sheet report

Landscape—gently undulating rises on Wianamatta Group shales and Hawkesbury shale. Local relief to 30 m, slopes are usually <5%. Broad rounded crests and ridges with gently inclined slopes. Cleared eucalypt woodland and tall open-forest (wet sclerophyll forests).

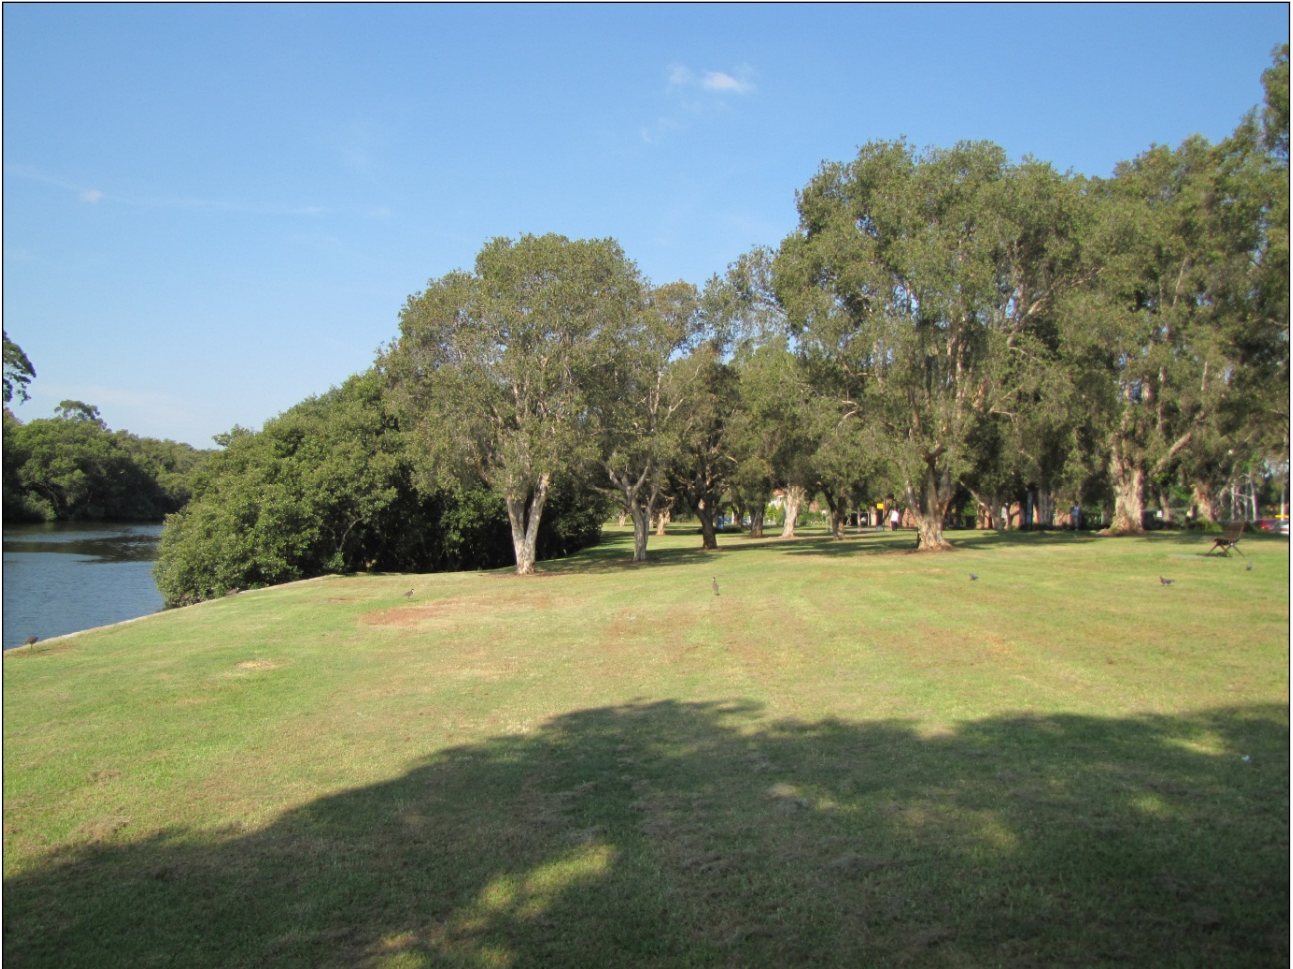
Source: Soil Landscapes of the Penrith 1:100,000 Sheet report

Landscape—level to gently undulating alluvial floodplain draining Wianamatta Group shales. Local relief to 5 m, slopes <3%. Broad valley flats. Extensively cleared tall open-forest and woodland.
