# ARBORICULTURAL IMPACT ASSESSMENT

PROPOSED RESIDENTIAL DEVELOPMENT OF 141 COMUR STREET, YASS

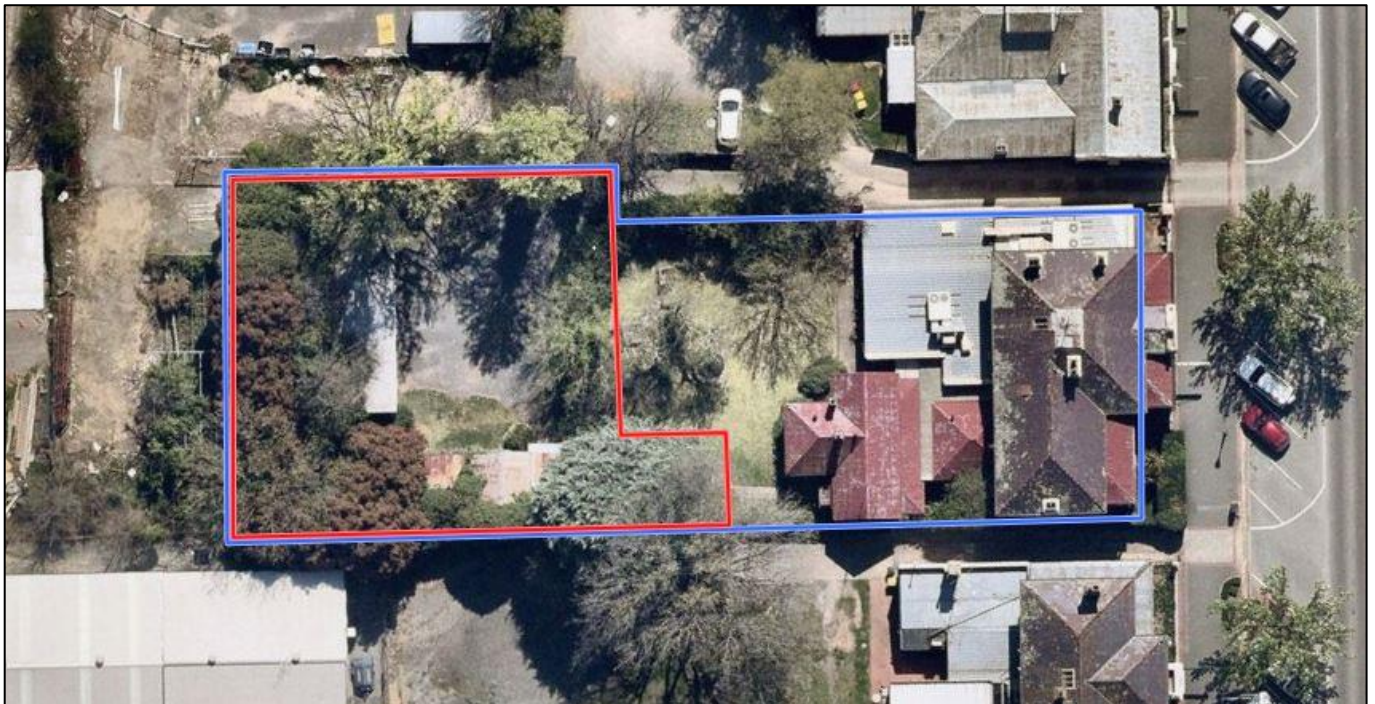
The extent of the study area is approximated in red, as shown in Figure 1 and will include all adjacent properties (including public lands) that may be impacted by the proposal.

Figure 1: Area of assessment denoted in red (NearMaps, 2024).

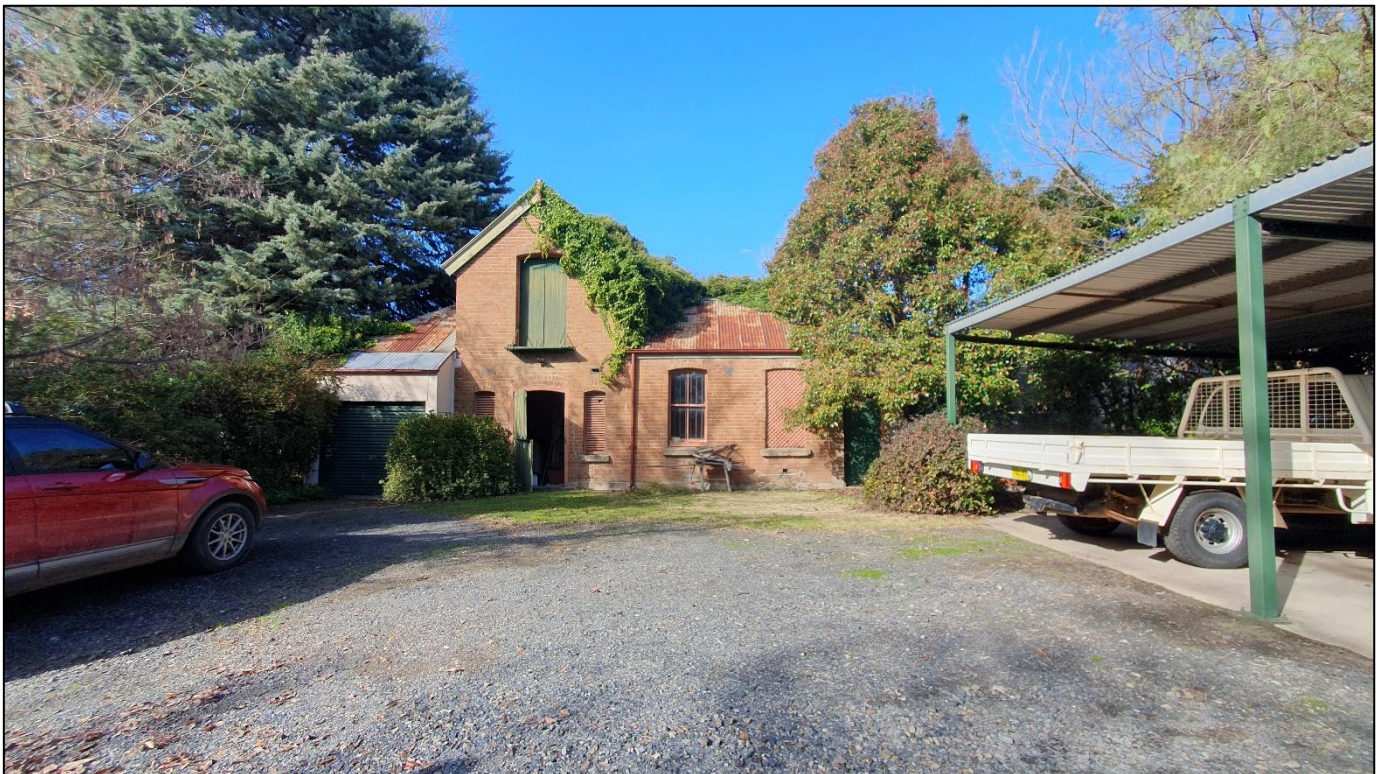
- 11.1 The proposal calls for the restoration and extension of the existing stable block, an item of local heritage significance (Figure 8).

Figure 8: Existing Stable block (Nadin, 2024).

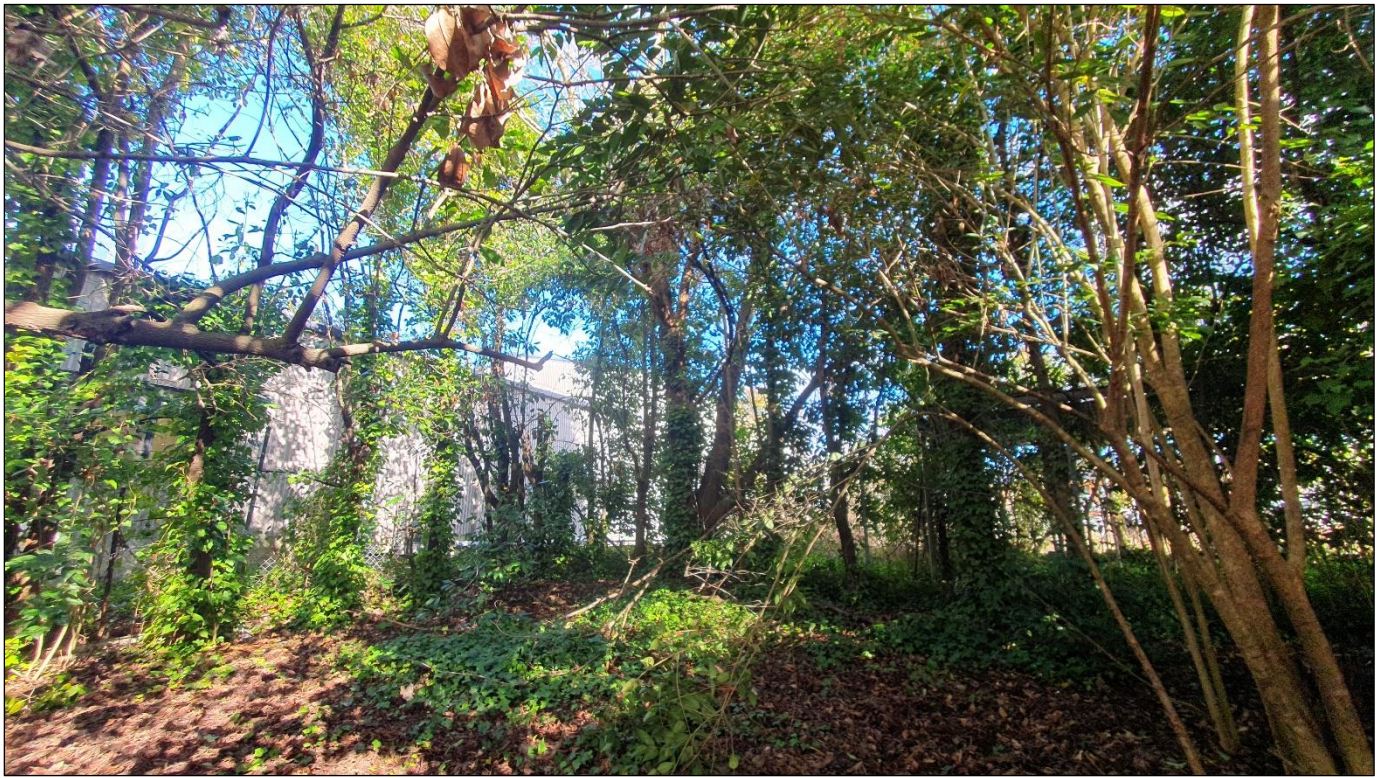
The tree population surrounding the rear of the existing stables and carport is rated as having low landscape significance and low retention value due to either the weed species status, poor live crown ratio due to overplanting or substantial encroachment by *Hedera helix* (English ivy) (Figure 9).

Figure 9: Southern extent of the garden (Nadin, 2024).

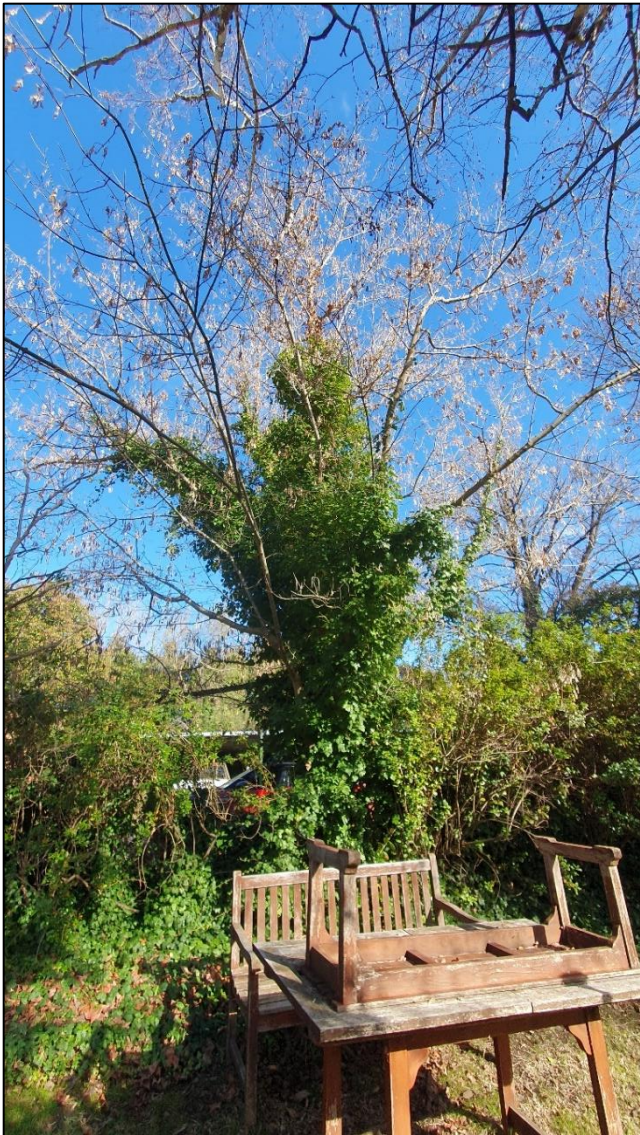
Figure 10: T3 to be retained and protected (Nadin, 2024).

To mitigate and achieve an acceptable level of impact, it is recommended that the paved area be constructed above grade using porous paving and that the vine be removed.

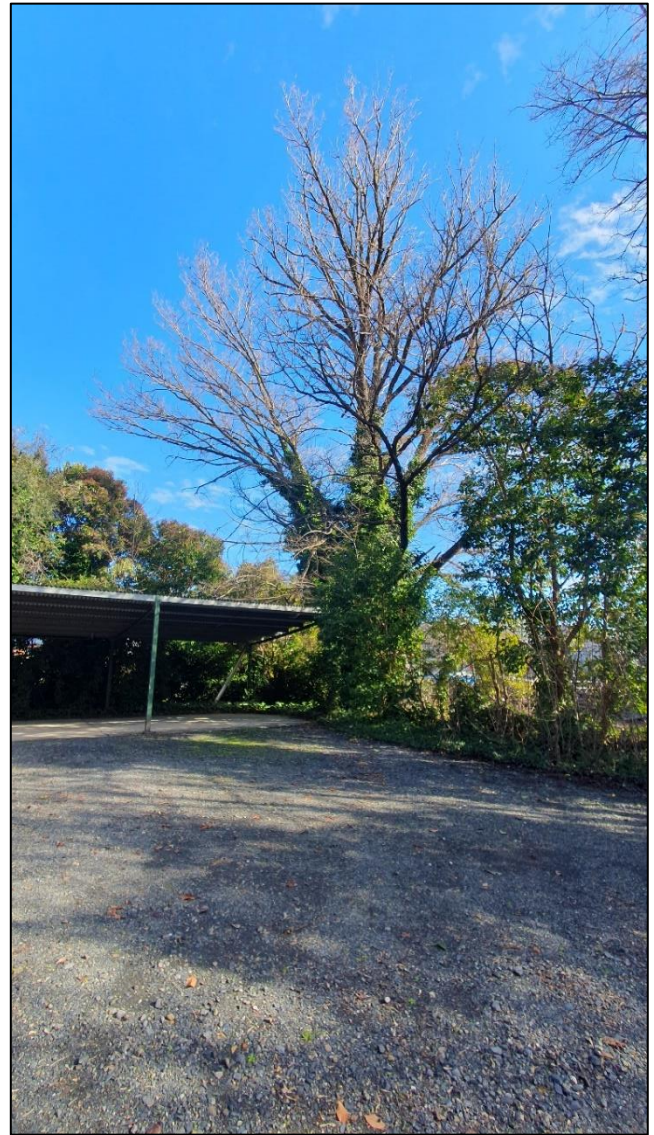
- 11.5 T4.1, T4.2, and T4.3 (neighbouring trees) and T5, T6, T7, T8, and T9 (Figure 11) are not impacted by the proposed development footprint and can be retained under the current design.

*Hedera helix* (English ivy) encroaches on many of the on-site trees. The author is satisfied that these trees will remain sustainable subject to the removal of this invasive weed species.

Figure 11: T9 to be retained with remedial maintenance (Nadin, 2024).

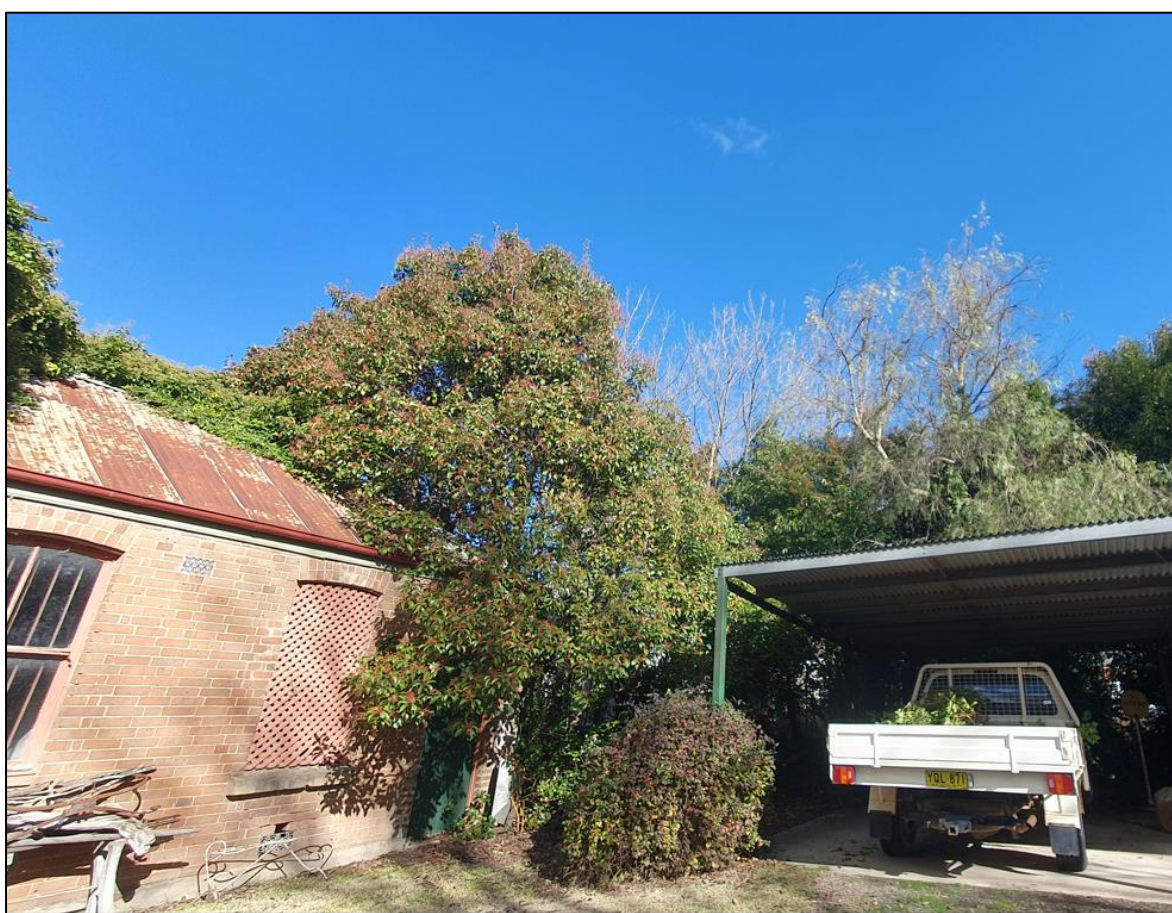
T18 and T19 are small *Schinus molle* (Peppercorn Tree), and T21.7 and T21.16 are *Photinia serratifolia* (Sawtooth Photinia) that are inappropriately positioned and pose a risk to the foundations on the northeastern side of the existing stable wall (Figure 12).

Figure 12: T21.7 adjacent to existing stables (Nadin, 2024).

The author is satisfied that the proposed landscaping plan provides adequate compensation for the removal of the subject trees and will significantly enhance the visual amenity of the site and neighbouring properties.

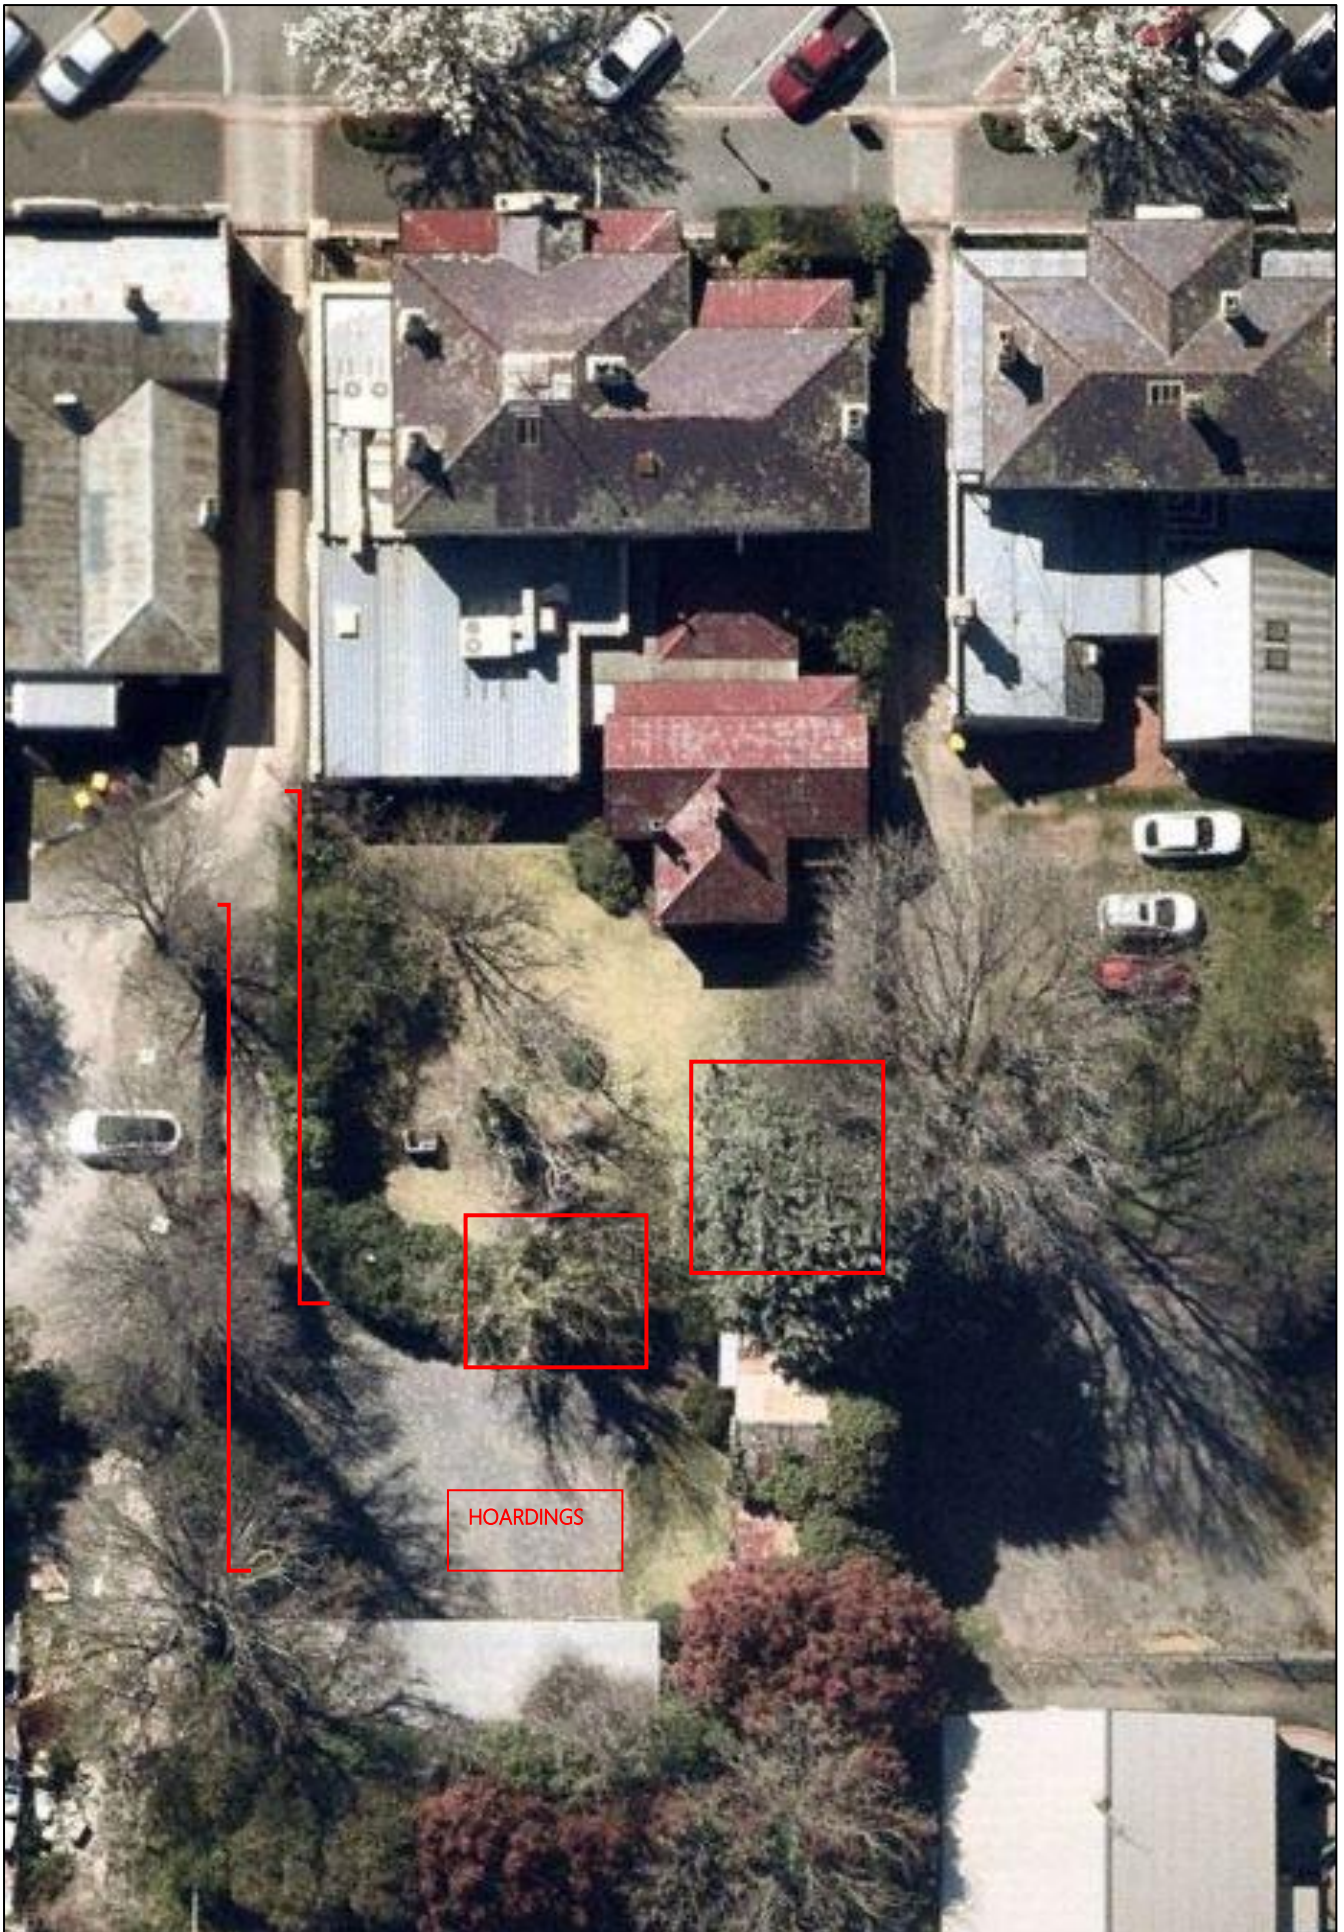
Figure 13: Indicative TPZ fencing layout denoted in red (Nadin, 2024).
