STATEMENT OF ENVIRONMENTAL EFFECTS

6 Bidgee Close
Jiparu
MURRUMBATEMAN NSW

22 April 2025 V01

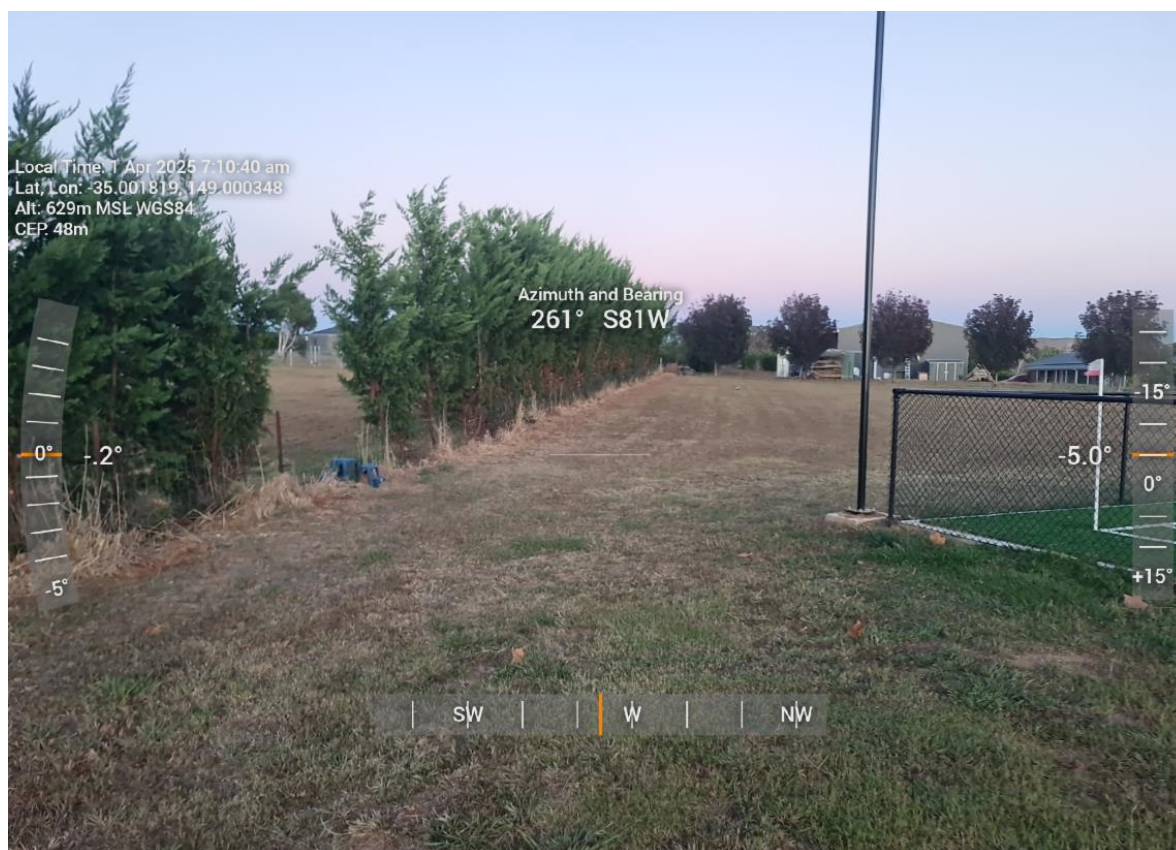
Figure 4: Boundary screen plantings on southern and southwestern boundary.

Neighbourhood impact: The neighbouring impact of the soccer field is similar to that of a private tennis court with lights. There is no overshadowing or privacy concerns due to the distance from surrounding houses. Boundary plantings provide screening from neighbouring dwellings, refer **Figures 4 & 5**.

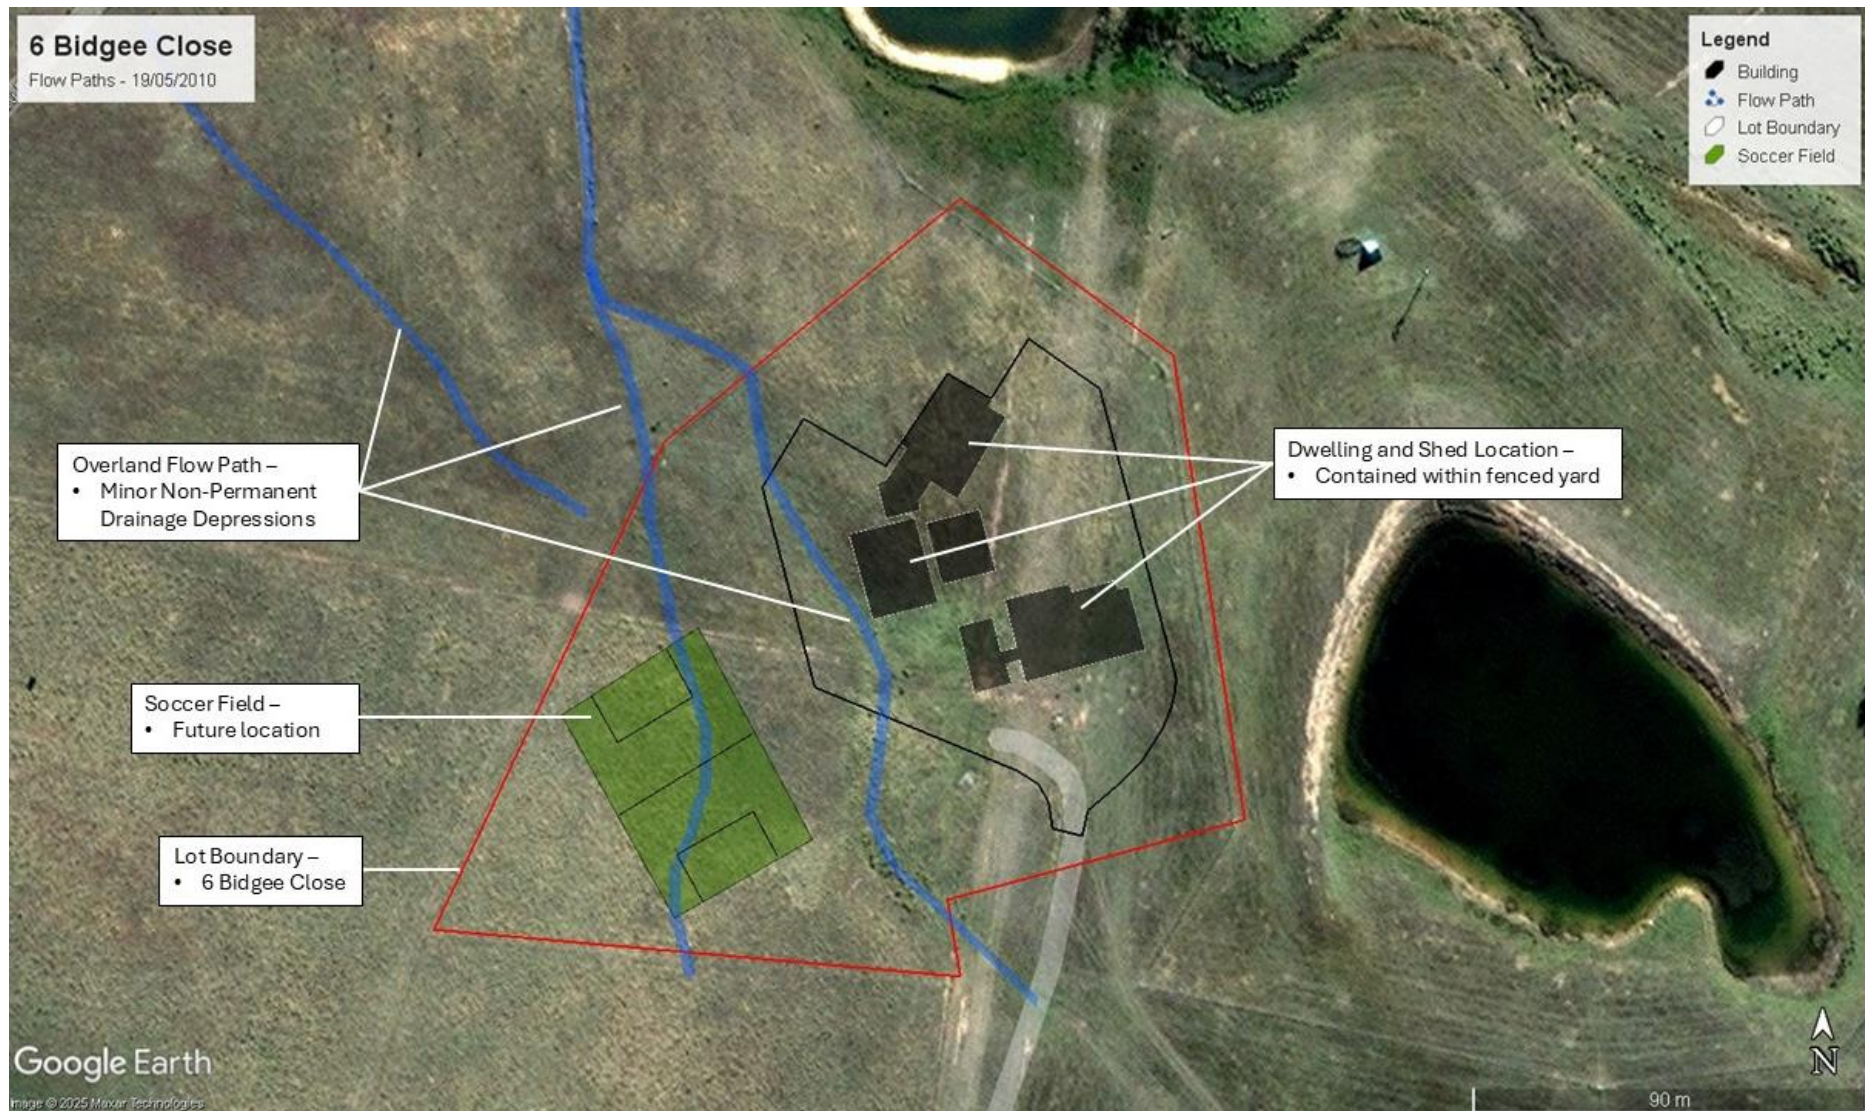
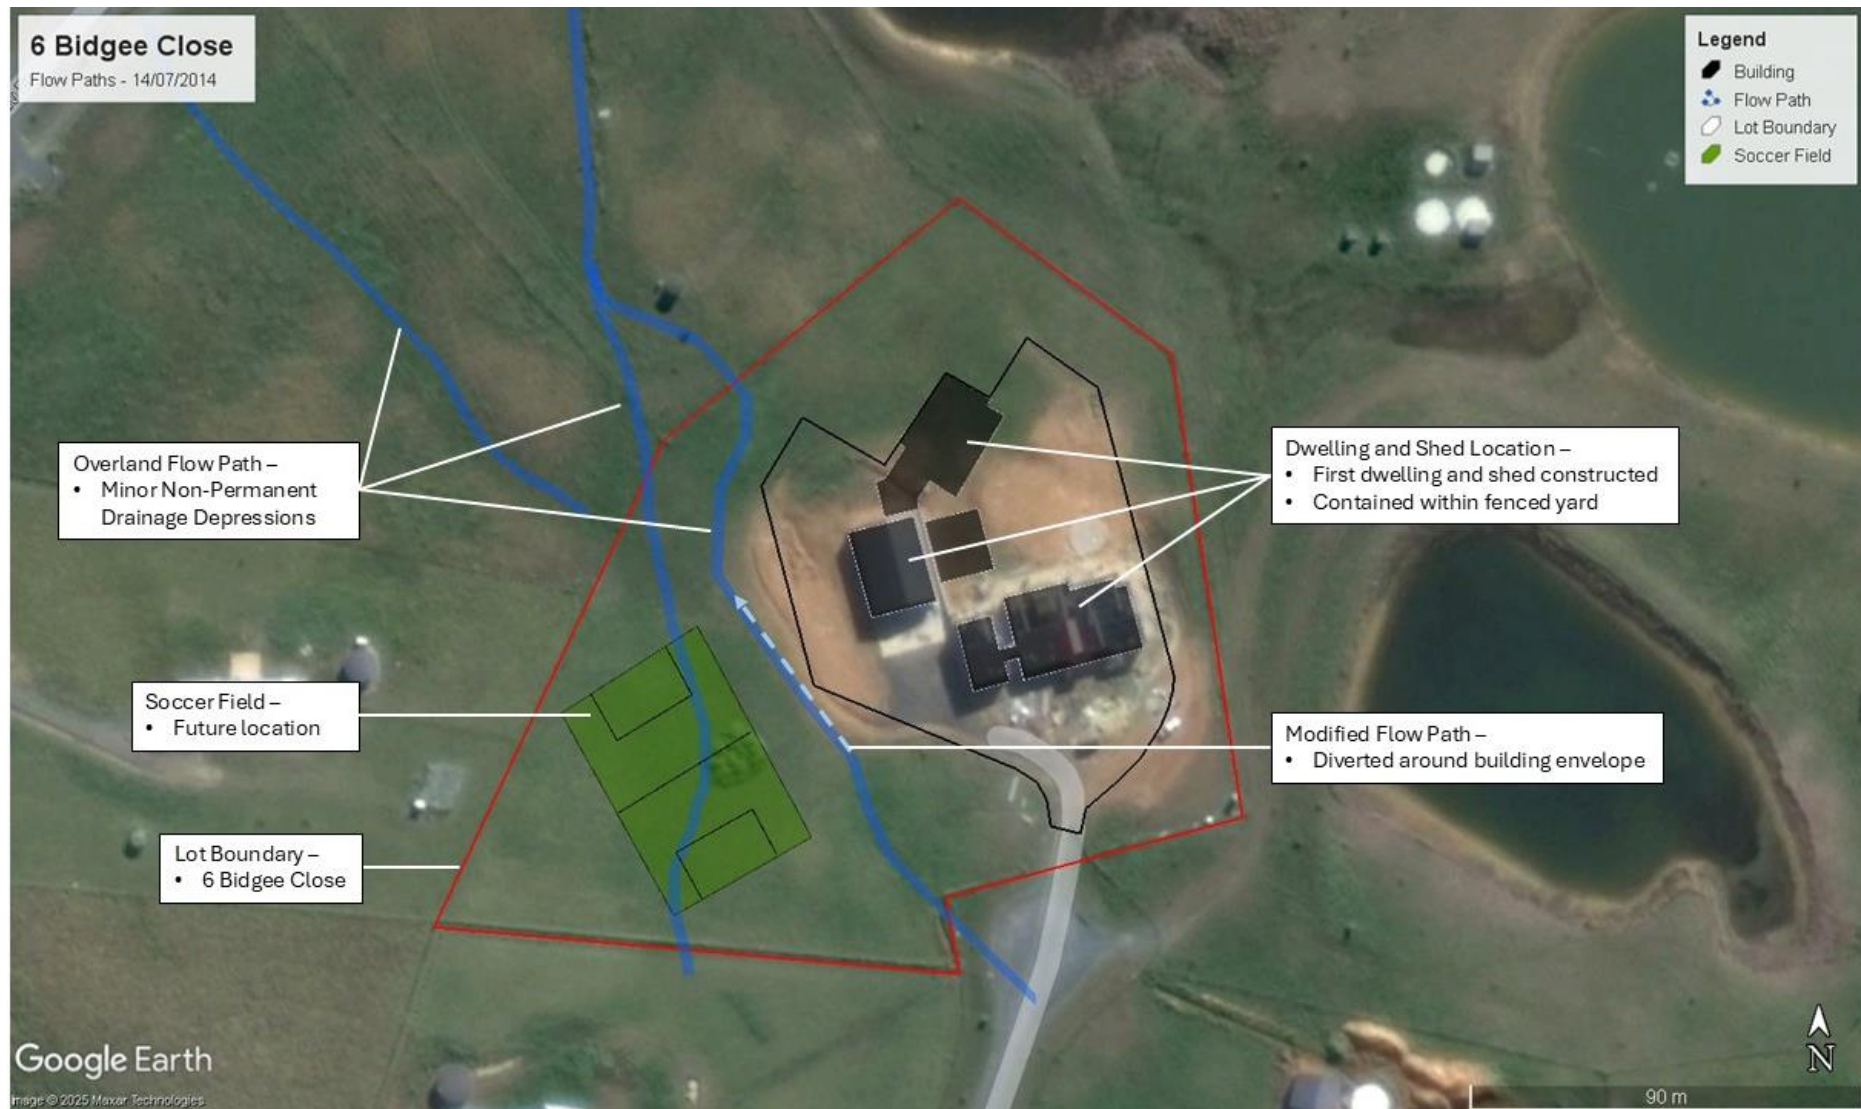
Figure 7: Flow Paths – 19/05/2010

Figure 8: Flow Paths – 14/07/2014

**Figure 9: Flow Paths – 14/10/2016**

Figure 10: Flow Paths – 27/04/2019

Figure 11: Flow Paths – 02/11/2021

Figure 12: Flow Paths – 07/10/2023

- 19/5/2010 – pre-development
- 14/7/2014 – post development (6 Bidgee Close plus dwellings to south, southwest and southeast built)
- 14/10/2016 – post development (6 Bidgee Close plus dwellings to west, south, southwest and southeast built)
- 27/4/2019 – post development (6 Bidgee Close second dwelling built plus dwellings to west, south, southwest and southeast built)
- 2/11/2021 – post development (6 Bidgee Close second dwelling built plus dwellings to northwest, west, south, southwest and southeast built)
- 7/10/2023 – post development (6 Bidgee Close second dwelling built and soccer field construction commenced plus dwellings to northwest, west [including large shed extension to rear], south, southwest and southeast built).

- 3. Overlay development footprint** The dimensioned site plan was overlaid on historical aerial images to show the potential for the development footprint to intersect with natural flow paths. The images are shown in **Figures 7-12.**
- 4. Significance of impacts to overland flow** The potential impacts to overland flow from the construction and operation of the soccer field facility are not considered significant based on the following:
- The development has limited potential to increase the volume of overland flow generated from the site,
 - The development interacts with the natural flow paths on the lot however flow paths exit the downslope property boundary in the same pre-development location,
 - The development has limited potential to back up run-on water which enters the property through the upslope boundary onto the upslope property.
