PRELIMINARY SITE INVESTIGATION

Proposed Industrial Subdivision - 2 Reddall Street, Yass

Preliminary Site Investigation

20 February 2025

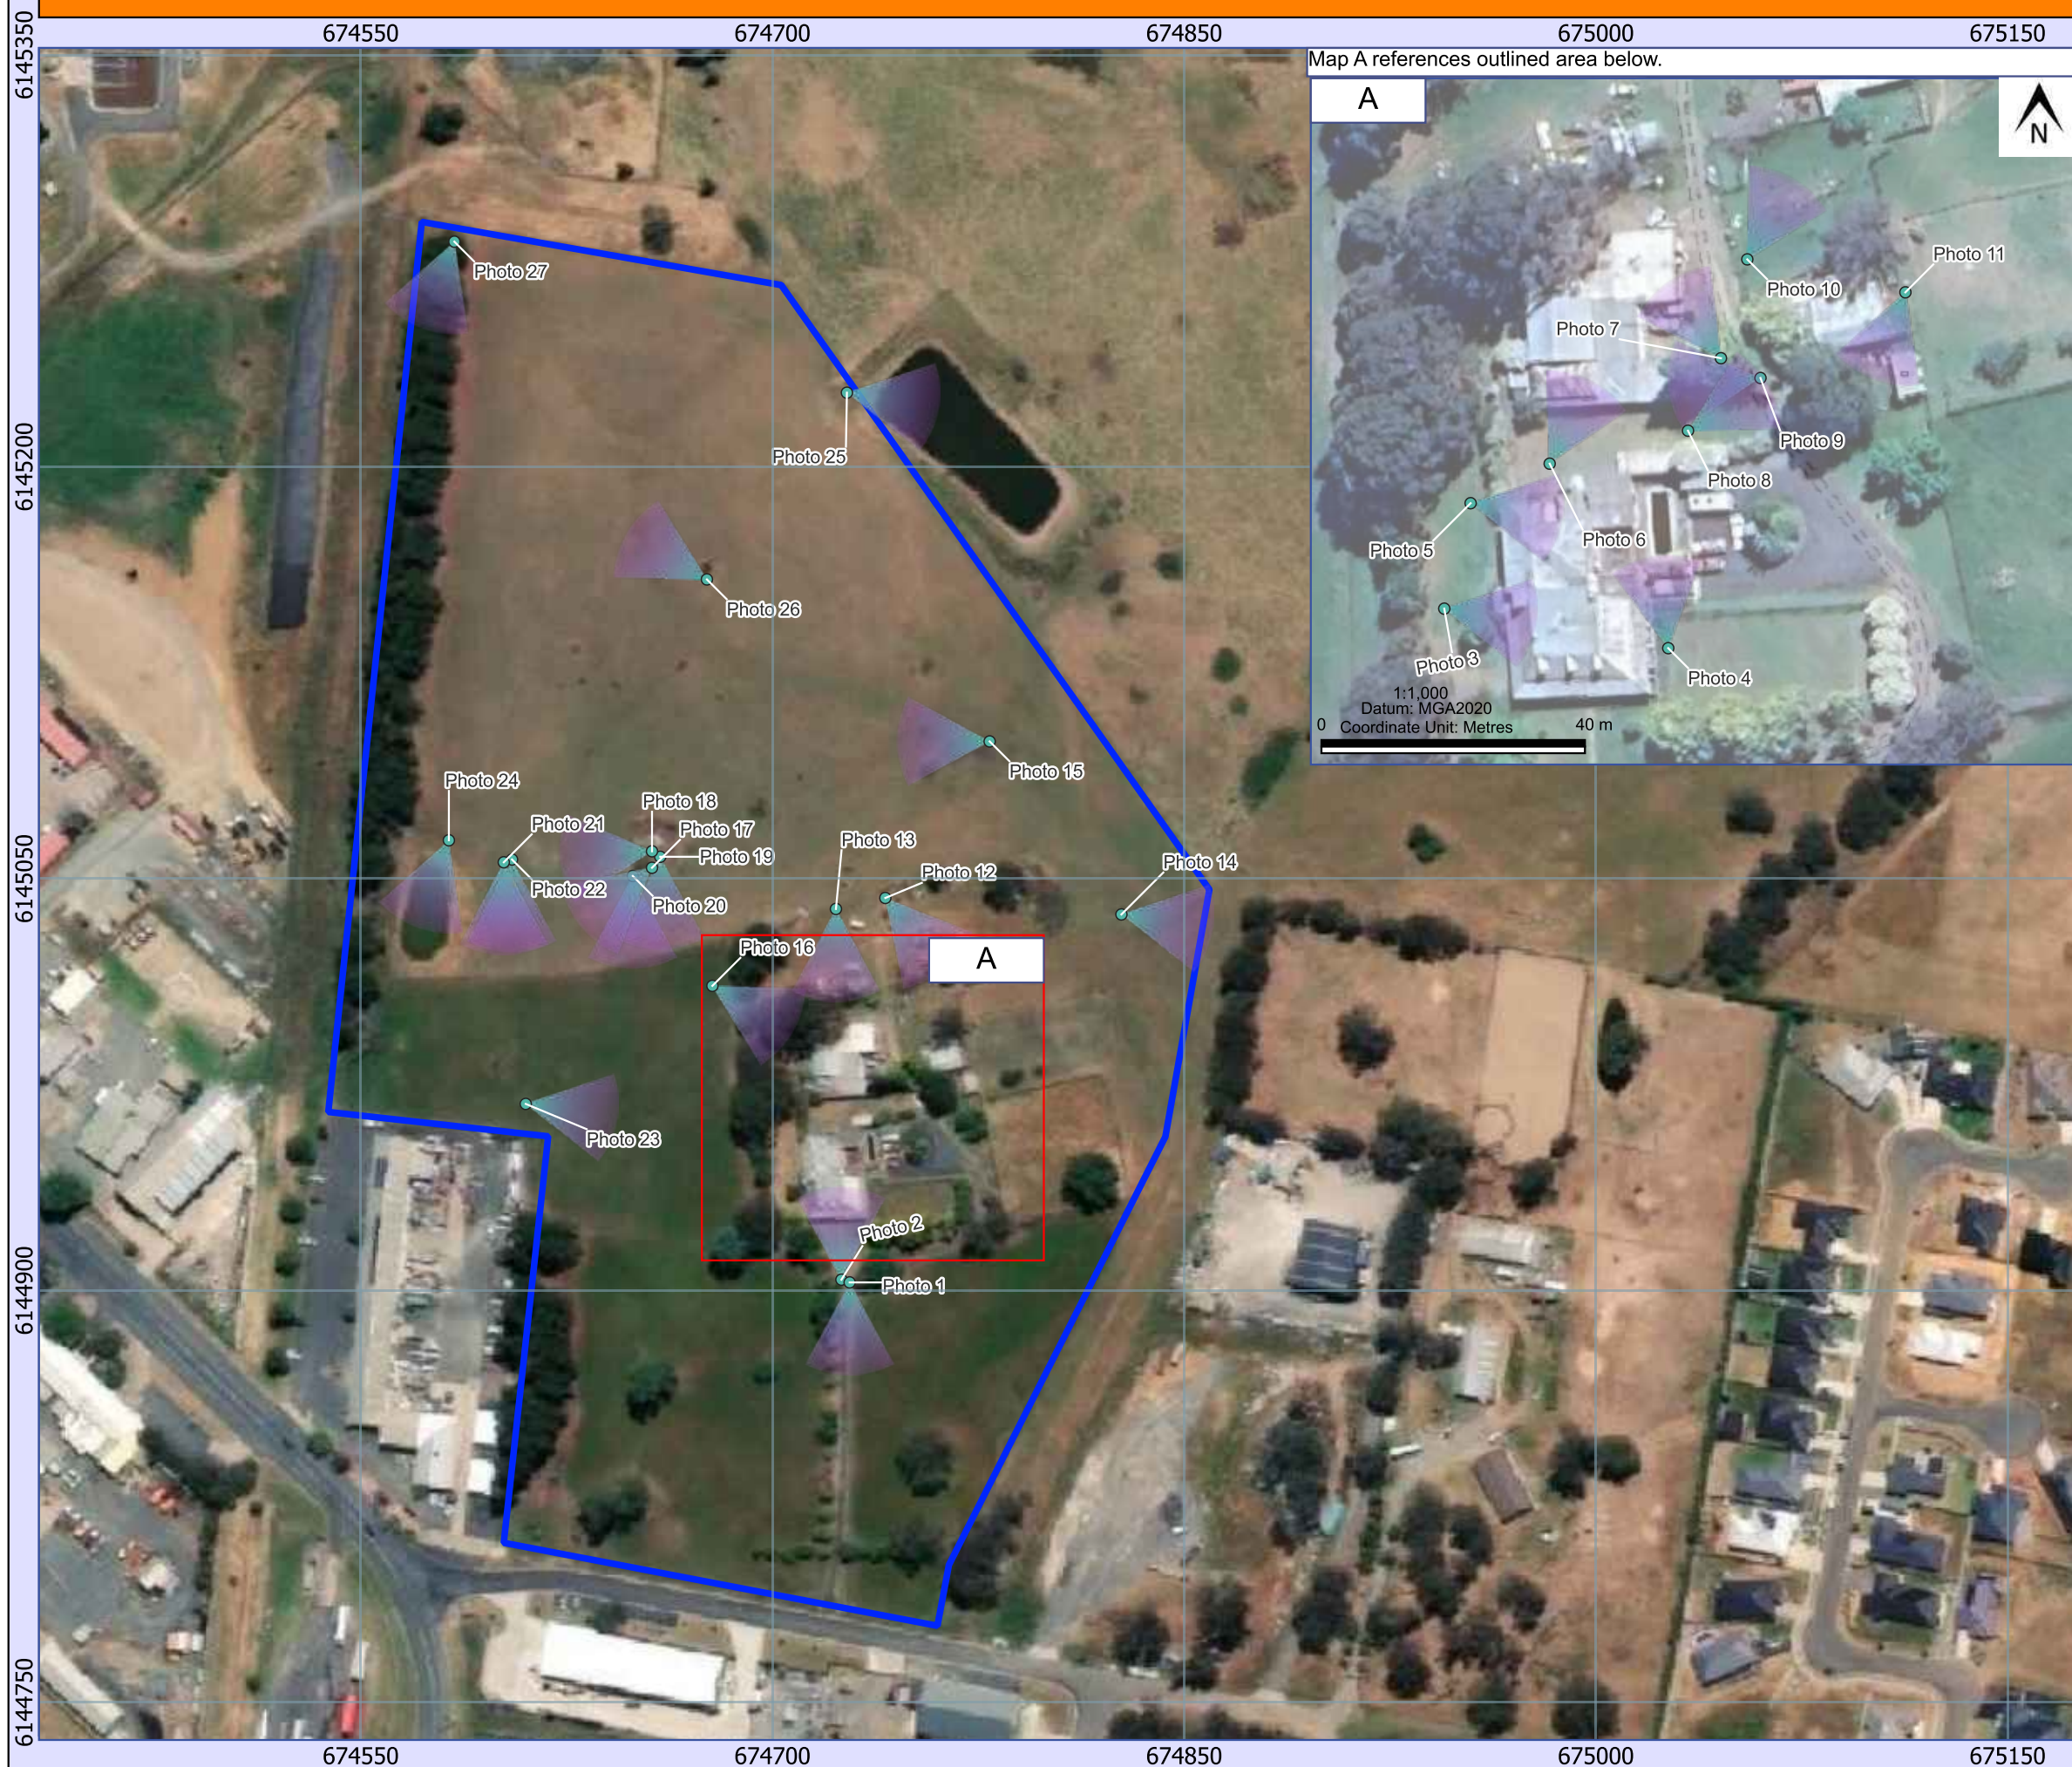
Figure 2 – Site Walkover Photographs

- Lot Boundary
- Photograph Location and Orientation (Approximate)

Site photographs collected during the walkover are presented in Appendix F, with the location and orientation of photographs (presented in Appendix F) depicted on Figure 2 (after text).

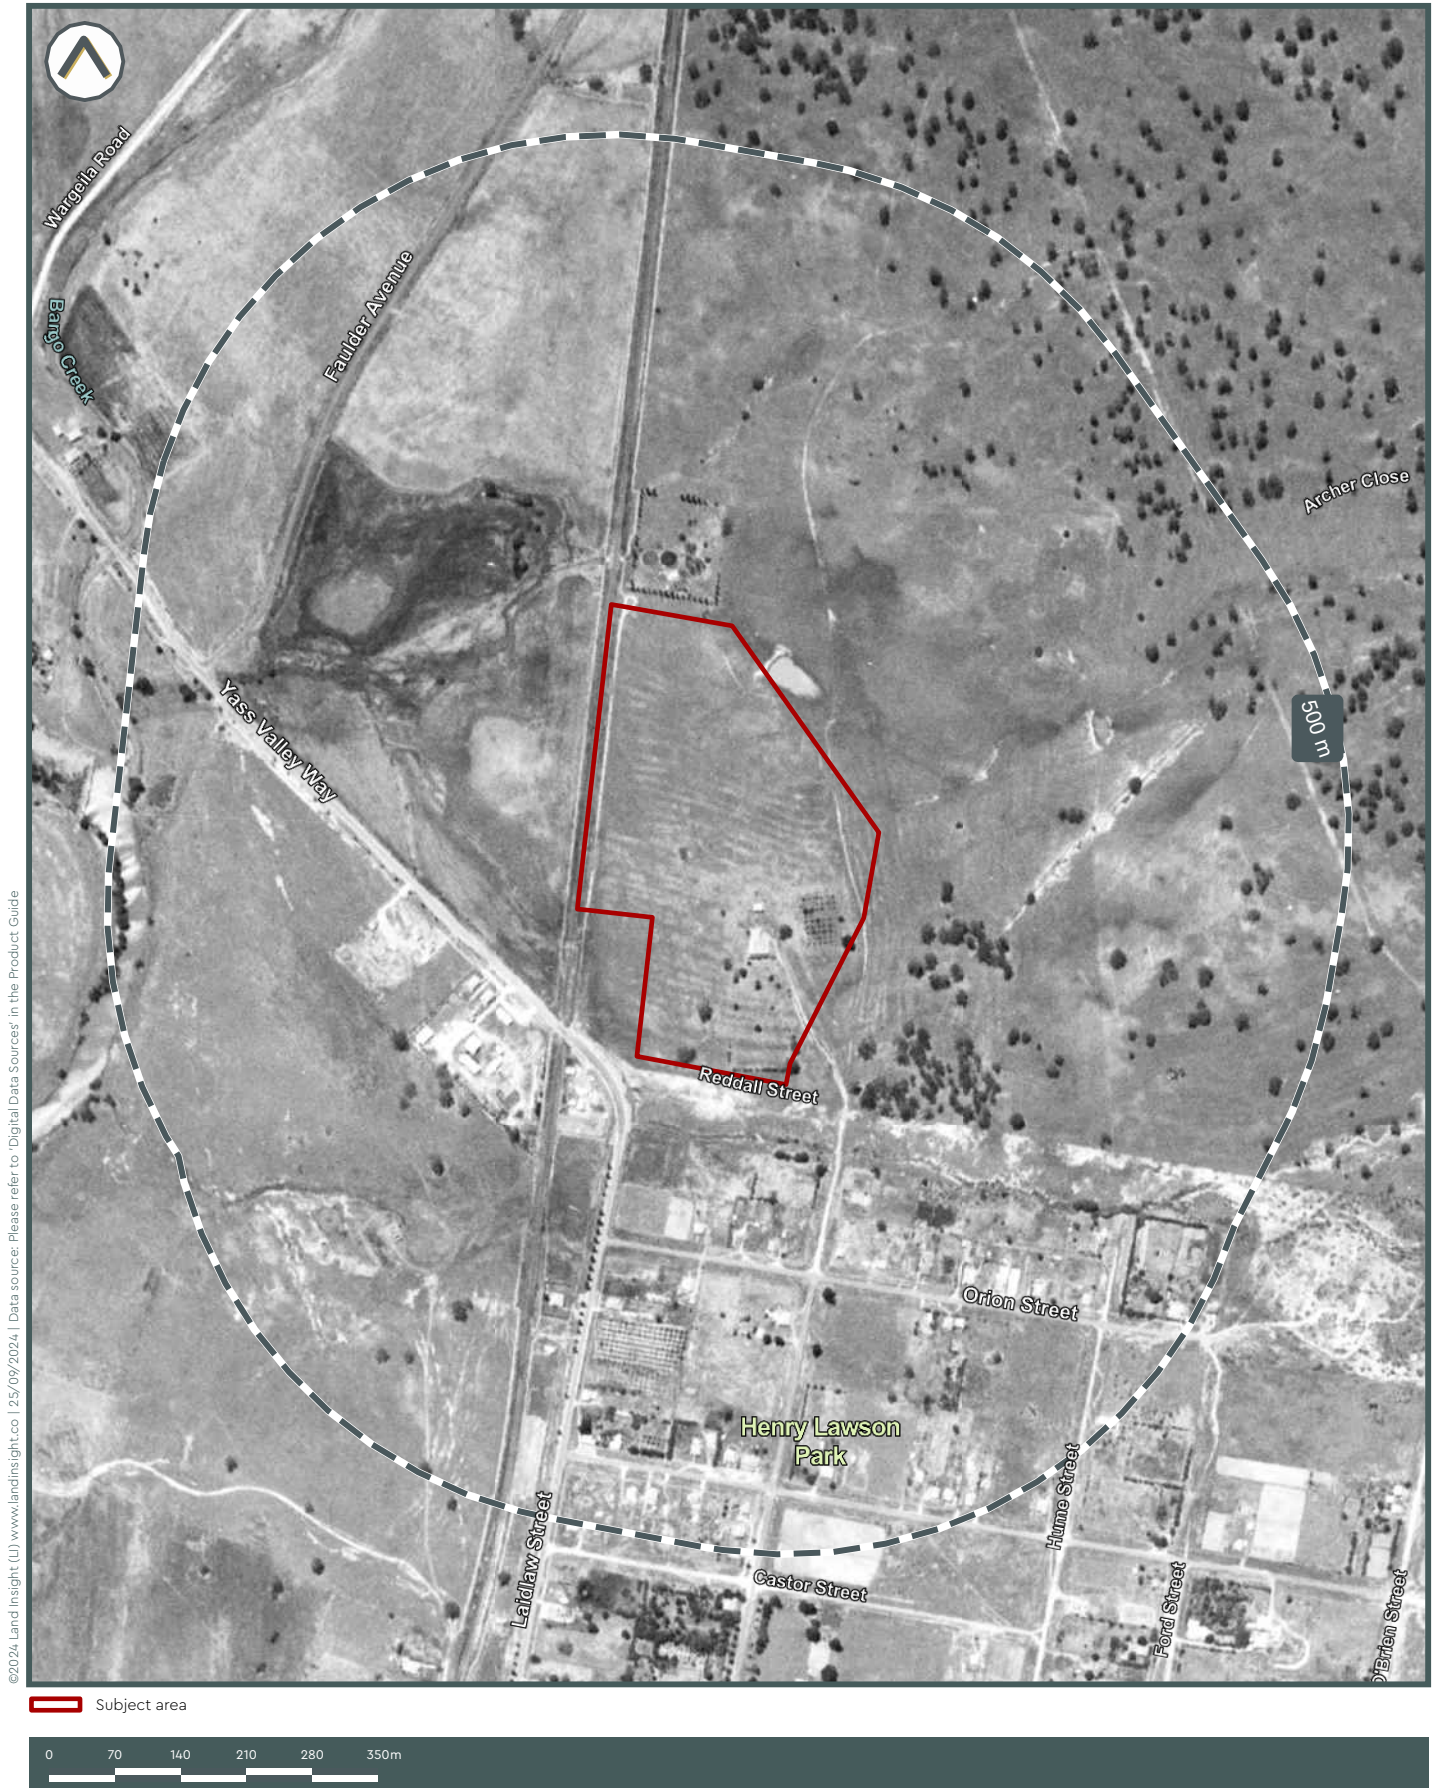
Historic Aerial Photograph - 1952

1. Agricultural activities; with indications of a historical market garden/orchard in operation east of the homestead (circa 1952).
2. Legacy Building(s); with the potential for hazardous building materials noting all structures on-site are to be demolished under an existing complying development certificate.
3. Waste Dumping; with historical and site observations indicating an area west of the homestead has been subject to waste dumping and burial; and
4. Historical Set down and Storage Areas; with potential chemical storage and various equipment (i.e., cars, shipping containers etc.) set down areas were identified in historical aerial imagery.

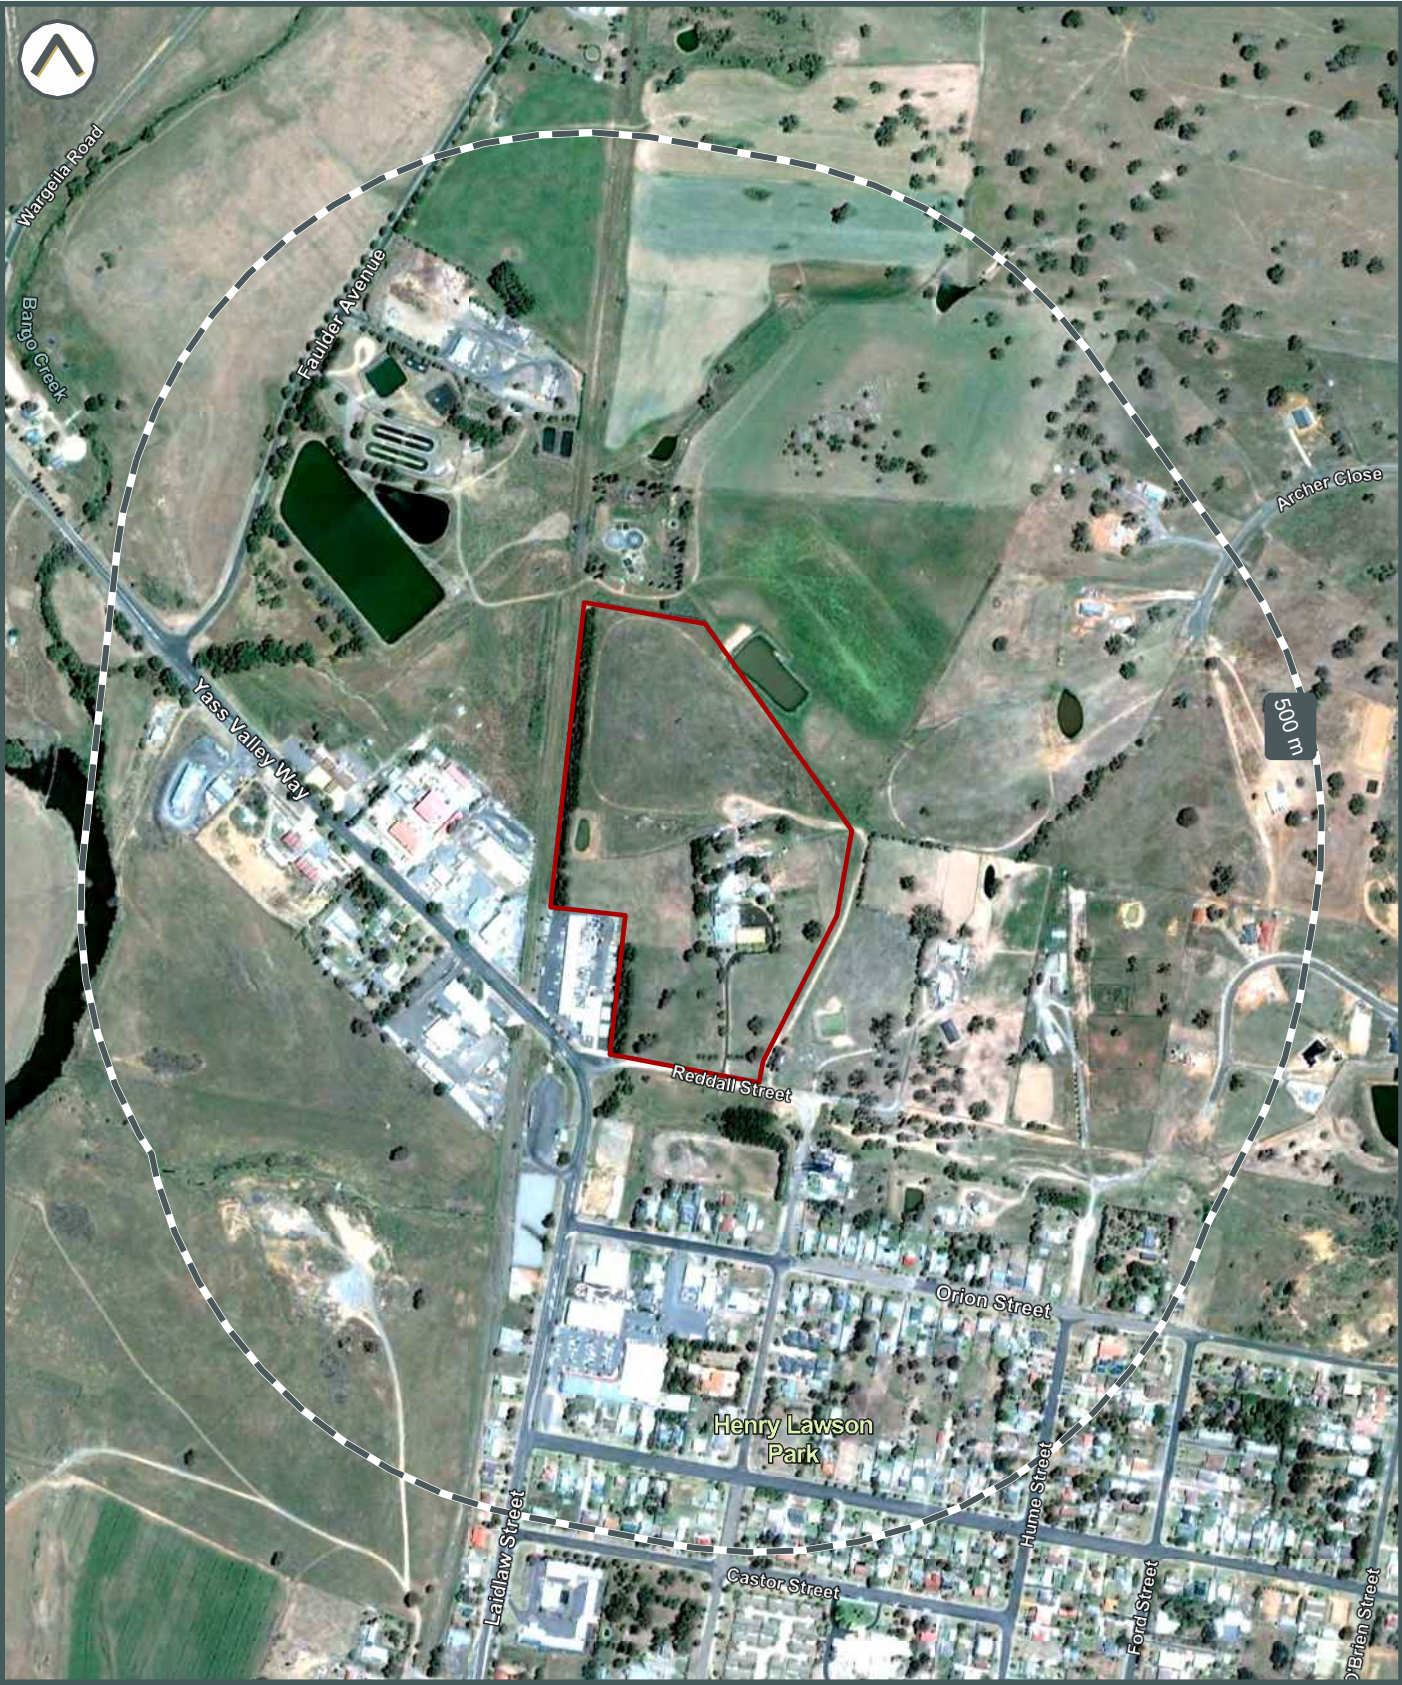
Historic Aerial Photograph - 2008

18. Two (2) terracotta pipes were observed in the centre of the northern paddock, atop high point of this area, with a bare patch of land adjacent (refer to Photograph 26). Historical aerial images from 2008 indicated this area was occupied by an unidentified cylindrical object, potentially a former storage tank recycled for use as a stock water storage tank.

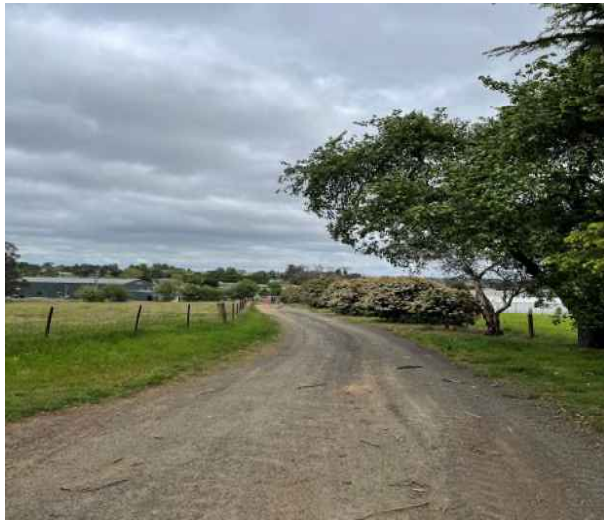
Photograph 1 – View of Site access/entrance (from Reddall Street) to homestead, looking south towards Reddall Street.

5. The Site is predominantly vacant land accessed by an unsealed paved road originating from Reddall Street (refer to Photograph 1) to the south, with an existing homestead and a sheet metal shed (Shed 1), currently undergoing demolition (refer to Photograph 2), located centrally within the property. The homestead consists of the original building footprint and subsequent building alterations to the north

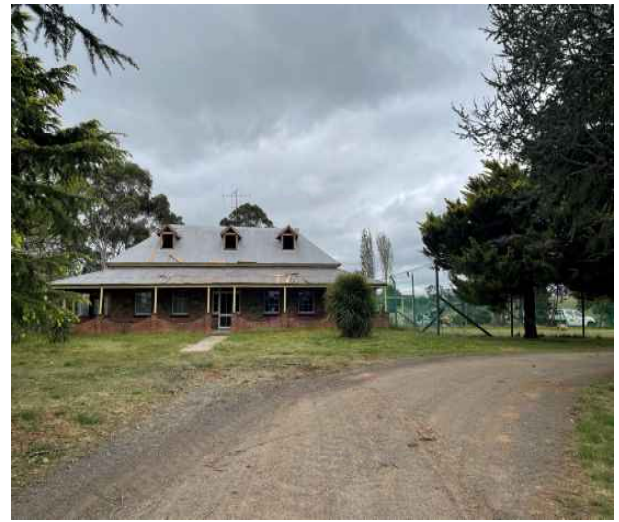
Photograph 2 – View of the front of the homestead and tennis court to the right, looking north.

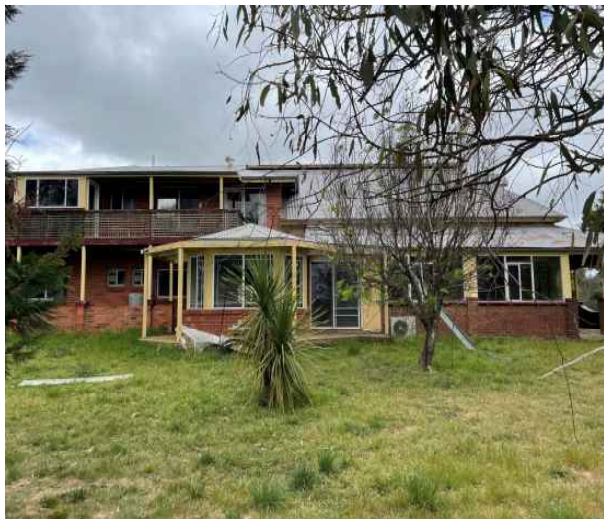
Photograph 3 – View of the homestead, facing east, highlighting (newer) additions to the homestead on the left.

(refer to Photograph 3), a pool and tennis court, an asphaltic-sealed parking area and an external flat (refer to Photograph 4). Sheep were observed grazing in the northern and western paddocks.

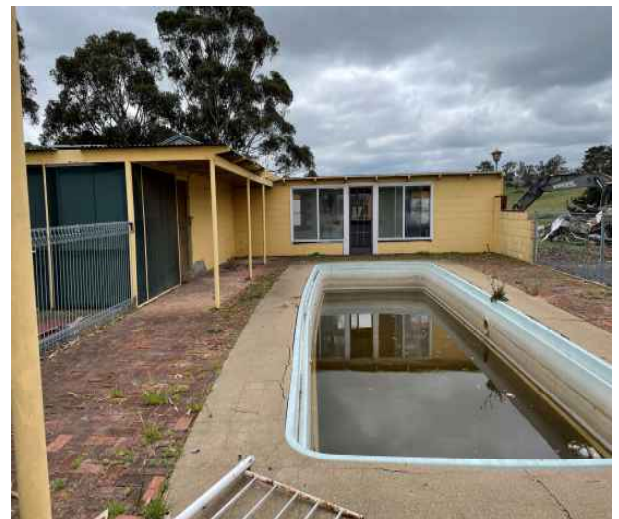
Photograph 4 – View of the outhouse and pool connected to the homestead, facing north.

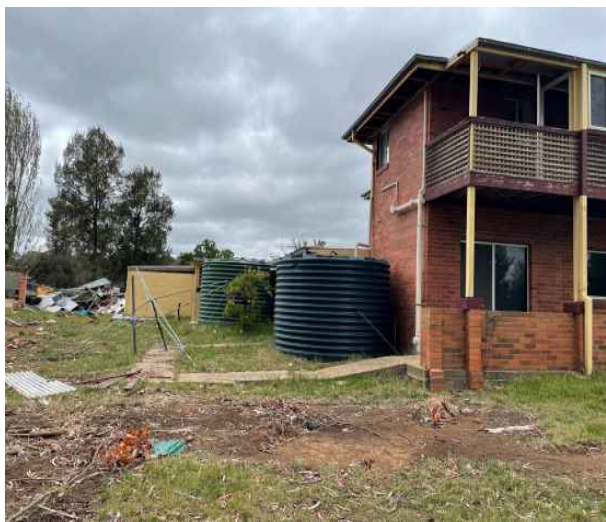
Photograph 5 – View of rainwater tanks connected to homestead (facing east) and demolition waste (to the left).

7. Two (2) rainwater tanks connected to the newer addition of the homestead were observed on-site (refer to Photograph 5) along with building wastes associated with the demolition of the homestead.

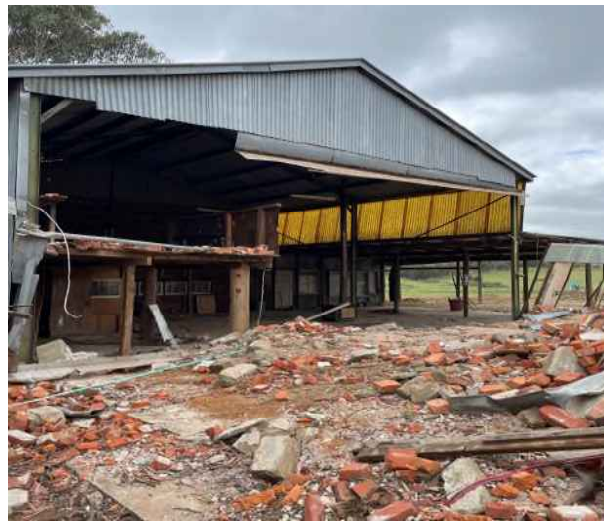
Photograph 6 – View of partially demolished Shed 1 (facing south-east) containing office and storage areas.

8. Shed 1, currently being demolished, was observed north of the homestead. This shed appeared to include an office and storage areas (refer to Photograph 6) and an animal shelter (refer to Photograph 7). Shed 1 appeared to have historically garaged equipment and machinery however evidence of the storage of chemicals and other products could not be ascertained.

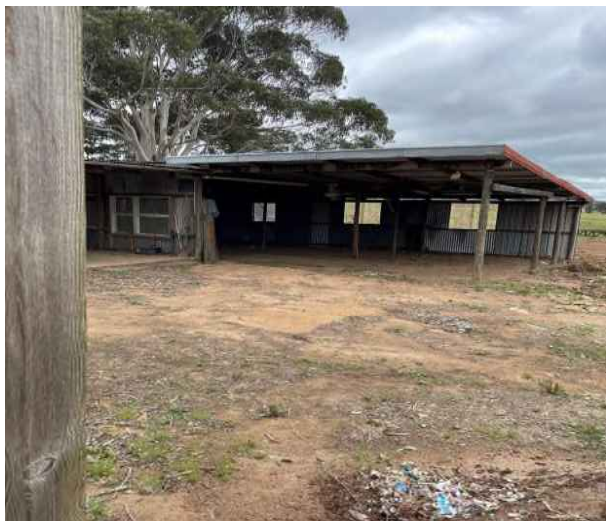
Photograph 7 – View of partially demolished Shed 2 (facing north-west) containing potential animal shelter and storage.

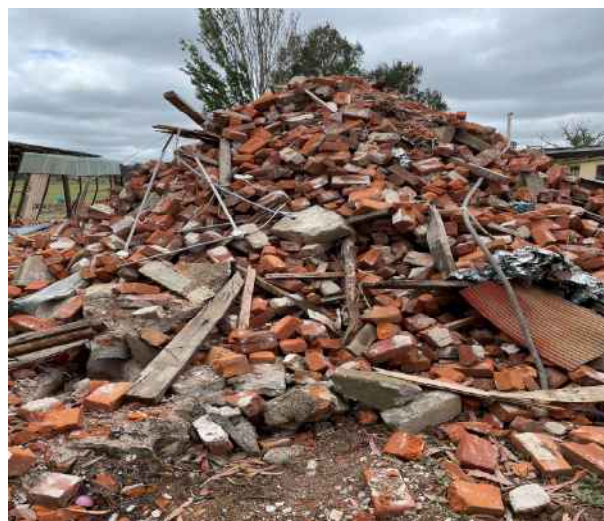
Photograph 8 – Construction & Demolition waste atop stockpile/filled in central portion of the Site, facing east.

9. Construction and demolition (C&D) wastes were observed sporadically around the homestead with a large pile of bricks and concrete, wood and metal waste (refer to Photograph 8) and corrugated sheet metal (refer to Photograph 9), located northeast of the homestead, adjacent the footprint of the demolished Shed 2. A stockpile of soil mixed with construction and demolition (C&D) waste was located on the footprint of Shed 3 (refer to Photograph 10).

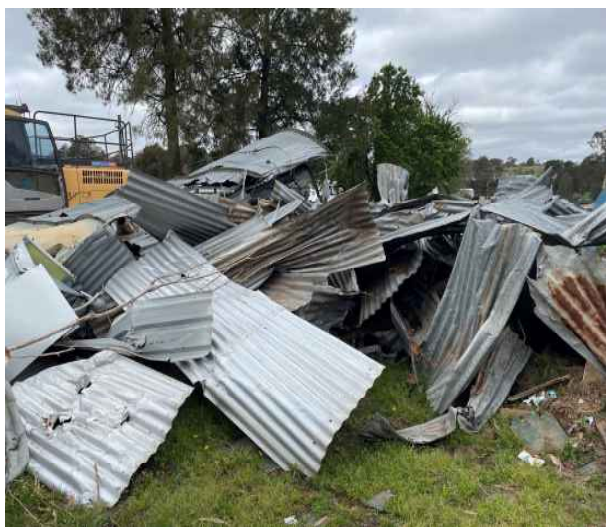
Photograph 9 – Construction and Demolition (C&D) waste (corrugated iron) atop stockpile/filled area in central portion of the Site, facing west.

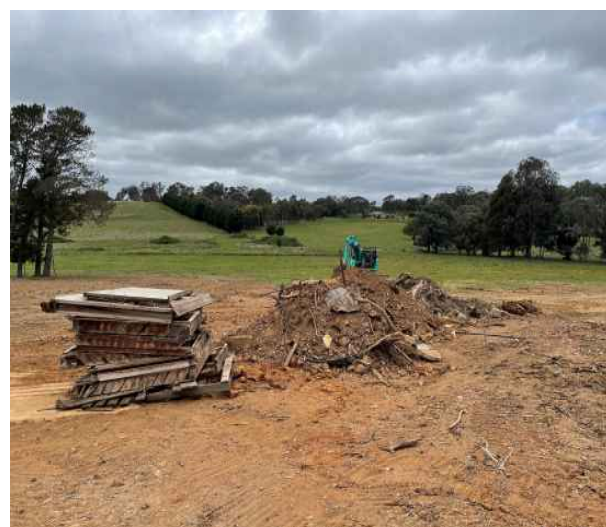
Photograph 10 – Looking north-east across the central portion of the Site with C&D waste atop stockpile/filled areas and stacks of pallets.

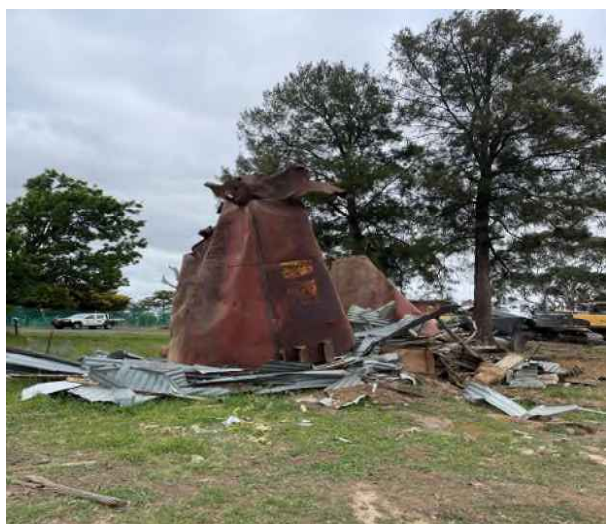
Photograph 11 – A partially demolished fuel tank atop of stockpiled C&D waste in central portion of the Site, facing south-west.

10. A partially demolished storage (fuel) tank was observed on-site, associated with C&D stockpiles adjacent the footprint of Shed 2 (refer to Photograph 11). Anecdotal information (obtained from demolition contractors on-site) indicated the damaged tank was sourced from nearby fuel stations for use as a water storage tank. The tank is likely the cylindrical object observed within the central northern portion of the Site, described in historical aerial images between 2008 to 2024.

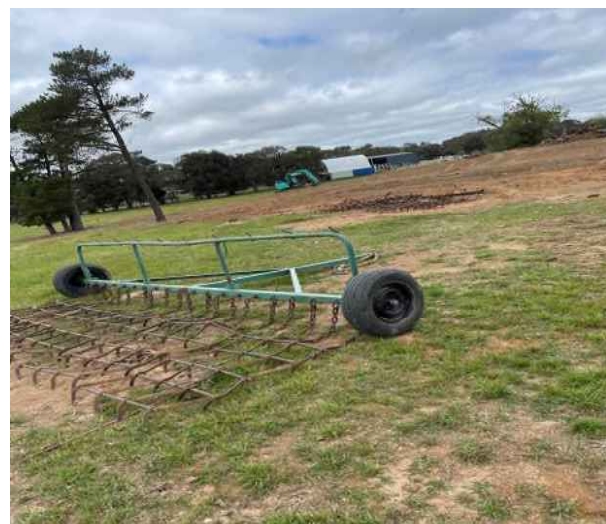
Photograph 12 – Remnant farm equipment located northeast of the homestead (facing south-east).

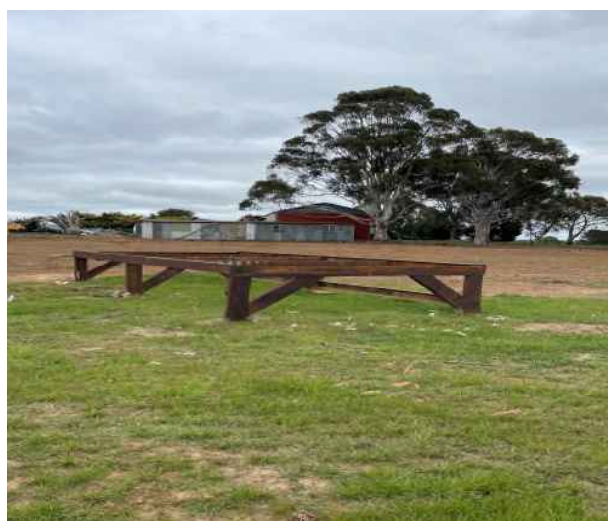
Photograph 13 – Remnant farm equipment, located north of Shed 1 (in background), facing south.

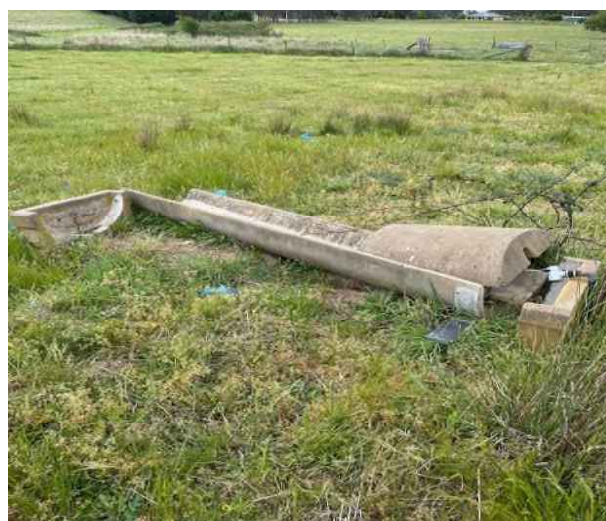
Photograph 14 – Remnant concrete cattle trough located northeast of the homestead and structures (facing east). Note PVC piping in right of photograph.

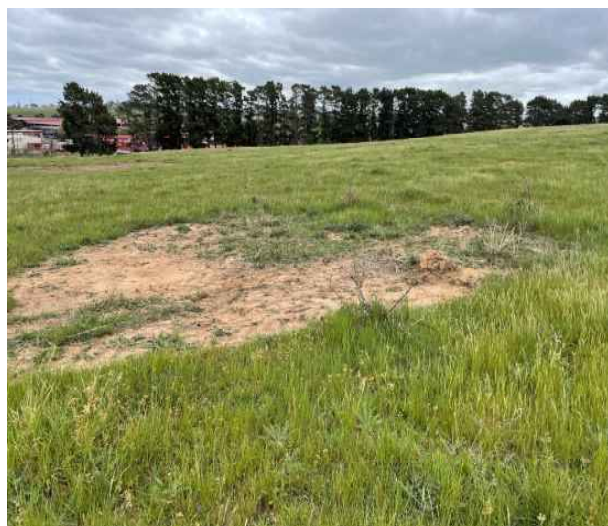
Photograph 15 – View of bare area associated with past equipment set down (facing west) located approximately 100 m north of the homestead.

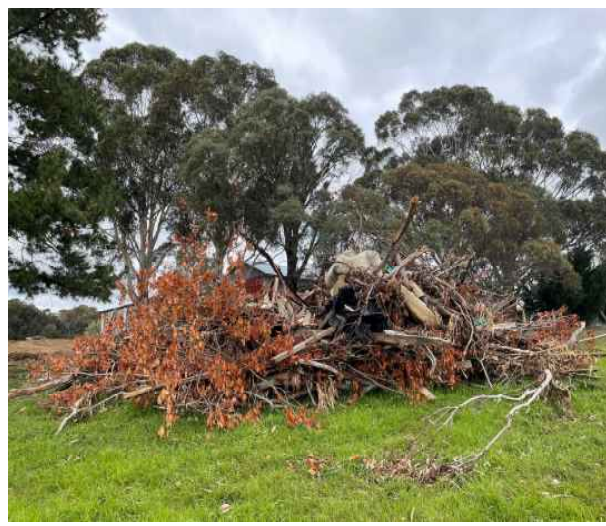
Photograph 16 – View of a stockpile (burn pile) located approximately 50 m west of the homestead (looking southeast), containing vegetation and C&D waste.

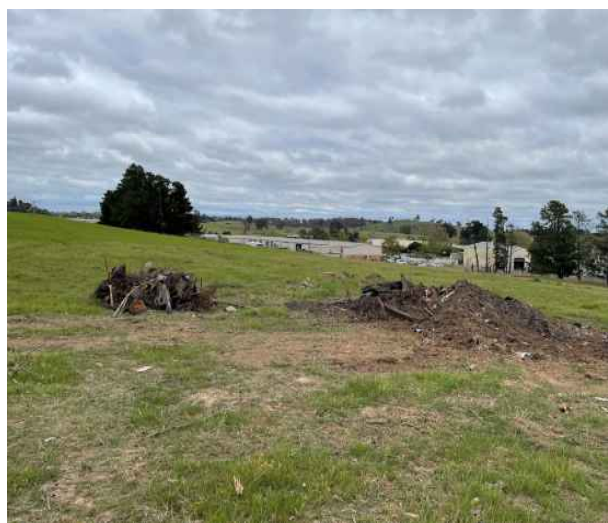
Photograph 17 – View of stockpiles and burn/burial site located in the back paddock north-west of the homestead, facing south-west.

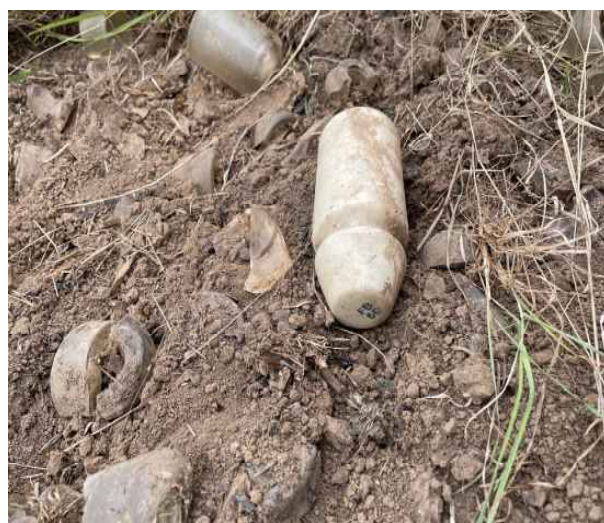
Photograph 18 – Electrical insulators and ceramic parts located within the stockpile and burn/burial site in the back paddock.

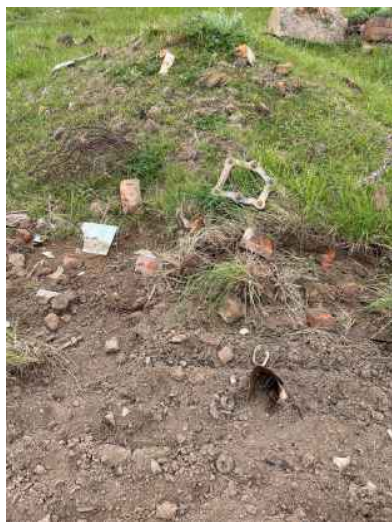
Photograph 19 – Brick and tile fragments in hummocky ground area, approximately 85 m northwest of homestead, with gaskets and engine parts also observed at surface.

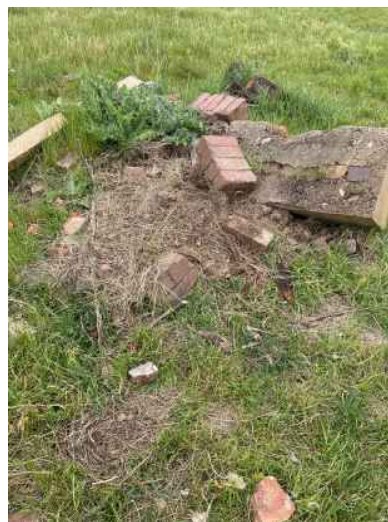
Photograph 20 – Concrete and brick fragments in hummocky ground area, approximately 85 m northwest of homestead.

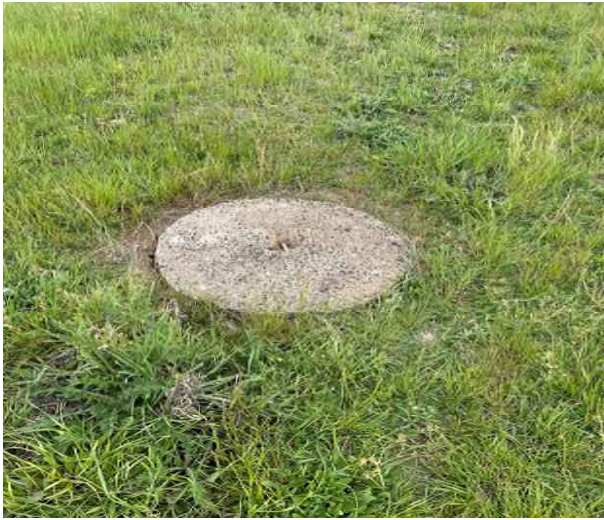
*Photograph 21 – View of northern concrete riser and lid (1 of 2)
located between hummocky area and western dam.*

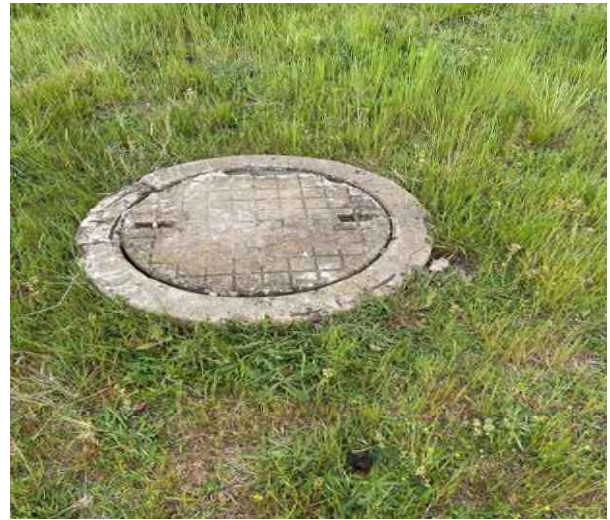
*Photograph 22 – View of southern concrete riser and lid (2 of 2)
located between hummocky area and western dam.*

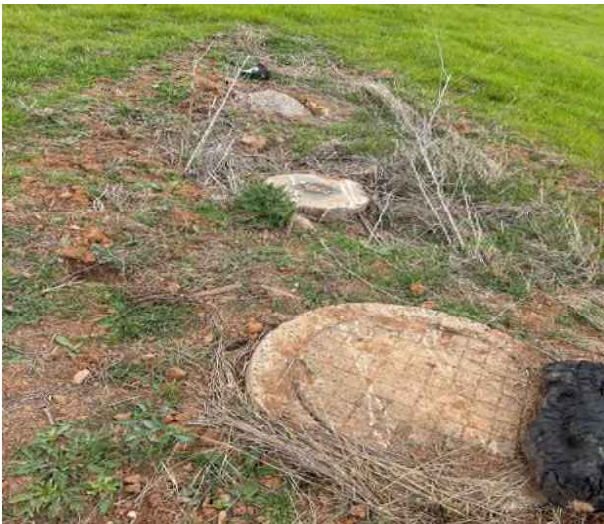
*Photograph 23 – View of two concrete risers and lids and service
valve (facing southeast), located 50 m east of western boundary.*

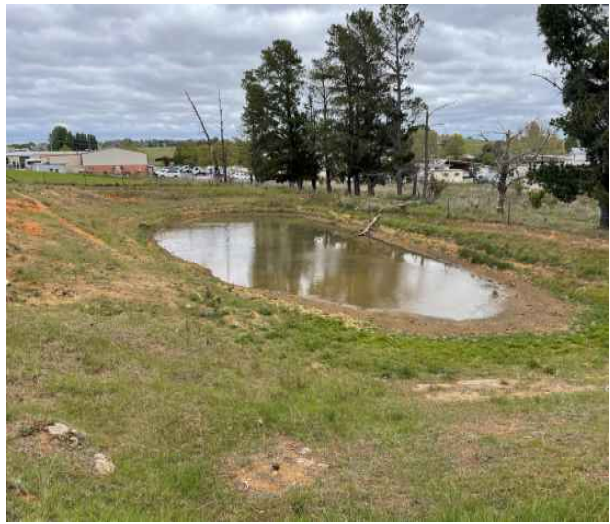
*Photograph 24 – View of western dam, facing south-west with off-
site commercial and industrial facilities in background.*

17. One (1) farm dam is located on-site, present centrally on the western boundary (refer to Photograph 24), whilst a second larger dam is located off-site, adjacent the north-eastern boundary (refer to Photograph 25).

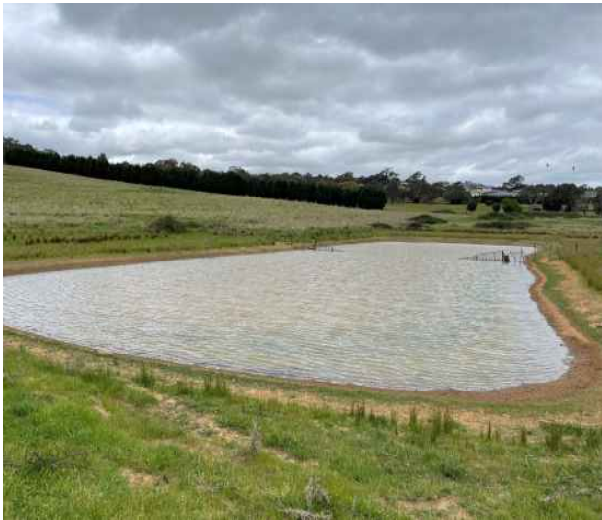
Photograph 25 – View of off-site (northern) dam, facing south-east.

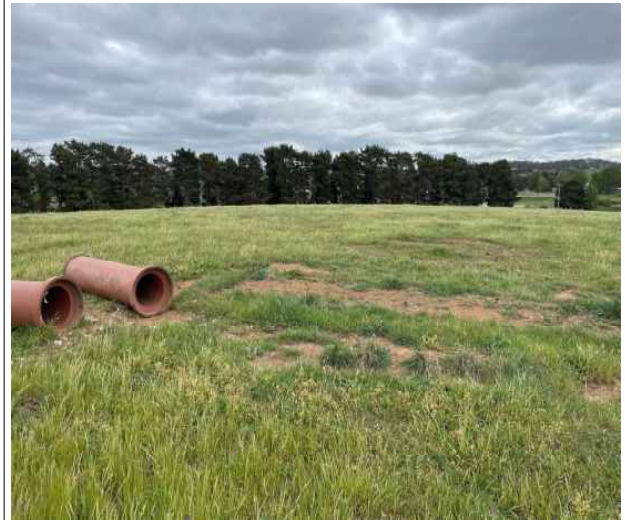
Photograph 26 – C&D waste located within back paddock atop slope, facing north-west.

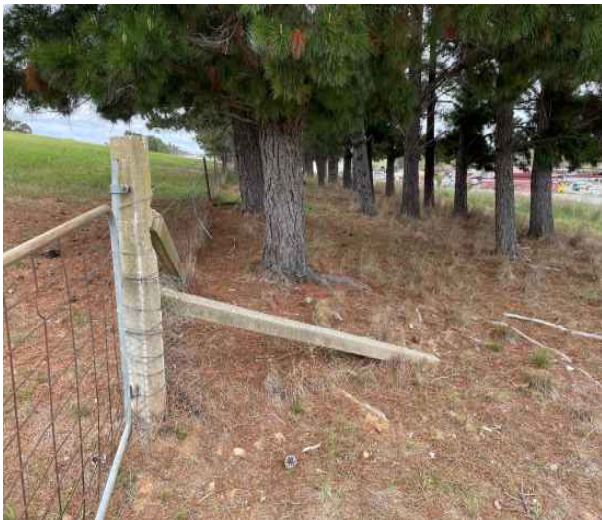
Photograph 27 – View of rail corridor running along western boundary of the Site, facing south-west.

19. The former Yass Tramway runs along the western boundary, separated from site by the planted stand of mature pine trees (refer to photograph 27). The tramway is also downslope of the Site with the grade sloping at approximately 10% from east to west and no spur lines or tracks accessing the Site were identified.
