ANDREW STARR & ASSOCIATES HERITAGE CONSULTANTS

Re: Demolition of a lean to on the St Paul's lower Hall.

Proposed is Demolition of a lean to on the St Paul's Lower Hall.

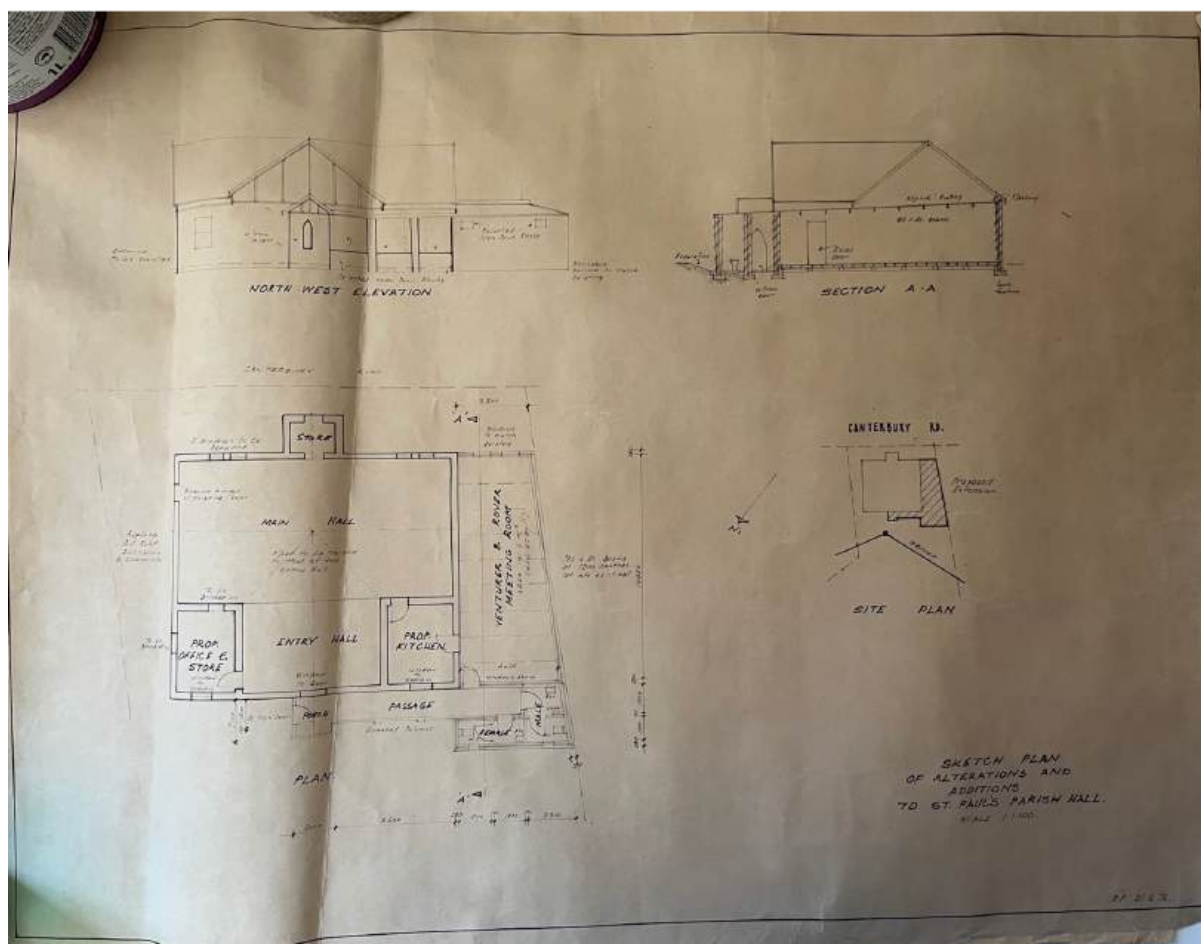
Fig. 2 Plans 1976 for an unbuilt side addition. This shows the existing form of the building. The store area was an entrance to the building. The original dimensions of the building were just the man hall and this entry. The entry hall is a later addition. The kitchen and office were constructed after 1976. This shows the development of the building in three stages. The original hall used as a school was first, later the entry hall was created with demolition of a large section of the original hall. The office store and kitchen additions were later constructions and are intrusive fabric.

Fig.26 Door to kitchen on plan fig.2.

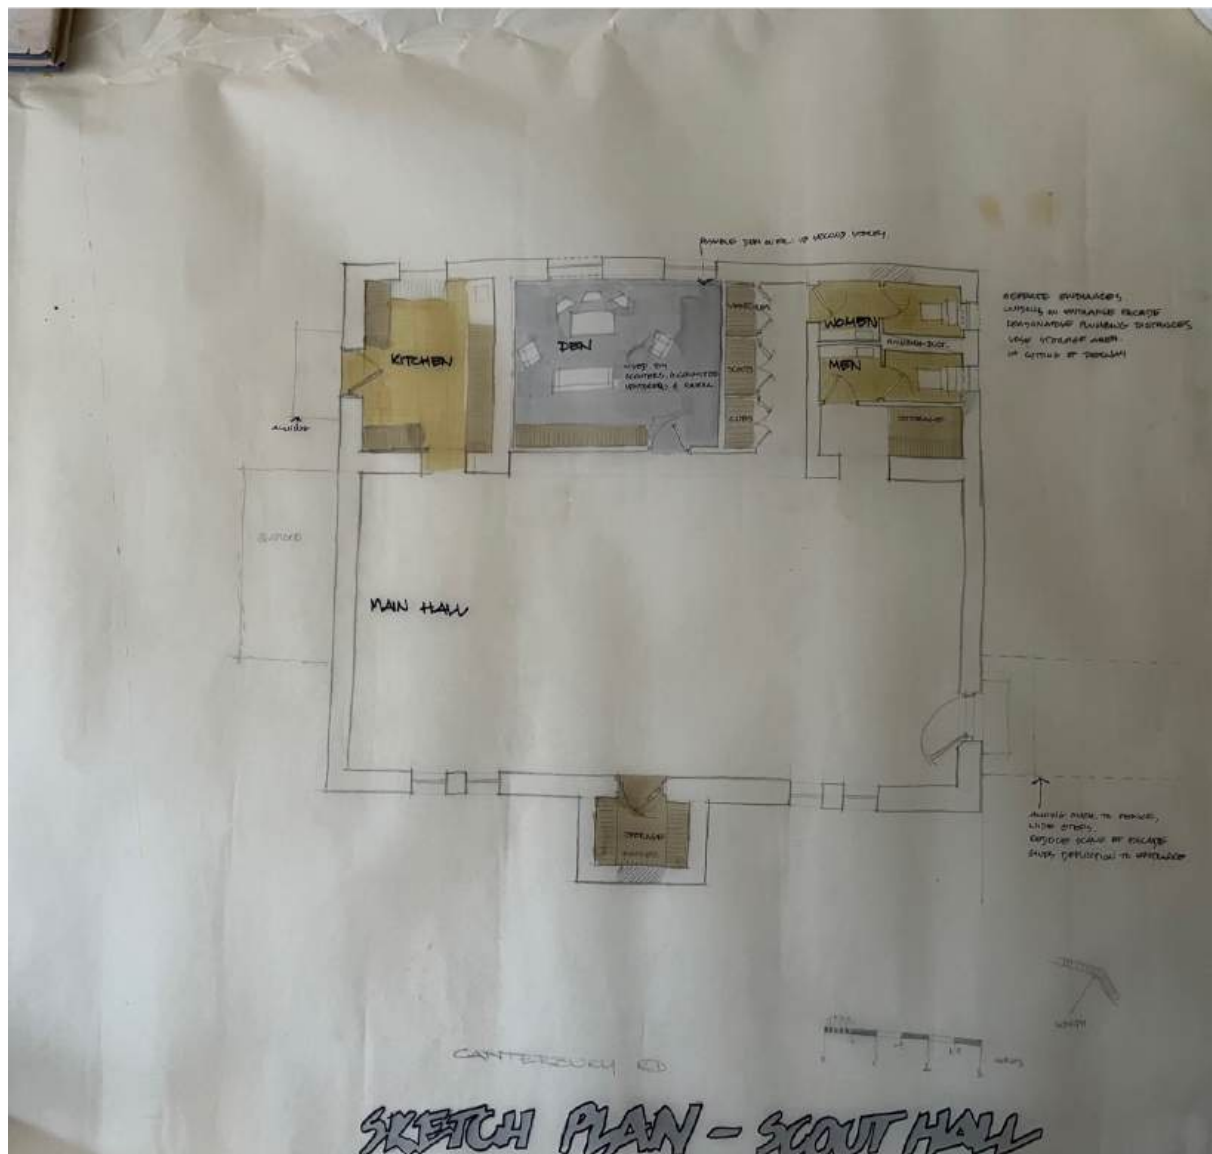
Fig.4 Undated plan. The entrance is used a storage, Restroom have been proposed The Den created. The kitchen has a proposed side entrance that was not constructed.

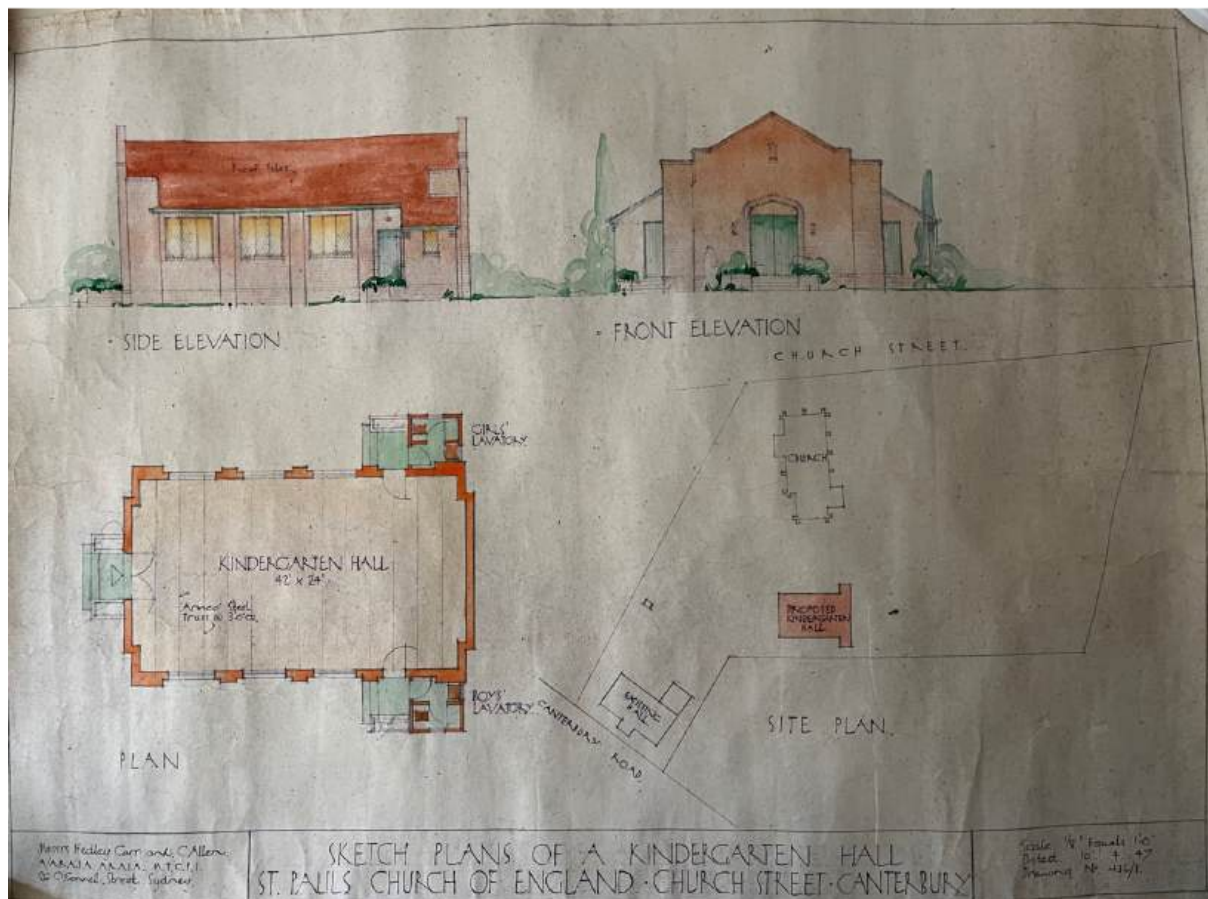
Fig. 5 Plans for a kindergarten hall (not built) in 1947 shows shape of lower hall. The Entrance hall was not constructed at this time.

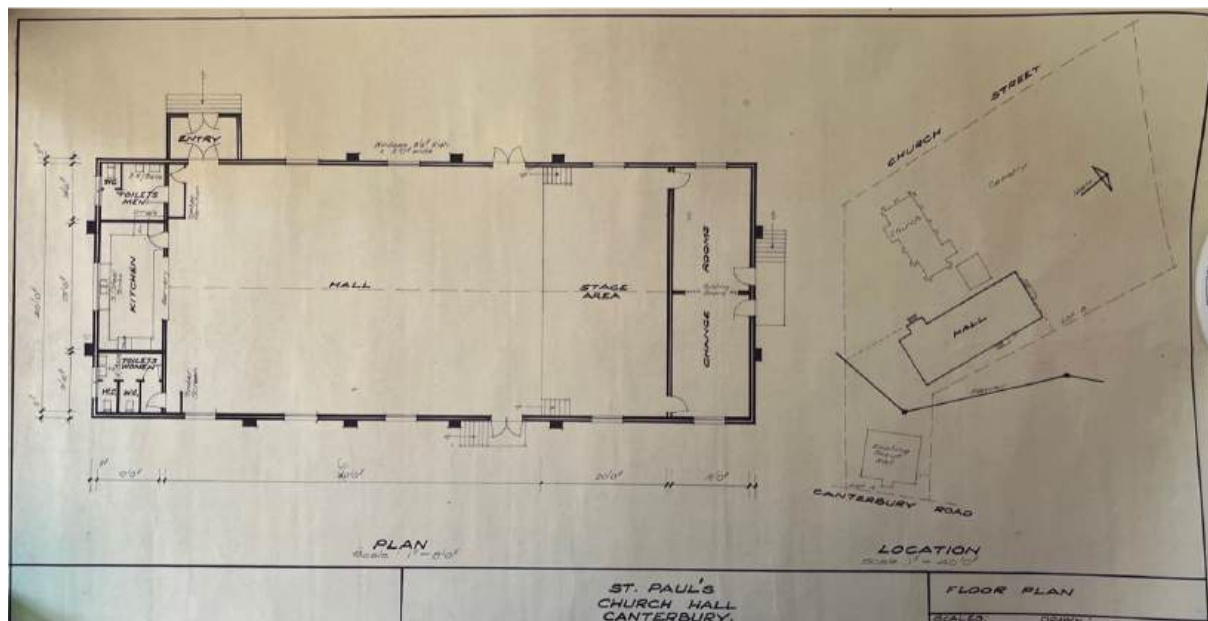
Fig.6 Plans for the new hall shows shape of the lower hall in 1972.

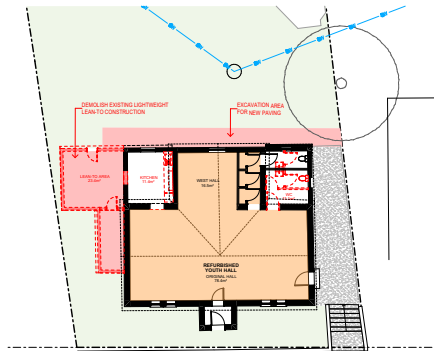
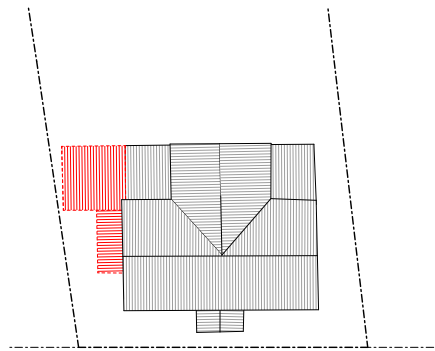
LEGEND	
[Red outline]	EXTERNAL SURFACES TO BE DEMOLISHED
[Red fill]	AREAS TO BE DEMOLISHED
[Orange fill]	HERITAGE BUILDINGS

1 GROUND LEVEL DEMOLITION PLAN
SCALE: 1:500

2 ROOF DEMOLITION PLAN
SCALE: 1:500

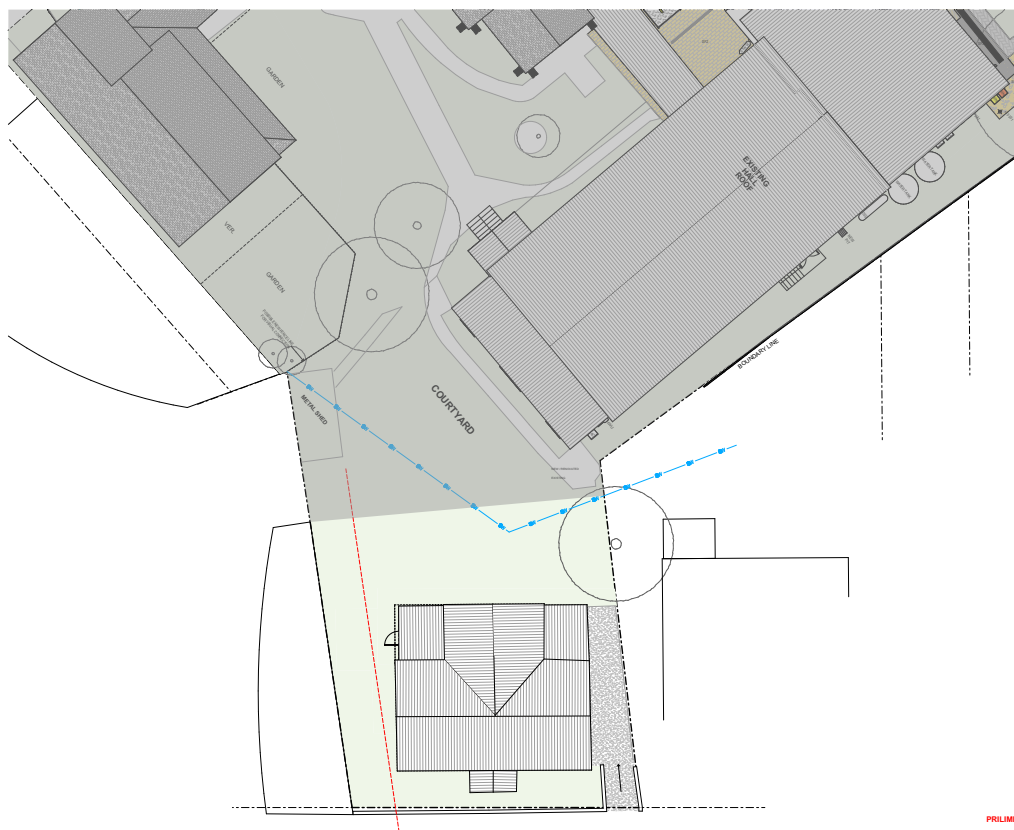
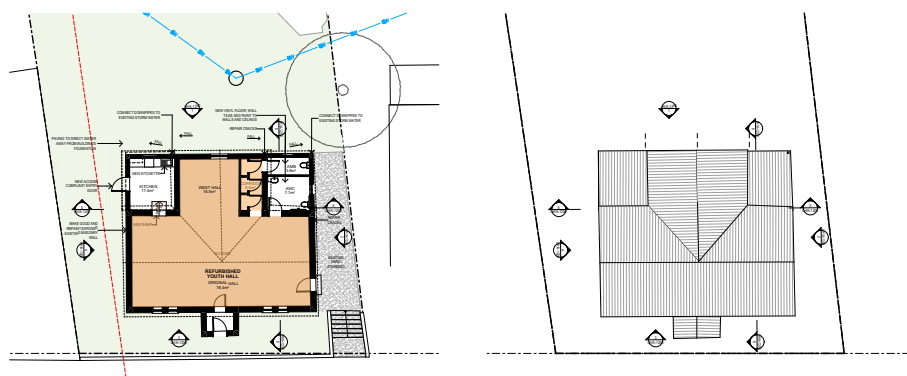
1 GROUND LEVEL - PROPOSED
SCALE: 1/100

2 LEVEL 1 - PROPOSED
SCALE - 1/160

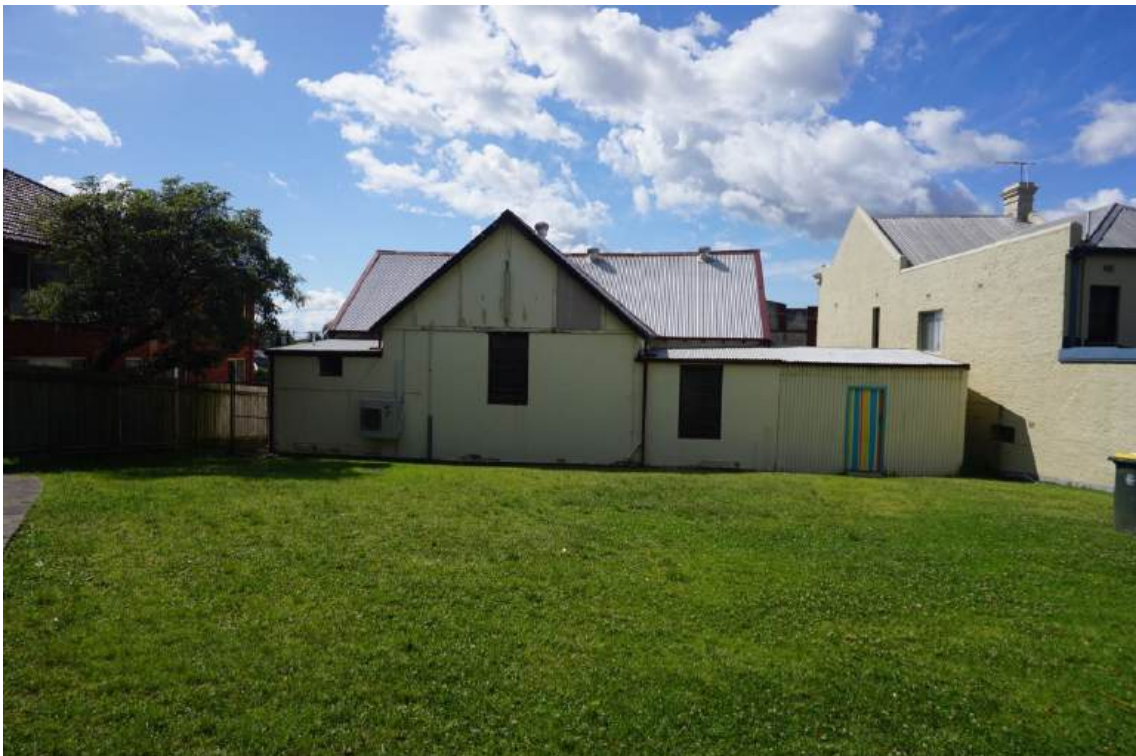
Fig.16 North (rear) façade. The building had two infill space infilled sometime between 1947 and 1972. An addition was later built to the west side infilling a section of breezeway.

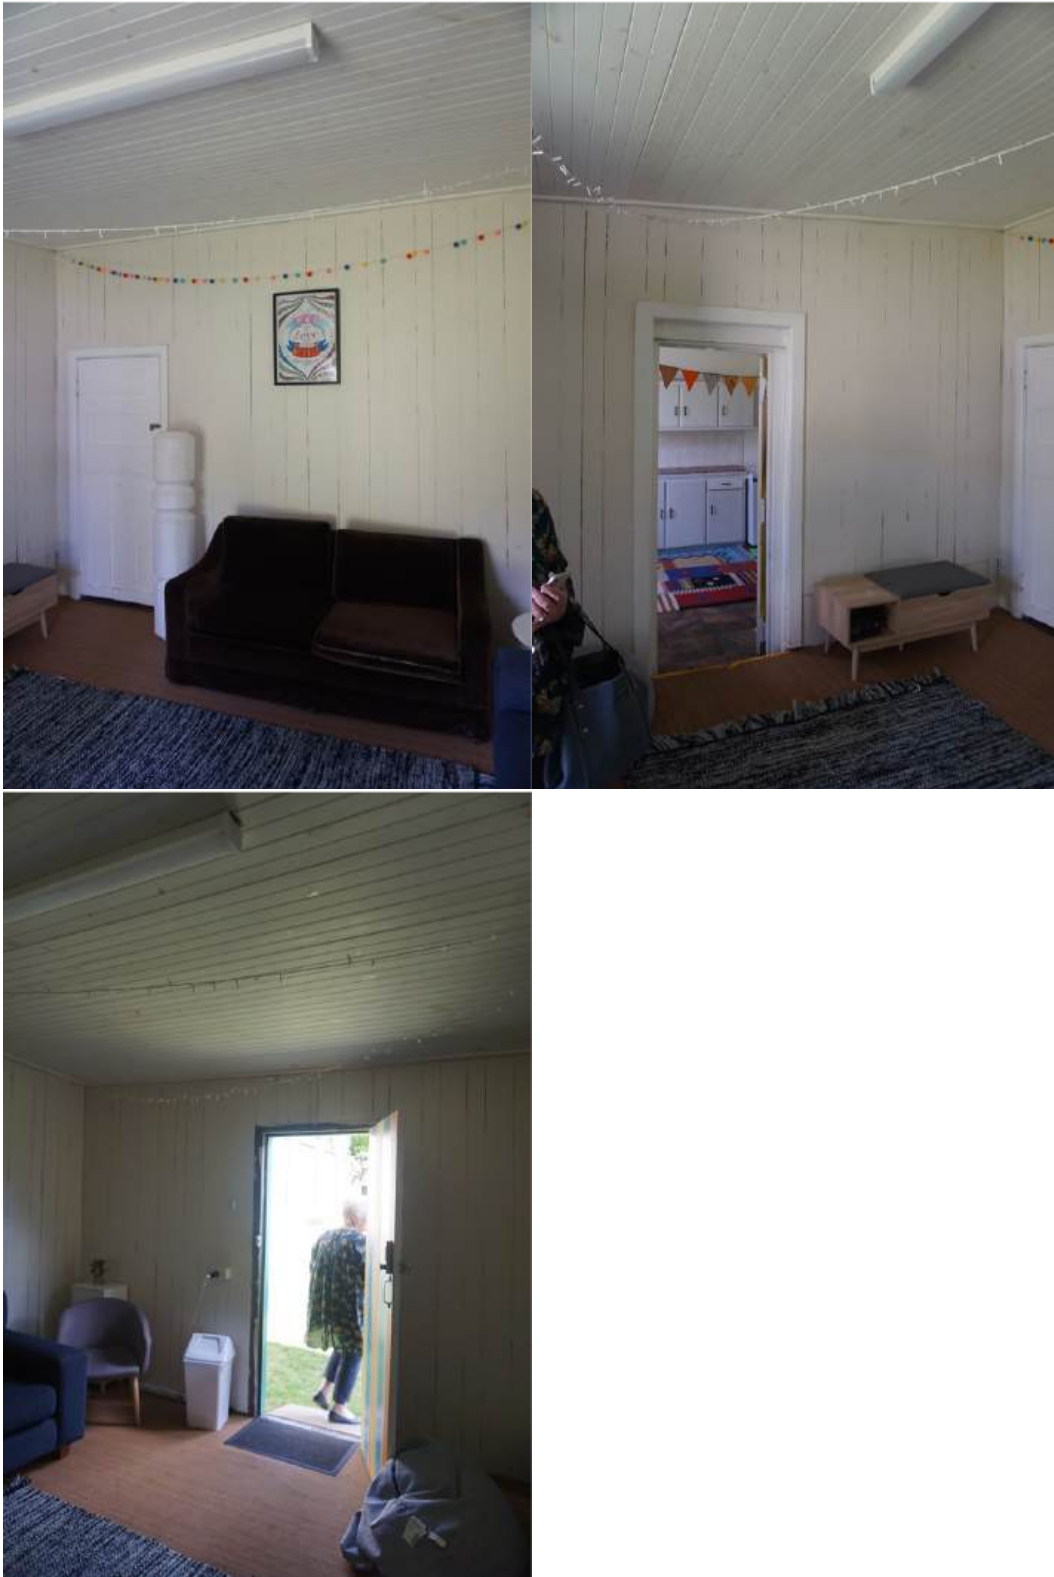
Fig.39 Interior of a side addition. The lining is a vinyl cladding on a timber frame that mimics boards.
