## Remediation and validation report

327 Boorowa Street, Young NSW

Ref: R12147val

Date: 19 December 2012

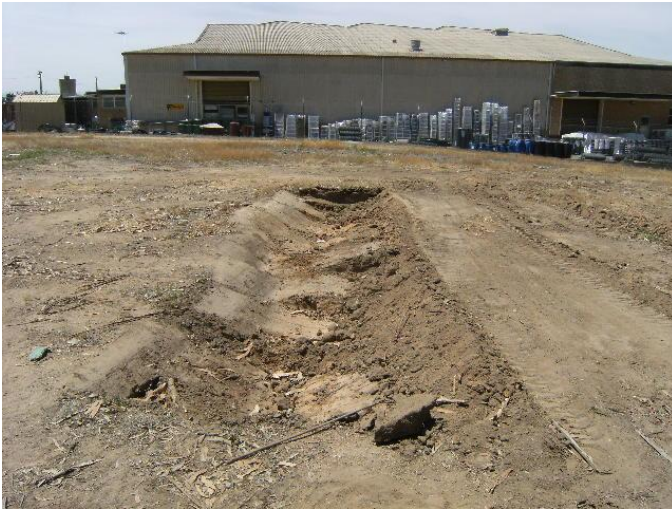
Excavation for the area south east of the former AST

The excavated areas had a total approximate volume of 52m<sup>3</sup>. The excavation pits sizes are listed in Section 9. No soil staining, odour or evidence of residual contamination was observed during inspection of the final excavated areas.

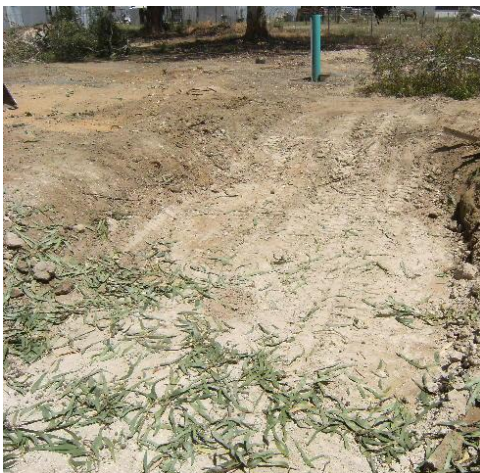
Excavation area of the former fibro shed

No asbestos cement (AC) fragments were observed on the surface in the area surrounding the former fibro shed.

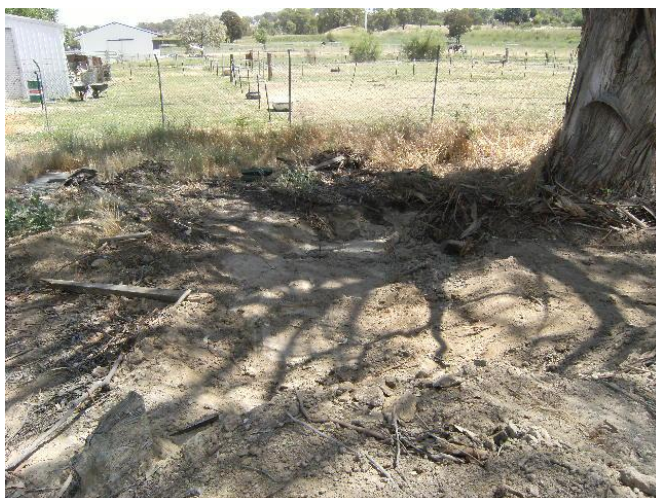
Ramp area excavation

1. Vehicle service ramp: TPH (C10-C36) was greater than the threshold criteria around sampling location 1 at the vehicle service ramp. The level of TPH (C10-C36) in this area was 39,250mg/kg where 1,000mg/kg is the sensitive land-use threshold. The level of lead in this location was elevated and below the commercial land-use threshold of 1,500mg/kg.
