# SITE CONTAMINATION REPORT

**PREPARED FOR:** MELROSS ENTERPRISES  
**SITE ADDRESS:** LOT 1 DP 1202085 323 BOOROWA STREET YOUNG NSW 2594

Revision: 01/07/2021  
Site Test: 28/02/2025  
Lab Test: 11/03/2025  
Job Number: 25016a

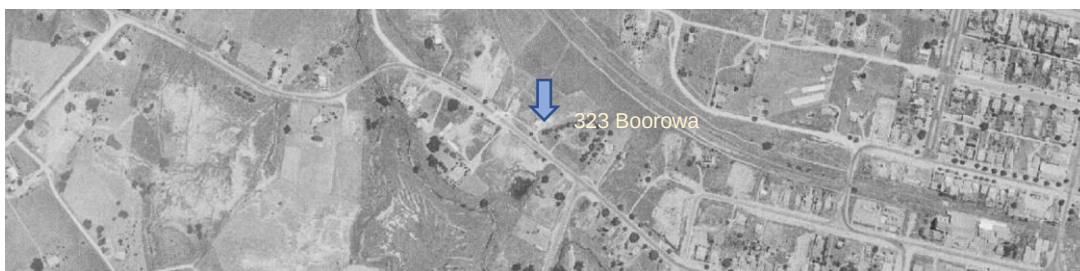
29 January 1969

Aerial photography shows that the commercialization of Lot 1 DP 1202085 has occurred over the past 25 years. Prior to the turn of this century, the site was residential. The photography is of relatively poor definition and the previous consultants have addressed the infrastructure that emerged with commercial buildings and fuel storage over the past 25 years.

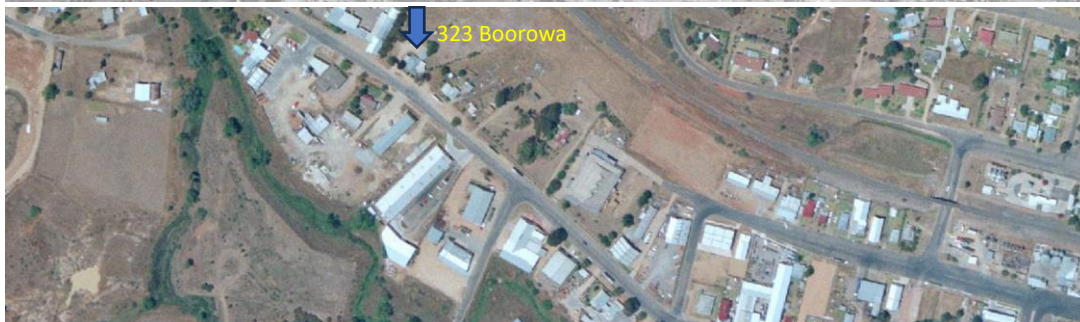
20 December 1997

- 1) No aerial evidence of further tank locations (although the pixilation is fair at best)
- 2) No evidence of Underground Storage Tanks (USTs)
- 3) No aerial evidence of rural vehicle accumulation.
- 4) No evidence of greater aggregation of buildings
