RGS03366.1-AB

**RE: 80 Seabreeze Parade, Green Point (Lot 40 DP31825)**  
**Geotechnical Site Classification for Proposed Residential Dwelling**

Regional Geotechnical Solutions Pty Ltd (RGS) has undertaken a geotechnical site classification for a proposed dwelling to be located at 80 Seabreeze Parade, Green Point (Lot 40 DP31825). The purpose of the geotechnical assessment was to provide a site classification in accordance with AS2870-2011 *Residential Slabs and Footings*, to assist in the design of the footings for the proposed building.

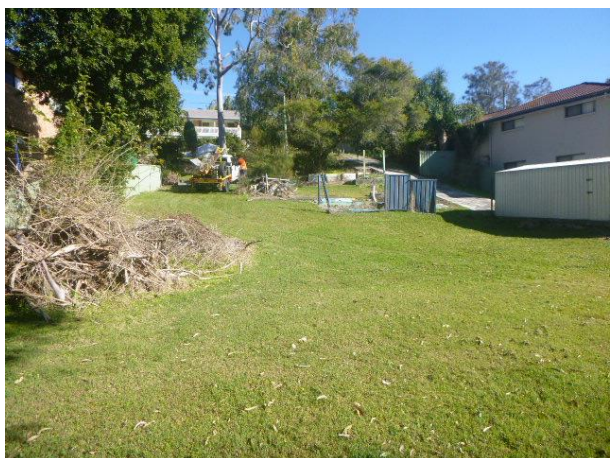
*Looking upslope towards the west over site showing moderately to gently sloping area, old shed, driveway and stockpiles.*

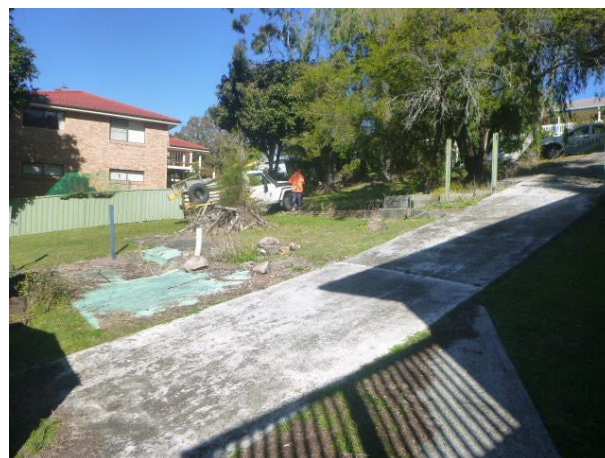
*Looking across and upslope to the south/southwest showing moderate slope, typical vegetation, small retaining walls and existing driveway.*

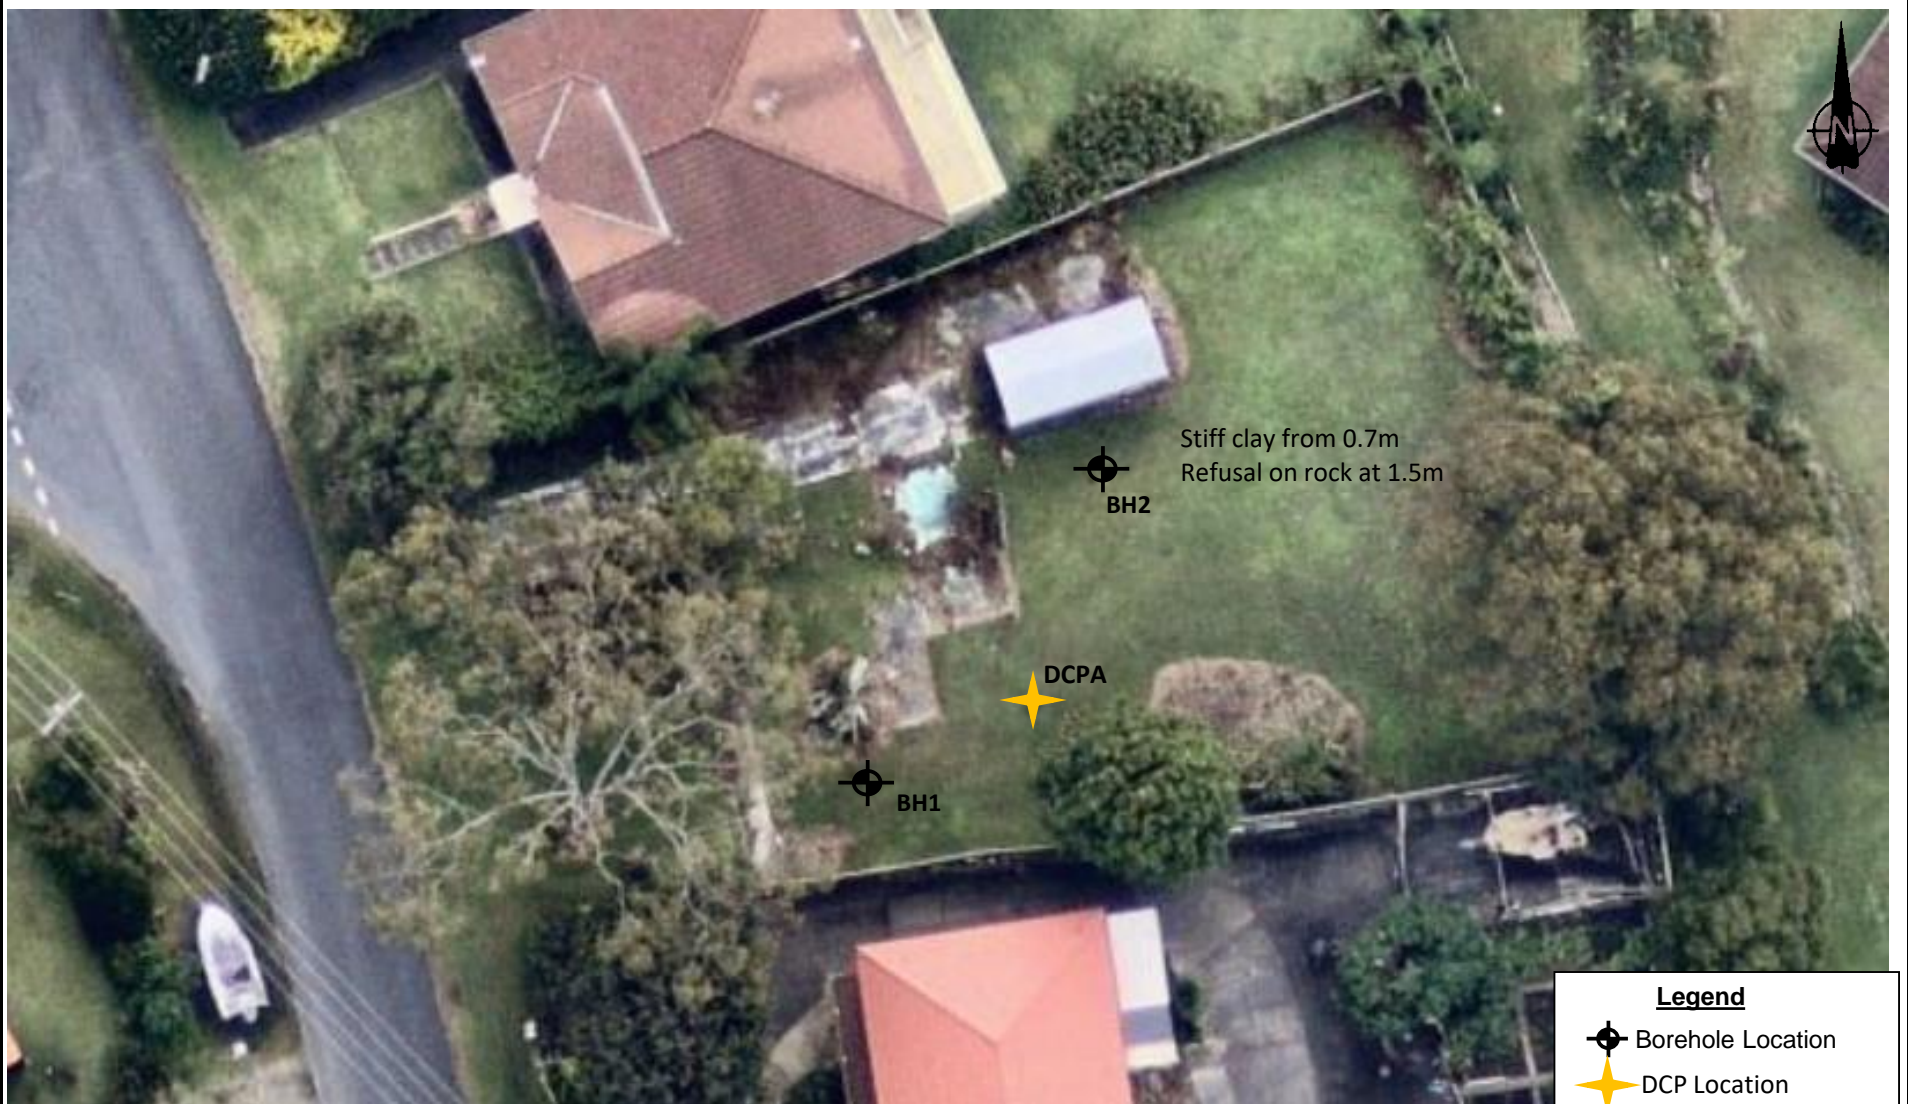
<b>Client:</b> <b>Project:</b> <b>Title:</b>	Coast Building Company	Job No.	RGS03366.1
	Proposed Dwelling	Drawn By:	JD
	80 Seabreeze Parade, Green Point	Scale:	NTS
	Borehole Location Plan	Date:	20-Jul-23
		Drawing No.	<b>Figure 1</b>

Engineering logs of the boreholes are attached. Test locations are shown on the attached Figure 1.

Borehole Location

DCP Location

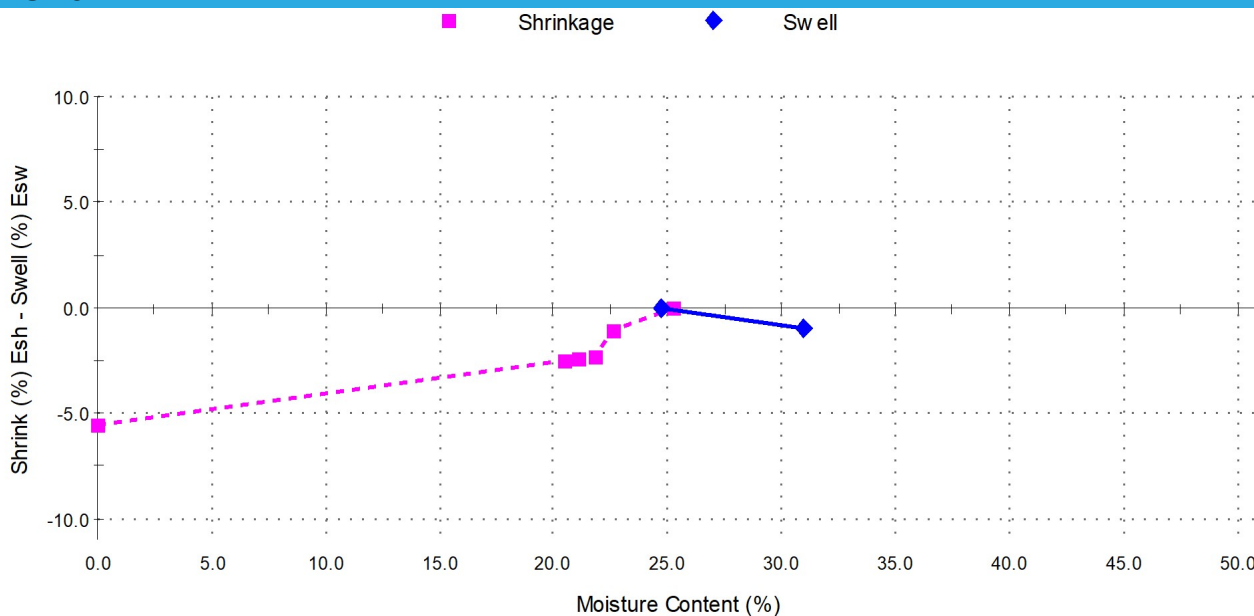
Laboratory testing on a representative sample of residual clay from BH2 (0.75 – 1.2m) indicates that the material has a shrink-swell index of 3.1%.

**Shrink Swell Index - Iss (%): 3.1**
