# Matong Hall

Address	26-28 Matong Street, Matong, NSW 2652.
Item name and number	Matong Street Conservation Area #C7

## Proposed Demolition Heritage Impact Statement

Report Number: HEP202521

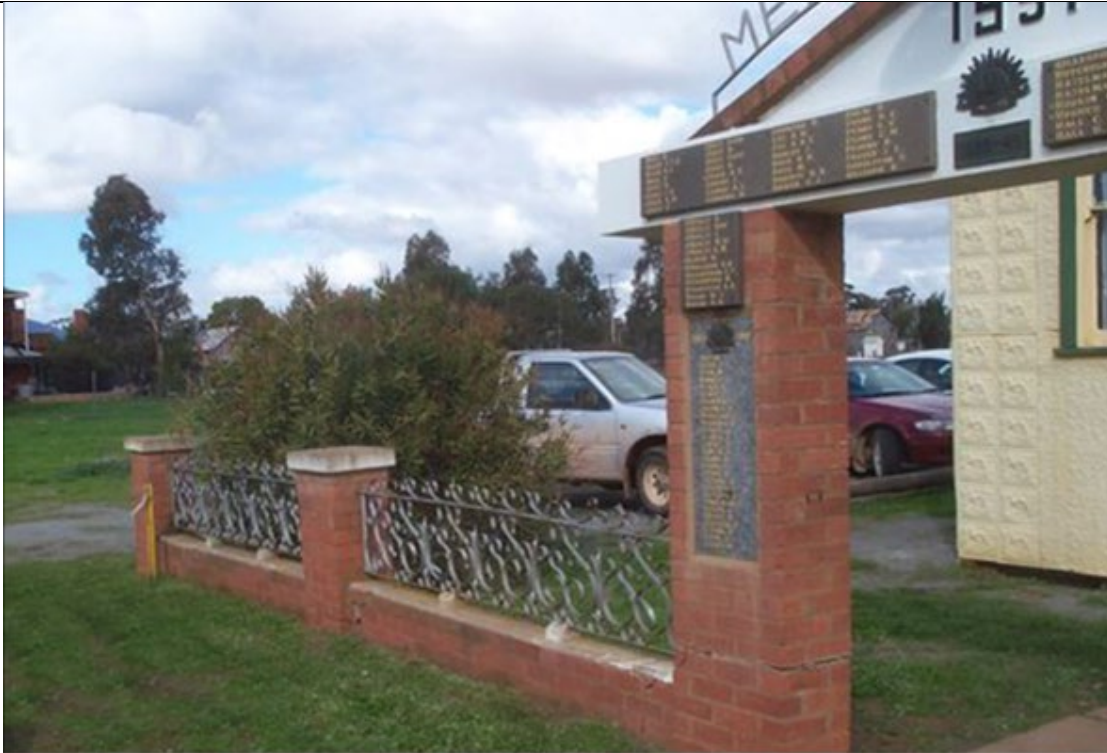
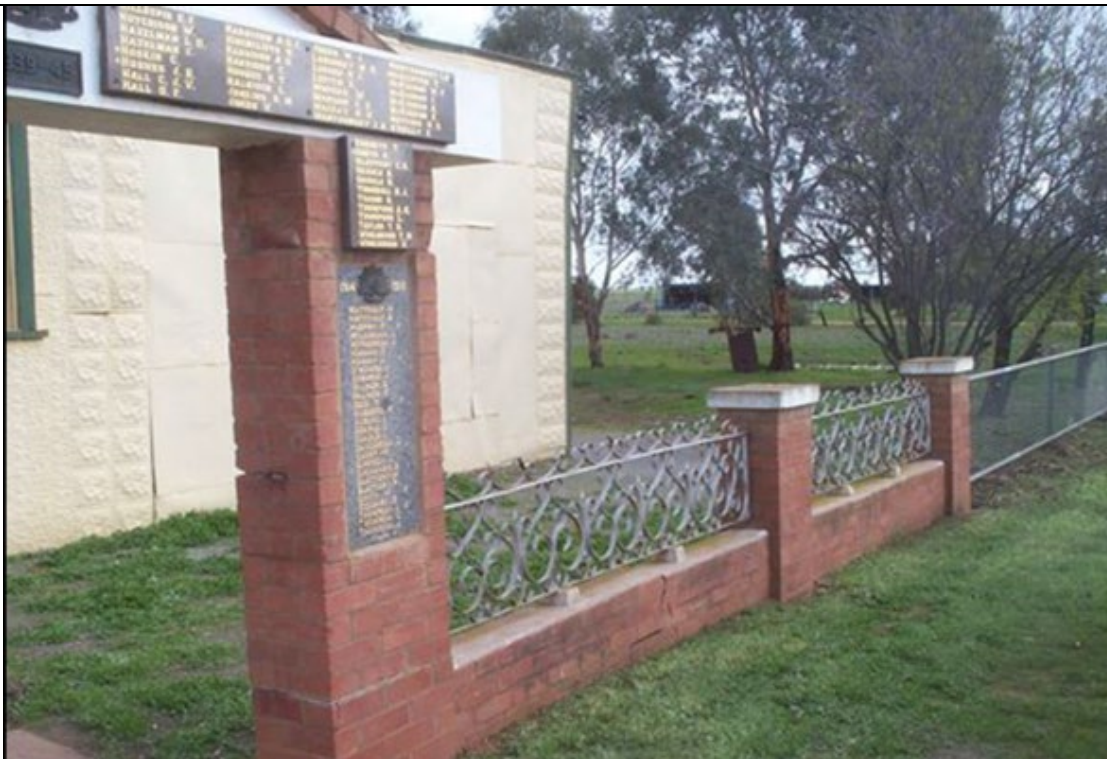
The memorial is in the form of a brick fence about 115 feet along the frontage of the Mechanics' Institute Hall, and is surmounted with grille work. At the small entrance gate the pillars are of brick, and are joined with a massive concrete flat arch, on which are the words in raised letters "Memorial Gates." The two sets of gates are the gift of Messrs. H. V. McKay. On each of the pillars is a granite tablet each bearing the names of 27 men who enlisted from Matong. The fence was erected by Mr. G. S. Baker, of Ganmain, who made a very good job of his contract.

Figure 2-9: Matong Memorial Gates in Original Position at Matong Hall 2021. (Source: NSW War Memorials Register Website.)

Figure 2-10: Matong Memorial Gates in Original Position at Matong Hall 2021. (Source: NSW War Memorials Register Website.)

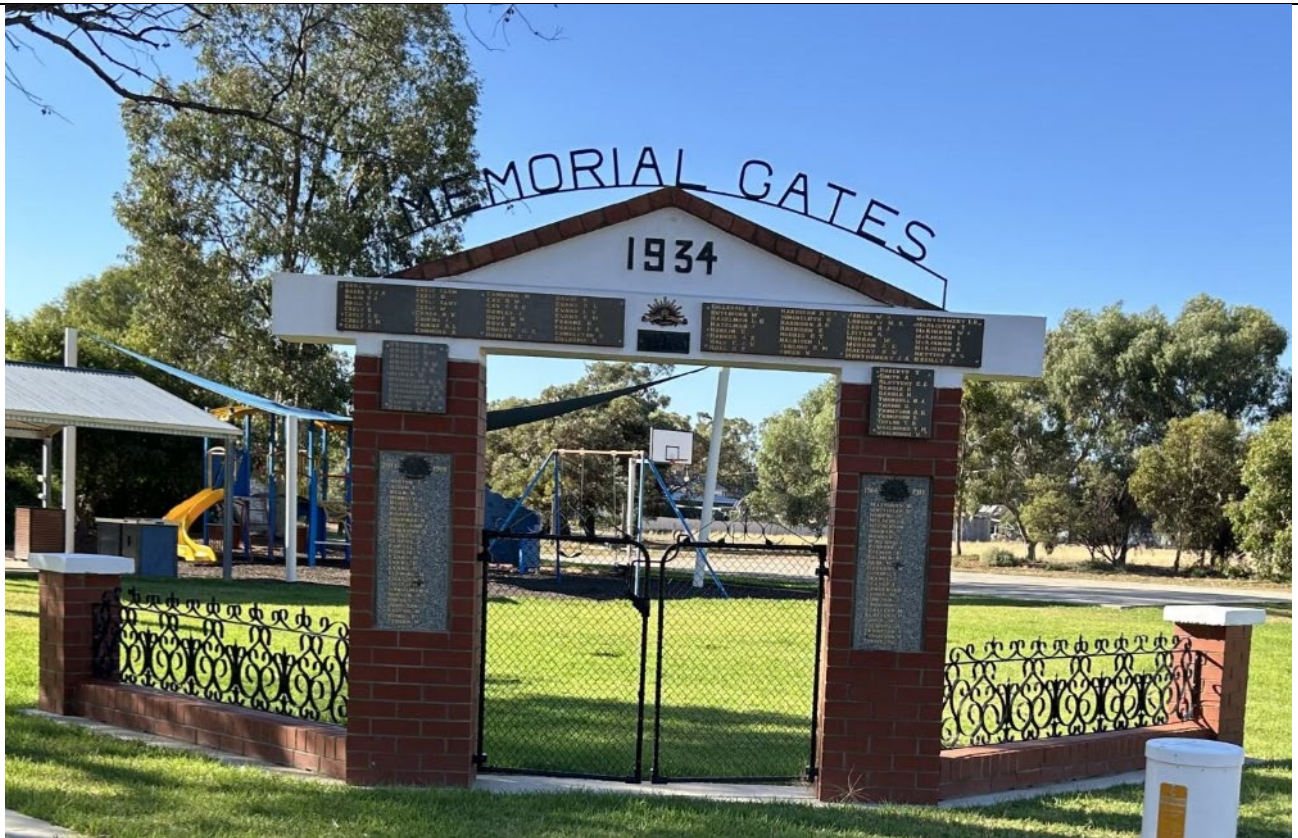
The Memorial Gates were re-located to Matong Park in 2023, on the southeast corner of Matong Street and Deepwater Road, see Figure 2-11. At that time, a plaque was installed on the gates, as seen in Figure 2-12 marking their relocation from the hall to the park. The Matong Memorial Gates are listed on the NSW War Memorials Register, although they are still shown on that register as being located in front of the hall.<sup>5</sup>

Figure 2-11: Matong Memorial Gates , relocated to Matong Park.

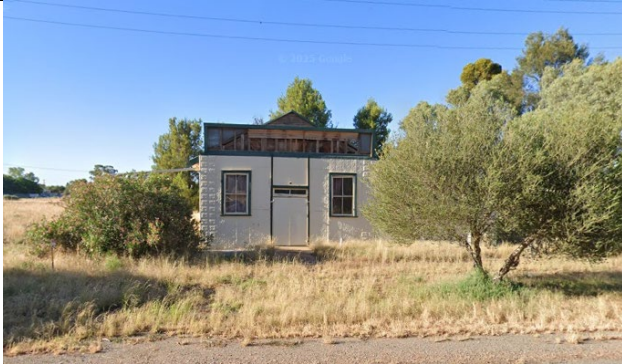
**Figure 2-13: View of north elevation from Matong Street. (Source: Google Maps)**

The front elevation of the original Matong Hall was deleteriously altered with the removal of the painted timber sign that was previously attached above the door. Other infrastructure, such as the external toilet, show signs that the building is indeed disused. The lack of use by

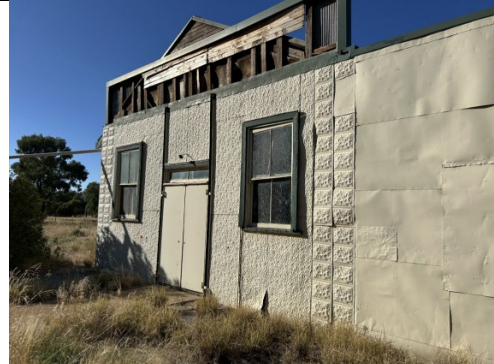
**Figure 2-14: North elevation.**

The principal elevation has a framed façade with a mixed arrangement of pressed metal sheet nailed in place. The upper part of the façade is partly stripped of its cladding (earlier imagery indicates a painted timber sign in this location). Entry doors are clad with sheet metal and the two front windows are double hung timber sash-type with four glazing panes, see Figure 2-13, Figure 2-14 and Figure 2-15. On the east elevation are two further sets of exit doors, and timber windows at higher level with timber two-light windows with simple architrave, see Figure 2-21 and Figure 2-22. The same arrangement is found internally on the west wall of the main hall space (now an internal wall between hall space and dining space). The western extension has external doors facing west and timber windows with textured glass. The kitchen annex has a timber batten door and louvred windows, see Figure 2-16, Figure 2-17 and Figure 2-23 for the interior. The southern wall of the dining space has a door sealed up with corrugated sheet, see Figure 2-18 and Figure 2-19. The toilet annex, shown in Figure 2-20, is weatherboard clad with louvered windows.

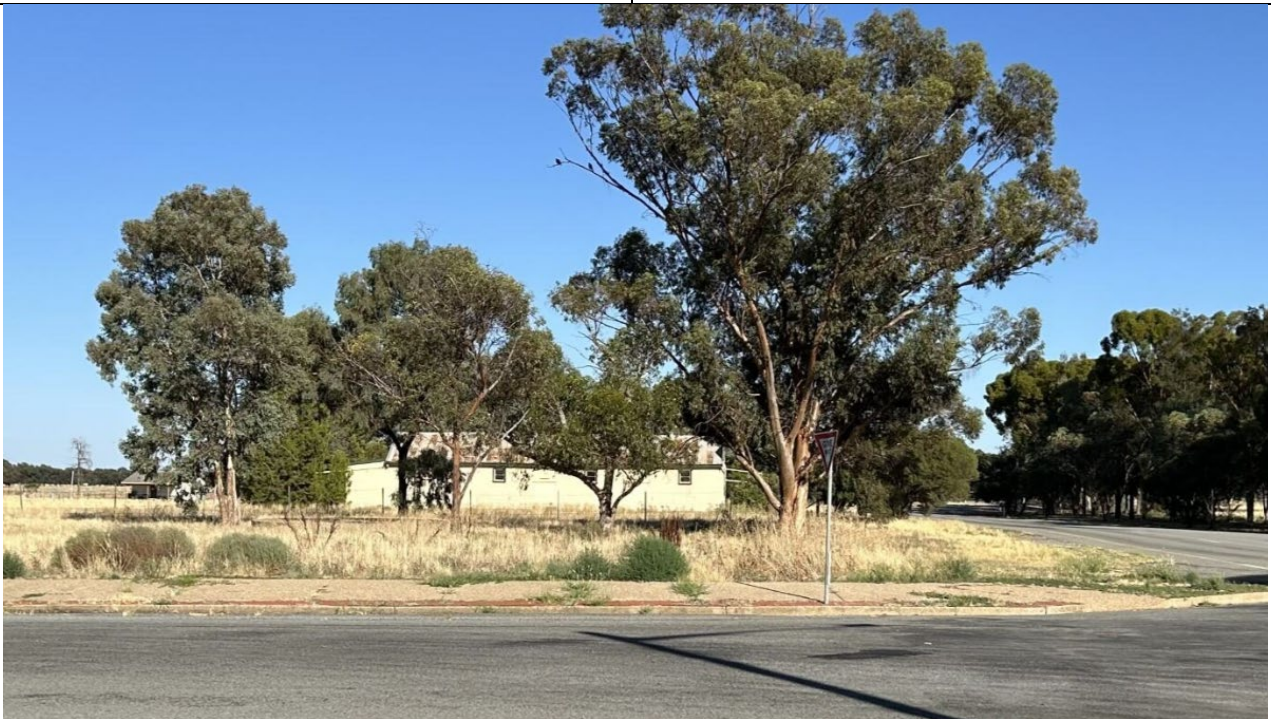
Figure 2-25: View of east elevation from Matong Park.

The Matong Hall, seen from Matong Park across Deepwater Road in Figure 2-25, is a rectangular single-story timber-framed building with weatherboard siding and corrugated iron roofing. The building has a western annex (dining area), also weatherboard clad with skillion roof, running the full length of the hall. Off that western extension is a smaller kitchen annex near the southern end. There is another double extension (one part being toilets, the other a backstage area) at the south end.

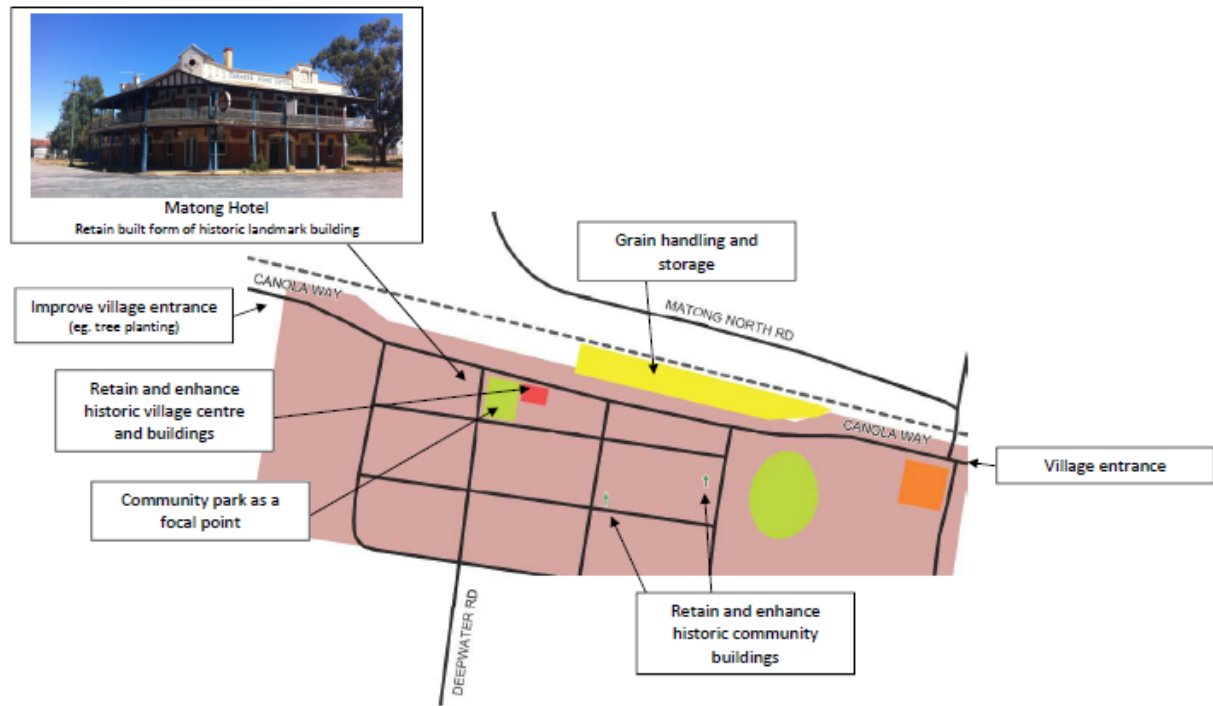
Figure 3-1: Matong Strategic Plan within the DCP. (Source: Coolamon Shire Council Website.)

The diagram at Figure 3-1, is provided within the DCP to inform future development within Matong, however it is outdated, as it calls for the historic landmark building, the Matong Hotel (Farmer's Home Hotel) to be retained, although it was demolished following a fire in 2018.
