# Detailed Site Investigation

Proposed Childcare Centre Development  
3 Memory Avenue, Crookwell, NSW 2583

Final Report

P2410601JR05V01

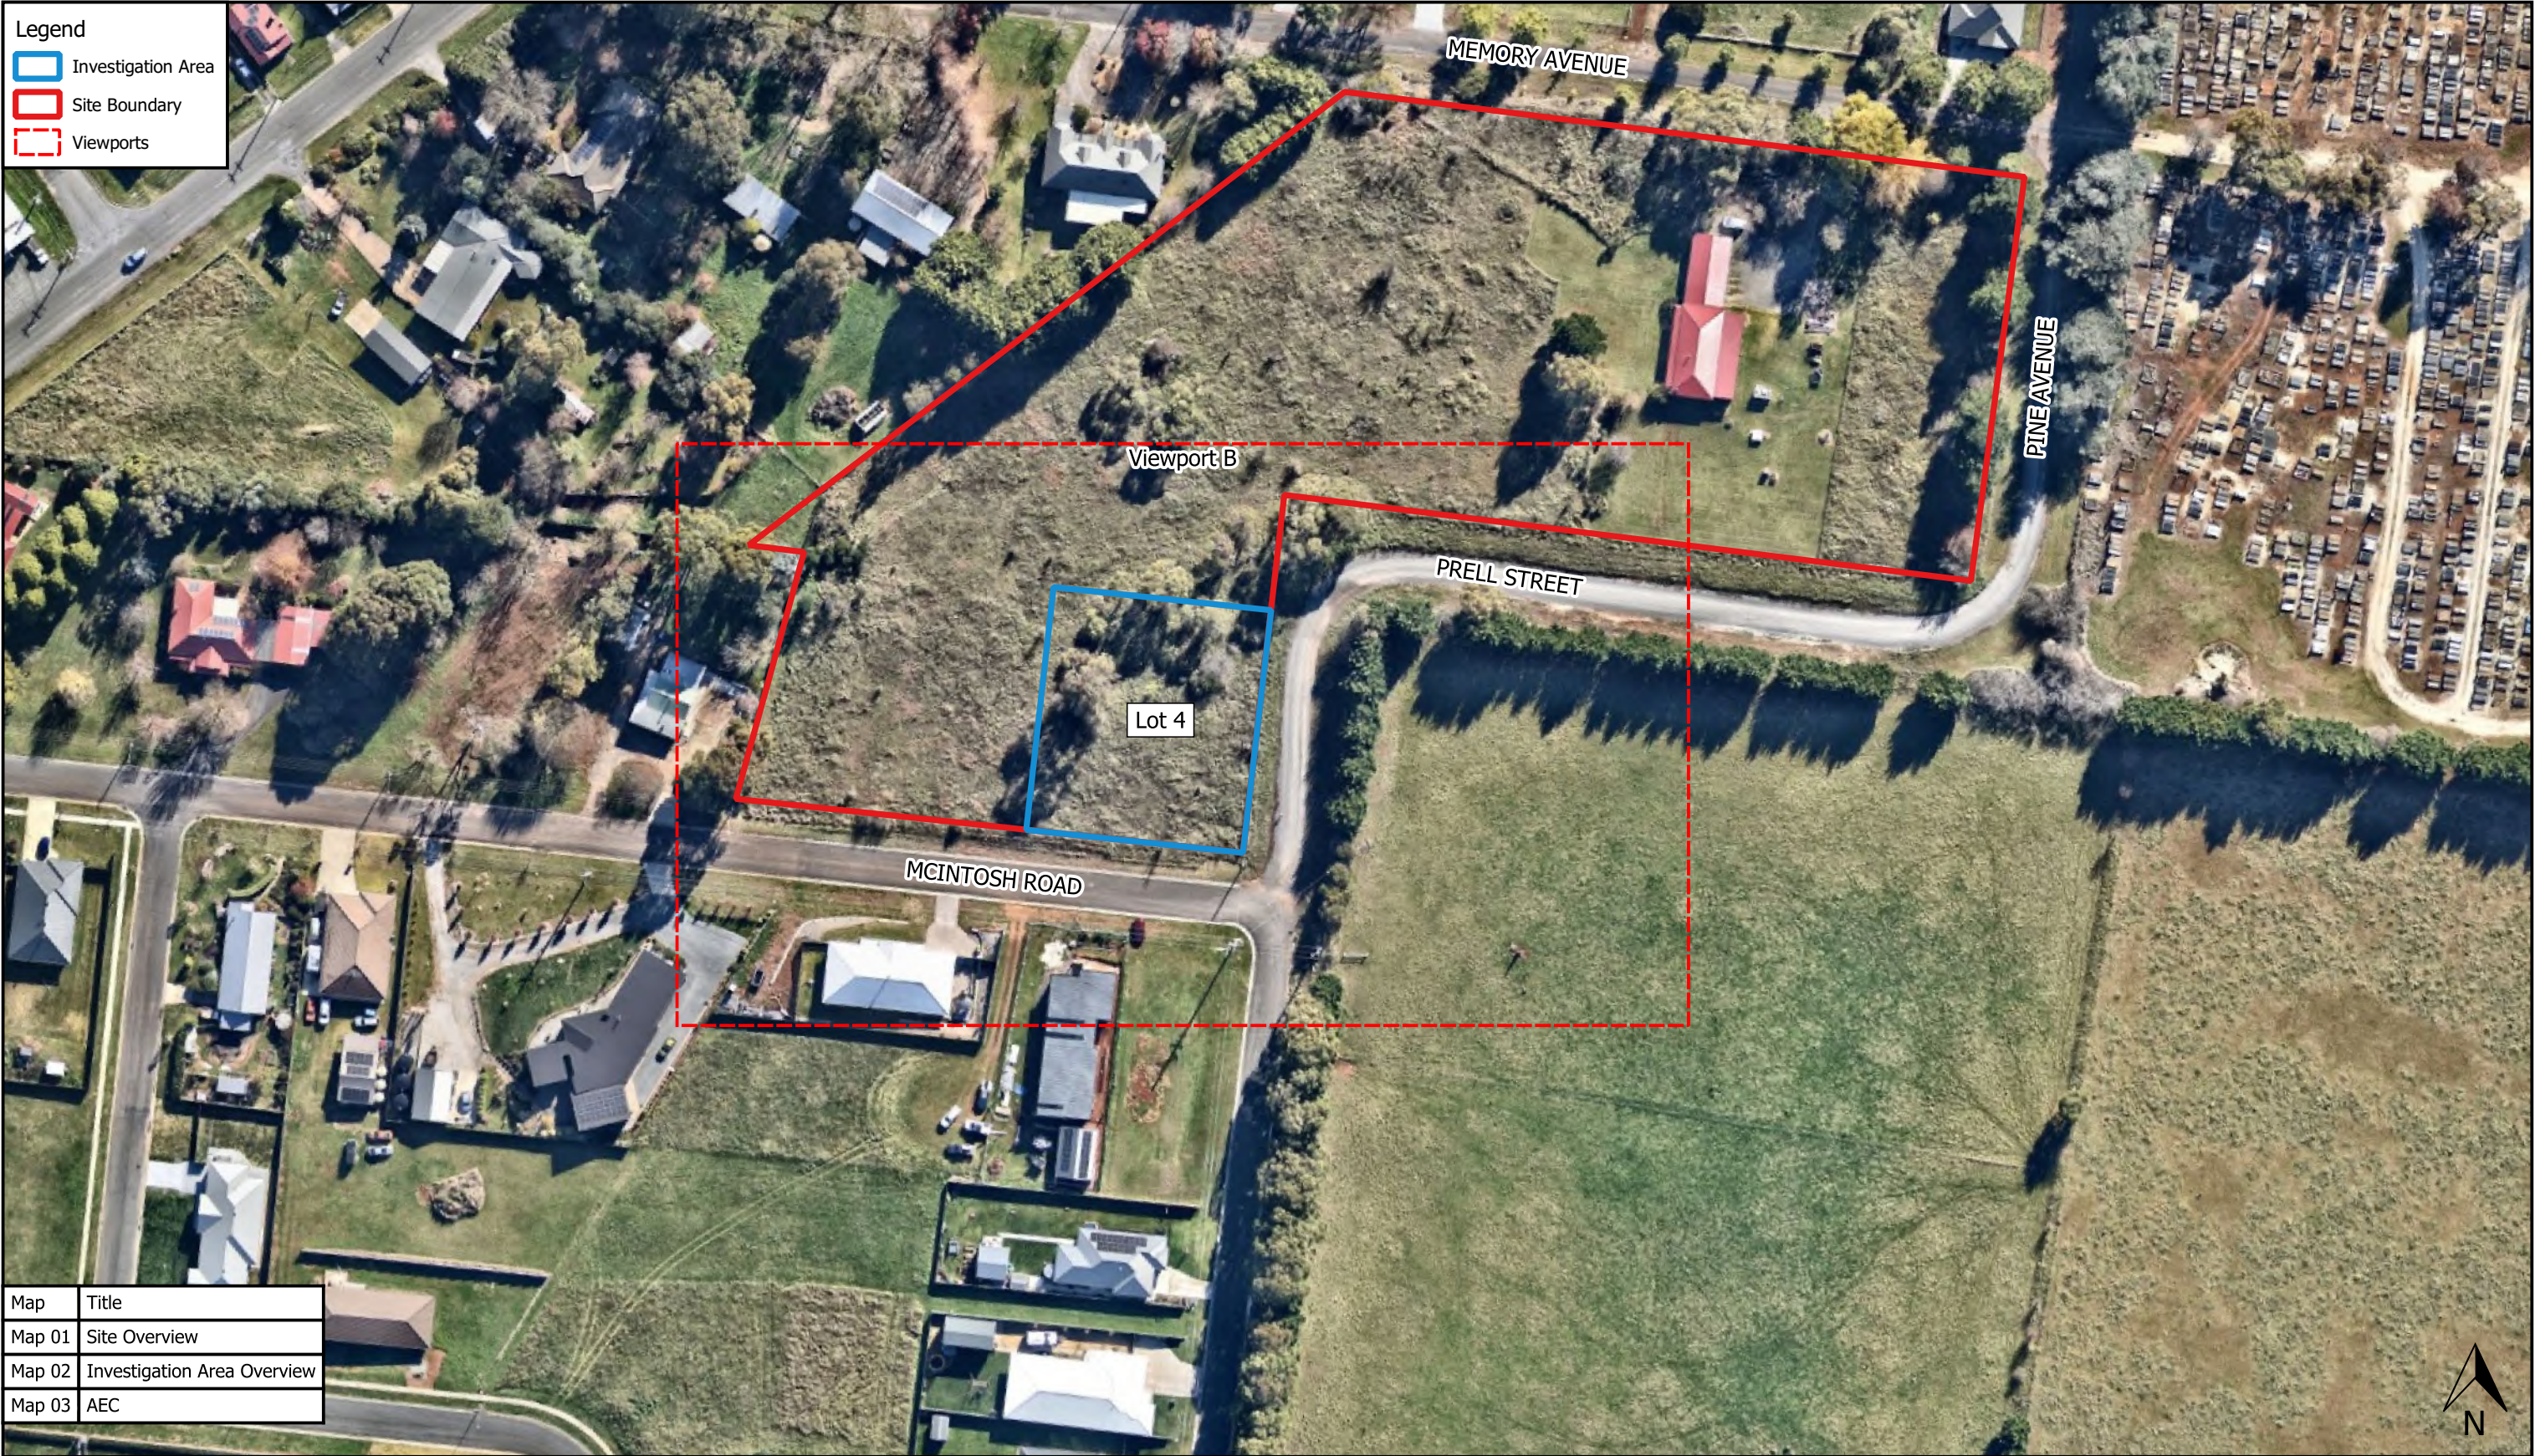
| Map 01 | Site Overview |

Site Boundary

Viewports

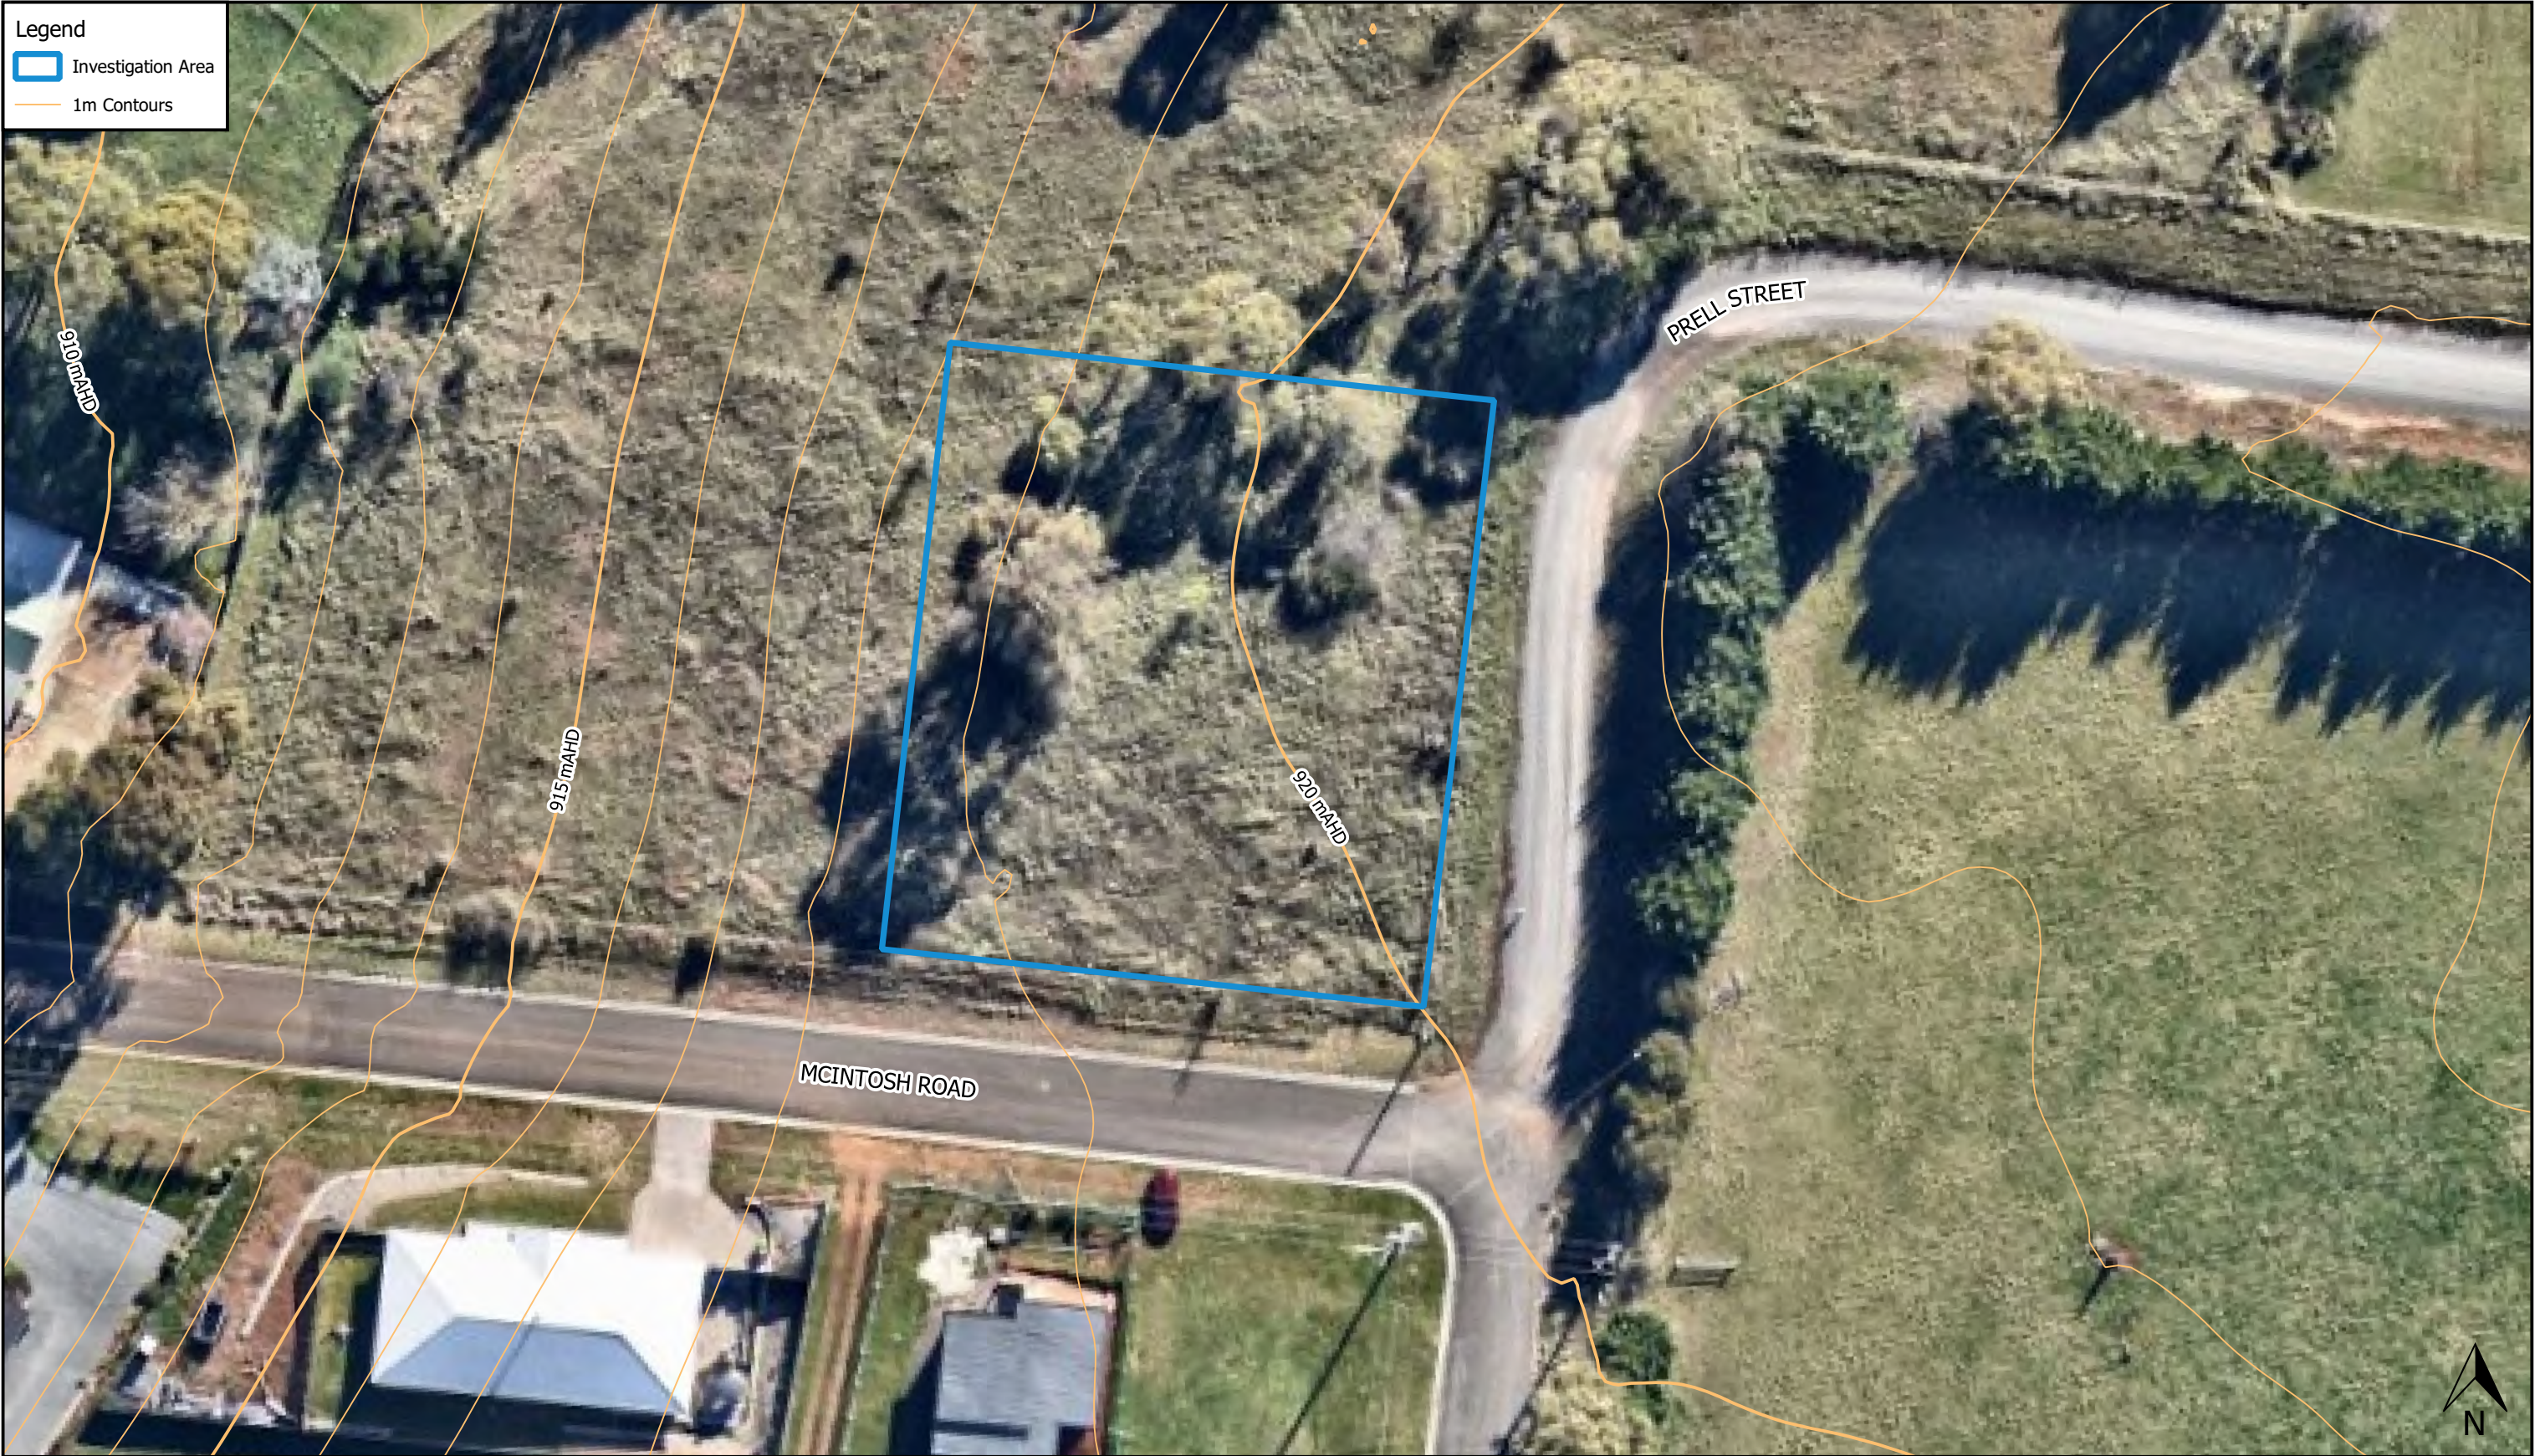
**Map 02**  
3 Memory Avenue, Crookwell, NSW 2583  
Childcare  
Detailed Site Investigation  
BlueSox Pty Ltd  
08/05/2025

1:500 @ A3  
Viewport B  
Notes:  
- Aerial from Nearmap (2025)  
- Topography from NSW Clip and Ship (2025)

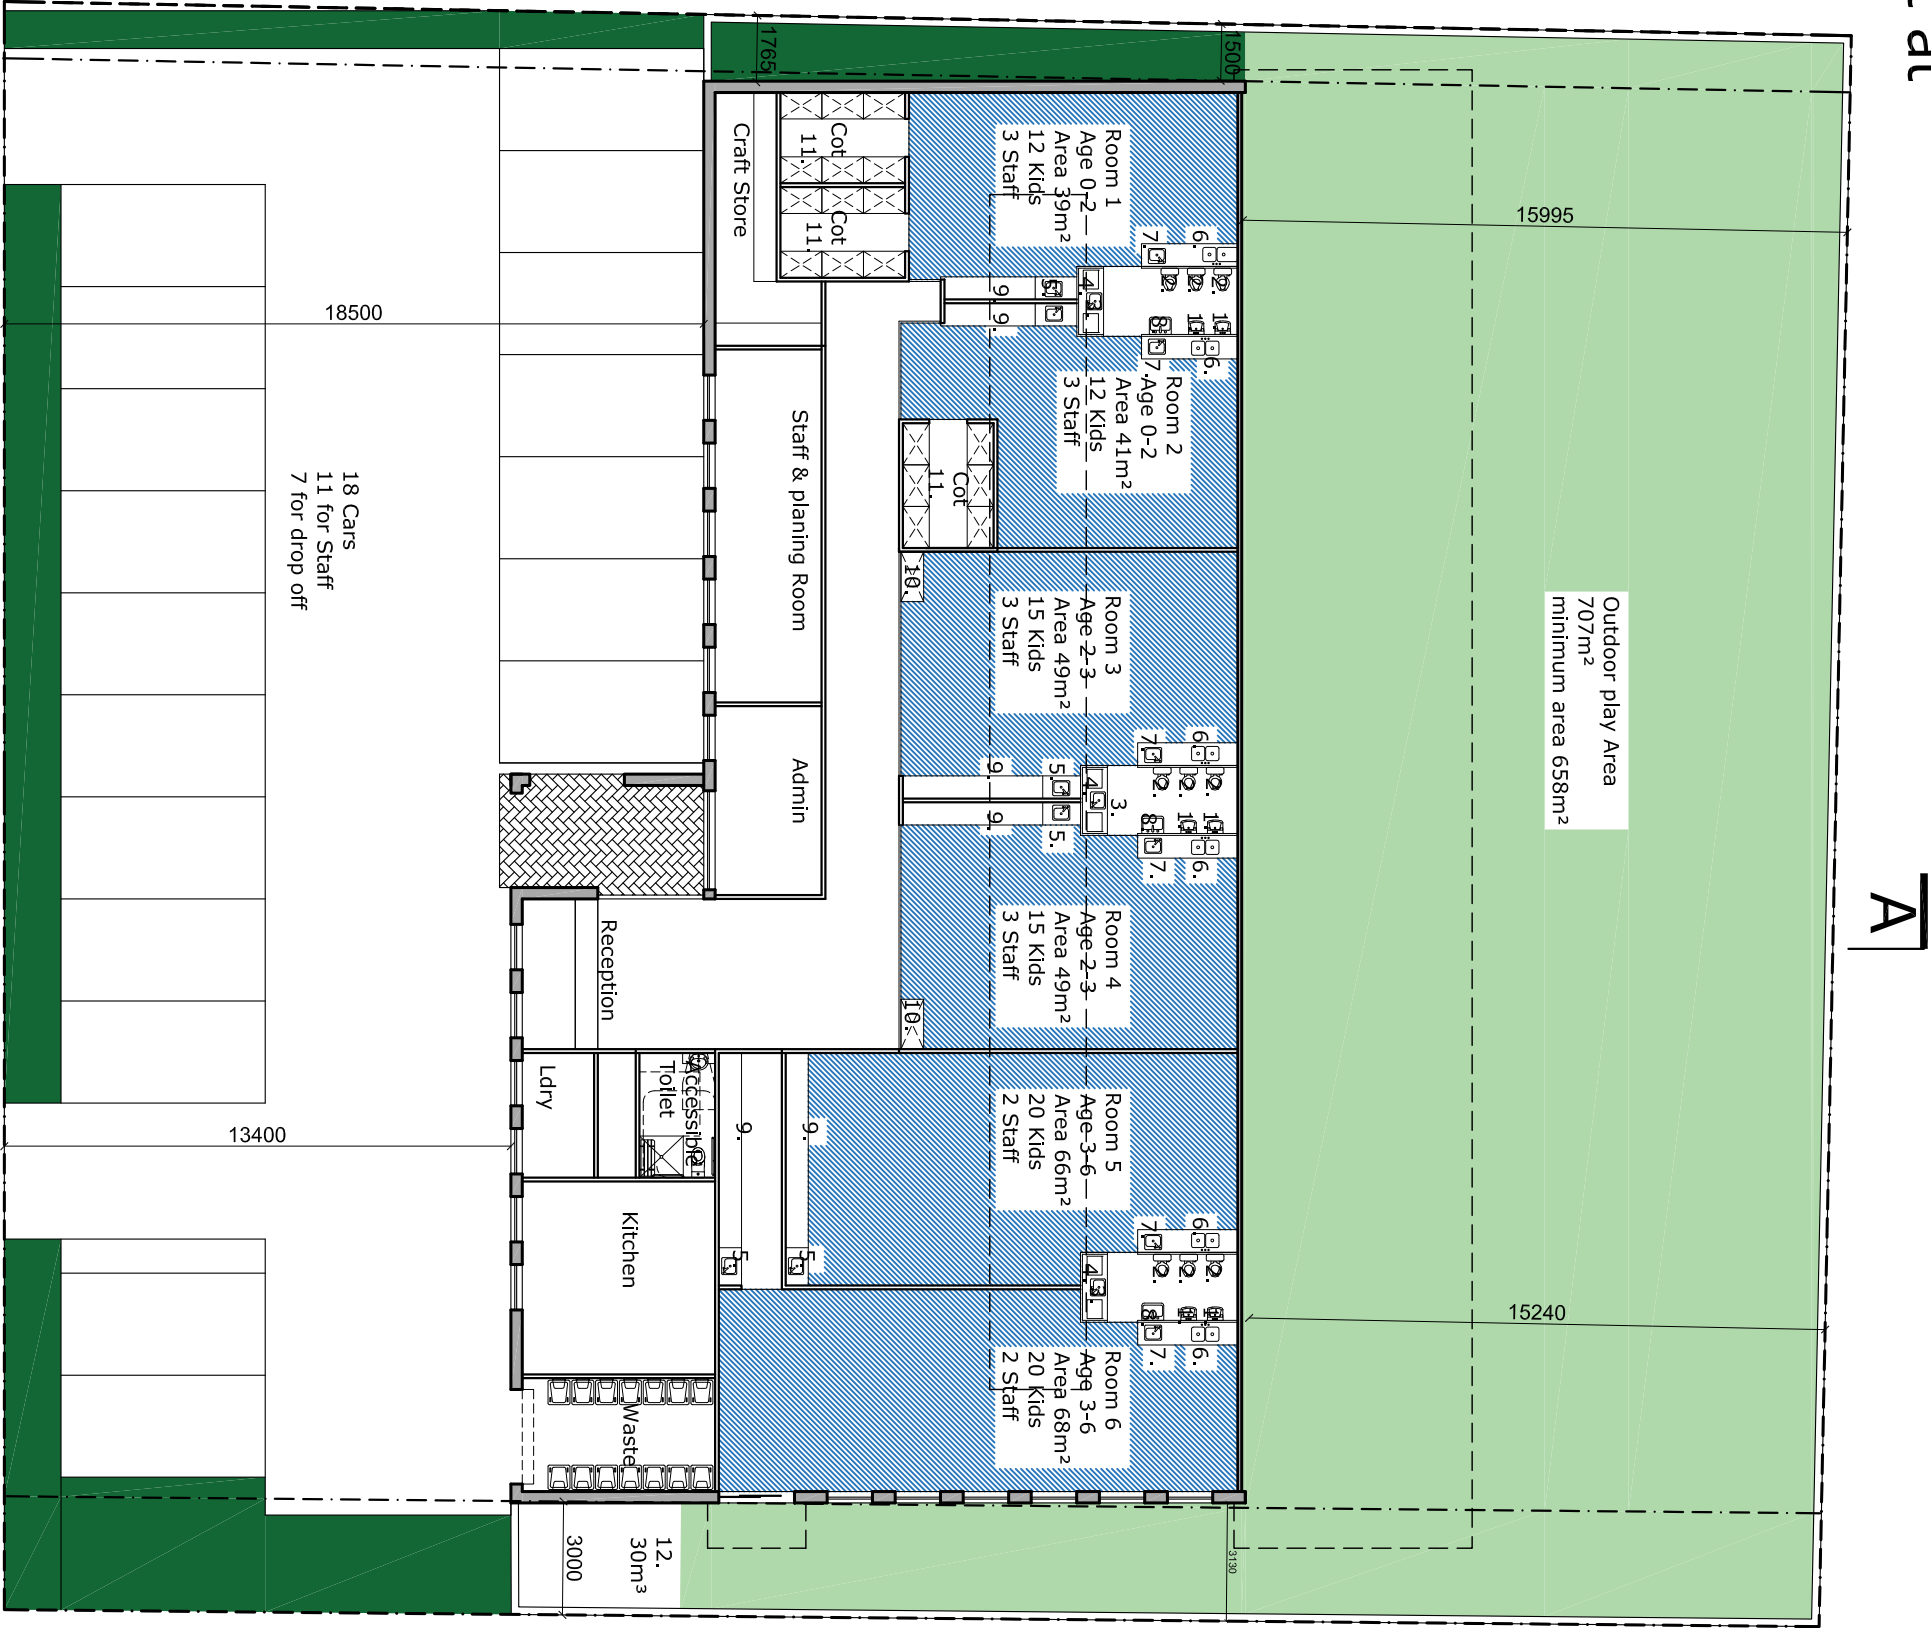
Proposed Childcare Development at  
3 Memory Ave, Crookwell

- 1. Kids Hands Basin
- 2. Kids Toilet
- 3. Bench Type Baby Bath
- 4. Bench Type Nappy Change
- 5. Bottle Prep
- 6. Crafts Sink
- 7. Kitchenette
- 8. Adult Hand Basin
- 9. Storage 1.5m High
- 10. Day bed storage
- 11. Cot area
- 12. Outdoor Storage 2.4m High

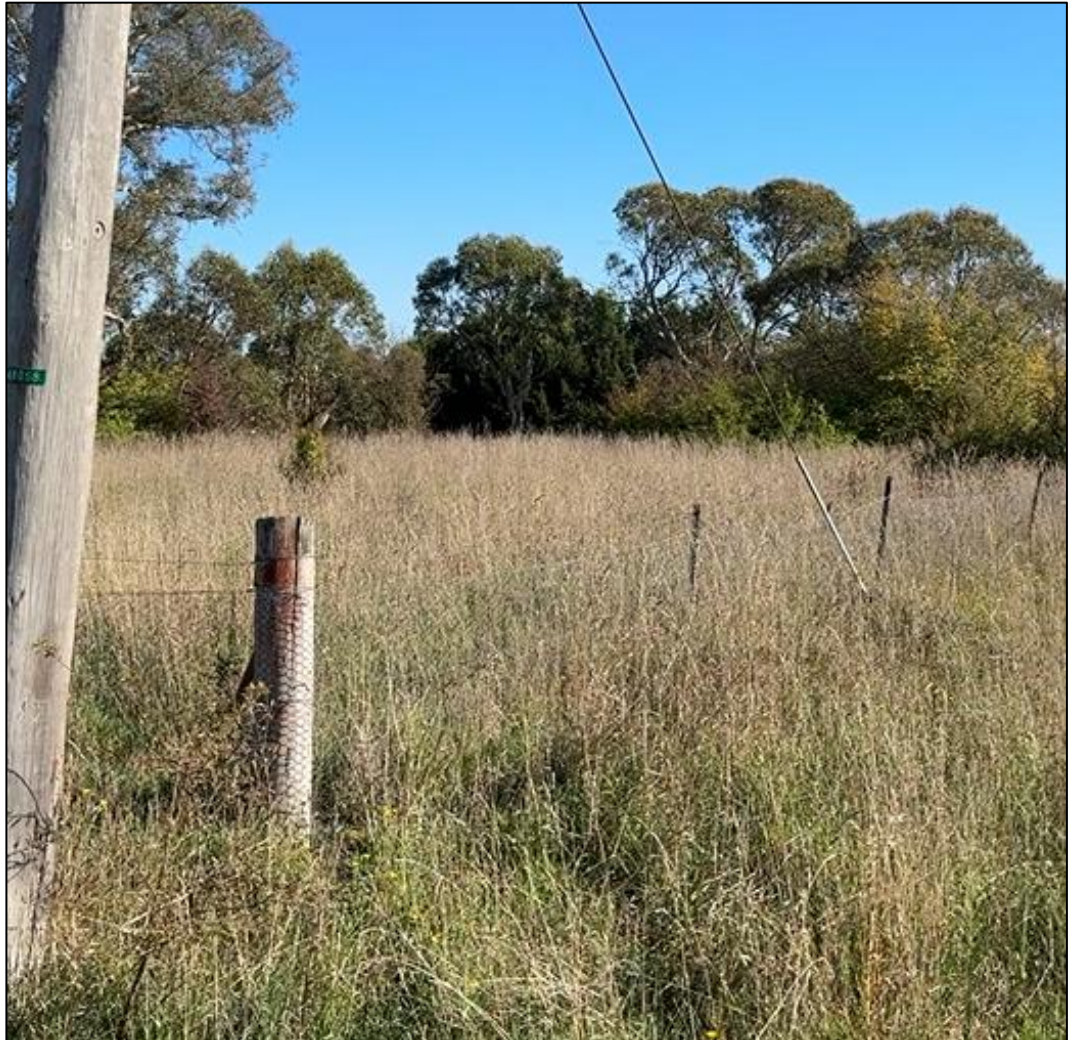
**Plate 1:** View adjacent to the southeast corner of the IA, facing north. Wire fence along southern and eastern boundaries. Grass, shrubs and trees indicative of entire IA. Dated 27 January 2025.

| Item | Observation |
|---|---|
| Buildings and structures | No buildings were present within the IA. A fence structure was noted along the southern and eastern boundaries (refer to Plate 1). |
| Ground surfaces and pavements | The IA was predominantly covered by rural vegetation (refer to Plates 1 and 2). No formal pavement or hardstand was observed. |

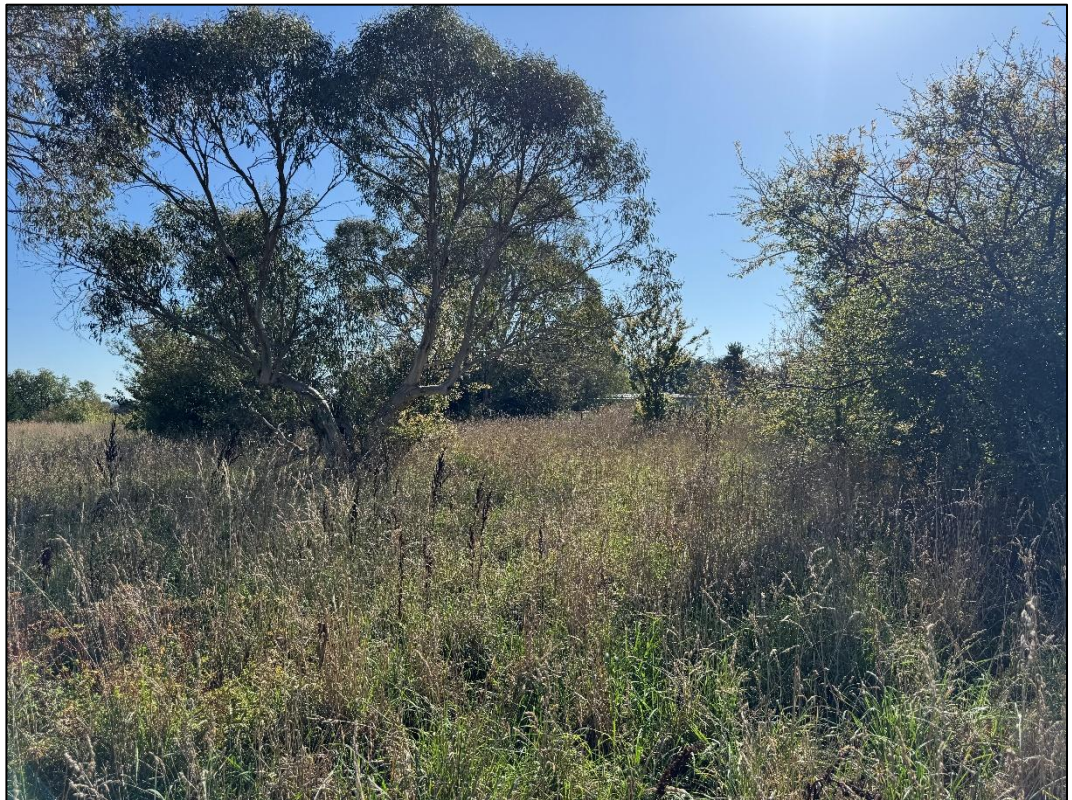
**Plate 2:** View in the centre of the IA, facing northeast. Grass, shrubs and trees. Dated 27 January 2025.

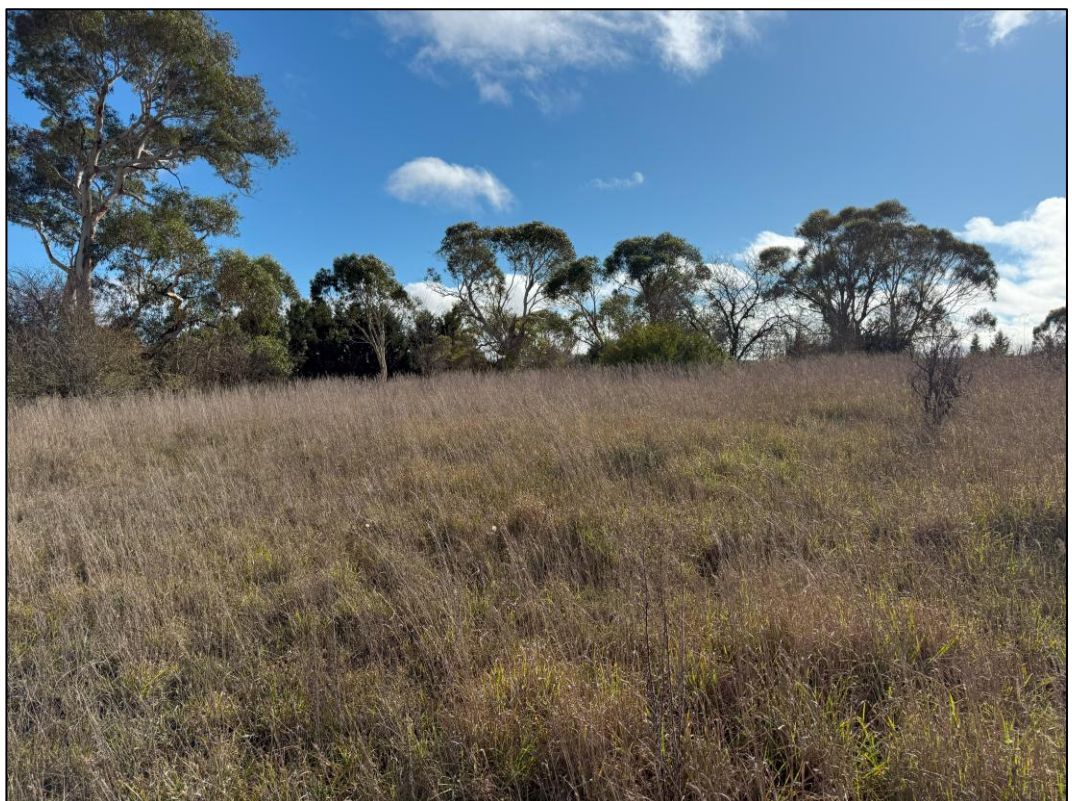
**Plate 3:** View in the centre of the IA, facing north. Grass, shrubs and trees. Dated 1 May 2025.

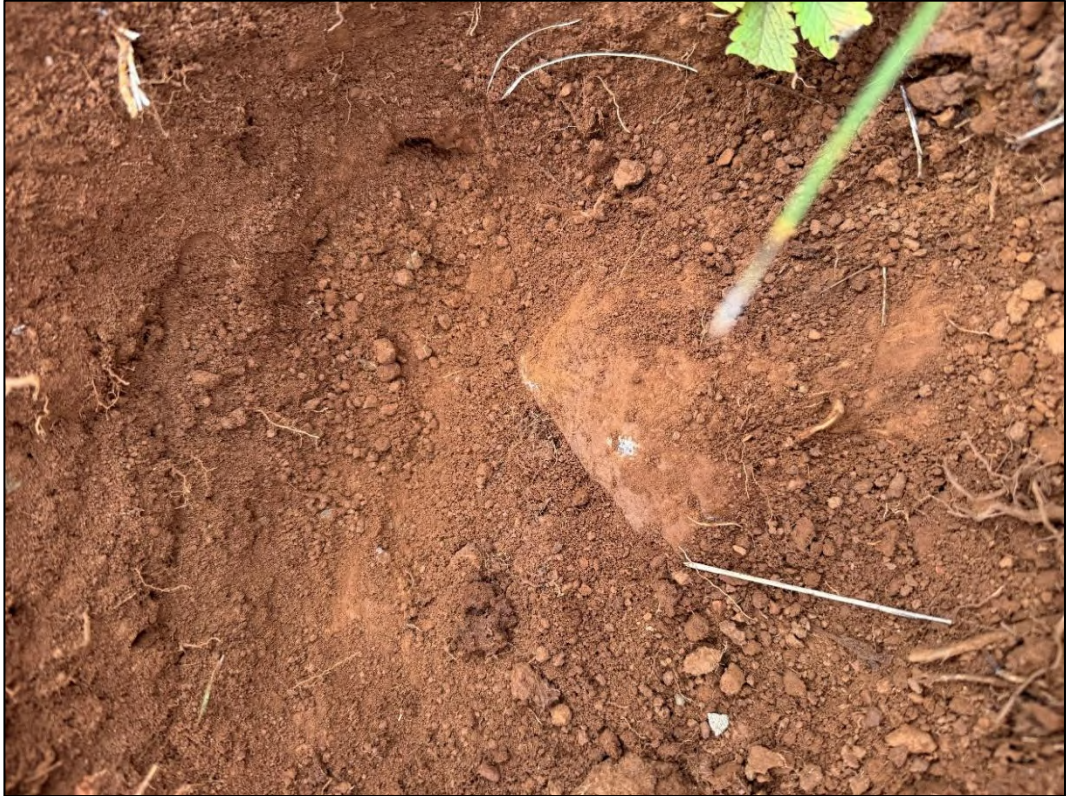
**Plate 4:** View of TP102. Soil is generally indicative of all locations across the IA. Dated 1 May 2025.

No fill material was observed at any test pit location within the IA. Natural soils were encountered to a maximum investigation depth of 0.3 m below ground level (mbgl) and generally comprised brown to light brown clayey silt.

No visual or olfactory evidence of contamination (e.g., staining or odours) was noted in soils during excavation. Anthropogenic materials, including demolition debris or potential asbestos-containing material (PACM), were not observed during test pitting or sample collection.
