Preliminary Site Investigation

Proposed Residential Subdivision
3 Memory Avenue, Crookwell NSW

Final Report

P2410601JR02V01

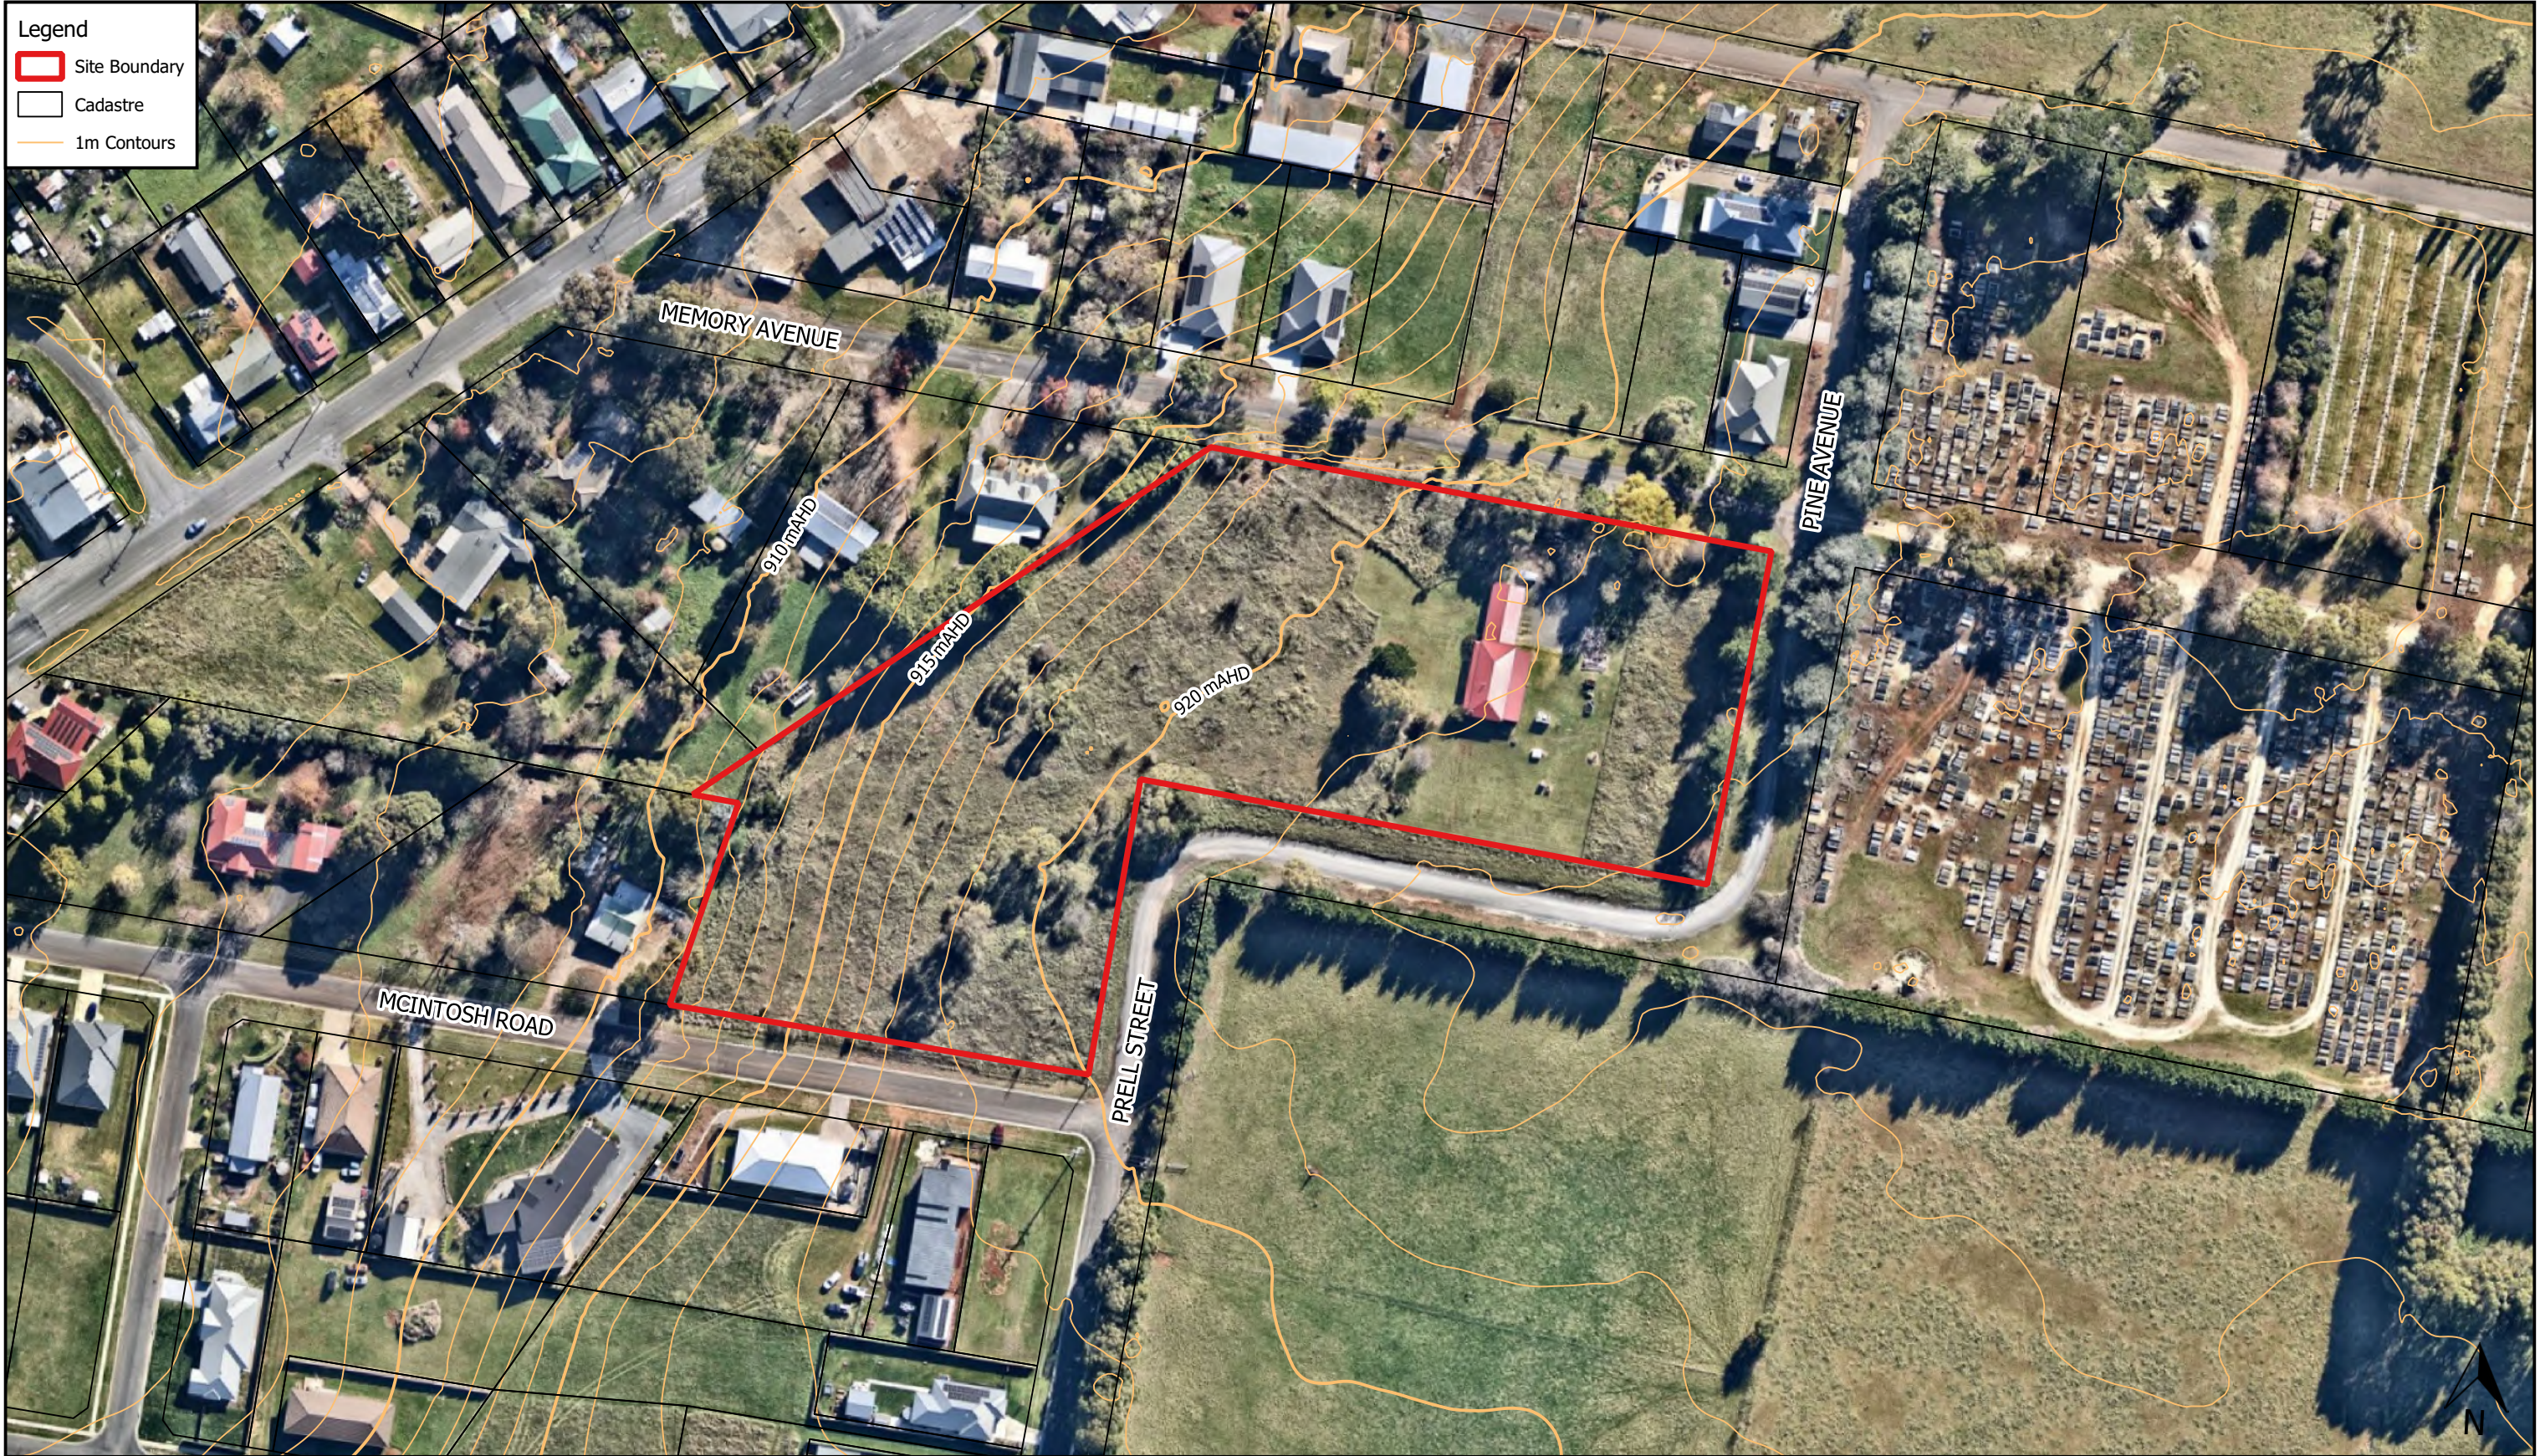
Map	Map 02
Site	3 Memory Avenue, Crookwell, NSW
Project	Lot Subdivision
Sub-Project	Preliminary Site Investigation
Client	Bluesox
Date	21/03/2025

Item	Detail
Topography	<p>The topography of the surrounding landscape is characterised by plateaux or valleys of gently undulating to undulating rises. Slope gradients are usually between 2 to 15% and local relief ranges between 5 to 40 m.</p> <p>Elevation of the Site ranges from approximately 910.5 mAHD in the southwest portion and 922 mAHD in the eastern portion of the Site.</p> <p>A topographic map of the Site is provided in Appendix A (Map 02).</p>

Map Title / Figure:
Topography

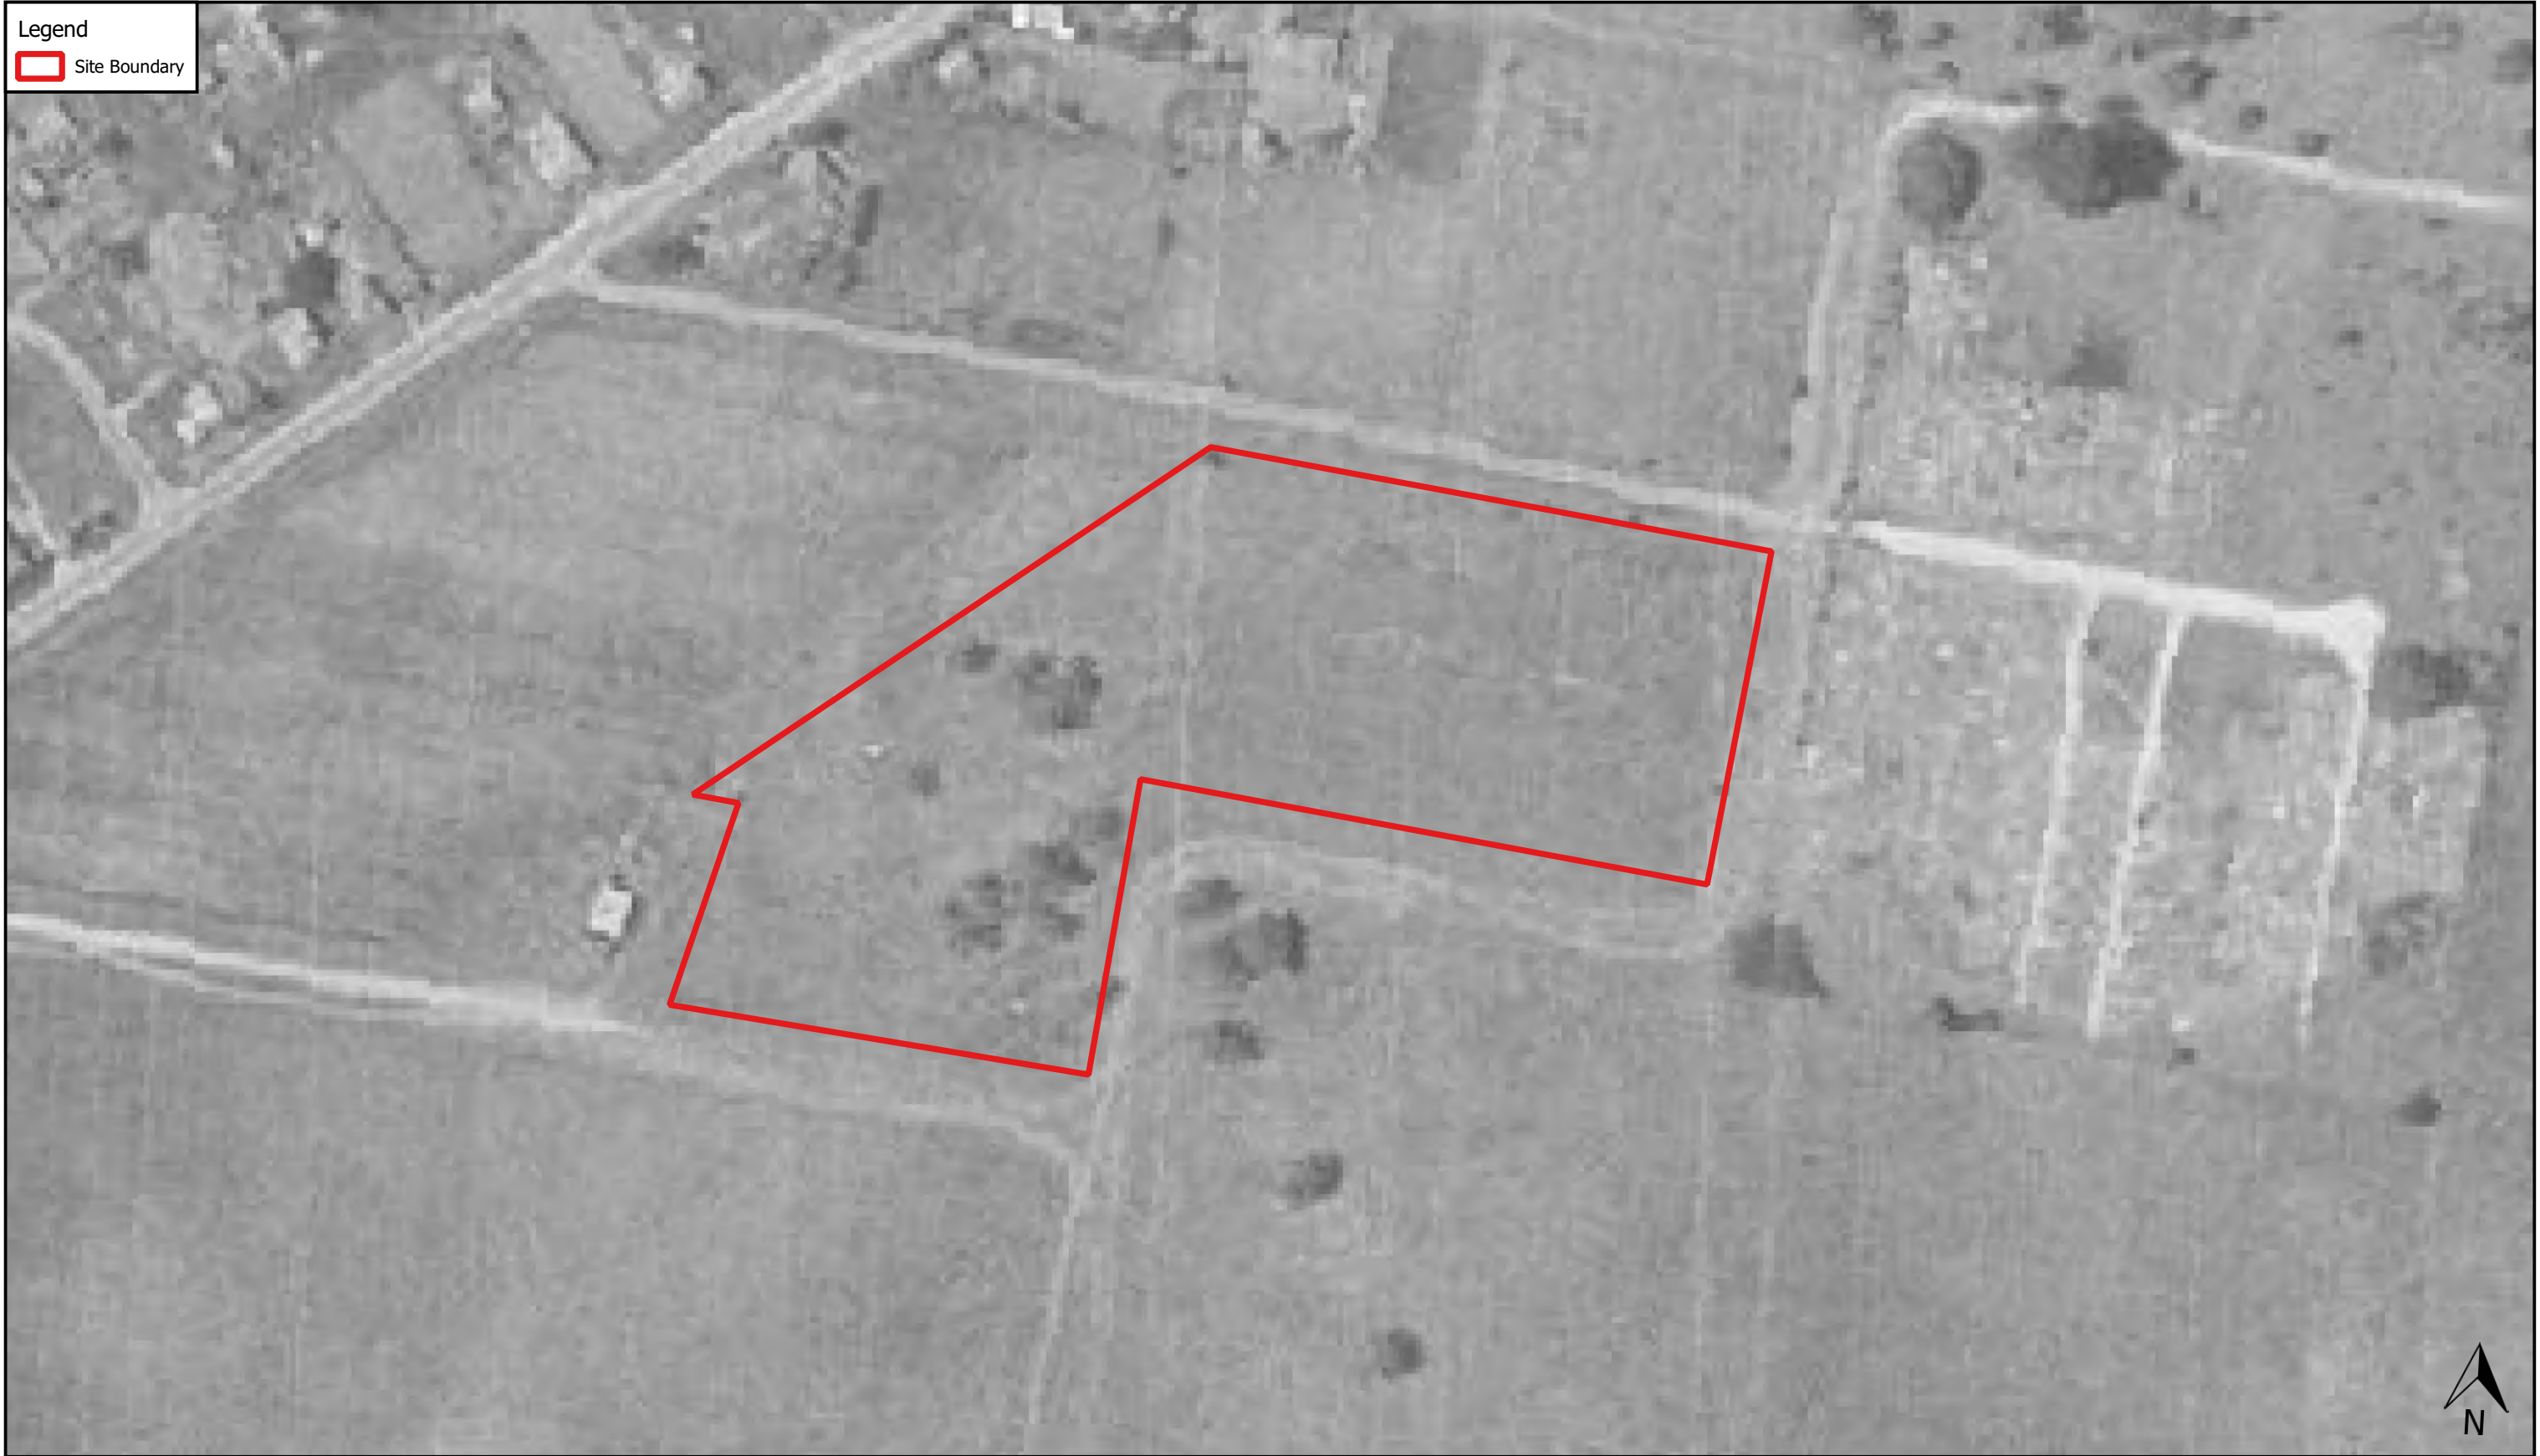
Map 05	Map
3 Memory Avenue, Crookwell, NSW	Site
Lot Subdivision	Project
Preliminary Site Investigation	Sub-Project
Bluesox	Client
21/03/2025	Date

Year (Source)	Site Observations	Surrounding Land Observations
1962 (HAPE)	The Site appears to be agricultural land. Due to poor image quality, definitive land use cannot be determined, but cropping is likely within the Site boundary.	Agricultural land use including cropping is evident on land directly to the north, south and west. Crookwell Cemetery is present directly east of the Site.
1973 ¹ (HAPE)	Generally, no change from previous image.	Little to no change from previous image.
1982 (HAPE)	Generally, no change from previous image. Potential cropping still appears evident onsite.	Increased residential development is visible to the northwest. The cemetery appears to have expanded. Otherwise, little to no change from the previous image.
1994 ¹ (HAPE)	Image quality is poor, but previous cropping may have ceased. The Site appears generally cleared, with grass-covered open space.	Further residential development has increased to the northwest, along with cemetery expansion.

Map Title / Figure:
Historical Aerial: 1962

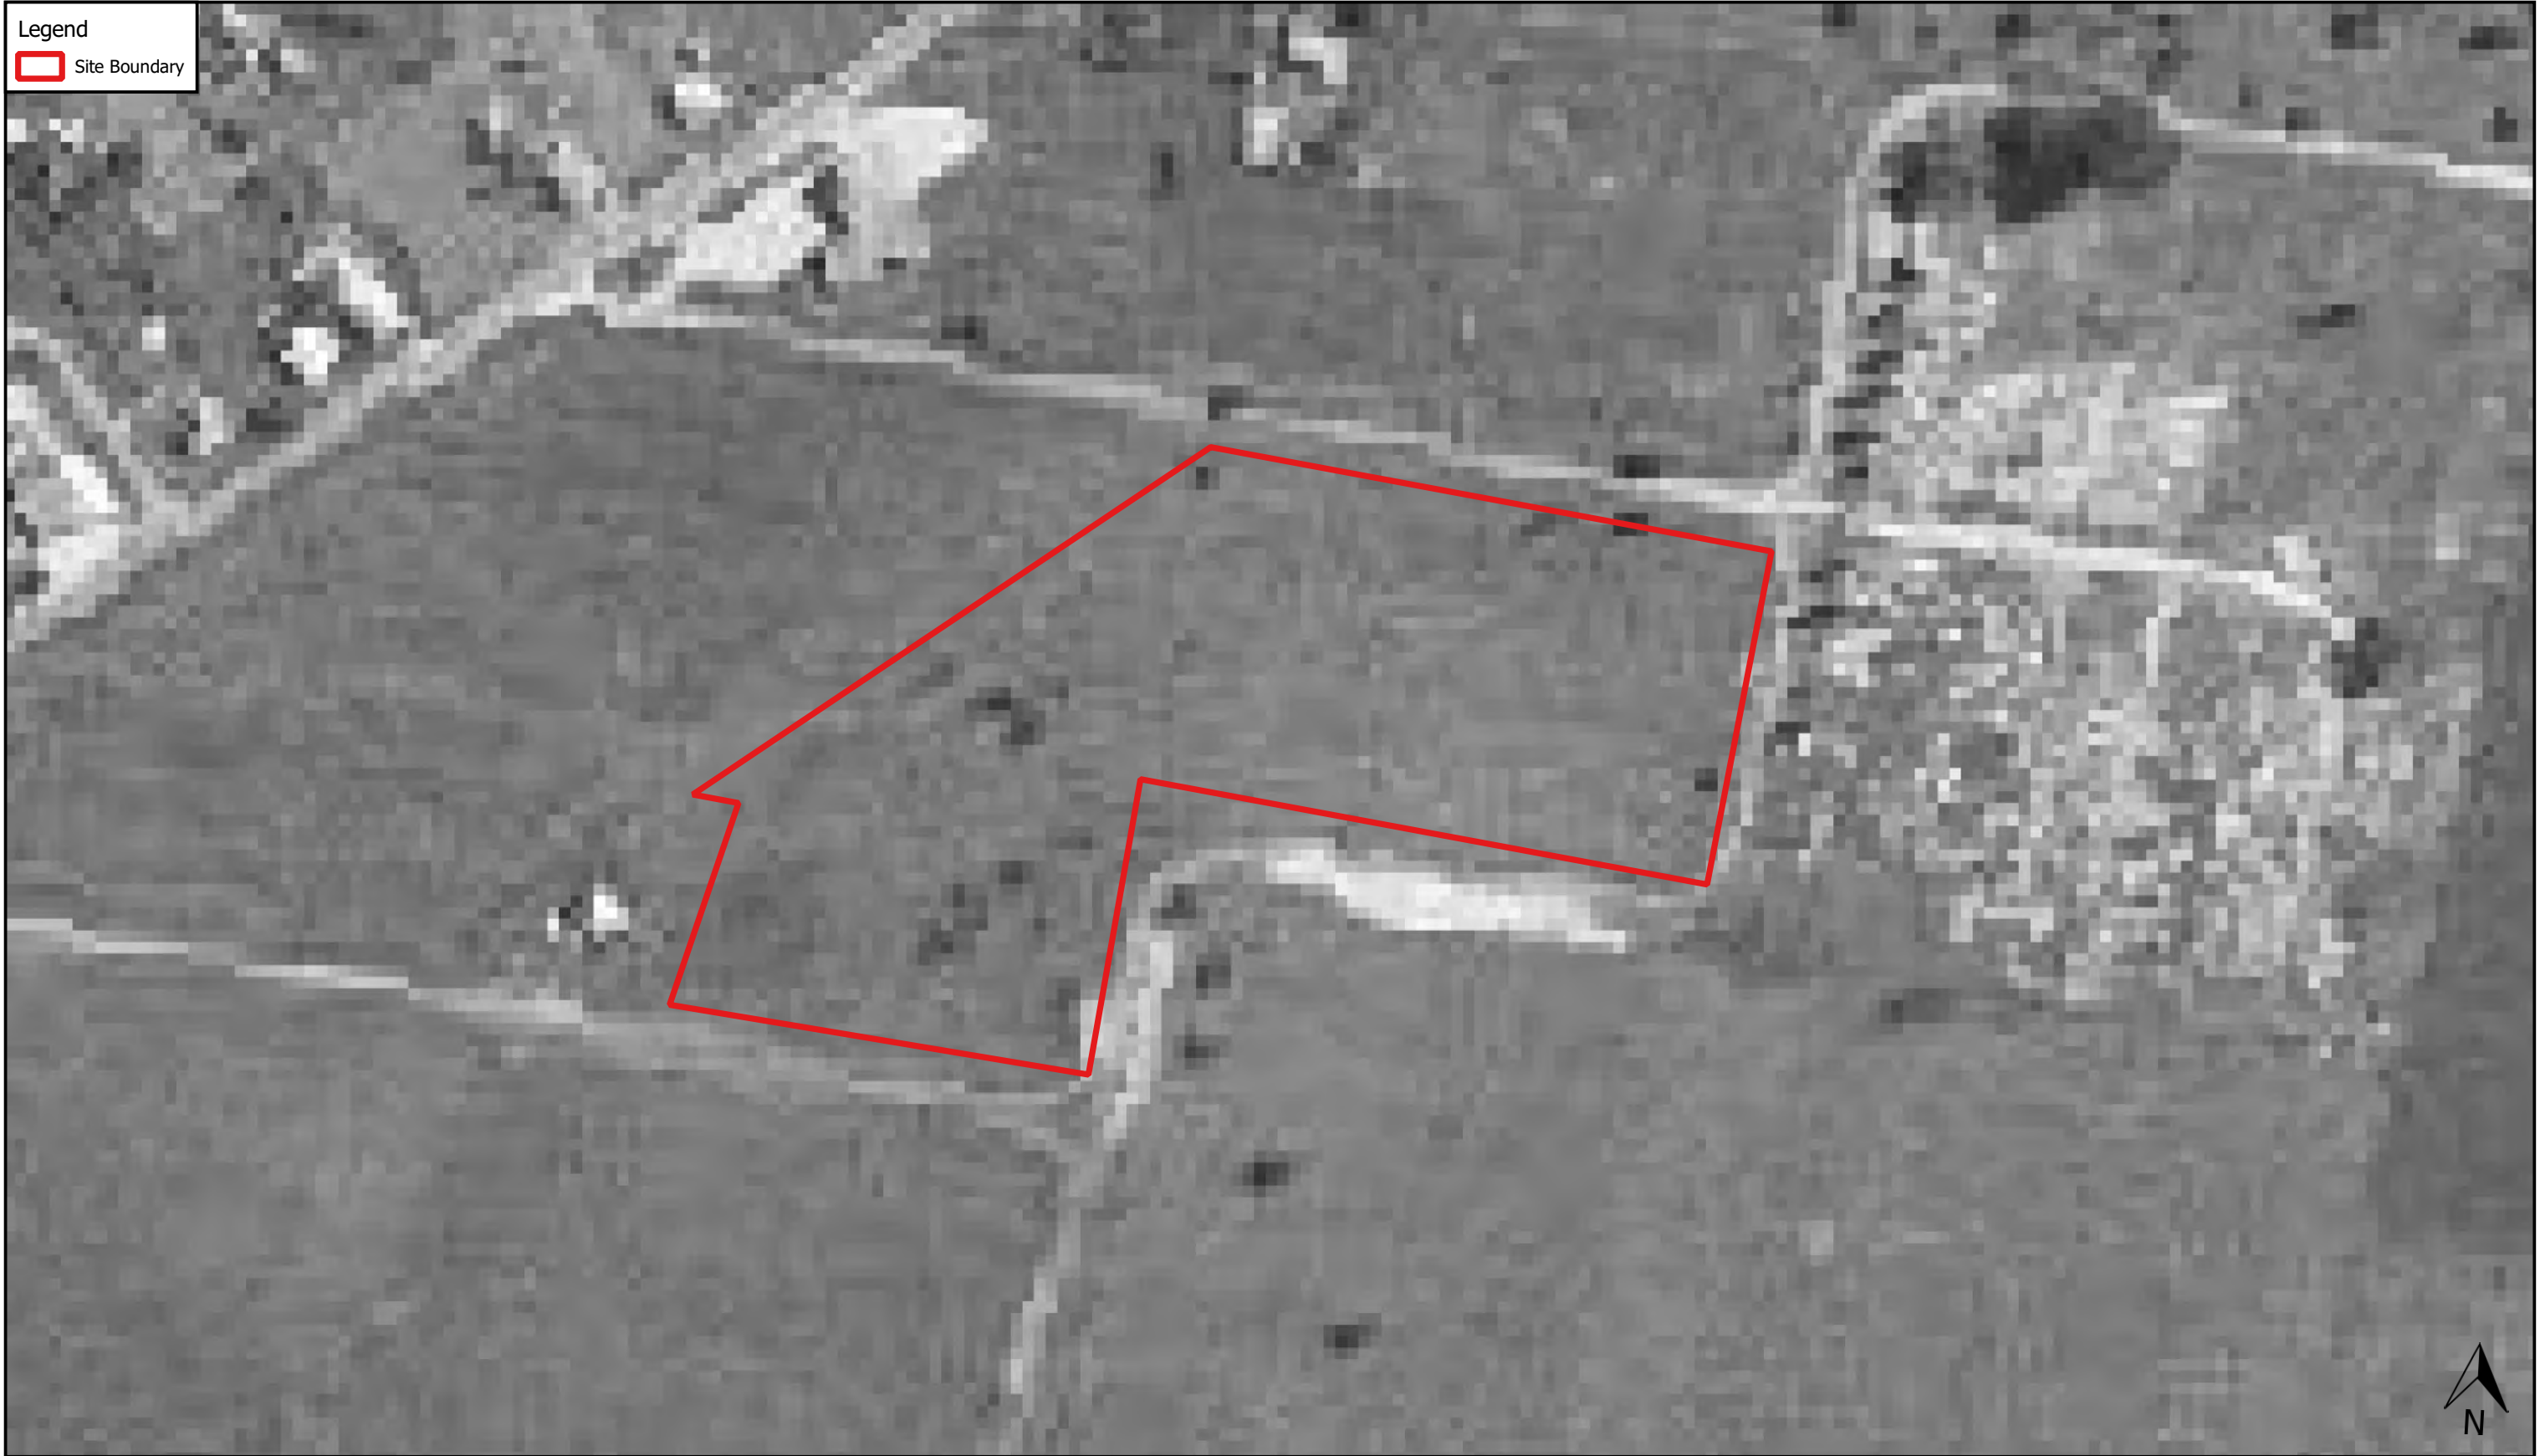
Map 06	Map
3 Memory Avenue, Crookwell, NSW	Site
Lot Subdivision	Project
Preliminary Site Investigation	Sub-Project
Bluesox	Client
21/03/2025	Date

Map Title / Figure:
Historical Aerial: 1973

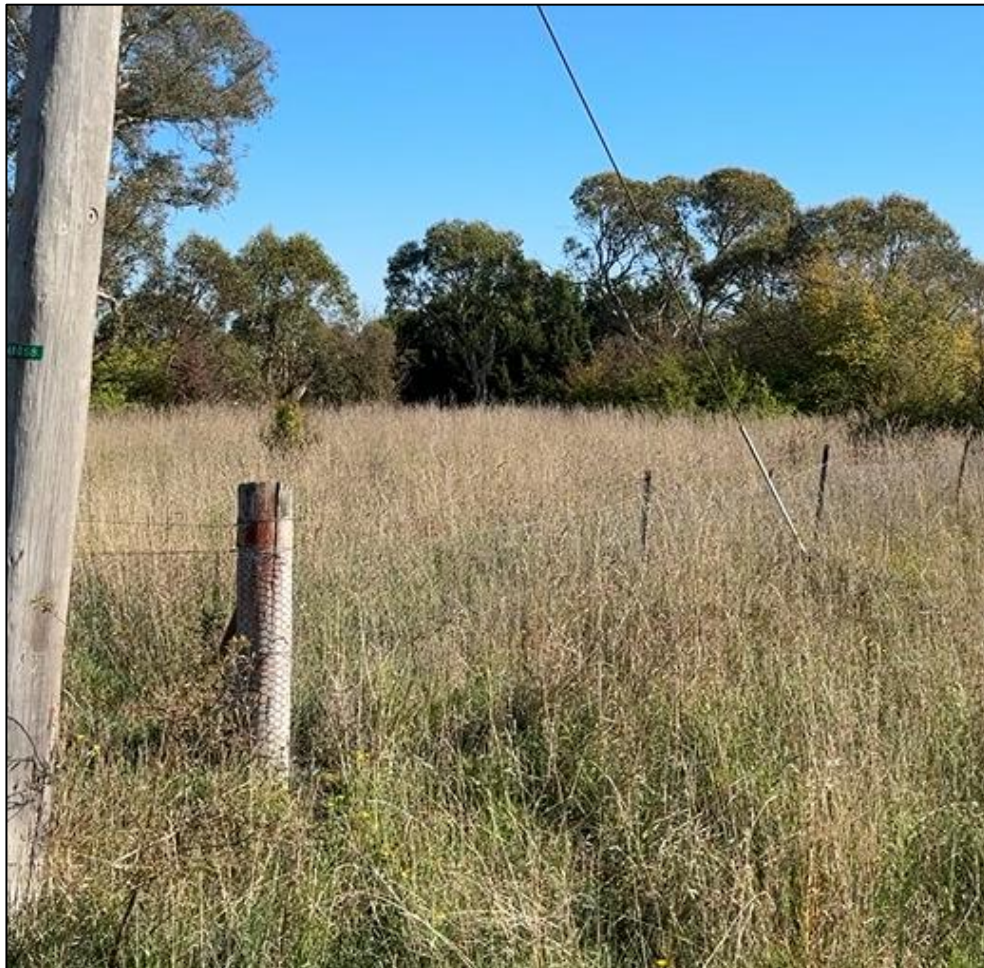
Plate 1: View adjacent to the southeast corner of the Site, facing north. Wire fence along southern and eastern boundaries. Grass, shrubs and trees indicative of majority of the Site. Dated 27 January 2025.

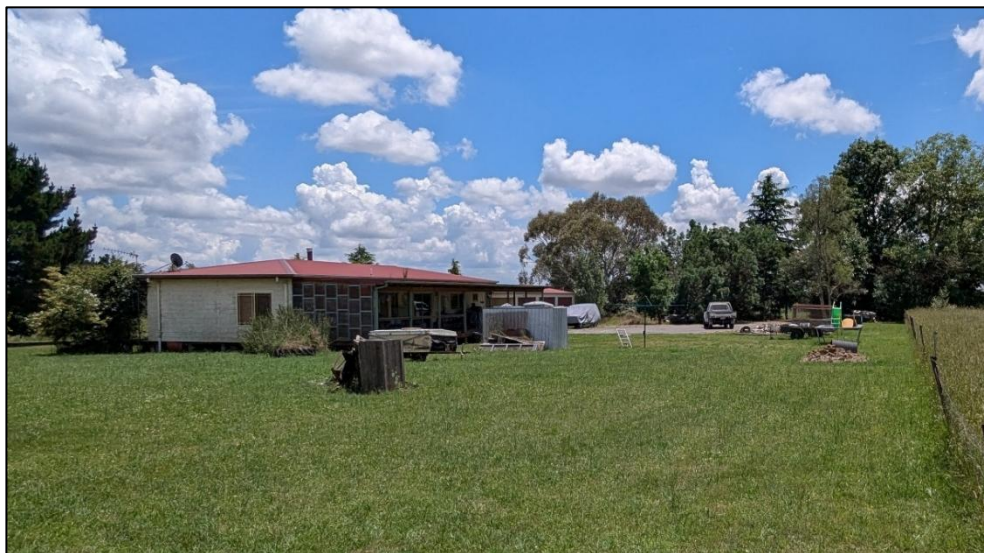
Item	Observation
Buildings and structures	<p>A single storey residential dwelling was observed in the northeast portion of the Site.</p> <p>A small shed structure observed adjacent to the southeast corner of the dwelling.</p> <p>Several trailers were observed to the north and east of the dwelling.</p> <p>Refer to Plate 2 to 9.</p>
Ground surfaces and pavements	<p>The majority of the Site was grass covered.</p> <p>Land surrounding the dwelling consisted of maintained grass with gravel driveway. The maintained grass area was separated from the remainder of the Site by a wire fence.</p> <p>Land outside of the fenced area considered of dense grass with some mature vegetation.</p> <p>Refer to Plate 1 to 7.</p>
Fill material and stockpiles	<p>Evidence of fill material was not observed during the inspection.</p> <p>Two separate small stockpiles of wood and rock boulders were observed to the east of the dwelling.</p> <p>Several small stockpiles of building debris were observed in the December 2024 walkover. However, most were no longer present in the February 2025 walkover.</p> <p>Refer to Plate 2 to 5 and 7.</p>

Plate 2: View adjacent to eastern corner of the southern boundary of the Site, facing northwest. Residential building with gravel driveway, trailers, shed, debris and stone pile. Dated 6 December 2024.

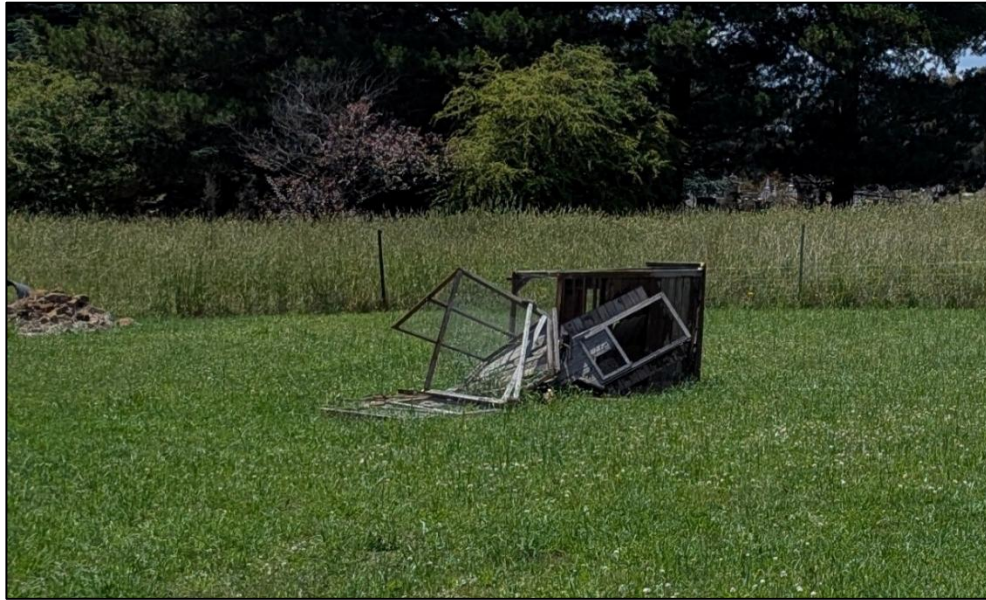
Plate 3: View adjacent to southern side of residential building, facing east. Debris and stone pile. Dated 6 December 2024.

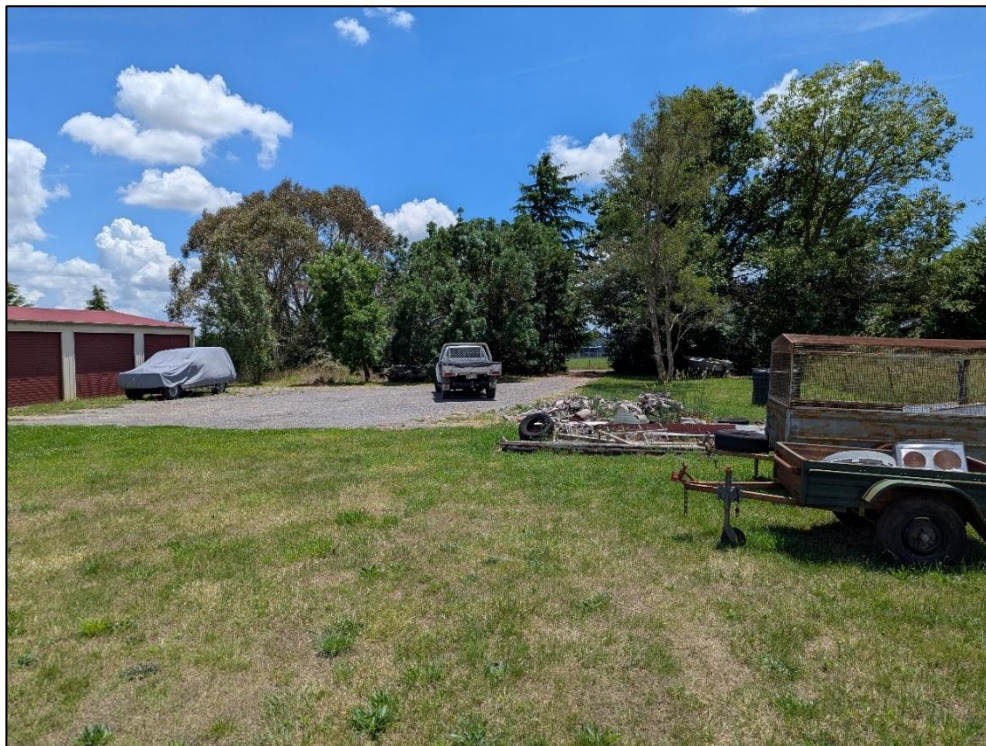
Plate 4: View in the centre of the eastern half of the Site, east of the residential building, facing northwest. Gravel driveway, debris and trailers. Dated 6 December 2024.

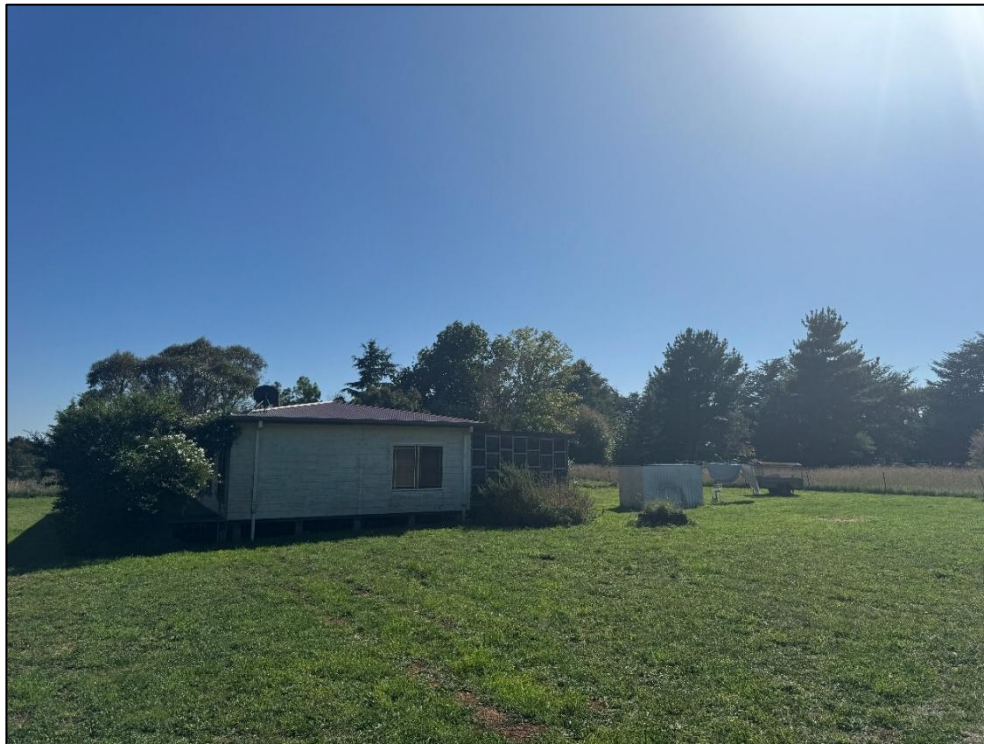
Historic structures	<p>A small shed observed in the December 2024 inspection was no longer present in the February 2025 inspection.</p> <p>Refer to Plate 2 to 7.</p>
Chemical storage	No evidence of chemical storage was observed during the inspection.
UPSS, USTs and ASTs ¹	No evidence of UPSS, USTs, and ASTs was observed.
Waste materials and storage	No waste materials or designated storage areas were observed.
Odours and staining	No significant odours or staining were observed.
Hazardous building materials	No evidence of hazardous buildings materials was observed.
Electrical substation kiosks	No electrical substation kiosks were observed on the Site or adjacent land.
Vegetation and phytotoxicity	<p>Vegetation on-site consisted mainly of grass, sparse shrubs, and trees. A maintained grass area was present within the fenced portion surrounding the existing dwelling.</p> <p>Vegetation appeared to be in good condition, with no evidence of phytotoxicity effects.</p>

Plate 5: View adjacent to southern side of residential building, facing north. Residential building, shed and trailer. Dated 27 January 2025.

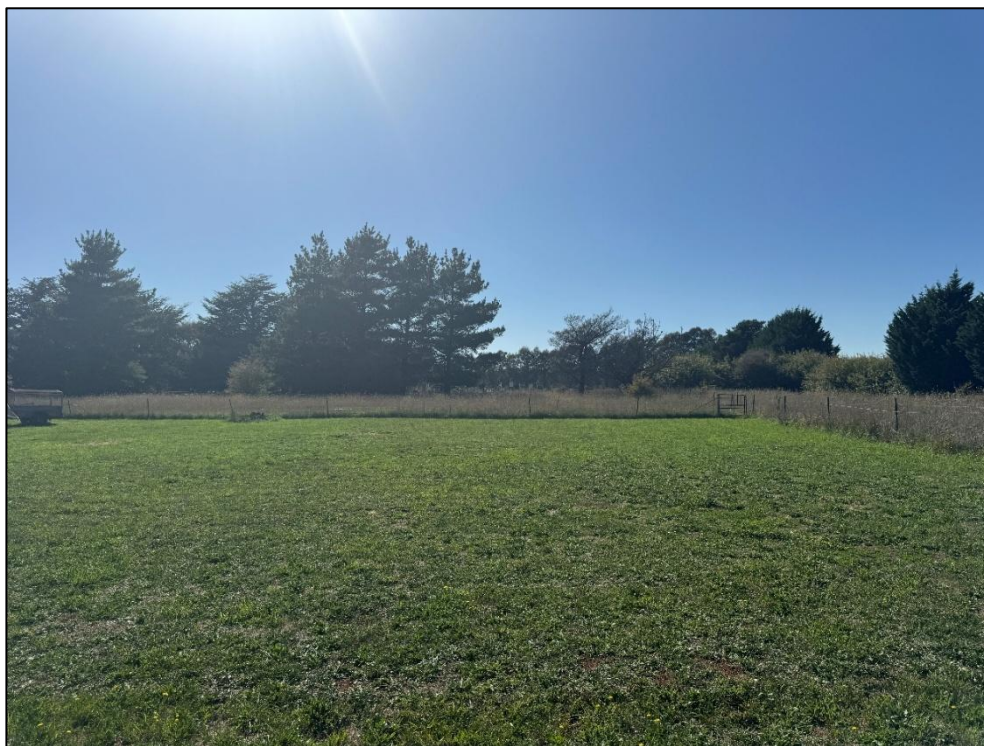
Plate 6: View adjacent to southern side of residential building, facing east. Trailer. Dated 27 January 2025.

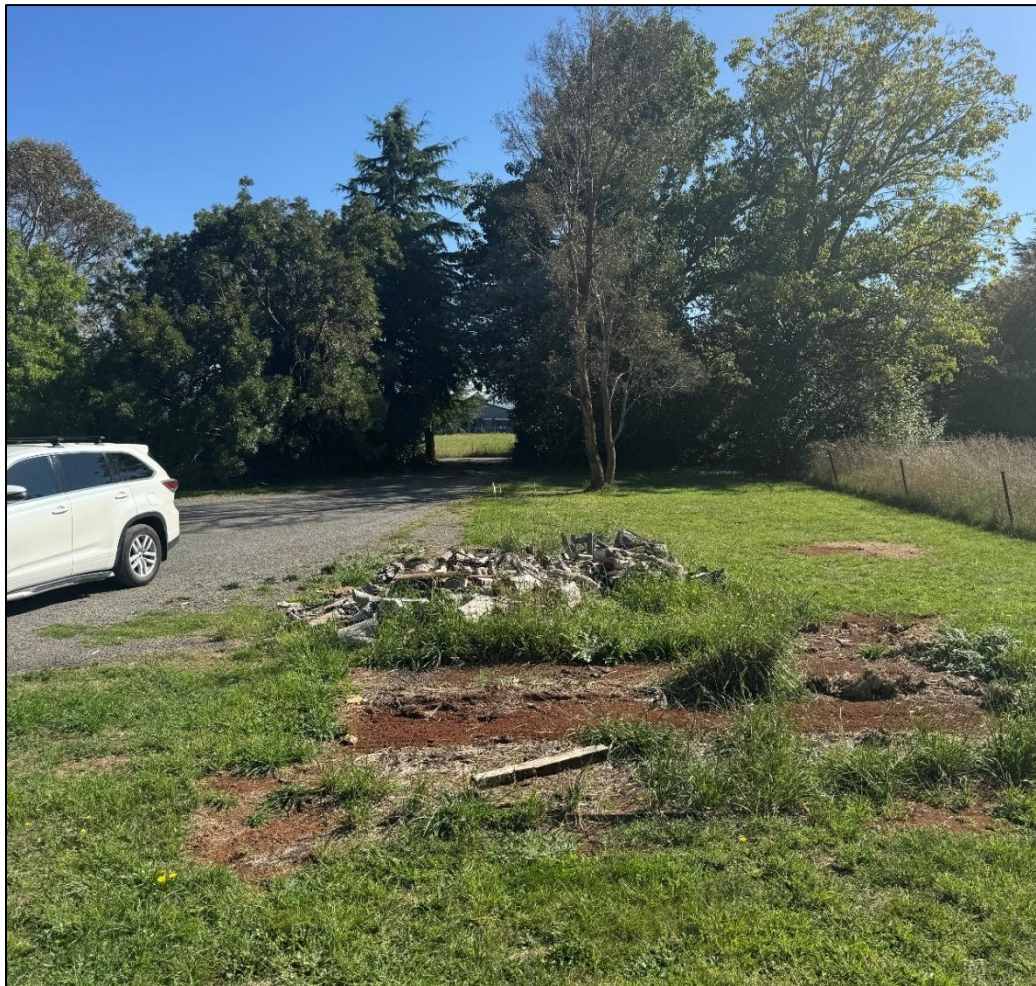
Plate 7: View adjacent to the southeast corner of the gravel driveway in the northeast of the Site. Wood pile and expose soil (formerly debris pile). Dated 27 January 2025.

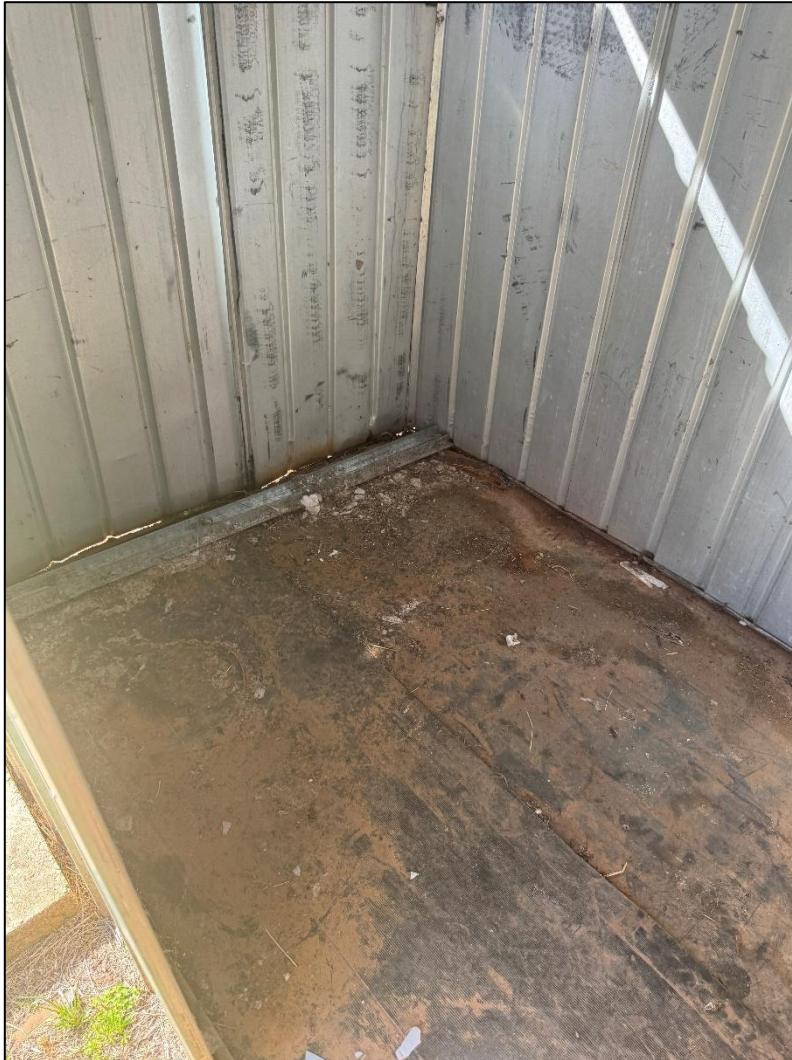
Plate 8: View within shed east of the southeast corner of the residential building on the Site. Dated 27 January 2025.

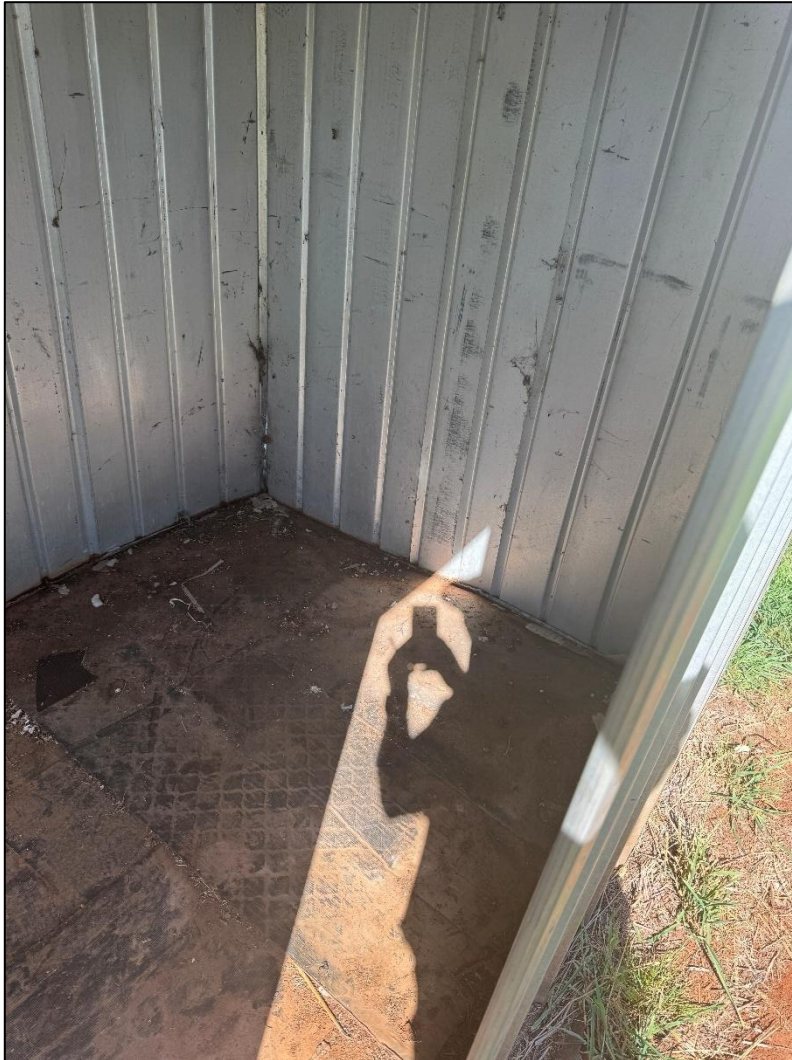
Plate 9: View within shed east of the southeast corner of the residential building on the Site. Dated 27 January 2025.
