Reference: SII 5183– AA

## ***Preliminary Site Investigation***

***1 Hunter Street, Muswellbrook NSW 2333***

***Lot 1 of DP 995228***

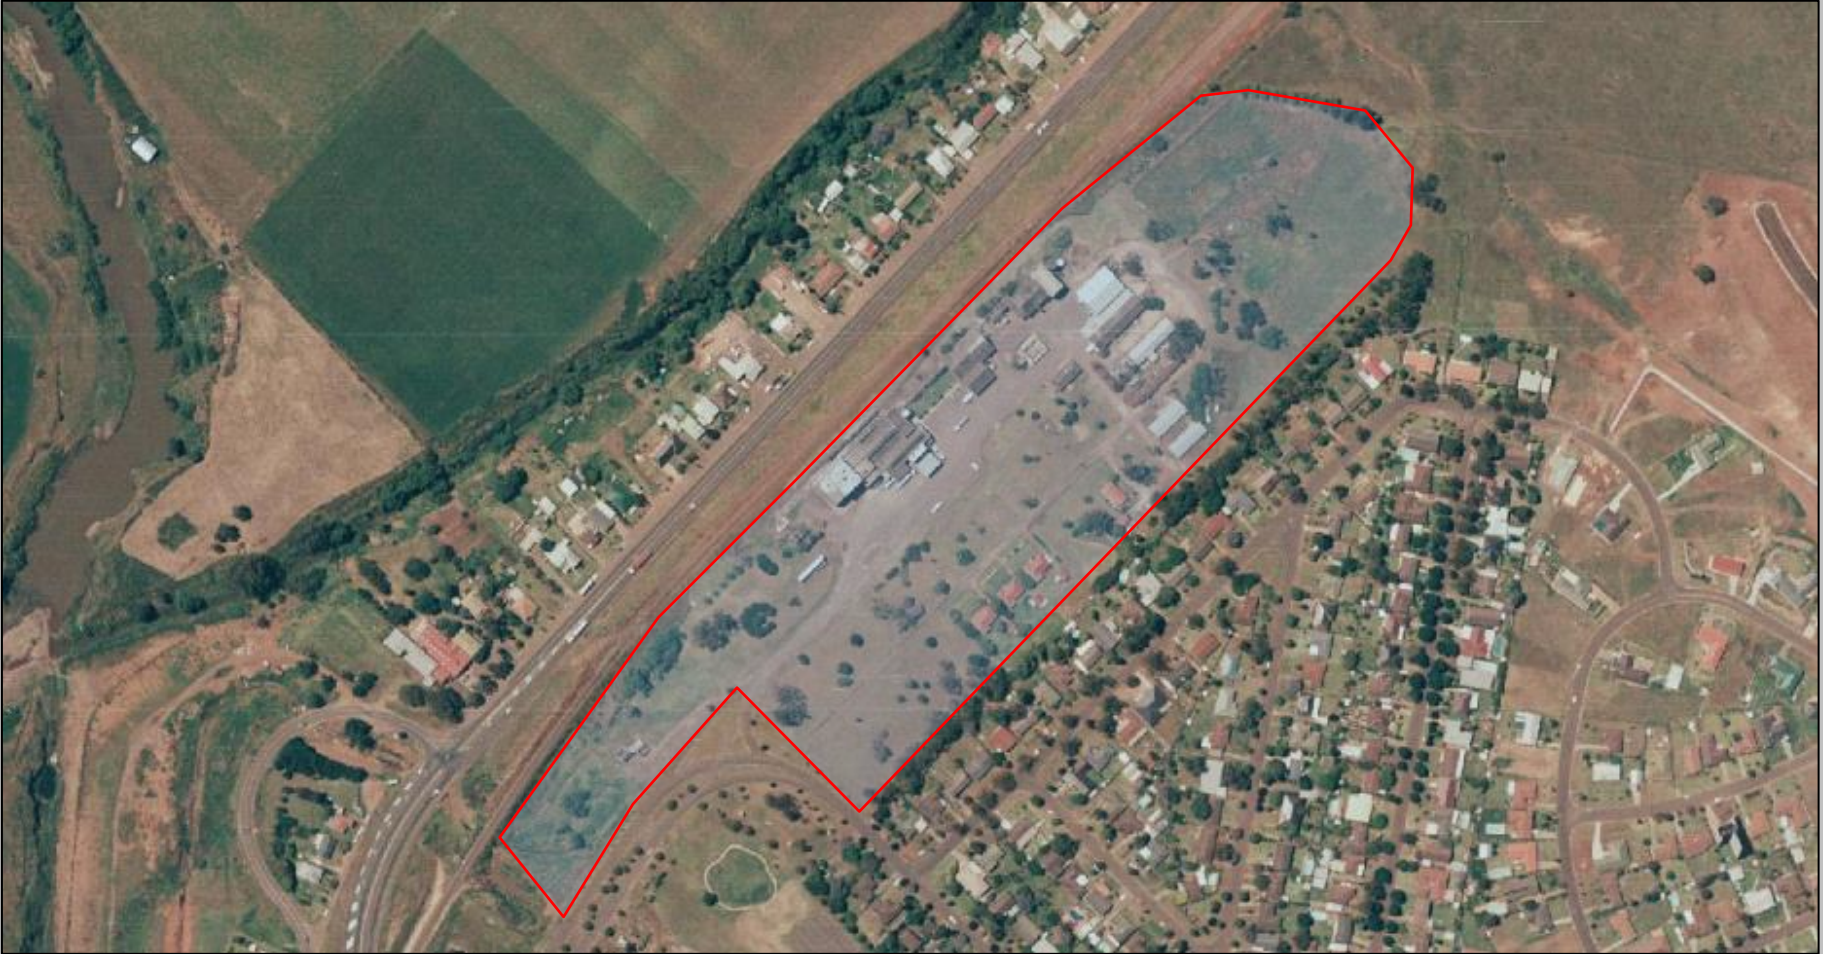
1993

<p align="center"><b>Site</b></p> <p>The approximate boundary of the site can be determined. The buildings on the site appear to be the same as are currently present. More land toward the centre of the site has been cleared of trees. It is now clear the brick cottages are present on site. The car workshop shed currently on-site has been built.</p>	<p align="center"><b>Surroundings</b></p> <p>The surrounding land has not changed significantly but increasing development of Muswellbrook can be seen, particularly of residential properties to the east.</p>

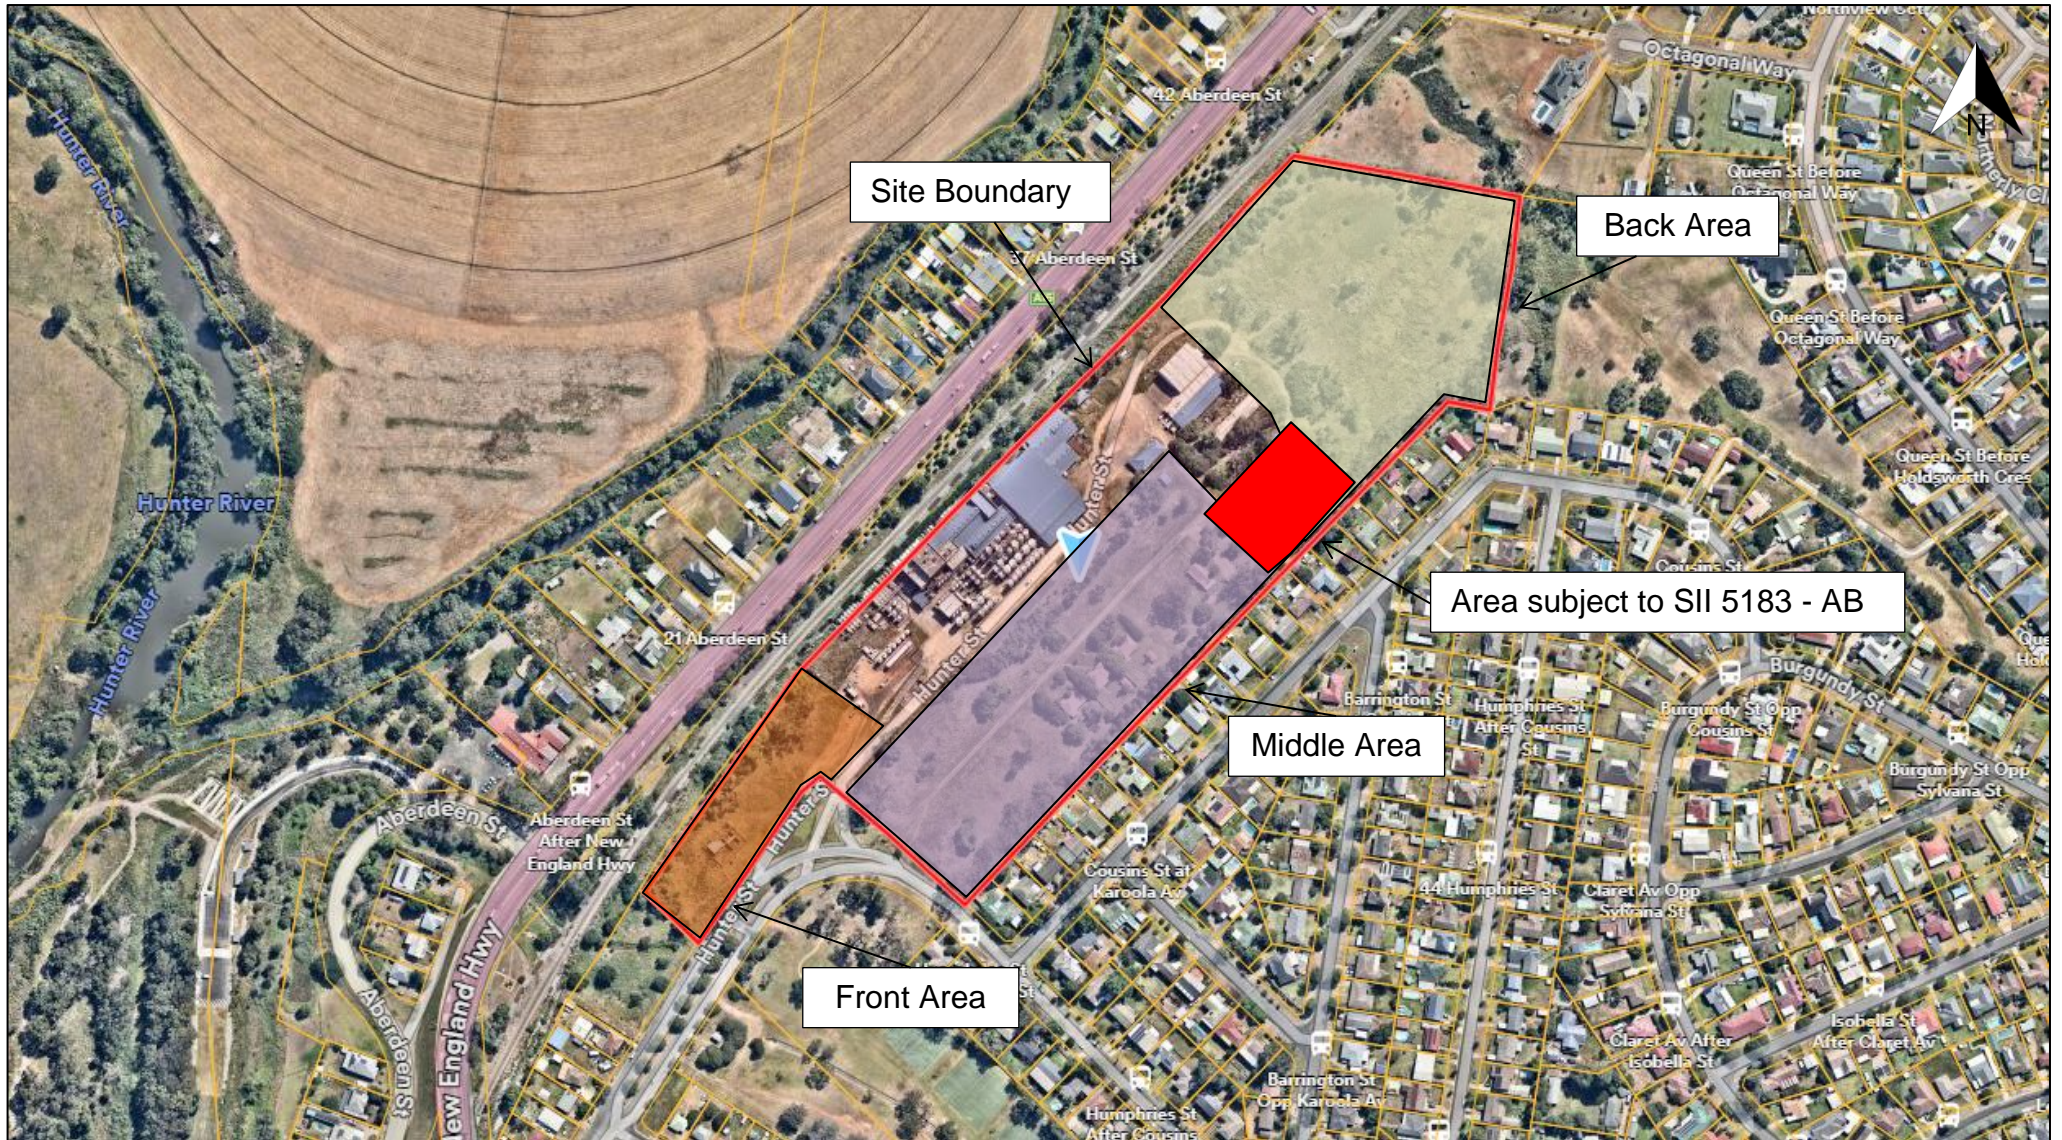
Drawing No:	AA 001
Project Code	
SII 5183 - AA

**Site Drawing**  
 Site drawing for the material of interest located at 1 Hunter Street, NSW 2333  
 Approximate GPS Coordinates of (GDA94): -32.250830, 150.894650.  
 Source: Nearmap, dated 6 March 2024

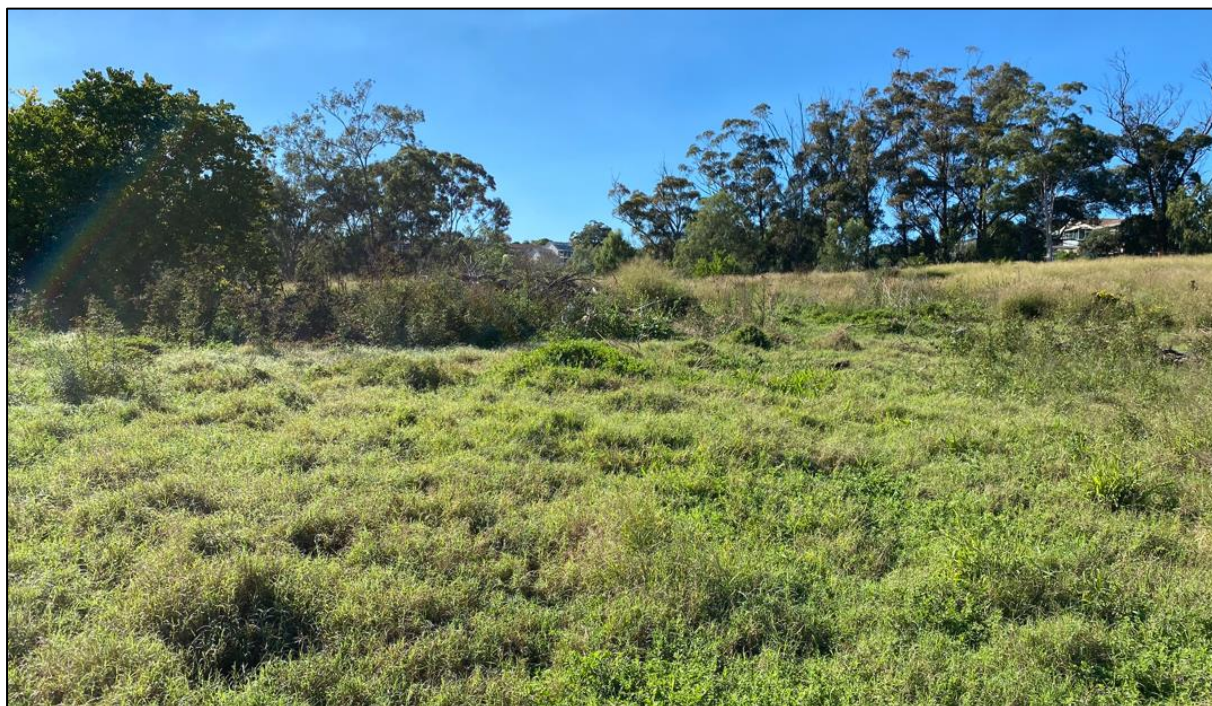
At the time of investigation, there was rubbish that had been dumped in this area. The rubbish in the back area consisted of bricks, timber, wood, hardboard, metal sheeting, ceramic tiles and plastic items (wheelie bin, a pram, and chairs). During the inspection, no indicators of significant contamination, such as the staining or discolouration of sub-surface material, or the emission of odours, was observed.

**Photograph 1** – Overview of the back area looking to the north east. Located at 1 Hunter Street, Muswellbrook NSW 2333 (Lot1 of DP995228). Approximate GPS Coordinates of (GDA94): -32.249133, 150.896514.

- If any demolition of existing structures is to be undertaken it should be conducted in accordance with the recommendations of the asbestos-containing materials survey conducted by Hazmat Services Pty Ltd in 2023.
- The site is generally made clean from anthropogenic deposits such as the rubbish in the back area of the site.

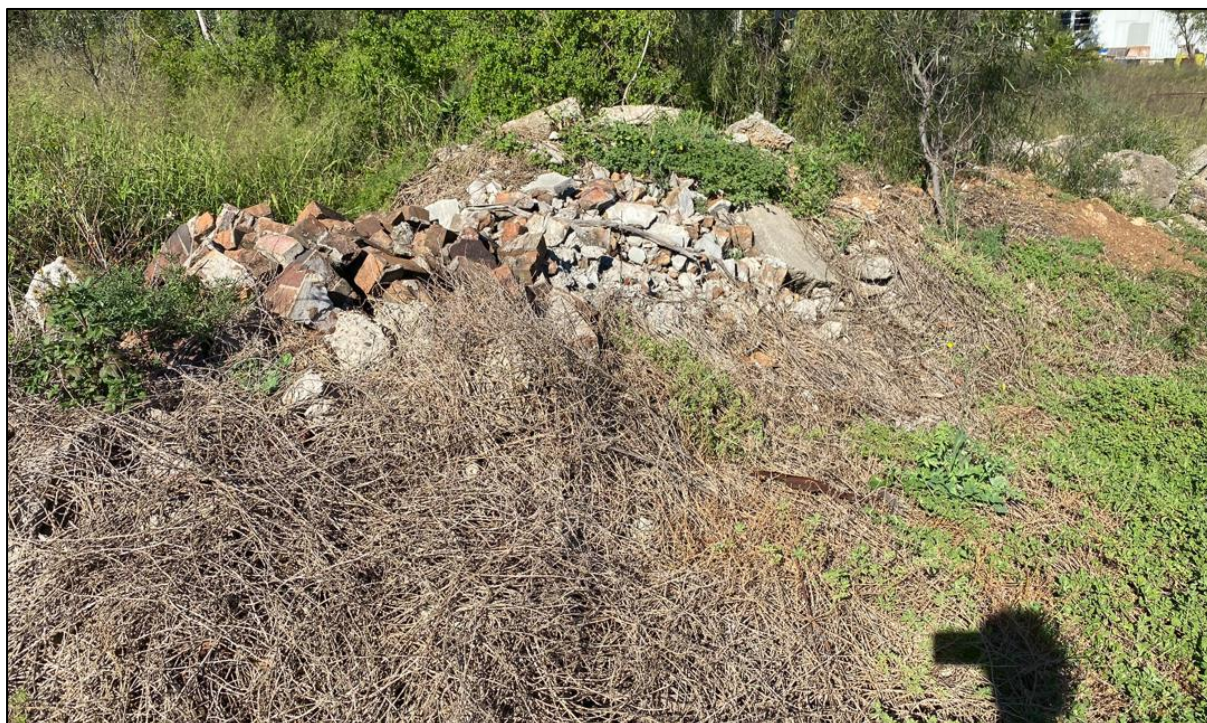
**Photograph 2** – Pile of bricks at the back area of site. Located at 1 Hunter Street, Muswellbrook NSW 2333 (Lot1 of DP995228). Approximate GPS Coordinates of (GDA94): -32.249133, 150.896514.

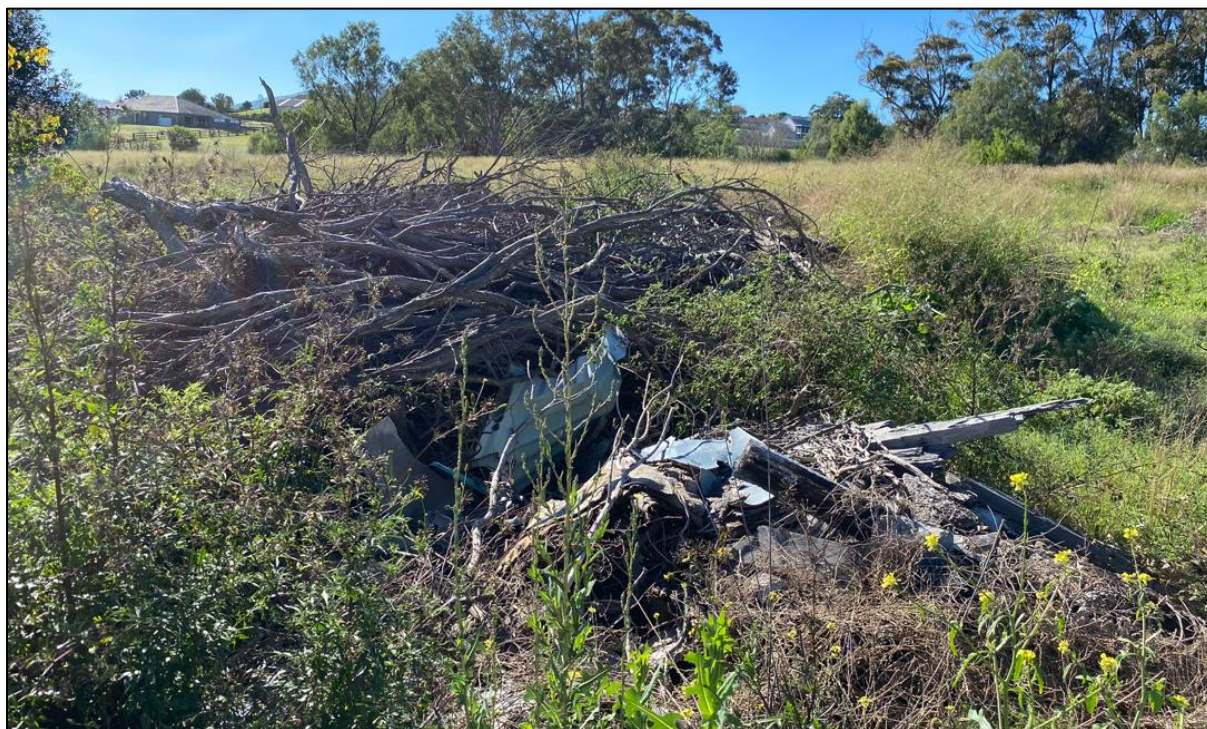
**Photograph 3** – Wood and scrap metal at the back area of site. Located at 1 Hunter Street, Muswellbrook NSW 2333 (Lot1 of DP995228). Approximate GPS Coordinates of (GDA94): -32.249133, 150.896514.

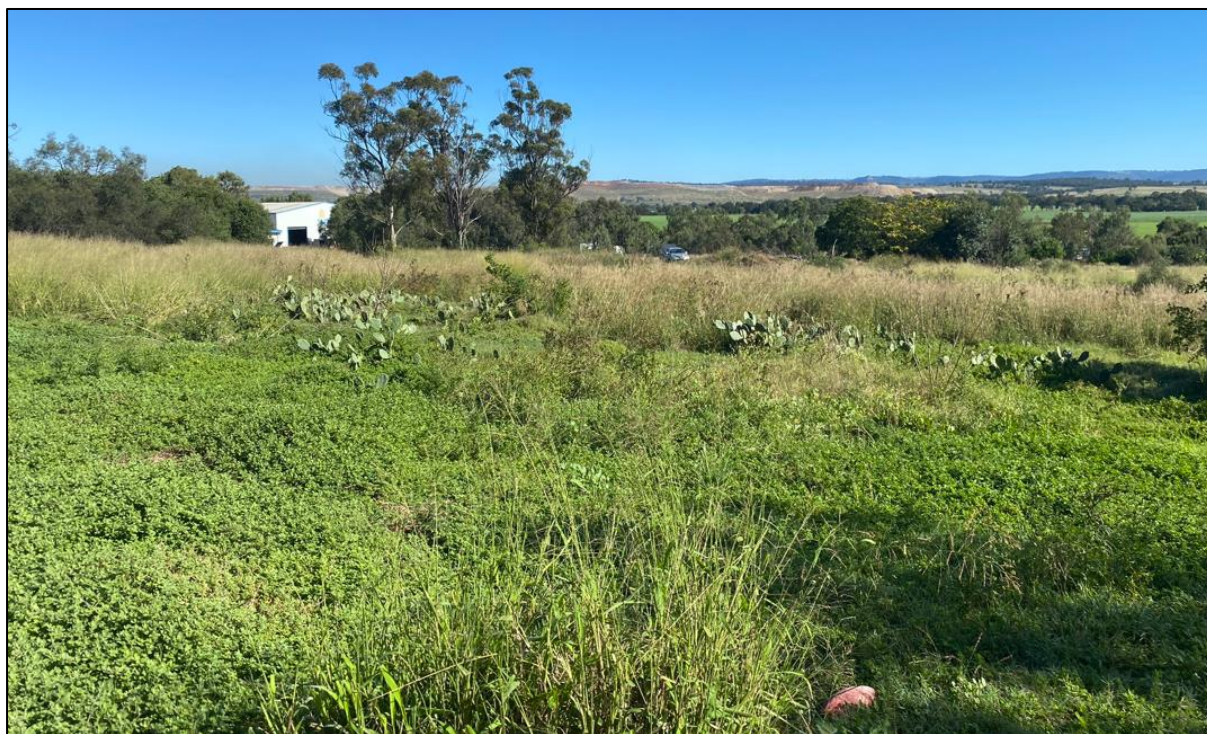
**Photograph 4** – Overview of the back area looking to the south west. Located at 1 Hunter Street, Muswellbrook NSW 2333 (Lot1 of DP995228). Approximate GPS Coordinates of (GDA94): -32.249133, 150.896514.

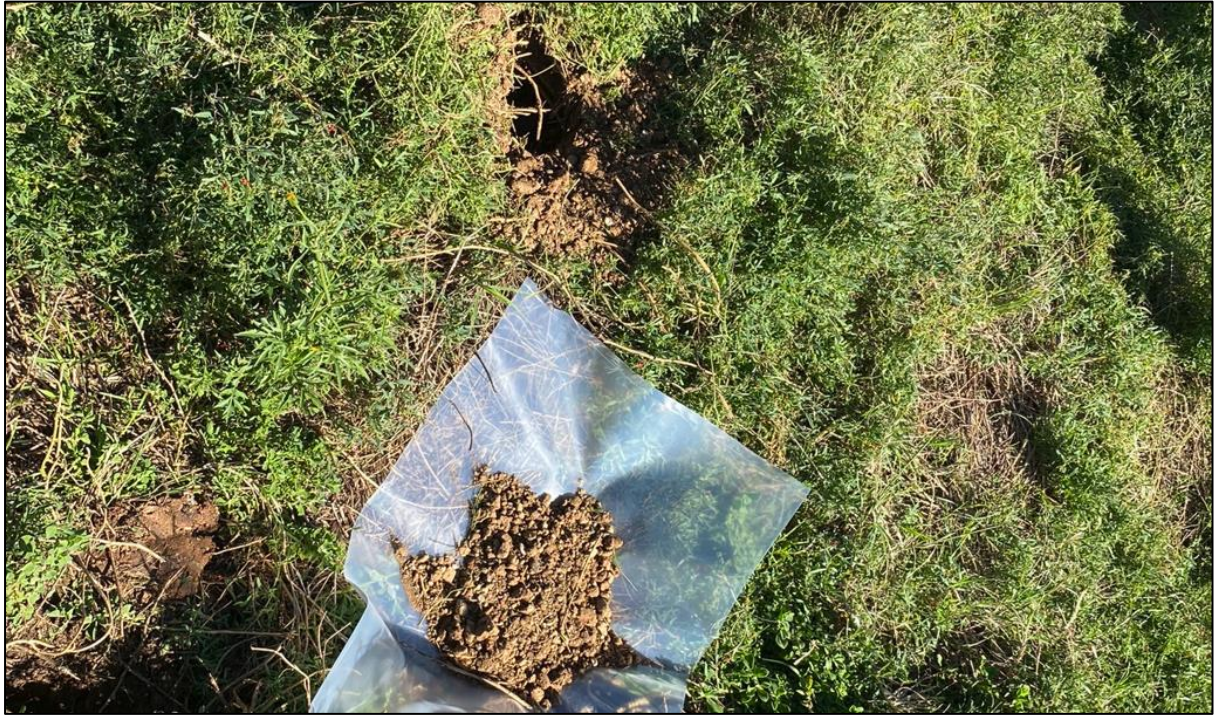
**Photograph 5** – Overview of bore hole 2 (BH2) with the material of interest pictured. Located at the back area of 1 Hunter Street, Muswellbrook NSW 2333 (Lot1 of DP995228). Approximate GPS Coordinates of (GDA94): -32.249133, 150.896514.

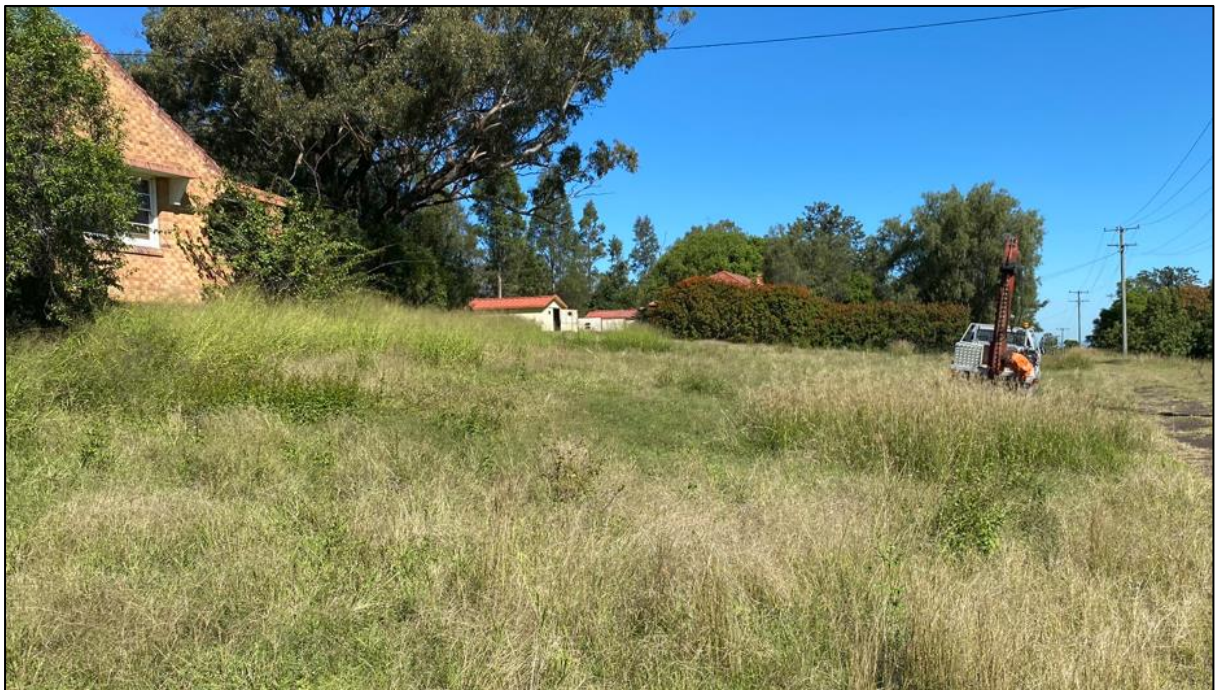
The middle focus area of the site was generally consisted of a grass field area containing an amenities block, toilet block, four (4) cottages and a plant room. All of these buildings were constructed with brick. Non-friable ACM had been identified in all of these buildings in the Hazmat Services 2023 ACM survey; however, these buildings were generally in good condition and no ACM was found at the time of investigation.

**Photograph 6** - Overview of the middle area of the site looking south. Located at the back area of 1 Hunter Street, Muswellbrook NSW 2333 (Lot1 of DP995228). Approximate GPS Coordinates of (GDA94): -32.252001, 150.89365..

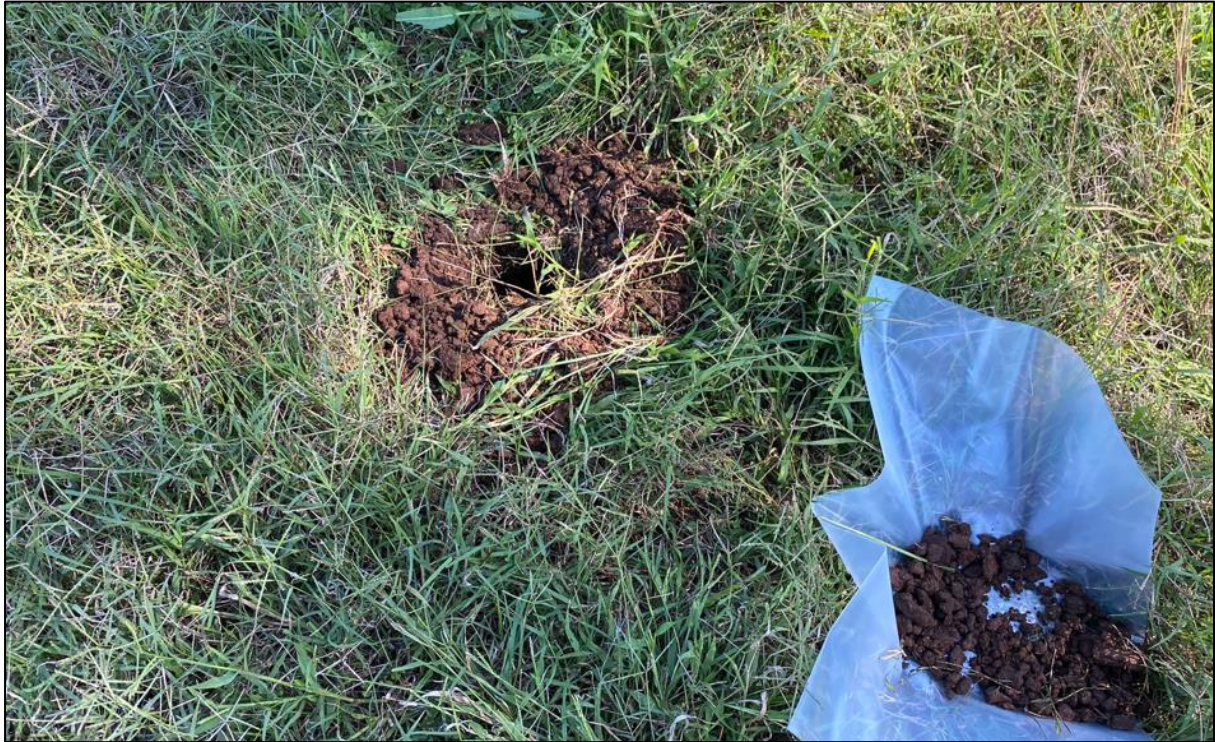
**Photograph 7** - Overview of bore hole 9 (BH9) with the material of interest pictured. Located at the back area of 1 Hunter Street, Muswellbrook NSW 2333 (Lot1 of DP995228). Approximate GPS Coordinates of (GDA94): -32.252001, 150.89365.

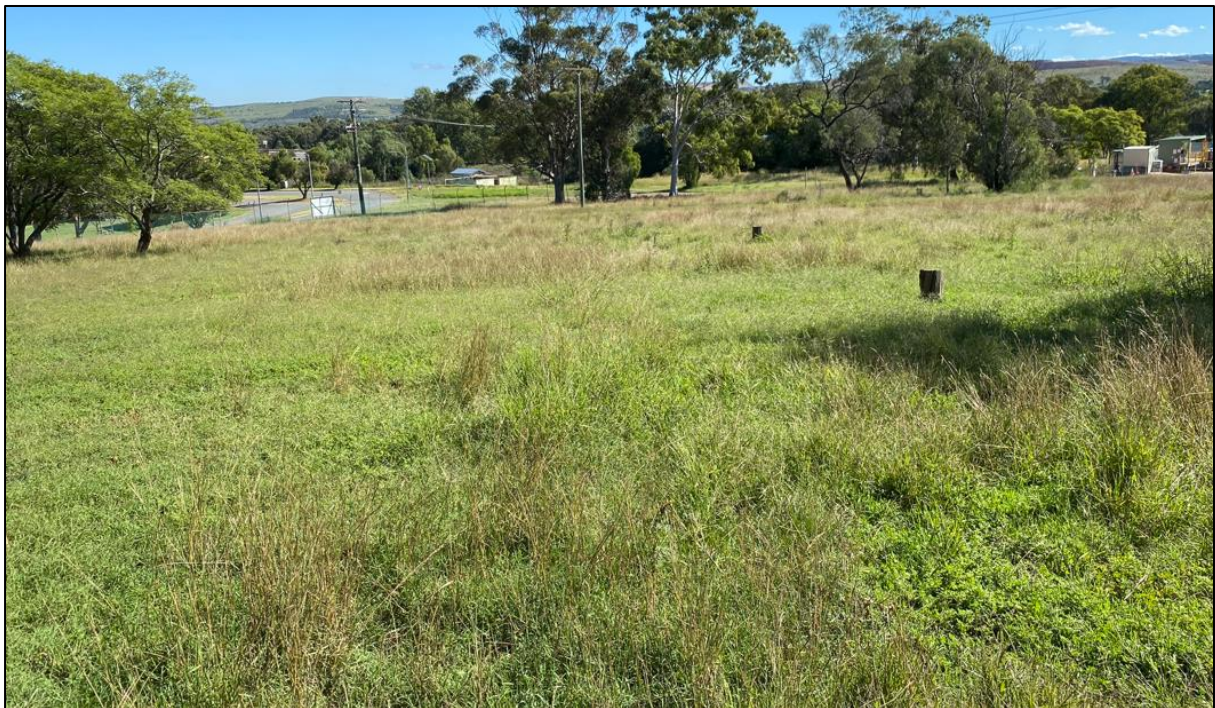
**Photograph 8** - Overview of the middle area of the site looking south. Located at the back area of 1 Hunter Street, Muswellbrook NSW 2333 (Lot1 of DP995228). Approximate GPS Coordinates of (GDA94): -32.252001, 150.89365.

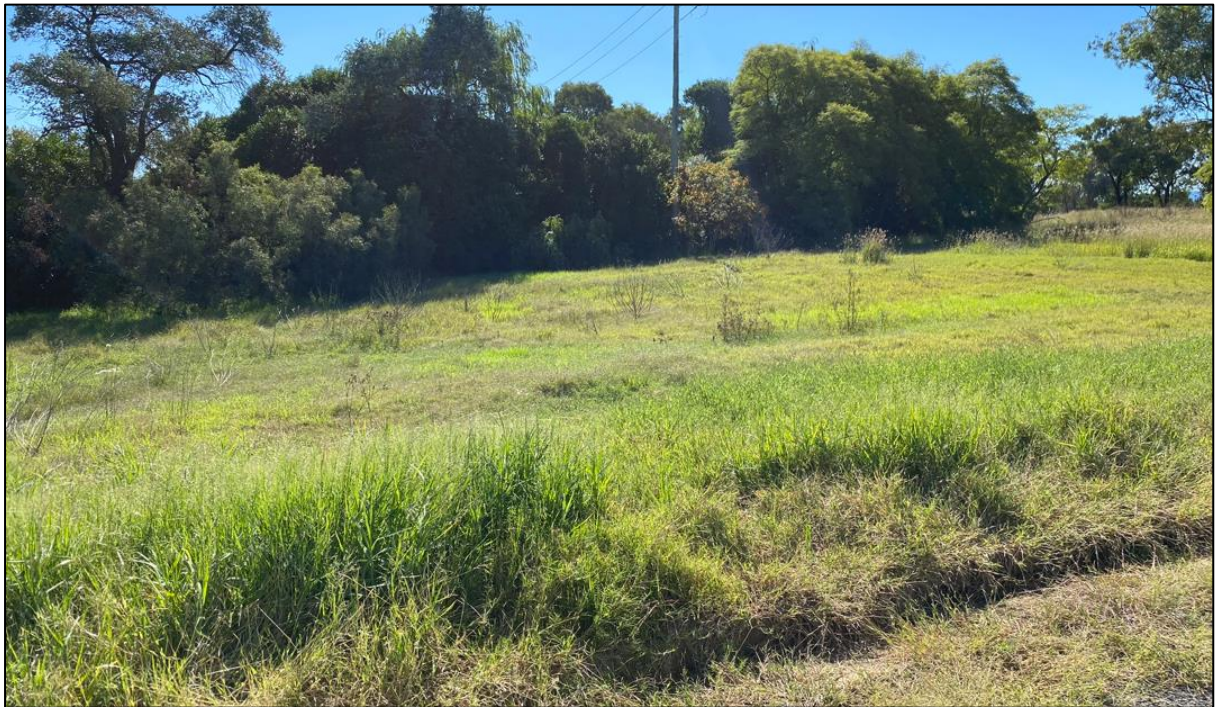
During the visual inspection, no indicators of significant contamination, such as the staining or discolouration of sub-surface material, or the emission of odours, was observed. No ACM or foreign materials were found at the time of investigation.

**Photograph 9** - Overview of the front area of the site looking to the north west. Located at the back area of 1 Hunter Street, Muswellbrook NSW 2333 (Lot1 of DP995228). Approximate GPS Coordinates of (GDA94): - -32.252001, 150.89365.

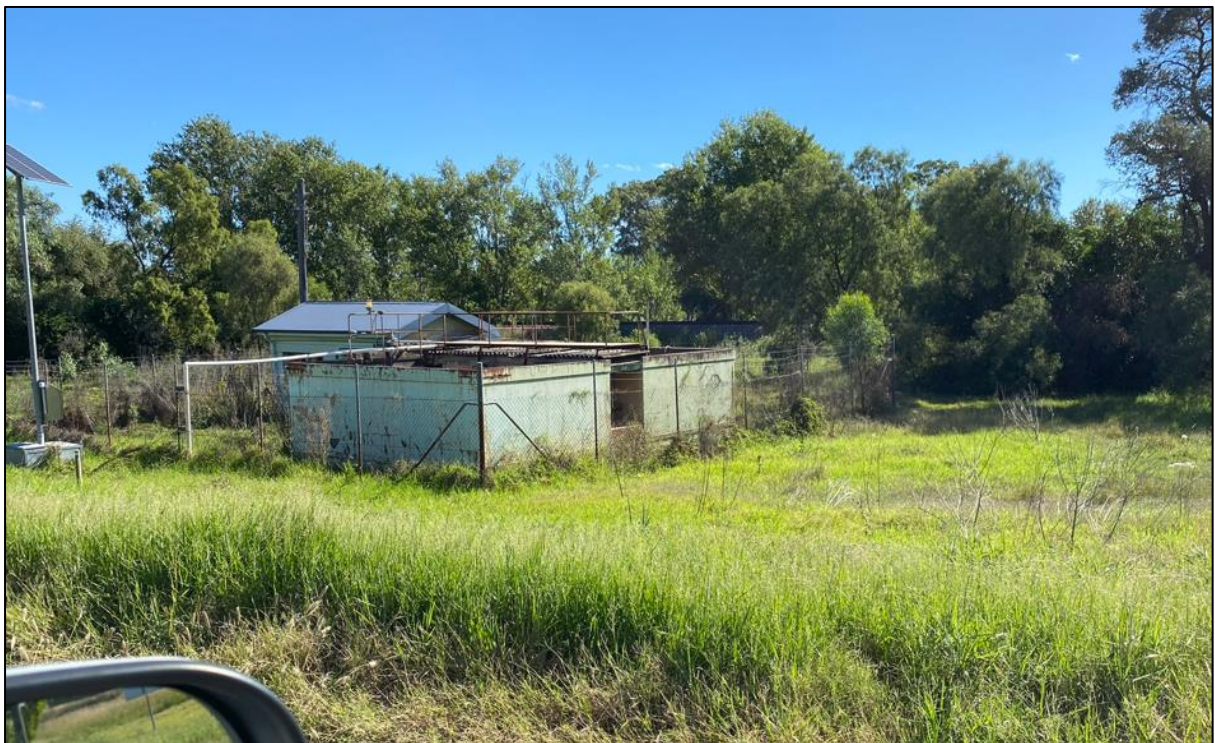
**Photograph 10** - Overview of the front area of the site looking to the north west. Located at the back area of 1 Hunter Street, Muswellbrook NSW 2333 (Lot1 of DP995228). Approximate GPS Coordinates of (GDA94): - -32.252001, 150.89365.
