STATEMENT OF HERITAGE IMPACT FOR:

STAGE 1 REDEVELOPMENT OF THE PEPPIN HERITAGE CENTRE AND MUSEUM (State Heritage Listing SHR#00144)

PEPPIN HERITAGE CENTRE AND MUSEUM

JUNE 2025

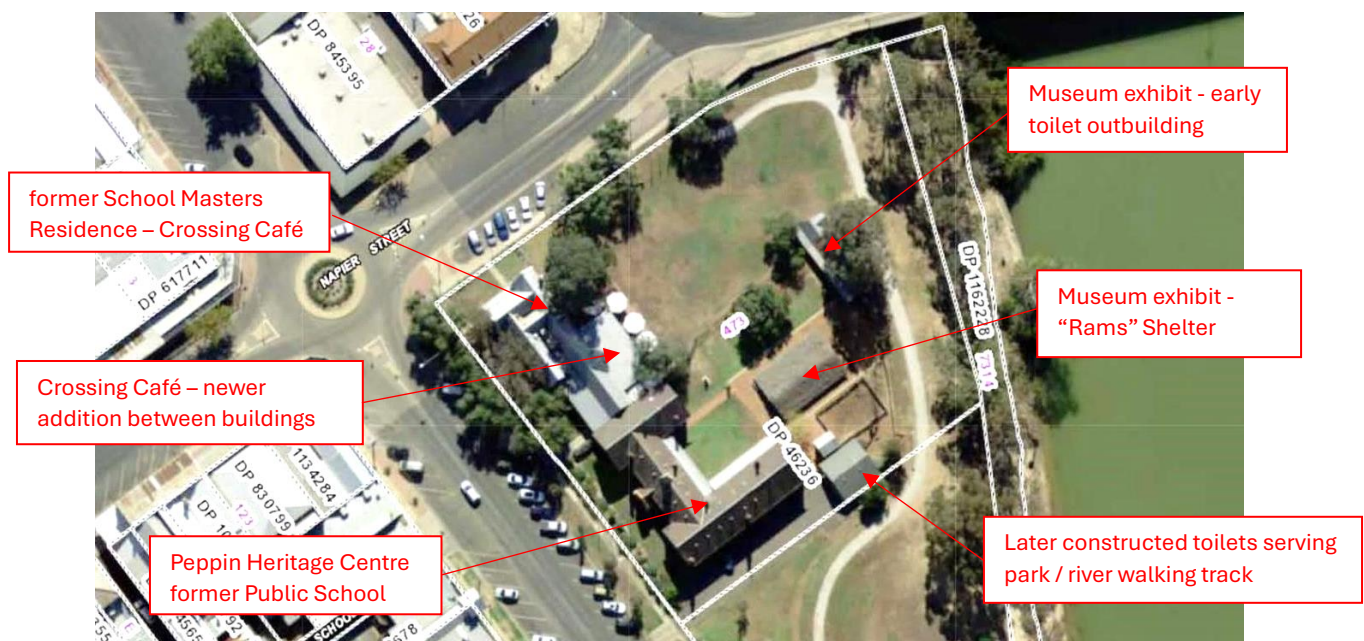
Fig 2: Peppin Heritage Centre (Public School & School Masters Residence - former) aerial mapping showing site components

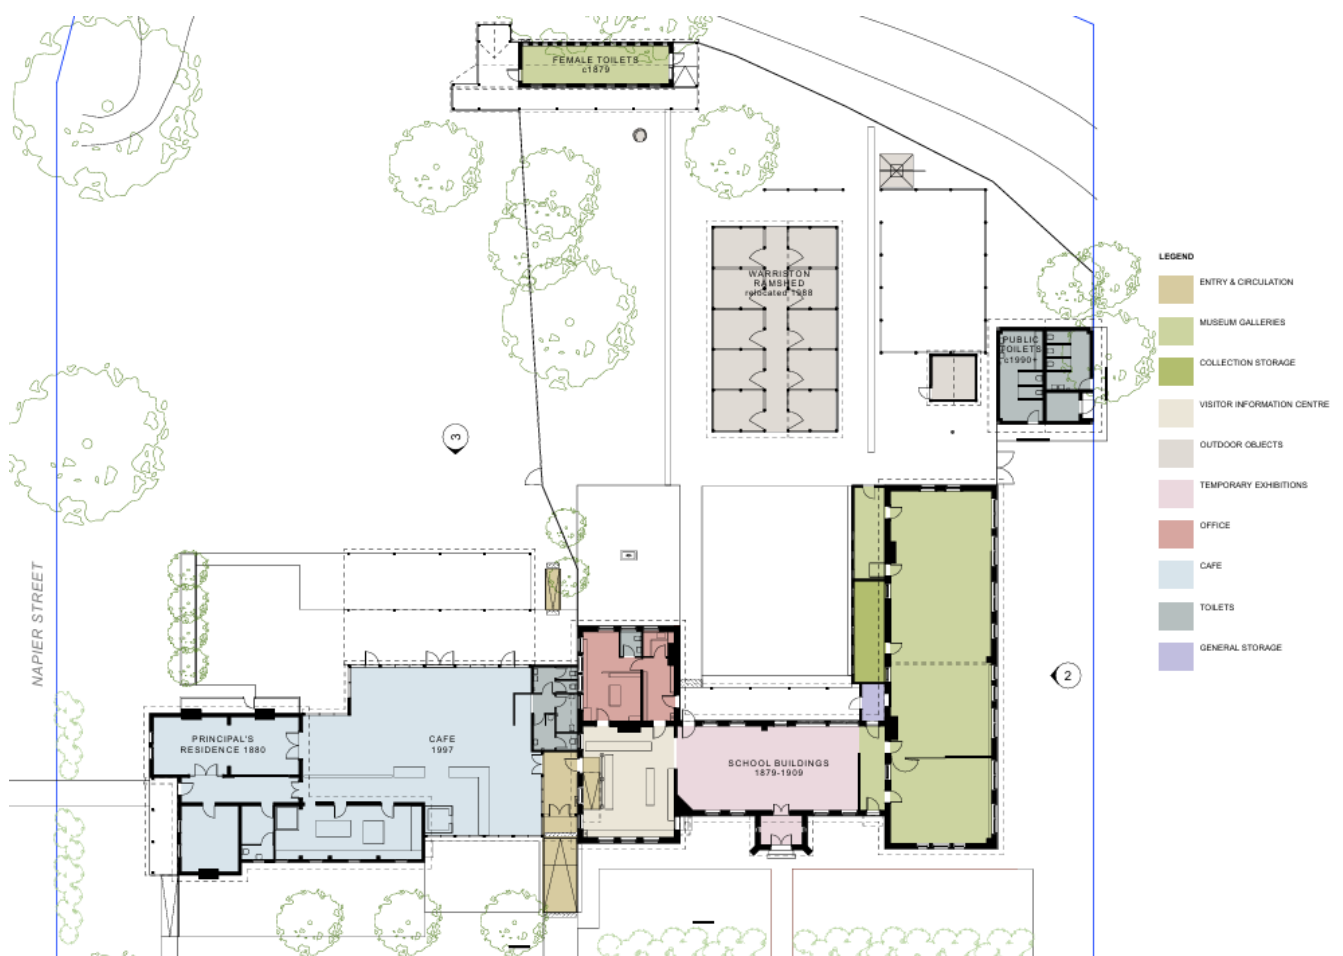
Fig 3: Peppin Heritage Centre (former Public School) Existing Layout

The outbuildings include a small brick structure, likely once a storage or utility building, and several later additions including sheds and covered walkways. These vary in heritage value; some are contemporary in construction and clearly distinguishable from the historic fabric, serving functional purposes related to the current museum and visitor uses. The site retains mature trees and landscaped open areas, including pathways and garden beds that contribute to the setting and interpretation of the precinct. The visual prominence of the Centre, especially when viewed from the northern approach across the National Bridge enhances its landmark status in the townscape. Overall, the Peppin Heritage Centre demonstrates strong integrity in terms of layout, form, and materiality. Despite adaptive reuse, the complex retains significant built elements that reflect its original educational purpose while effectively accommodating its modern function as a museum and cultural facility.

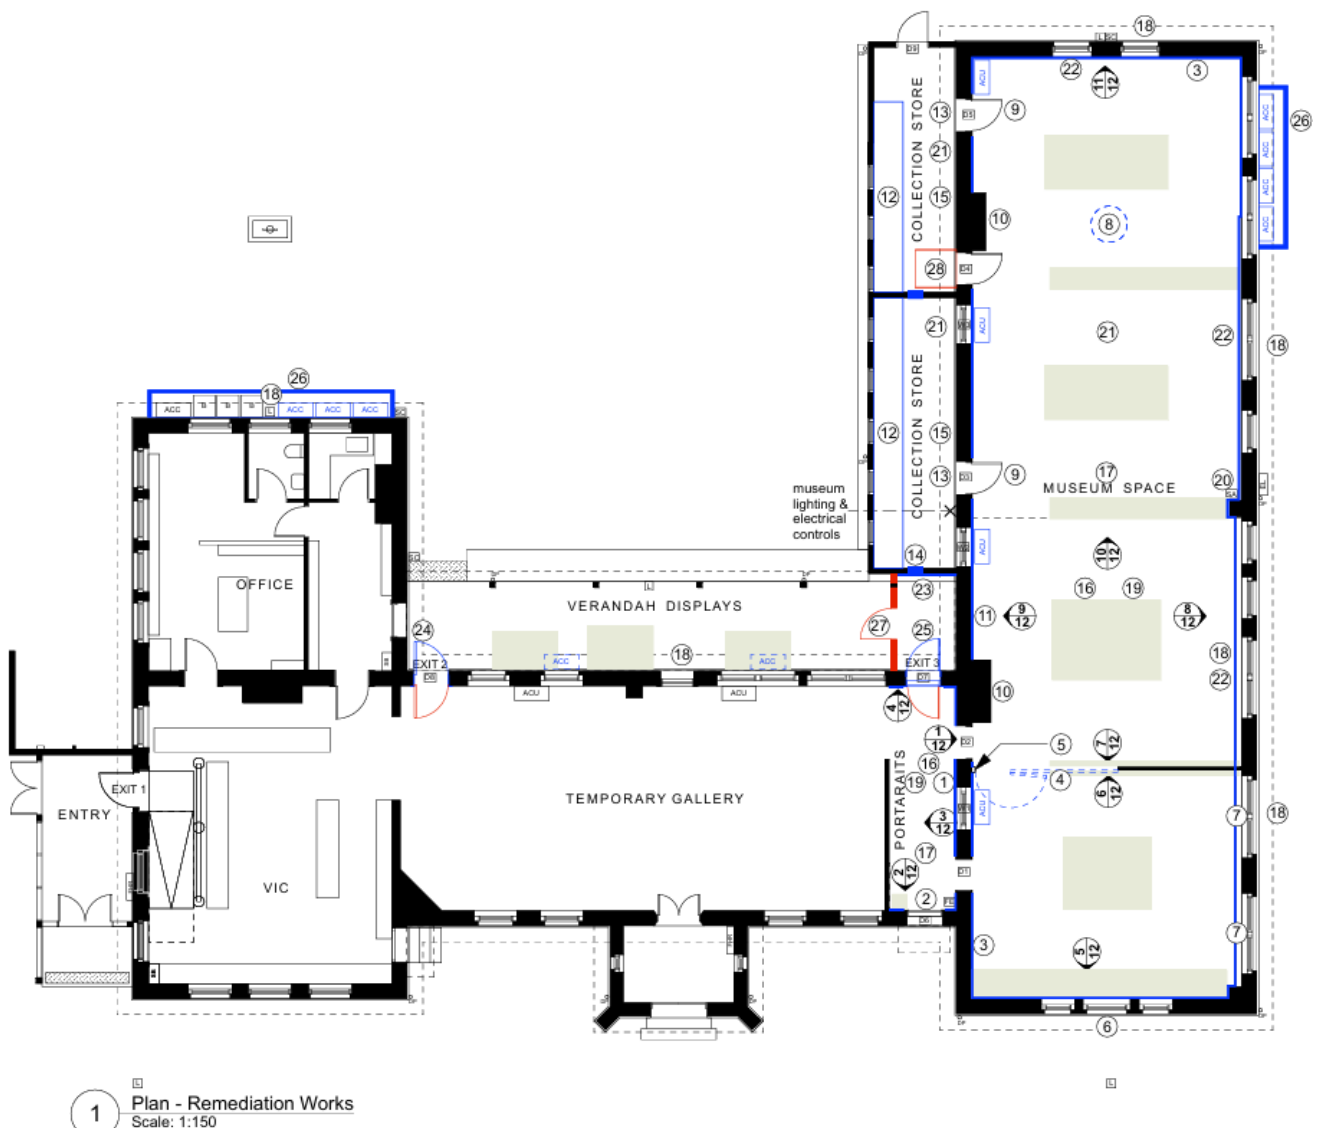
1. new skirting to match temporary gallery skirting, 140mm high. paint finish tba.
2. repair door & architrave, remove barriers, seal gaps, fill holes & paint finish tba.

3. new skirting square edge, 140mm high. paint finish tba.
4. remove sliding door, track & hardware. relocate to conservation storage. fill holes in timber partition wall + paint finish tba.
5. fix existing edge post to wall. paint finish tba.
6. replace broken stained glass in window to match existing.
7. remove winders from windows.
8. existing ceiling ventilator - clean, paint & reseal ventilator. micaceous paint finish tba.
9. doors & windows treatment to schedule.
10. open fireplace and edge opening with metal lintel.
11. paint outline of former door.

17. paint walls, skirtings, timber partition, doors & windows joinery and ceilings to paint schedule.
18. repair window frames, fill in gaps, re-putty as required south & east walls (including under verandah).
19. original timber ceiling - remove fans, lighting tracks & electrical fixtures. plug holes in ceiling + paint finish.
20. check & replace smoke alarms.
21. remove existing electrical fixtures and fittings all areas.
22. new blinds to external windows (not including west facing George St).
23. reline external weatherboards to match existing. pant finish tba.
24. exit 2: reframe doorway as required, infill gaps, & install new outward opening door to schedule.
25. exit 3: reframe doorway as required, install new fanlight glazing & new outward opening door to schedule. replace architrave to match existing.
26. permeable utilities enclosures, details tba.

27. demolish infill timber frame wall & cladding, remove panels & shelving blocking exit 3 door.
28. remove ramp and railing

Fig 4: Peppin Heritage Centre (former Public School) – Plan showing Museum Scope of Works as numbered

The removal of the weatherboard wall on the verandah is identified as a later infill and not part of the original heritage fabric. Its removal is unlikely to have any negative heritage impact and may, in fact, restore original spatial relationships. The removal of this wall is to activate an old door that is now to become an exit from the building.

The removal of the internal sliding door, track and hardware at the old 'classroom' is required to allow for placement and circulation of museum displays. This is to be placed in storage on the site for future reinstatement.

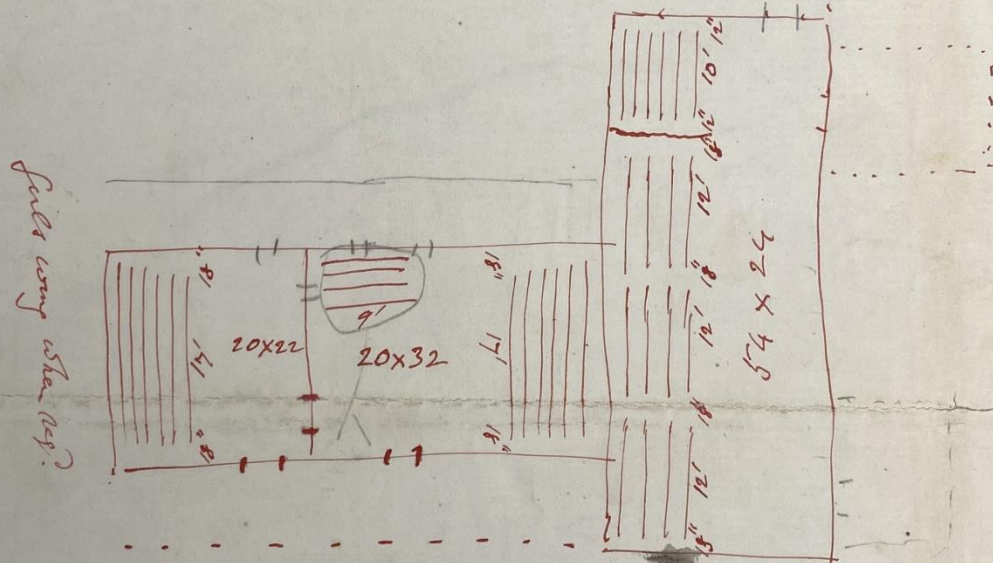
1877 School Plan (Detail)

I would recommend the Council to erect new buildings, & to employ Mr Jones as Architect. Start with two departments, but make provision for adding a full school when necessary.

Ground plan somewhat as under:—

Class room about 15×17 at end on side of Primary school.

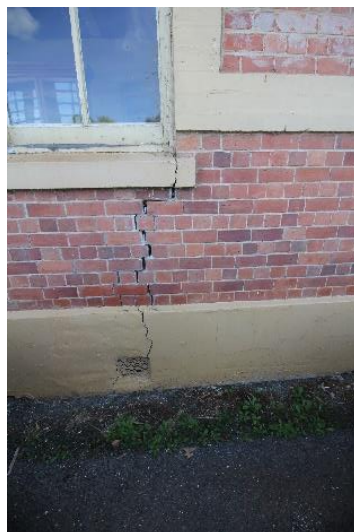
8: Cracking at brickwork – south façade

In 2021 \$450k worth of repair and refurbishment works planned for September were proposed. These will see sections of the centre closed temporarily, including the art gallery. Cracking in walls and foundations, along with weathering to the roof and ram shed, promoted the need for works. Information Centre services will be temporarily moved to Council's Project HQ building in Napier Street, while Peppin Centre works proceed. External work includes repairs and replacement of the slate roof and guttering, renewal and replacement of the verandah, painting timber work, replacing verandah substructure, posts, decking, roof structure, corrugated roofing and guttering, repairs to external walls (mortar and brick cracking, structural roof repairs, repainting existing finishes, and replacing the ram's shed's thatch roof. Internally there will be painting and updates to the ceiling, internal trims and frames in the visitors' centre, gallery and office. Repairs to mortar/brickwork of the wall between gallery and the old classroom, and some additions to the info centre office. A master plan prepared by consultant Sivonne Binks are in the wings, aiming to modernise the centre. These are yet to be formalised and made available for public consultation (Deniliquin Pastoral Times, 15/10/2021).

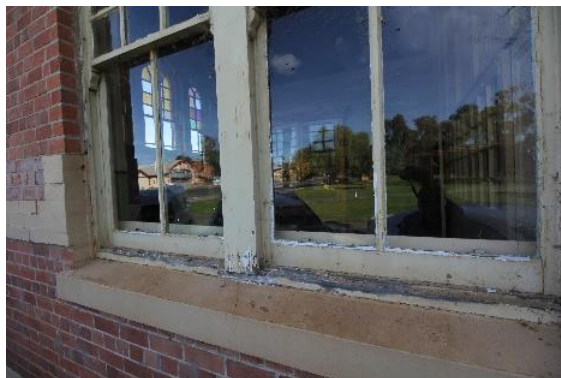
10: Window sills – showing deteriorated paint finish

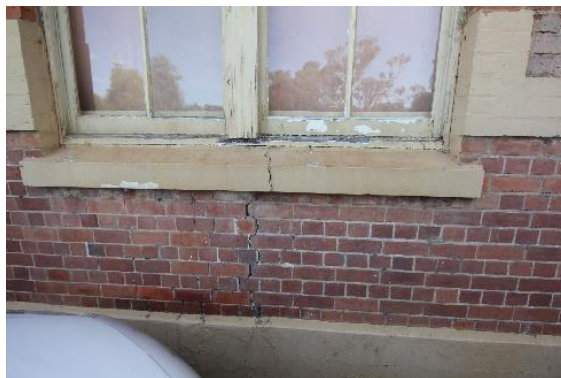
12: Window sills – showing deteriorated paint finish
