192 FERGUSON STREET, GLENN INNES

Statement of Environmental Effects

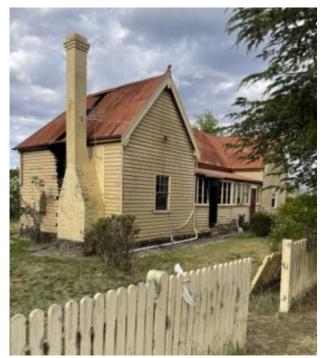
Picture 1 South-west facing cottage

The dual occupancy building has a U-shaped building layout plan with pitched roofs with twin gables at the front and hips at the rear, an enclosed verandah at the front, and a series of small annex rooms at the rear. There is also a timber picket fence which perimeters the site to the east and south, facing Ferguson Street/Gwydir Highway and Lambeth Street. The fence is decaying with the one side of double gate on Gwydir Highway frontage damaged and off its hinges.

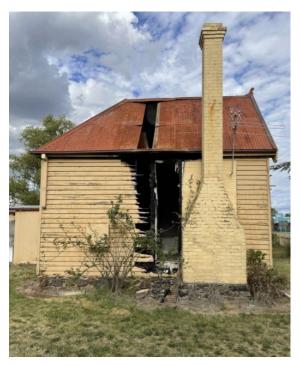
Picture 2 West facing cottage

The western residence is badly fire damaged, with all internal floor, wall and ceiling finishes as well as door and window framing charred or smoke damaged, several parts of the ceiling have collapsed and some studs, rafters and roof battens are either damaged or completely burned away. Some exterior weatherboard and roofing is also heavily damaged and completely collapsed in some areas. There is also some minor collapse of the perimeter sub-floor walls under the walls and fireplaces. Additionally, some weatherboards, timber trims, floorboards and floor framing across the existing building have been subject to decay and charring. The interior of the west-side of the building is significantly fire damaged and while the interior of the east-side of the building (other side of the partition wall) isn't subject to the same extent of fire damage, it is currently in a state of decay.

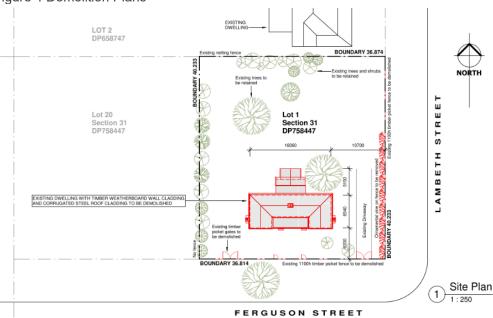
Picture 9 Demolition Site Plan

- Demolition of existing main cottage building.
- Demolition of existing timber picket fence/gates (including removal of ornamental vine growing on east facing timber fence).
