Darlington Point Quarry

Resource Assessment

Prepared for: Mawsons Concrete & Quarries

Date: December 2024

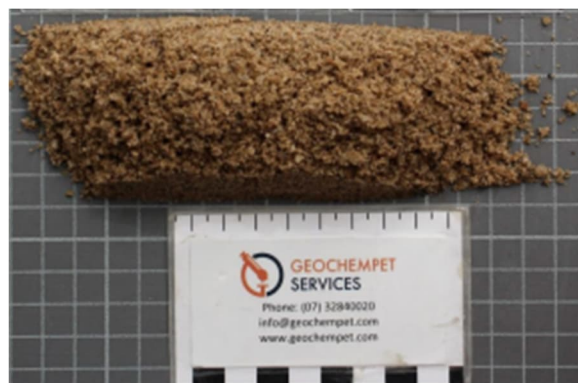
Plate 3: A damp subsample of sand (Geochempet)

A sand sample from Darlington Point (M23-1019A) was submitted by E B Mawsons and Sons Pty Ltd for petrographic analysis, conducted by Geochempet Services. The analysis was performed to assess the sample's suitability for use in concrete and asphalt. The sample was a medium to coarse quartzofeldspathic and lithic sand and was found to consist primarily of quartz and feldspar grains alongside various lithic clasts. The grains were subangular to sub-rounded, and a crude dry sieving test revealed that the majority of the sample comprised medium-sized particles (67.1%), with a smaller proportion of coarse (25.5%) and fine (6.5%) material. Minor amounts of silt and clay were detected. Microscopically, quartz was the dominant mineral, accounting for 69% of the sample, with various degrees of strain observed in the grains. The Petrographic Inspection Report can be found in Attachment 1.

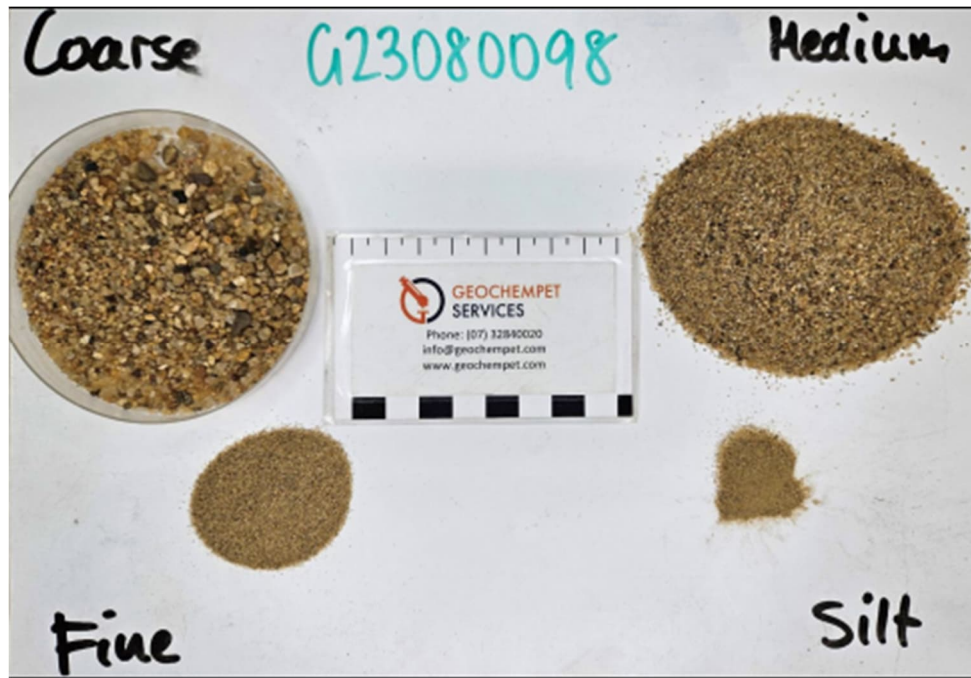
Plate 5: Seive fractions as recorded above (Geochempet)

A crude, dry sieving test of the petrographic sample provides an indication of sand particle size distribution. This is by no way a true and representative sample of the resource. A summary of the grading is presented in the Table 1. And shown in Error! Reference source not found..

Sand Sample	Wt % of sample
Coarse (>1.18 mm)	25.5 %
Medium (>0.3 to <1.18 mm)	67.1 %
Fine (>0.075 to <0.3 mm)	6.5 %
Silt (<0.075 mm)	0.9 %

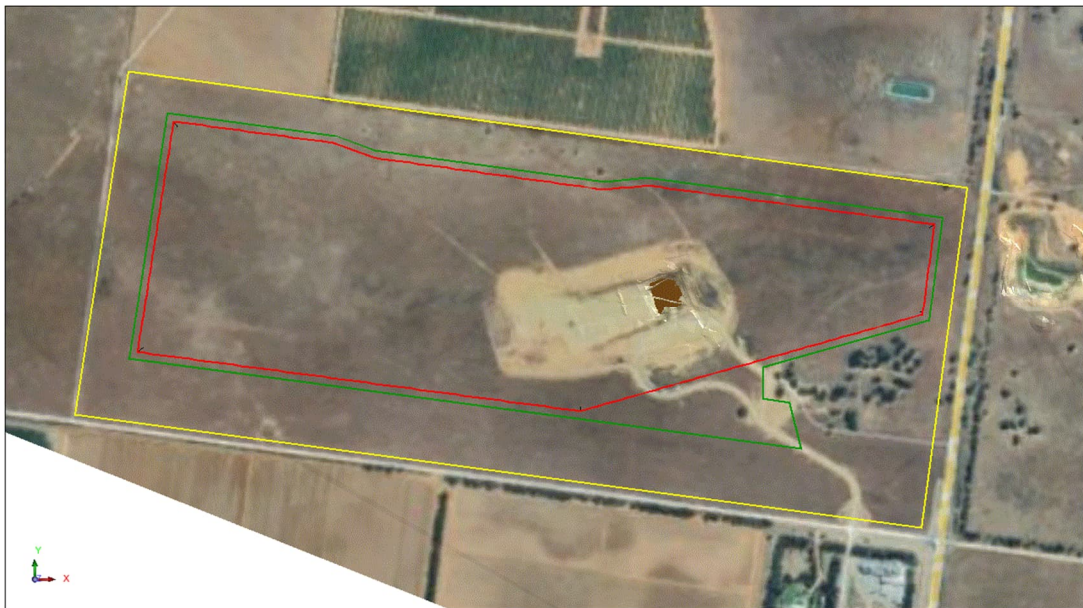
Plate 5: Pit Crests (plan view)

A conceptual pit design was created using the following criteria:

- Single bench of 10m
- Batter slope of 1V in 3H

The current and proposed depth of extraction is approximately 10 meters below the surrounding topography. The surrounding topography is approximately 124m AHD and the proposed pit floor is approximately 114m AHD.

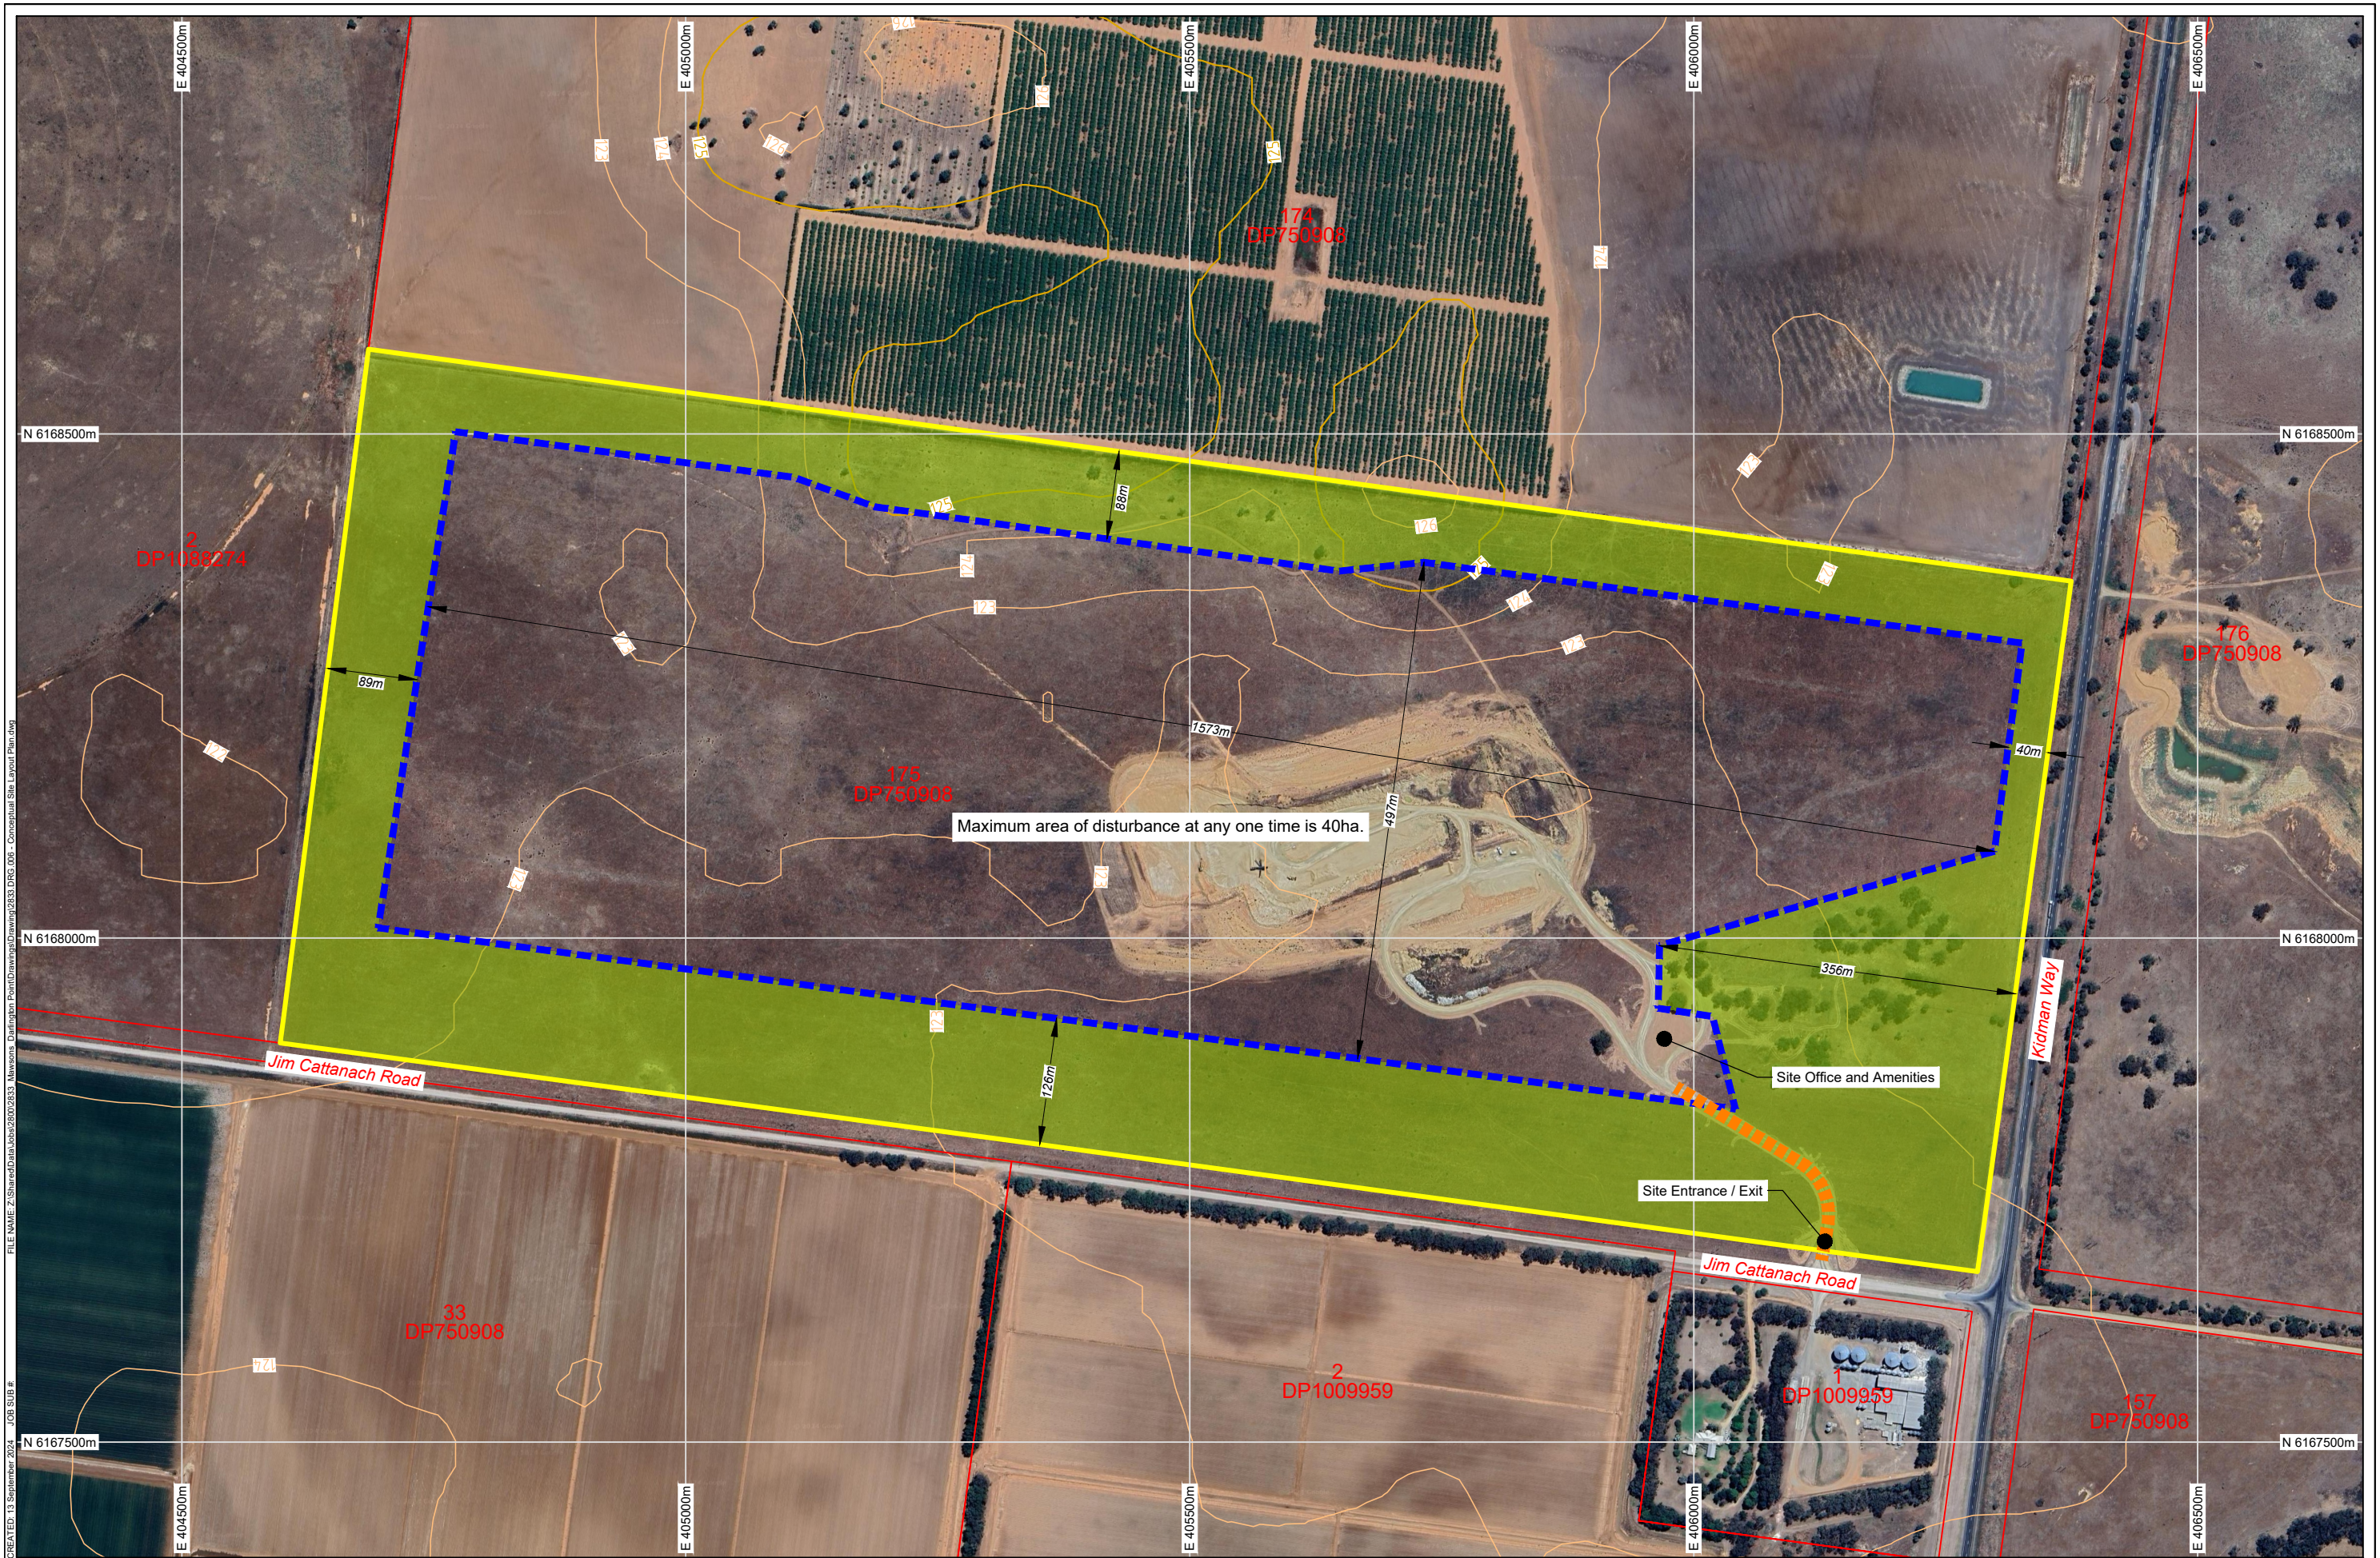
DRAWING NUMBER: 2833.DRG.005

- Site Boundary (Area = 117.88 ha)
- Cadastral Boundary
- Access Road
- Proposed Quarry Footprint (Area = 70.95 ha)
- Buffer (Area = 46.94 ha)

- Proposed Extraction Depth of 114m AHD
- Maximum area of disturbance at any one time is 40ha

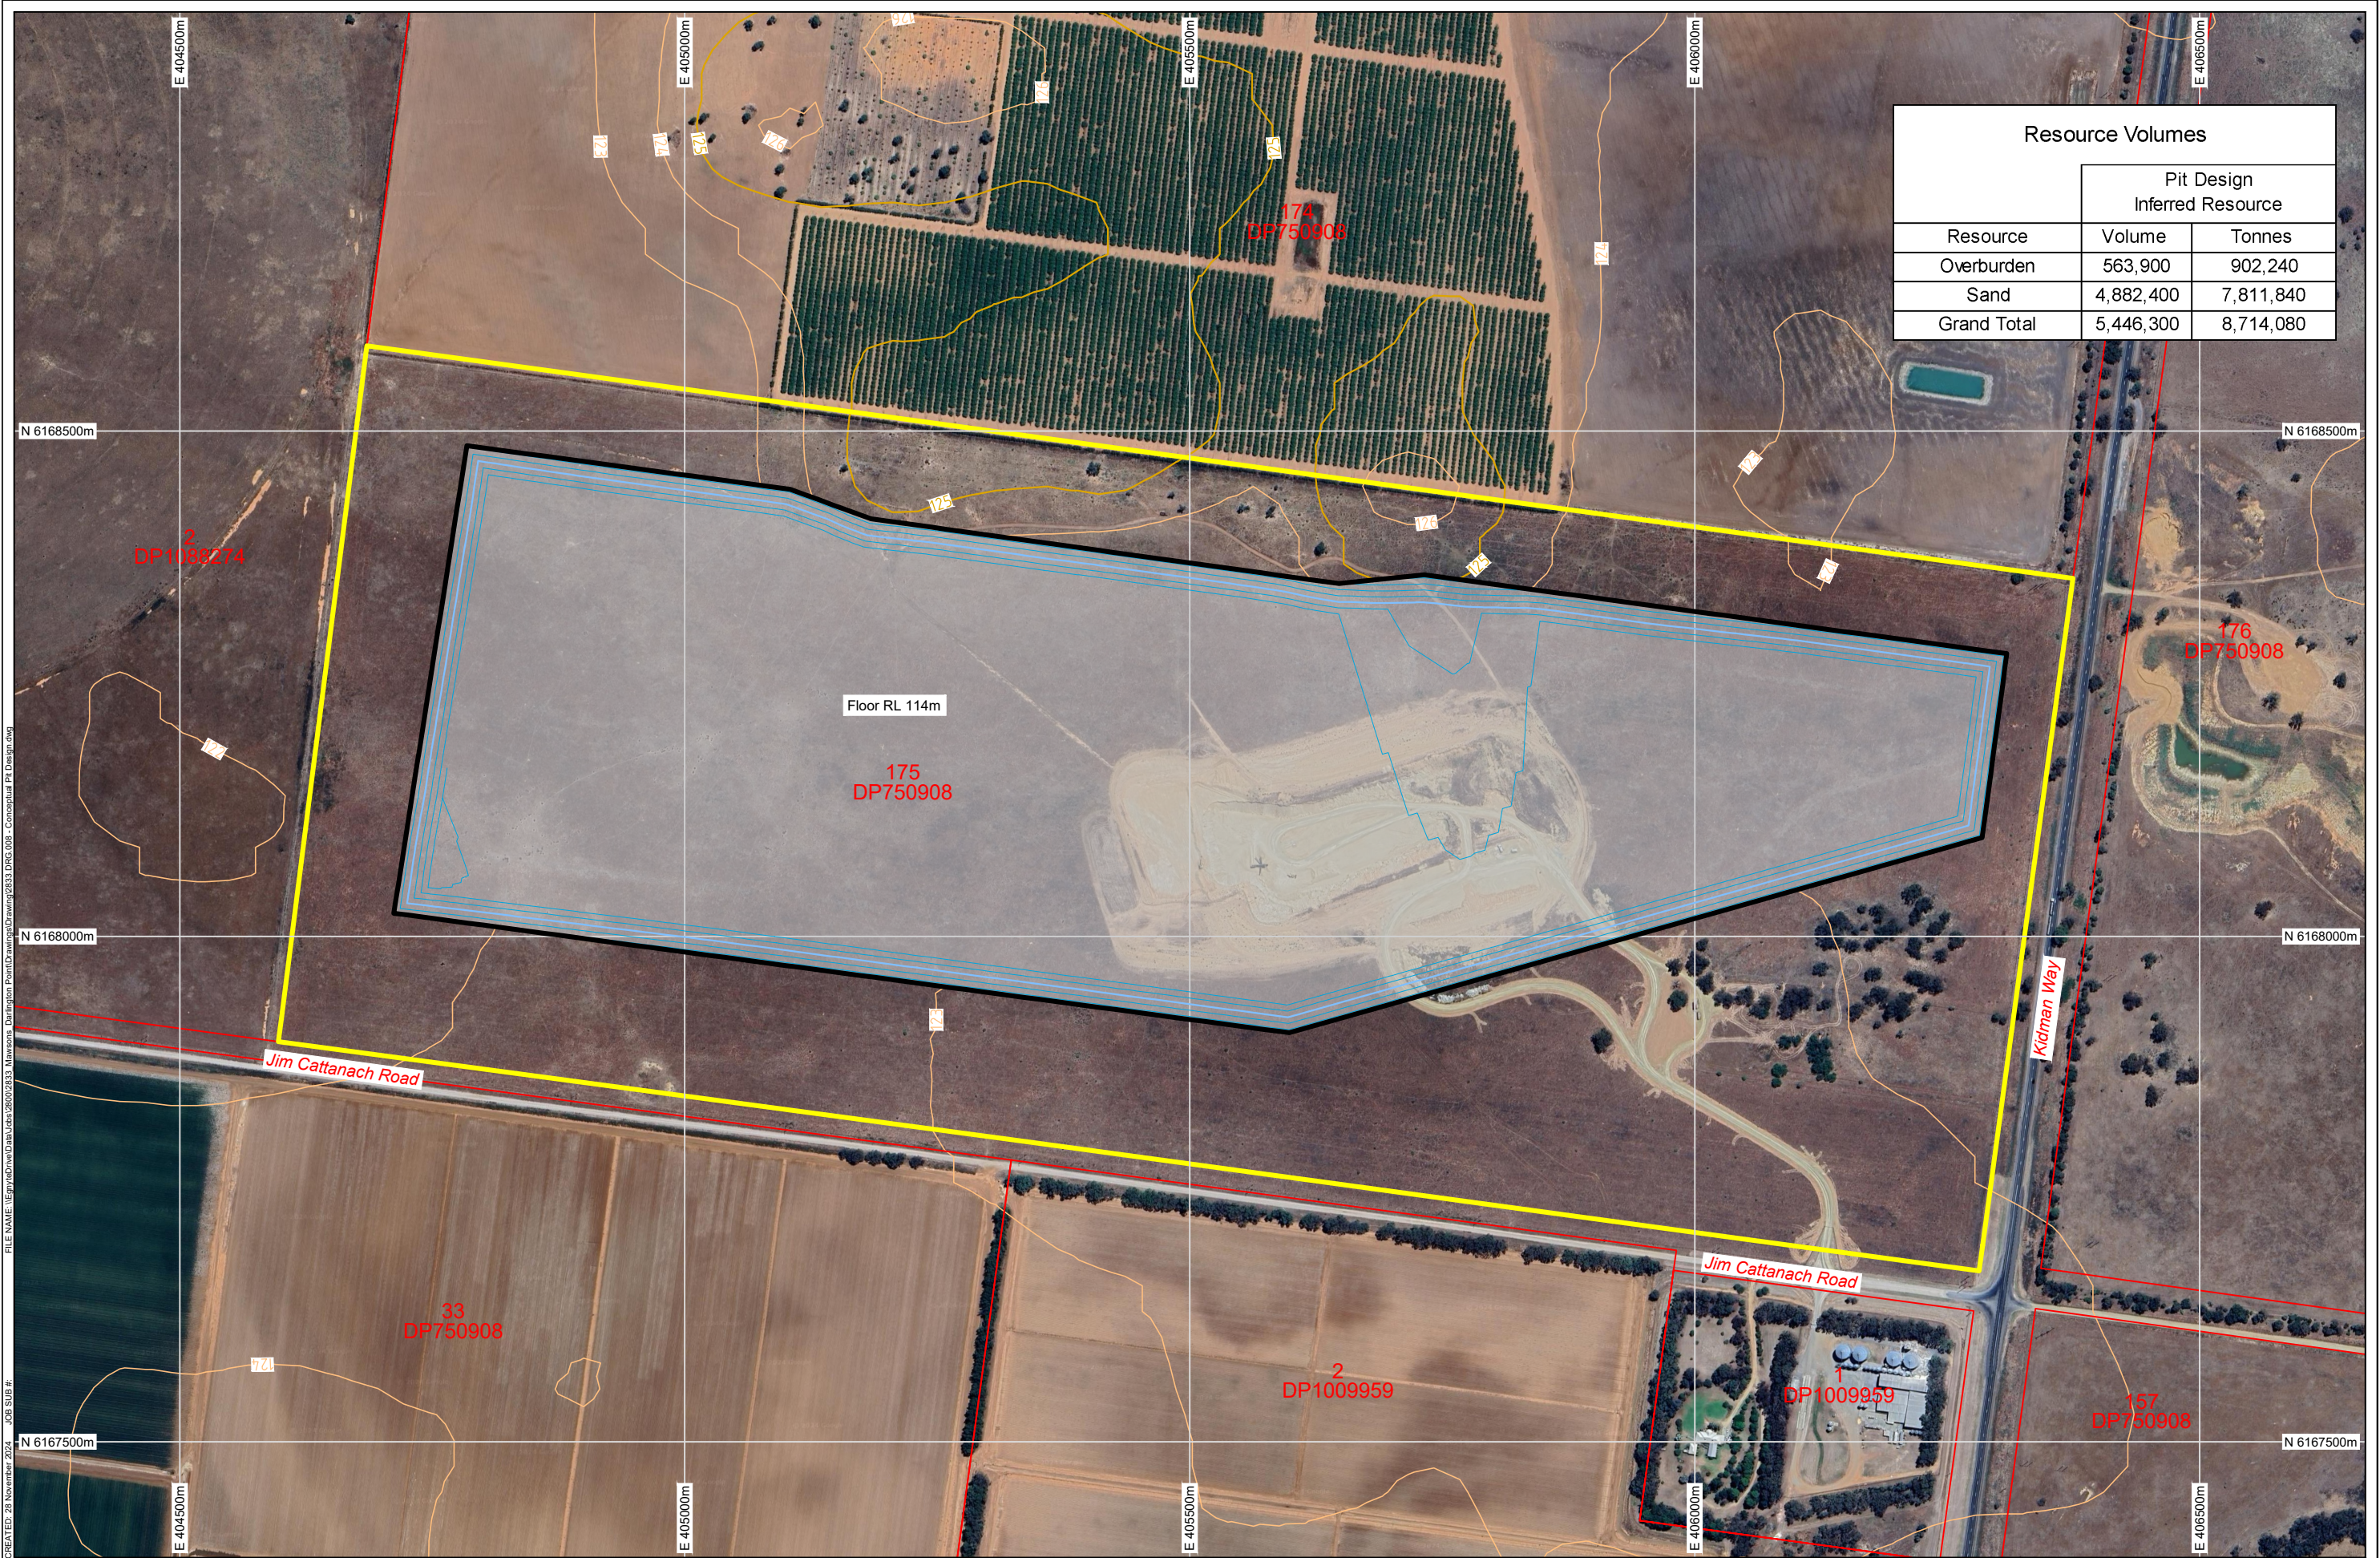
DRAWING NUMBER: 2833.DRG.008
	DATE: 29 November 2024	DRAWN: GL	DATUM: HORIZONTAL / VERTICAL / ZONE
	PRINTED: 29 November 2024	CHECKED: TH	GDA94 / MGA / AHD / 55
REVISION:

Resource Volumes		
Resource	Pit Design Inferred Resource	
	Volume	Tonnes
Overburden	563,900	902,240
Sand	4,882,400	7,811,840
Grand Total	5,446,300	8,714,080

Proposed Quarry Footprint	
Material	Volume (m ³)	Tonnes ¹ (t)
Overburden	564,000	902,000
Sand	4,882,000	7,812,000
Total	5,446,000	8,714,000

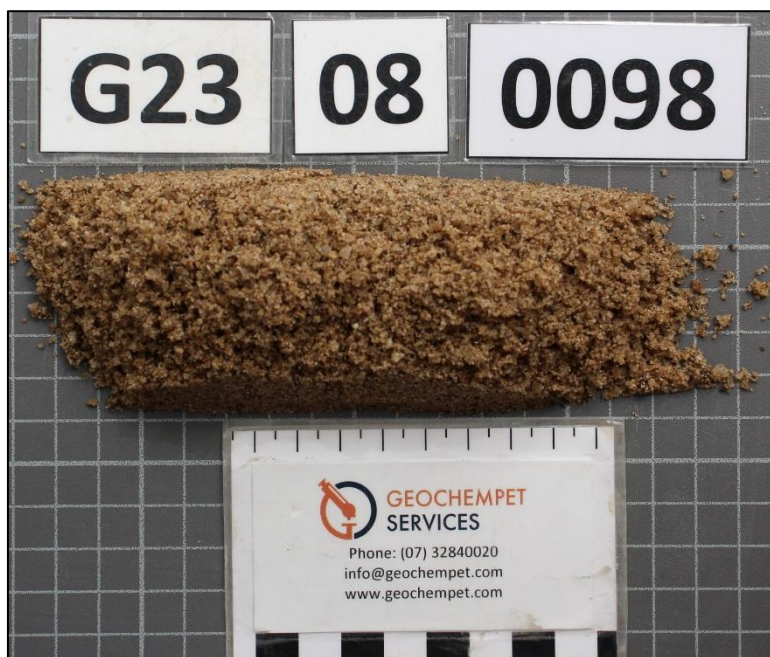
Figure 1: A damp subsample of the supplied sample.

<u>Identification</u>	Medium to coarse quartzofeldspathic and lithic sand		
<u>Description</u>	The sample consisted of moderate yellowish-brown sand composed primarily of quartz and feldspar grains and lithic clasts. Grains are dominantly sub-angular to sub-rounded.

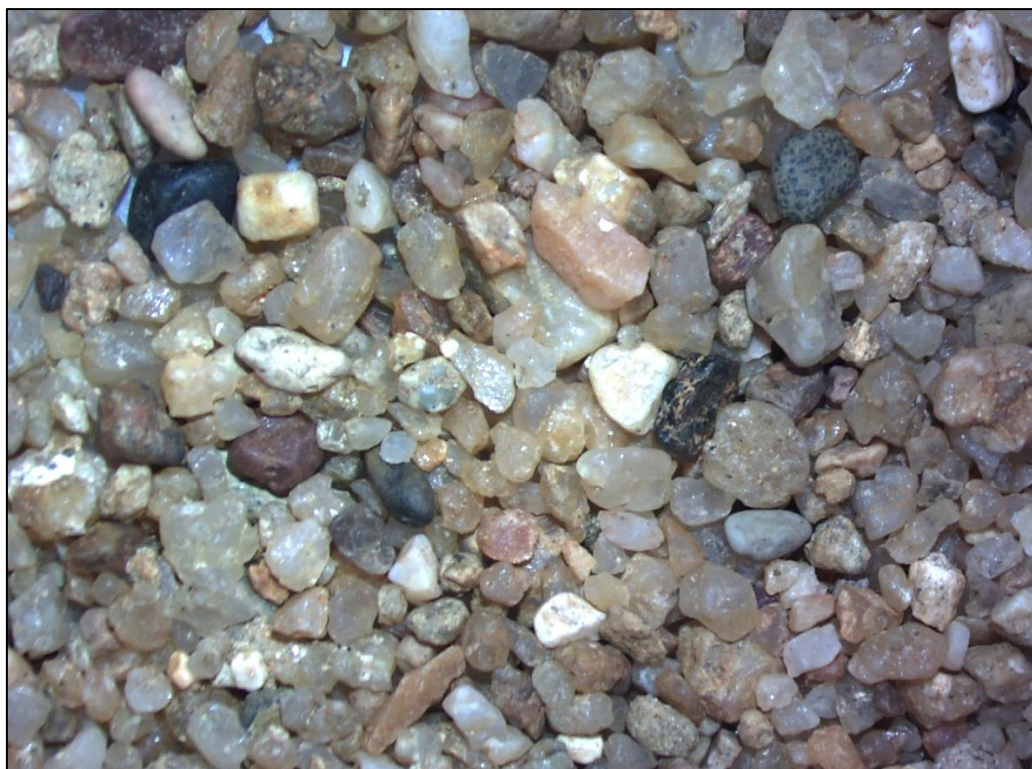
Figure 3: Coarse fraction as recorded above, composed mainly of quartz and lithic clasts.

The coarse fraction consists of mainly rounded to sub-rounded quartz and feldspar fragments, with some lithic clasts, averaging 1–2 mm.
