## **Appendix D – Preliminary Site Investigation**

348 Meadows Lane, Warral NSW 2340

### Preliminary Contaminated Site Investigation

| <b>Report Number</b> | 24-438 PSI |

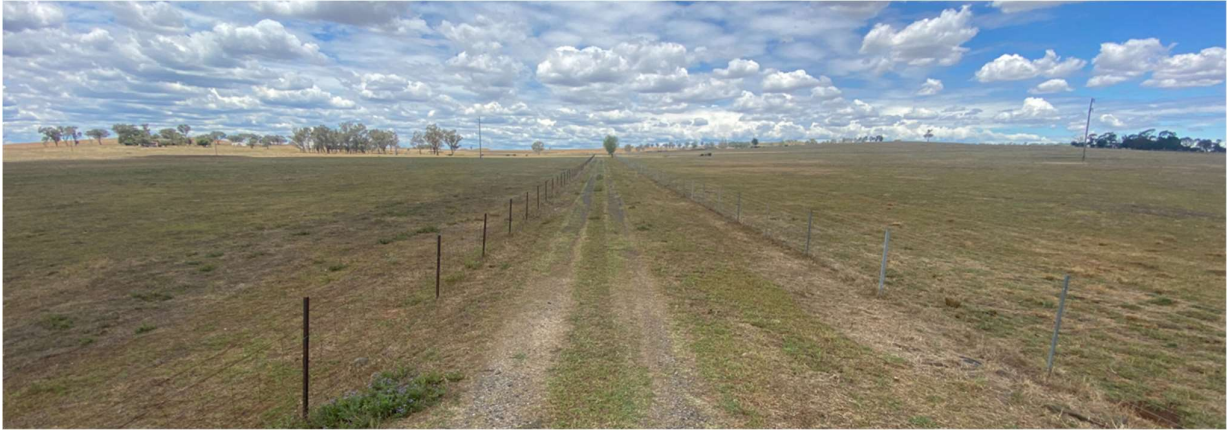
**Figure 2: View from western boundary (Gowrie Rd) – looking east.**

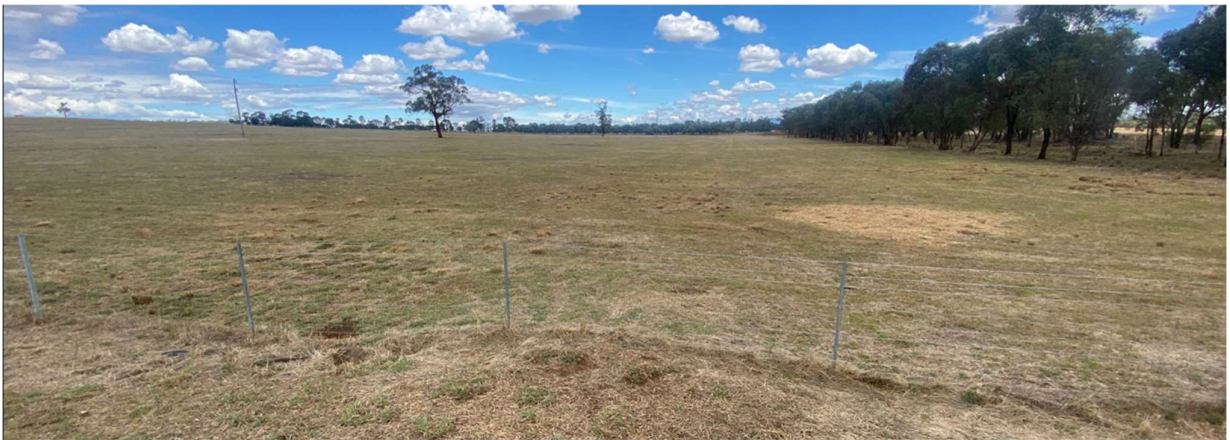
**Figure 3: View from western boundary (Gowrie Rd) – looking south**

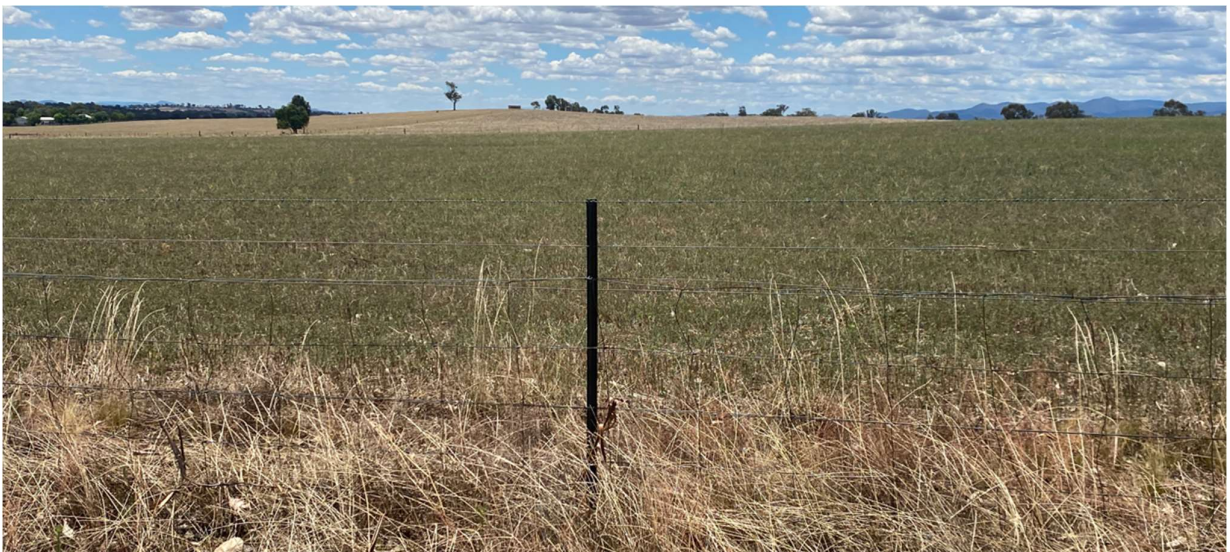
**Figure 4: View from Southern boundary (Meadows Lane) – looking north**

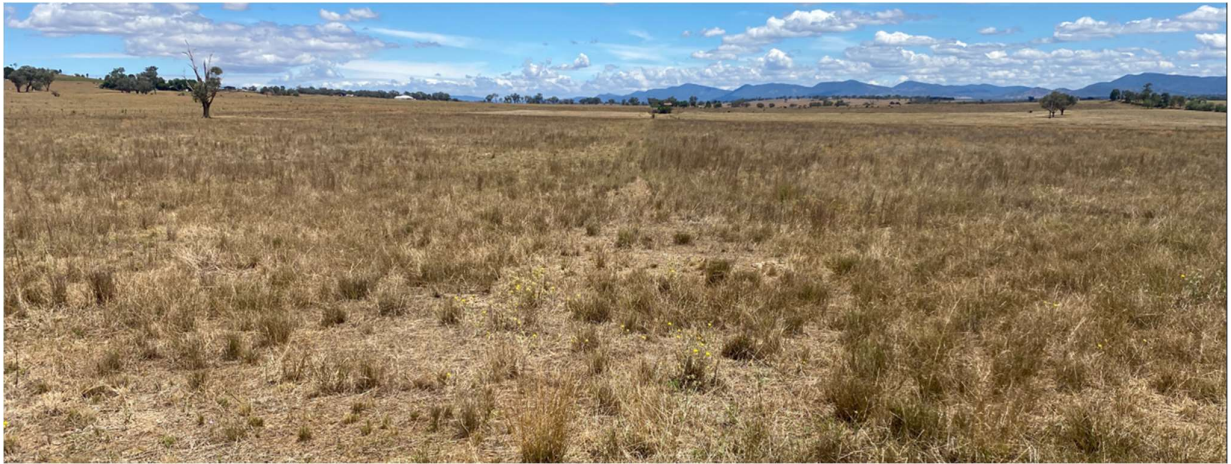
**Figure 5: View from northern boundary (Spains Lane) – looking south**

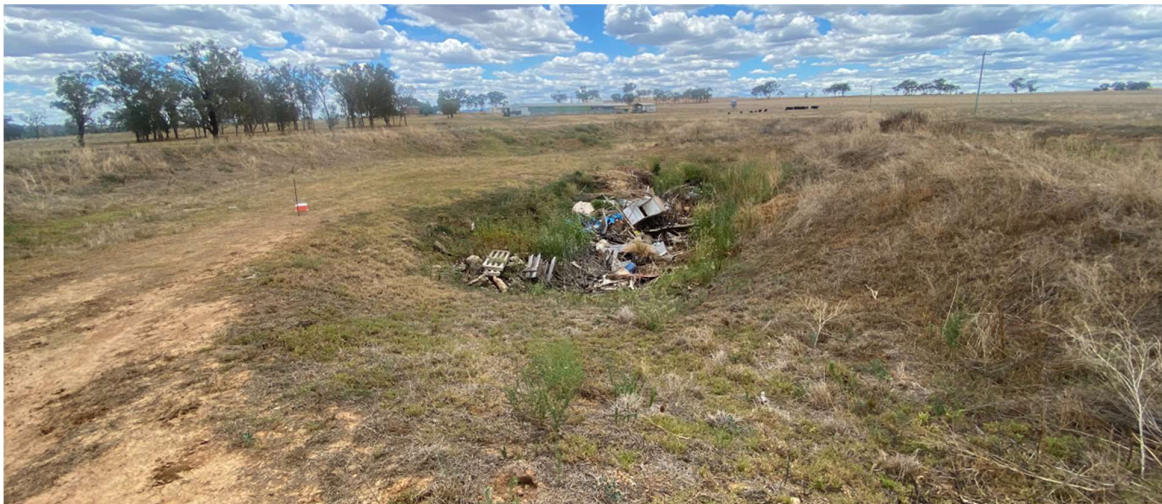
**Figure 6: General household hard waste dump in old piggery effluent pond**

One of the piggery effluent ponds has been used as a stockpile site for domestic hard waste. The pond was dry and no potential sources of chemical contamination were observed in this pile (Figure 6). No stockpiles of soil or waste material from other locations were identified on the site.

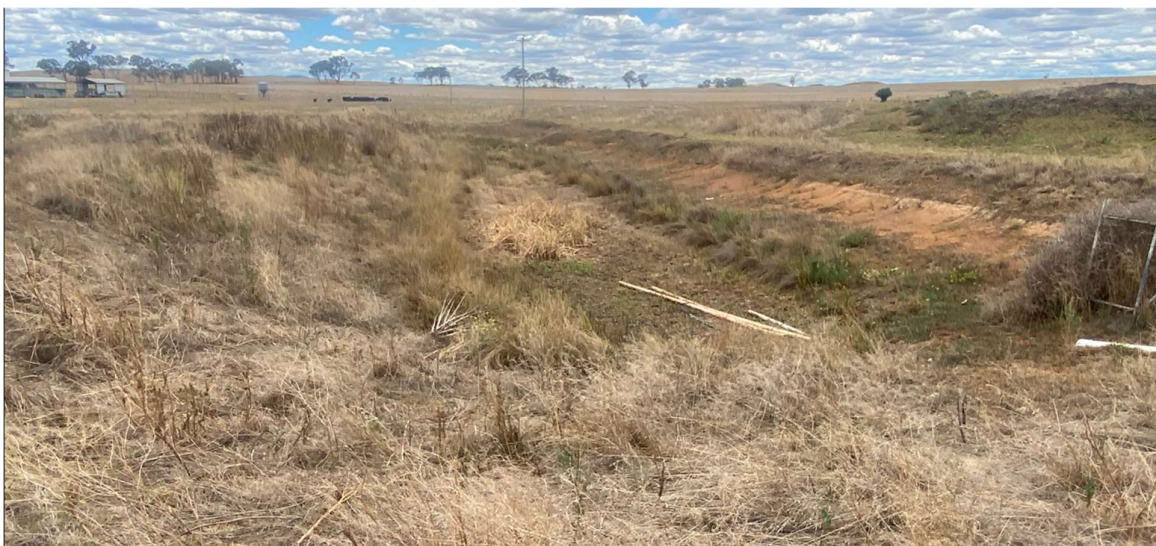
Two of the remaining piggery effluent ponds are internally draining and do not generally receive external storm water runoff. The remaining most upstream pond receives external stormwater runoff from time to time from a relatively small catchment.

**Figure 7: Remnant Effluent Ponds**

While no contamination is evident around the remnants of the old piggery effluent ponds, the current landform and associated drainage may not be a desirable feature for the proposed future subdivided lot. Earthworks to return the overall surface contour to enable better land use options and an improved and stable drainage system may be desirable. The uppermost pond catches runoff from the old piggery site and effectively works as a normal farm dam. This could be retained as a useful feature upon a subdivided lot.

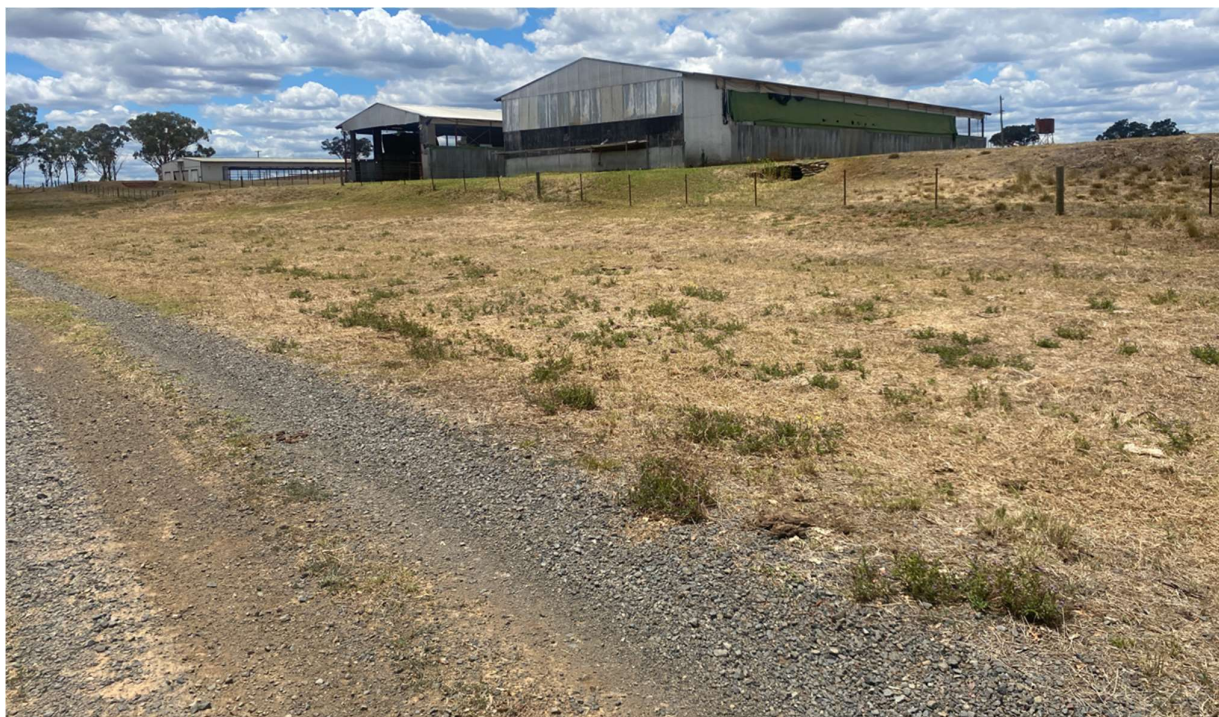
The area of the site downstream of the neighbouring decommissioned poultry sheds is well grassed and showed no surface evidence of contamination.

**Figure 8: Drainage line from neighbouring decommissioned poultry sheds into subject site – facing north east**

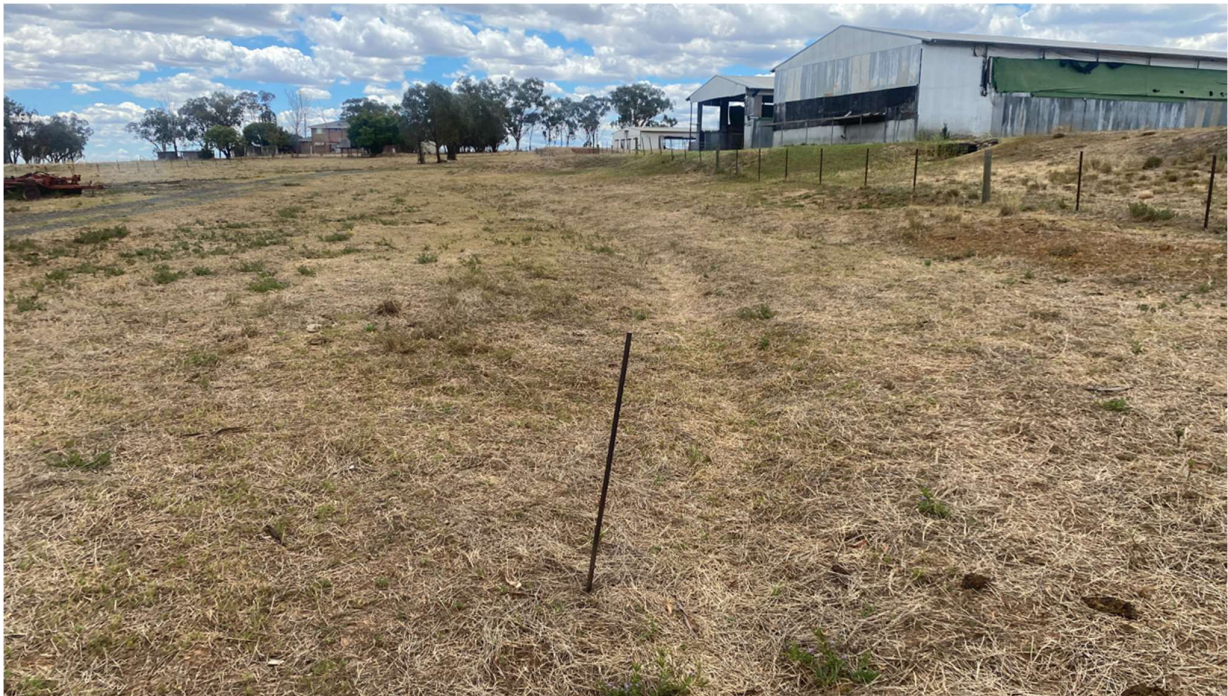
| SMK Sample Number | Sample Description | Description |
|---|---|---|
| 24-438-01 | Runoff line from adjacent poultry sheds:<br>0-300mm | Generally representative of potential runoff from adjacent land |

**Figure 10: Location of soil sample point 24-438-01 – facing north**

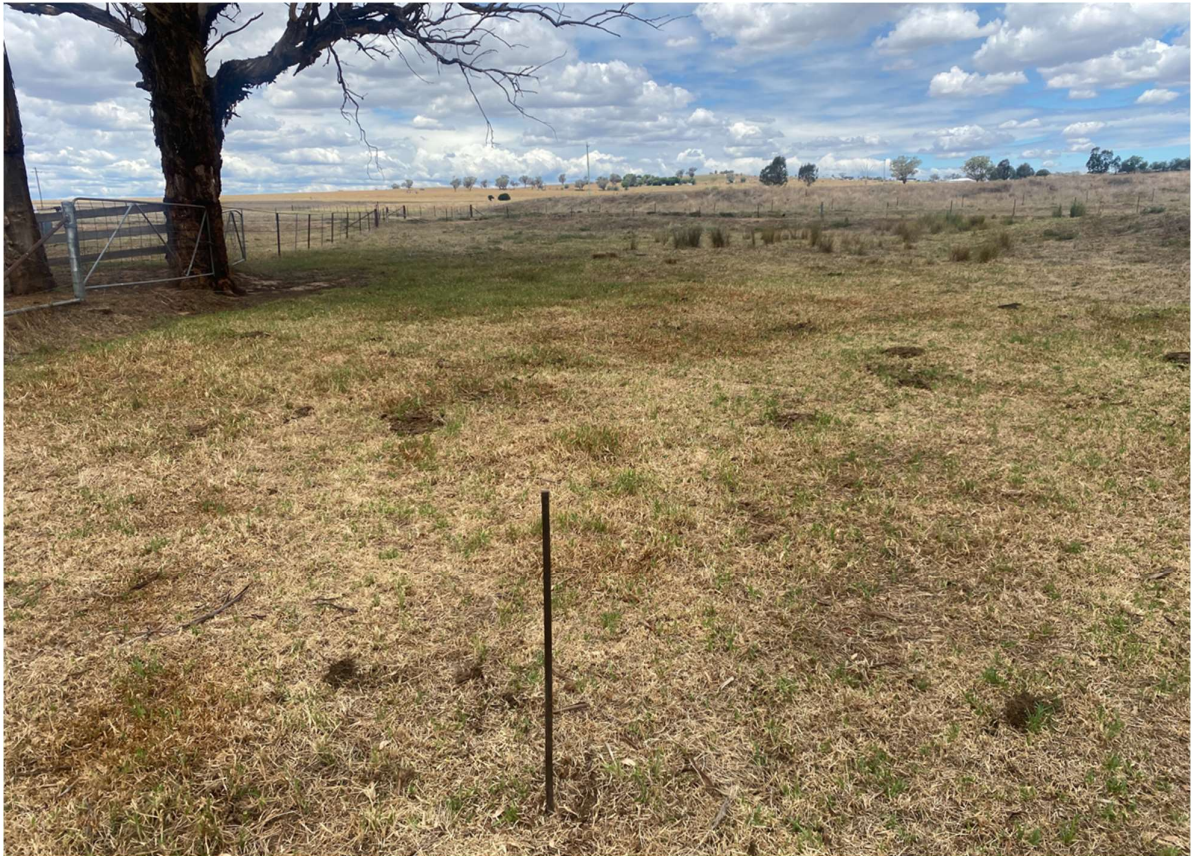
| SMK Sample Number | Sample Description | Description |
|---|---|---|
| 24-438-02 | overflow line from dam capturing runoff from poultry sheds and old piggery:<br>0-300mm | Generally representative of runoff from historic intensive farming areas |

**Figure 11: Location of soil sample point 24-438-02 – facing south east**
