CASTLEREAGH TOURISM DEVELOPMENT

*39-65 Old Castlereagh Road, Castlereagh NSW*

***ABORIGINAL ARCHAEOLOGICAL DUE DILIGENCE ASSESSMENT***

*Final | September 2024*

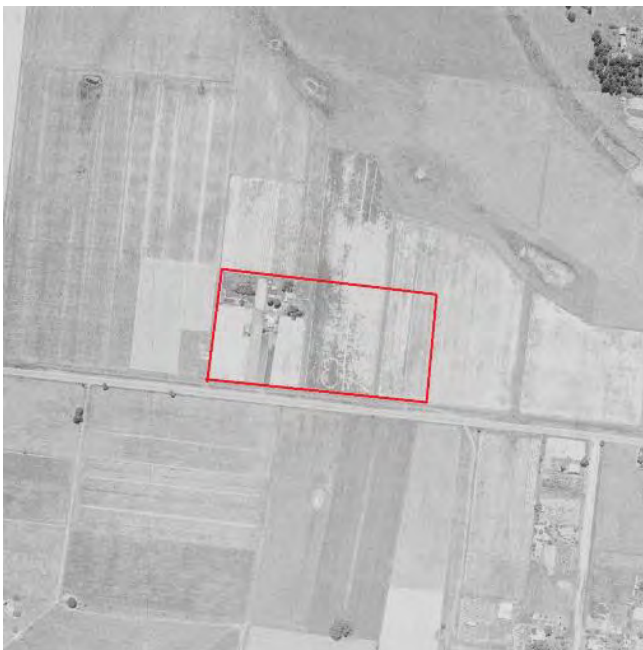
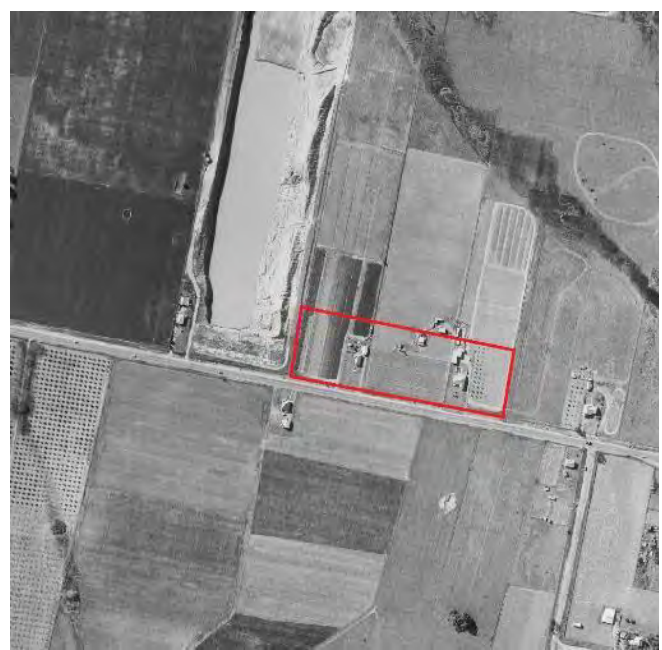
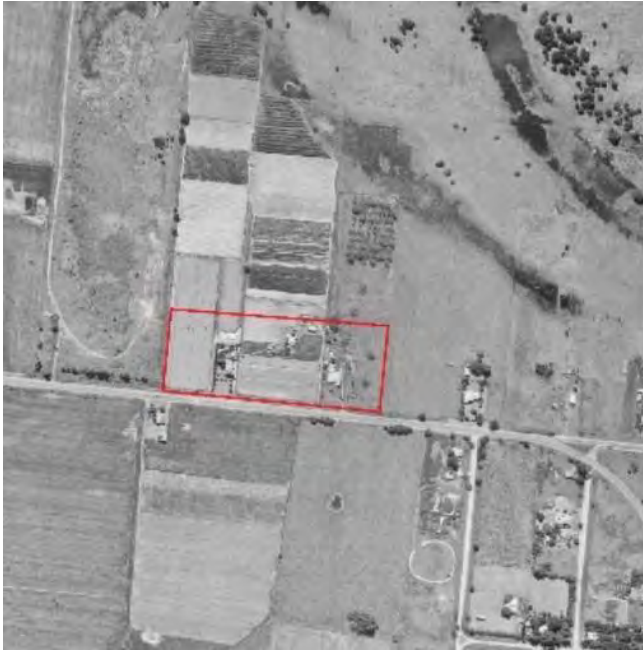
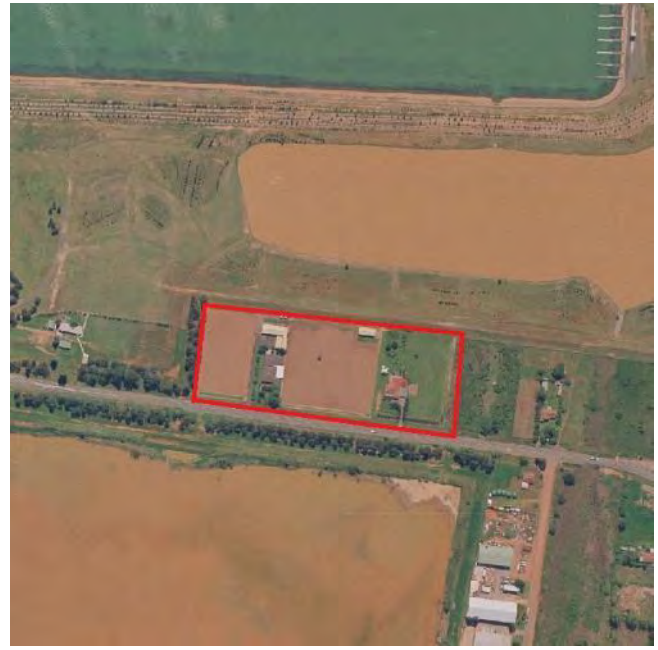
*Figure 2. Historical Aerial Images.*

*1955 Aerial Photograph.*

*1965 Aerial Photograph*

*1978 Aerial Photograph.*

*1998 Aerial Photograph.*

A drainage channel is evident northeast of the project area in the 1955–1978 aerial photographs that is removed by the construction of the Sydney International Regatta Centre in the 1990s (see **Figure 2**). This drainage channel is an unnamed tributary of Cranebrook Creek, as identified in a 1942 survey of Windsor (Royal Australian Survey Corps 1942, **Figure 3**).

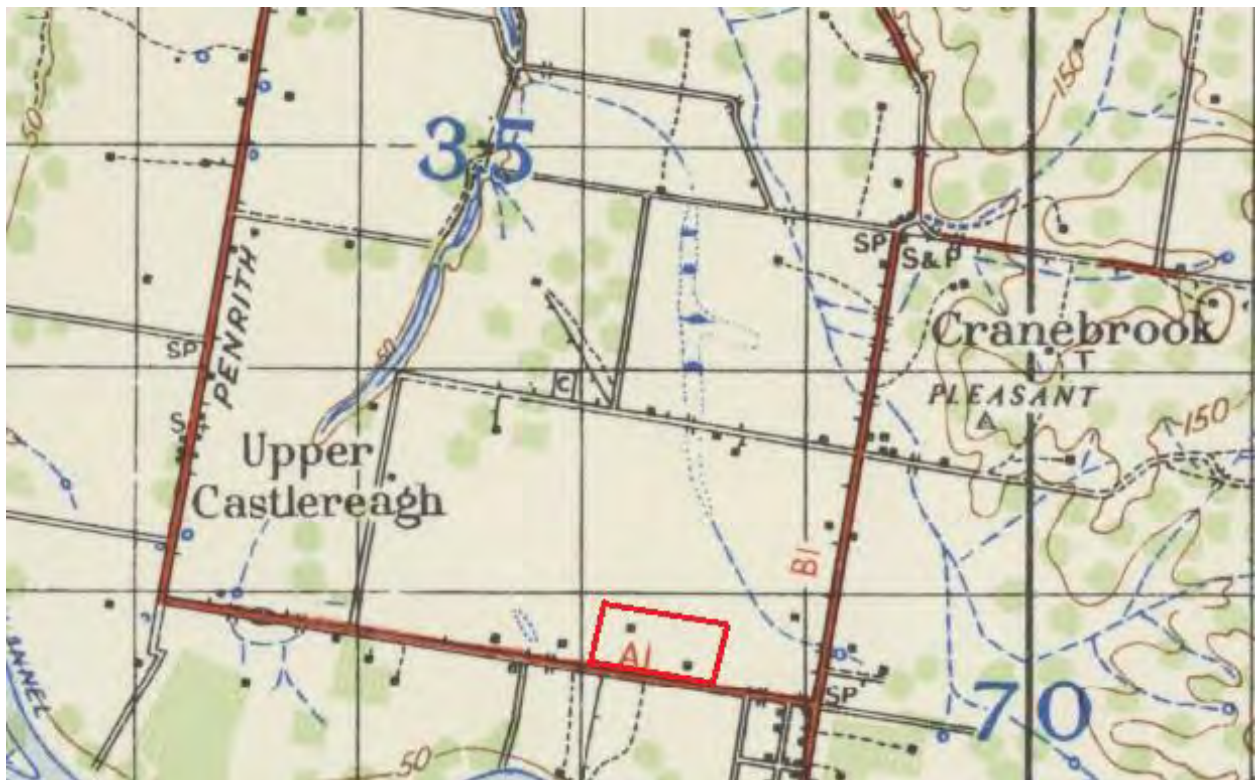
*Figure 3. 1942 Royal Australian Survey Corps topographic map of Windsor including the project area and unnamed creek*

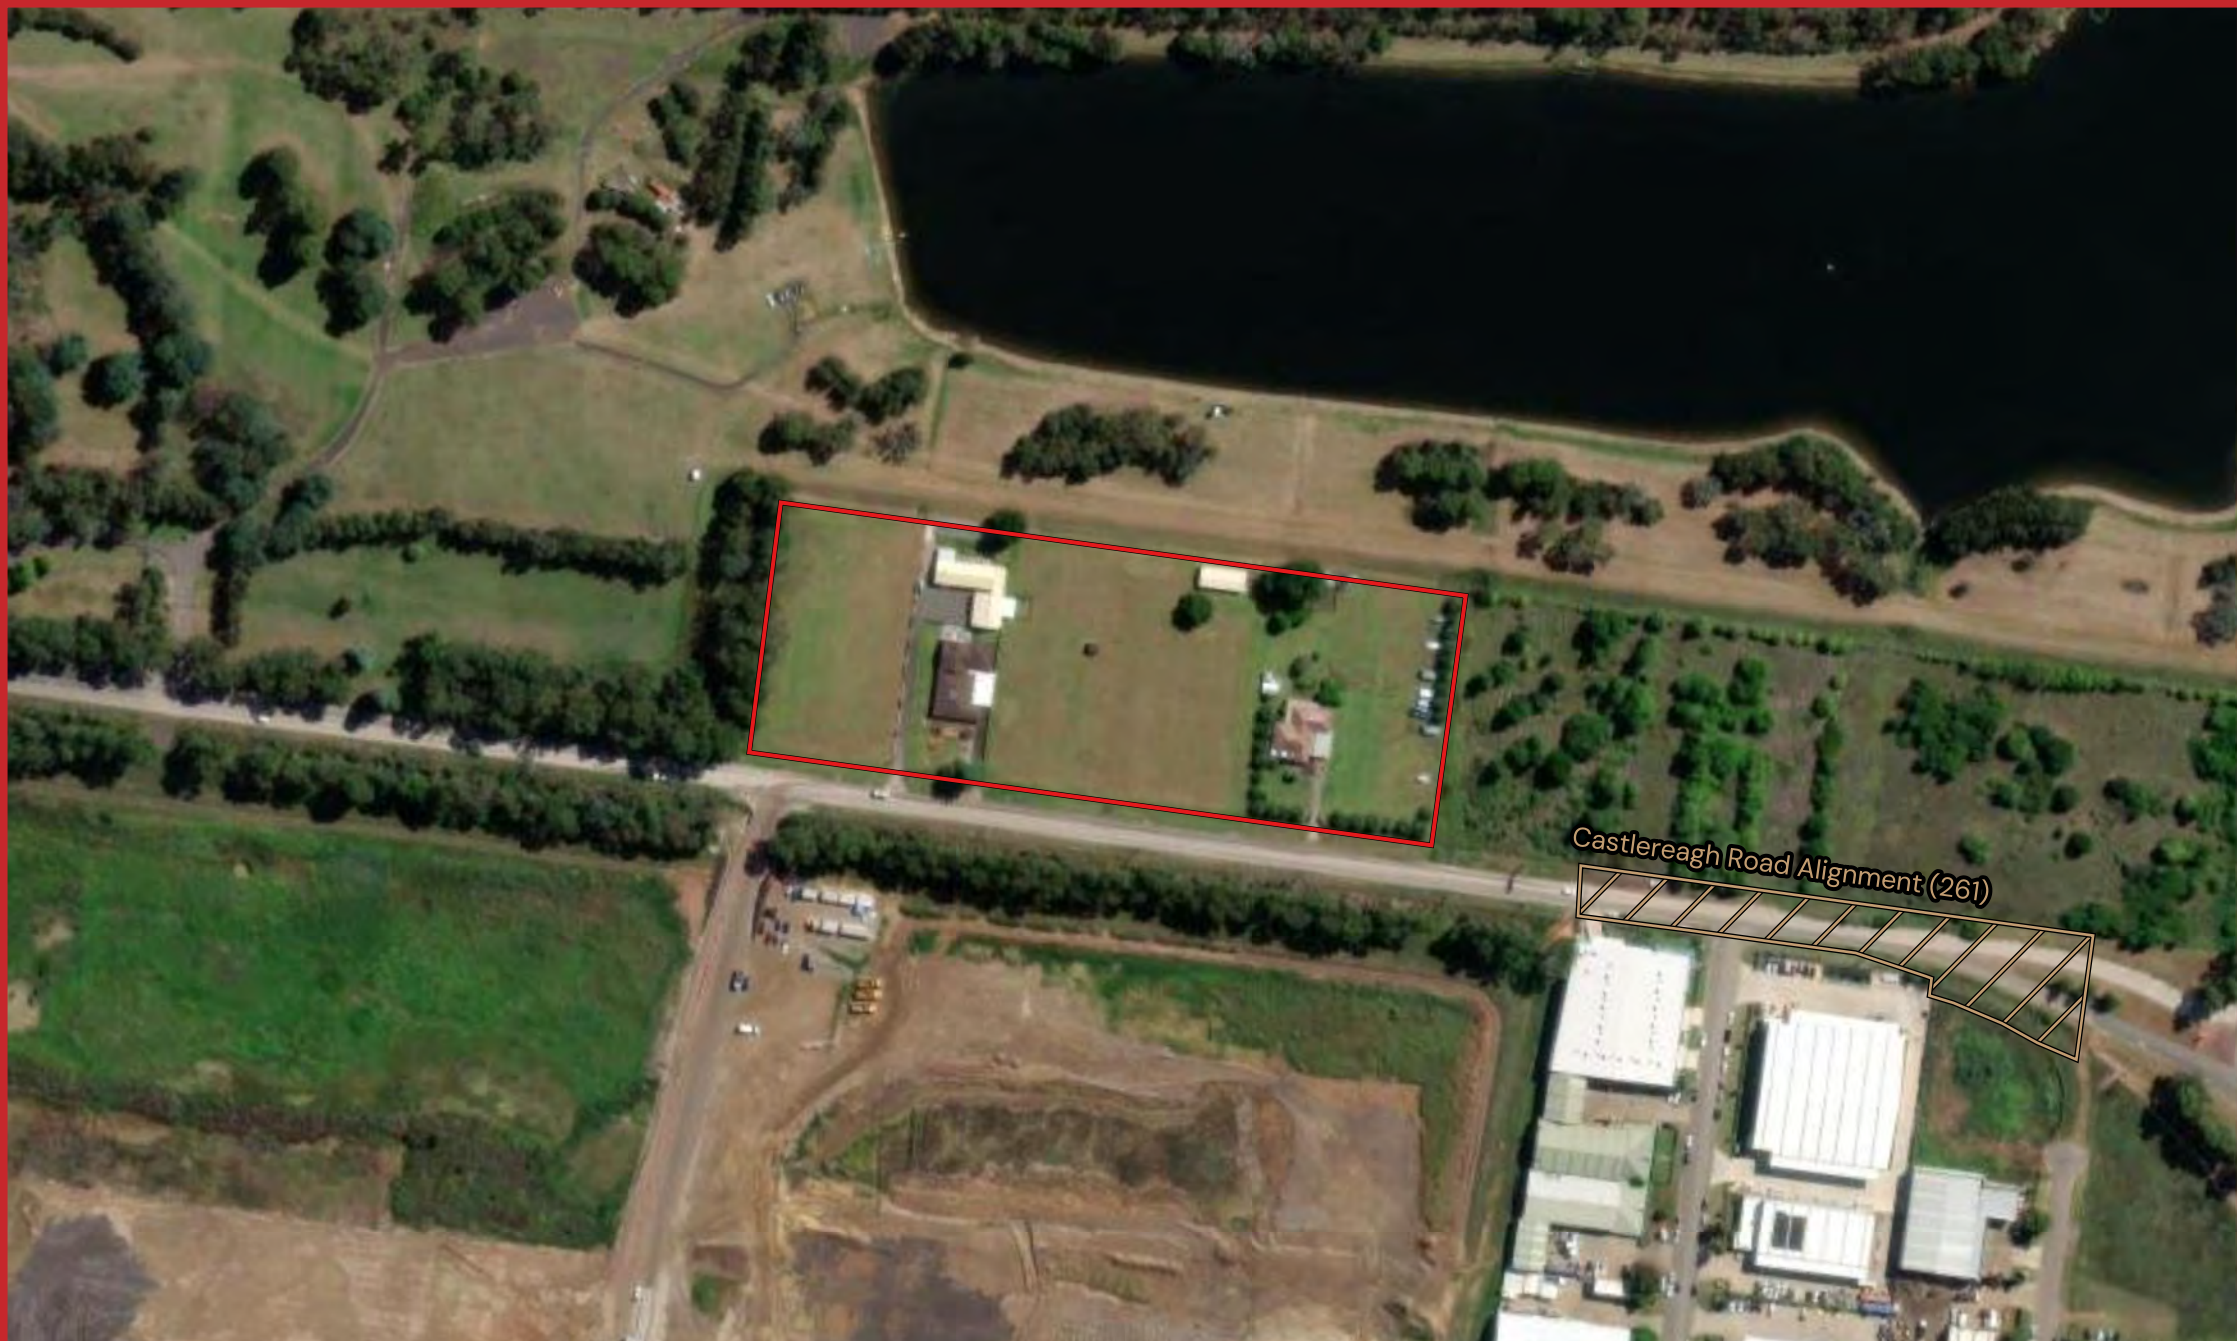
537 Morson Group – Penrith Lakes Due Diligence  
Castlereagh, NSW  
Figure Project Area and

- Only heritage item, #261 Castlereagh Road Alignment, borders the project area to the south, but is not within the project area. No other heritage items, conservation areas or archaeological sites are within the project area.

Heritage items in close proximity to the project area are displayed in **Figure 4**

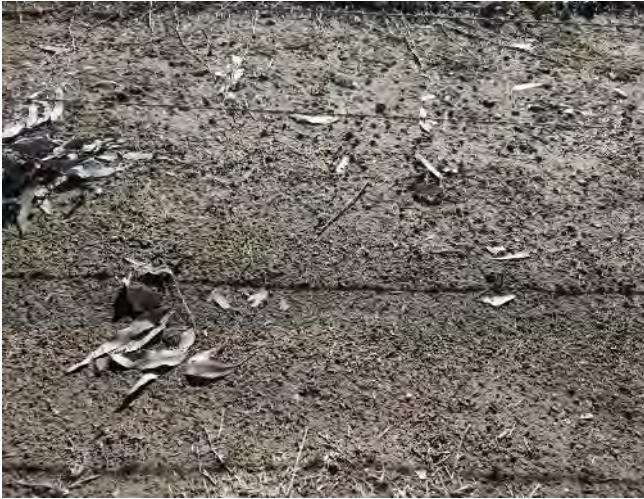
No Aboriginal objects or places were identified within the project area during the site inspection. Soil exposures found around the proximity of the project area confirmed the soils to be a yellowish-brown clayey sand (see **Figure 8**). Ground surface visibility in the project area was extremely limited (<1%) due to the high level of non-native grass (see **Figures 9–10**). All mature trees within the project area were identified as non-native species (see **Figure 9**). The inspection confirmed that the project area had undergone extensive ground disturbance associated with the construction of the existing houses, and landscaping works that had levelled the project area in association with previous site developments (see **Figures 10–13**). Further impacts were identified in water piping associated with a protruding irrigation tap on the western lawn, and a water tank identified in the middle lawn (see **Figures 12–13**). These impacts also suggest underlying piping is present within the project area and impacts associated with their construction have previously taken place.

*Figure 8. Soil exposure within the project area.*

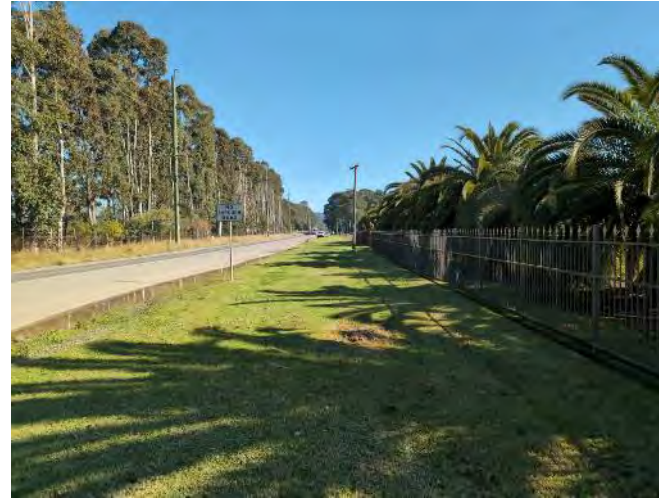
*Figure 9. Exotic trees within the project area (right) compared to native trees outside project area (left).*

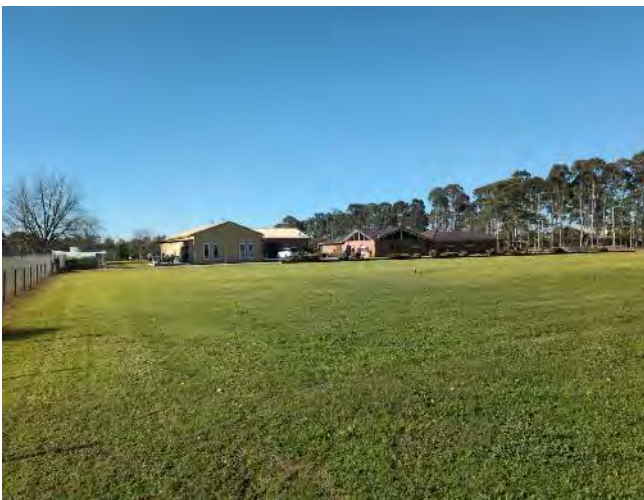
*Figure 10. Buildings present and levelled landscape from north-west corner of project area.*

During the site inspection Steve Randall commented that the project area had been extensively disturbed by previous activities evident during the site inspection. Steve also commented on sites being identified west, north and south of the project area, in association with sand lenses in close proximity to the Nepean River.

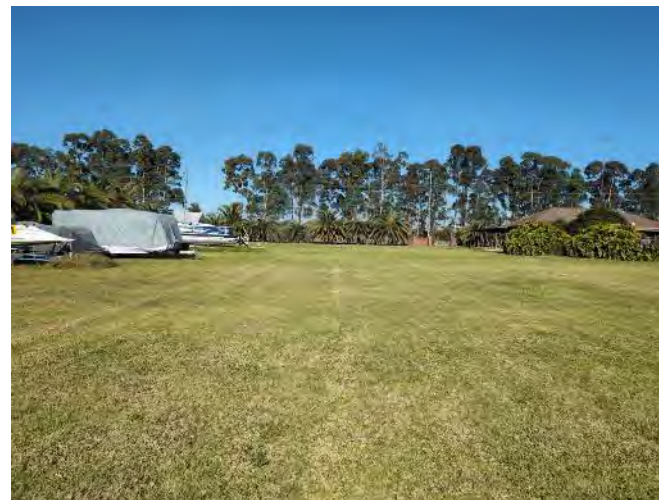
*Figure 11. Building present and levelled landscape from north-east corner of project area.*

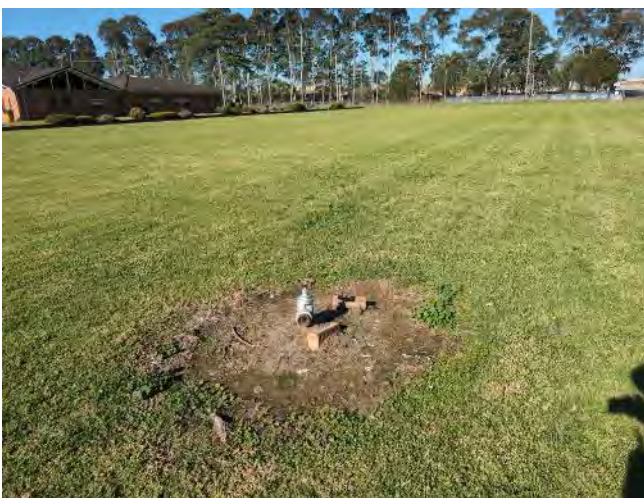
*Figure 12. Irrigation tap identified in western project area.*

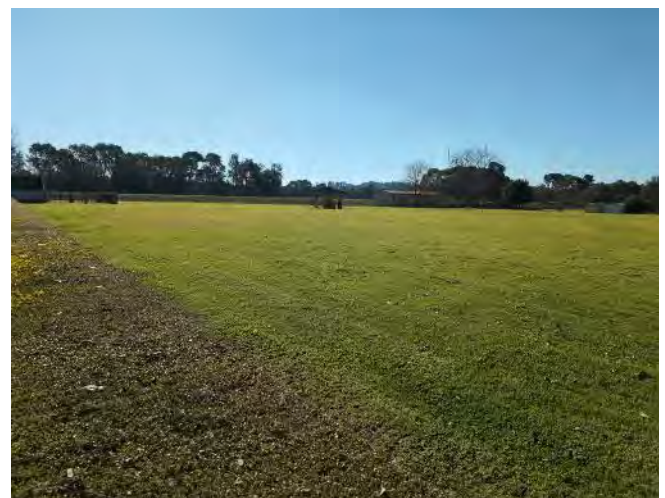
*Figure 13. View to roofed-water tank in central project area.*
