# **Geotechnical Investigation Report 39–65 Old Castlereagh Road, Castlereagh NSW**

**Prepared for: Jacob 4765 Investments Pty Ltd**

**Reference: P3023\_02Rev1**

**Date: 21 May 2025**

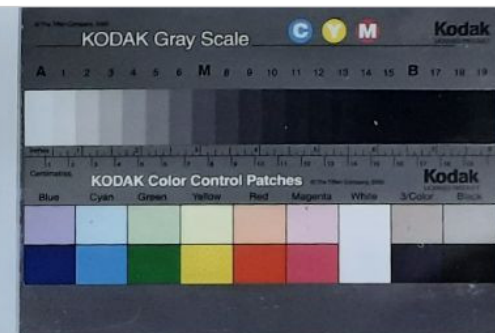
BOREHOLE ID: BH1  
 DEPTH: 13.0 to 14.60 m  
 CORE TRAY NO. 1 of 1  
 DATE: 15/09/23

CLIENT NAME: Jacob 4765 Investments Pty Ltd  
 PROJECT: Castlereagh  
 LOCATION: 47 Old Castlereagh Rd  
 JOB NUMBER: P3023  
 LOGGED BY: MJ
