PROPOSED SOLID WASTE LANDFILL

GROUNDWATER IMPACT ASSESSMENT

**TUMBLONG RESERVE ROAD
TUMBLONG NSW 2729**

REPORT NO. 5985

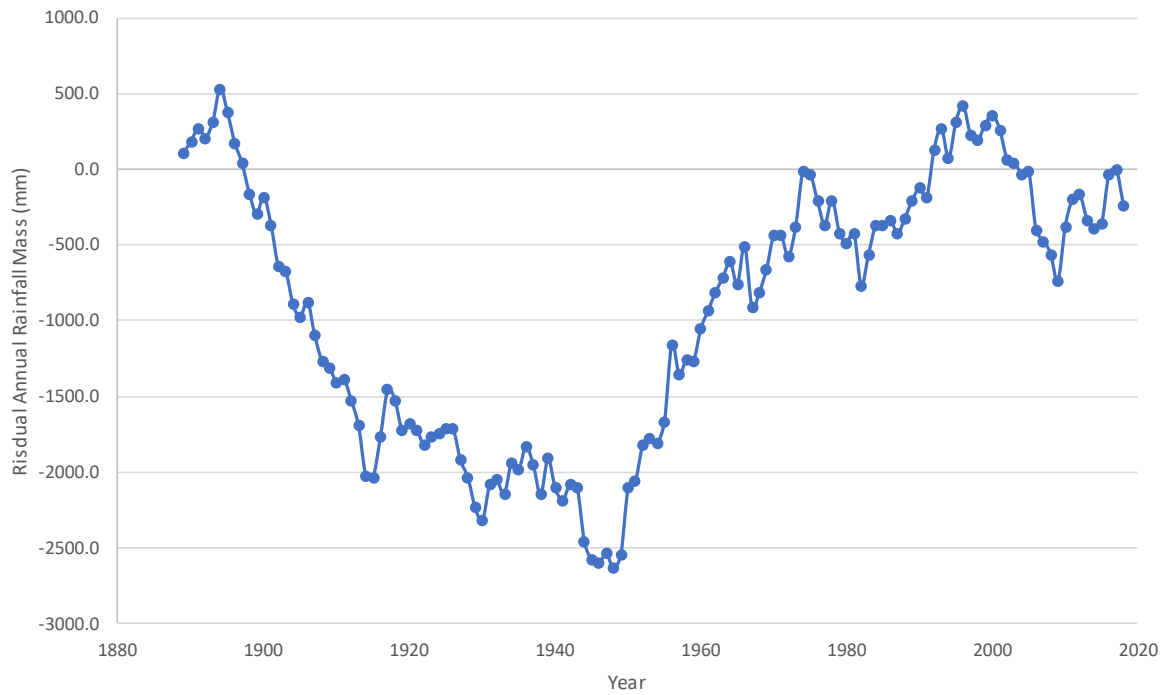
Figure 5: *Annual residual rainfall mass curve*

The long term annual residual mass rainfall curve shows that for the first half of the 20th century that rainfall was below average, whilst the second half of the 20th century was above average, **Figure 5**. In the millennium drought (2000 to 2009) rainfall was below average. Since then rainfall has been above average in 2010 to 2012, 2016 and 2017. Since 2018 there has been below average rainfall.

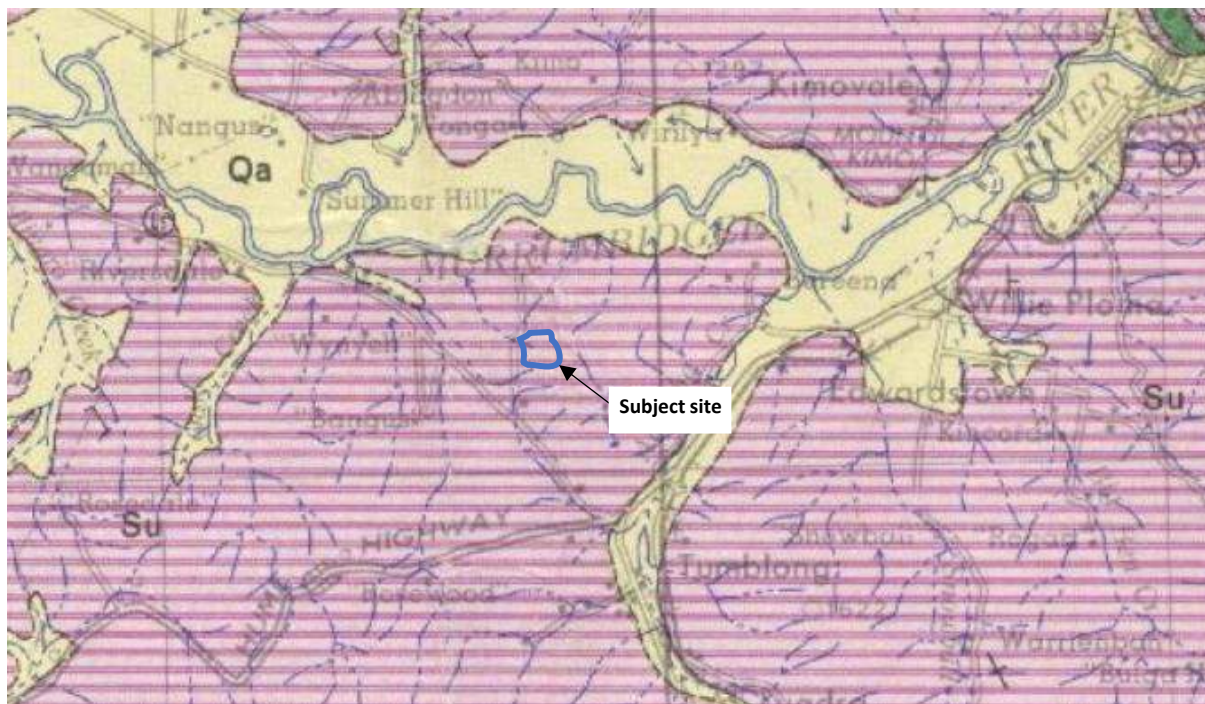
Figure 6: Regional Geology (Wagga Wagga 1:250,000 geological map sheet)

The site is in Silurian aged weathered and fractured rocks of the eastern Lachlan Fold Belt, **Figure 6**. The regional geological map (Wagga Wagga 1:250,000) describes the geology in the region of the site as conglomerate, sandstone, siltstone and minor volcanics. The Tumut 1:100,000 geological map which covers the area to the west of the site and contains the continuation of the geological unit (Su) at the site identifies it as quartz rich shale/slate siltstone and fine sandstone of the Bumbole Creek Formation. The fine-grained siltstone and sandstone are defined as fined grained and predominantly quartz arenites.

The Tumut 1:100,000 does not include a detailed structural study of the formation. The fine-grained beds have a strong foliation. The siltstone and sandstone beds generally have blocky jointing than foliation. Small scale folding (metres) is common and difficult in outcrop to find consistent strike and dip across the structure (Barsden 1990).

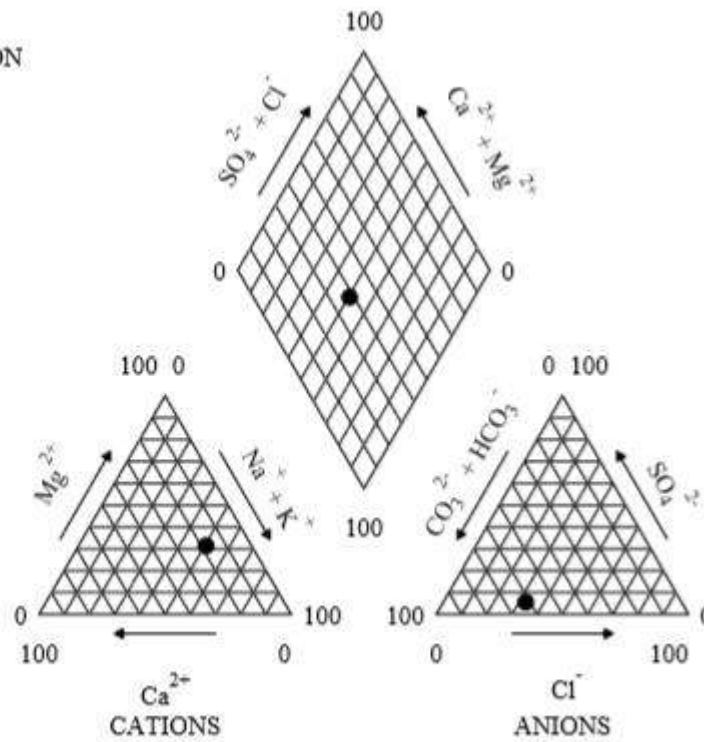
Figure 10: Piper plot BH5D

One water quality sample was collected from BH5D, the only site with an observed low permeability water bearing zone. The bore could not be fully developed due to its low permeability. Following development of the bore, a water sample was collected. Due to the low yield characteristics of the water bearing zone, the bore could not be purged prior to sampling and the high TDS reflects that the bore was not able to be fully developed. The water quality sample therefore reflects that standing water within the bore.

Manganese is commonly found in groundwater as it is commonly associated with soil and rock weathering. The high concentration may indicate anoxic conditions (depleted of dissolved oxygen) which could be associated with restricted water exchange. This would be associated with an intermediate to regional groundwater flow system as identified in the groundwater flow process in the region of the site.
