# Site Audit Statement

Site audit statement no. 0301-2522

| Address | 191 Miller Road | | |

**JBS&G 70509 | 171,715 Rev A**

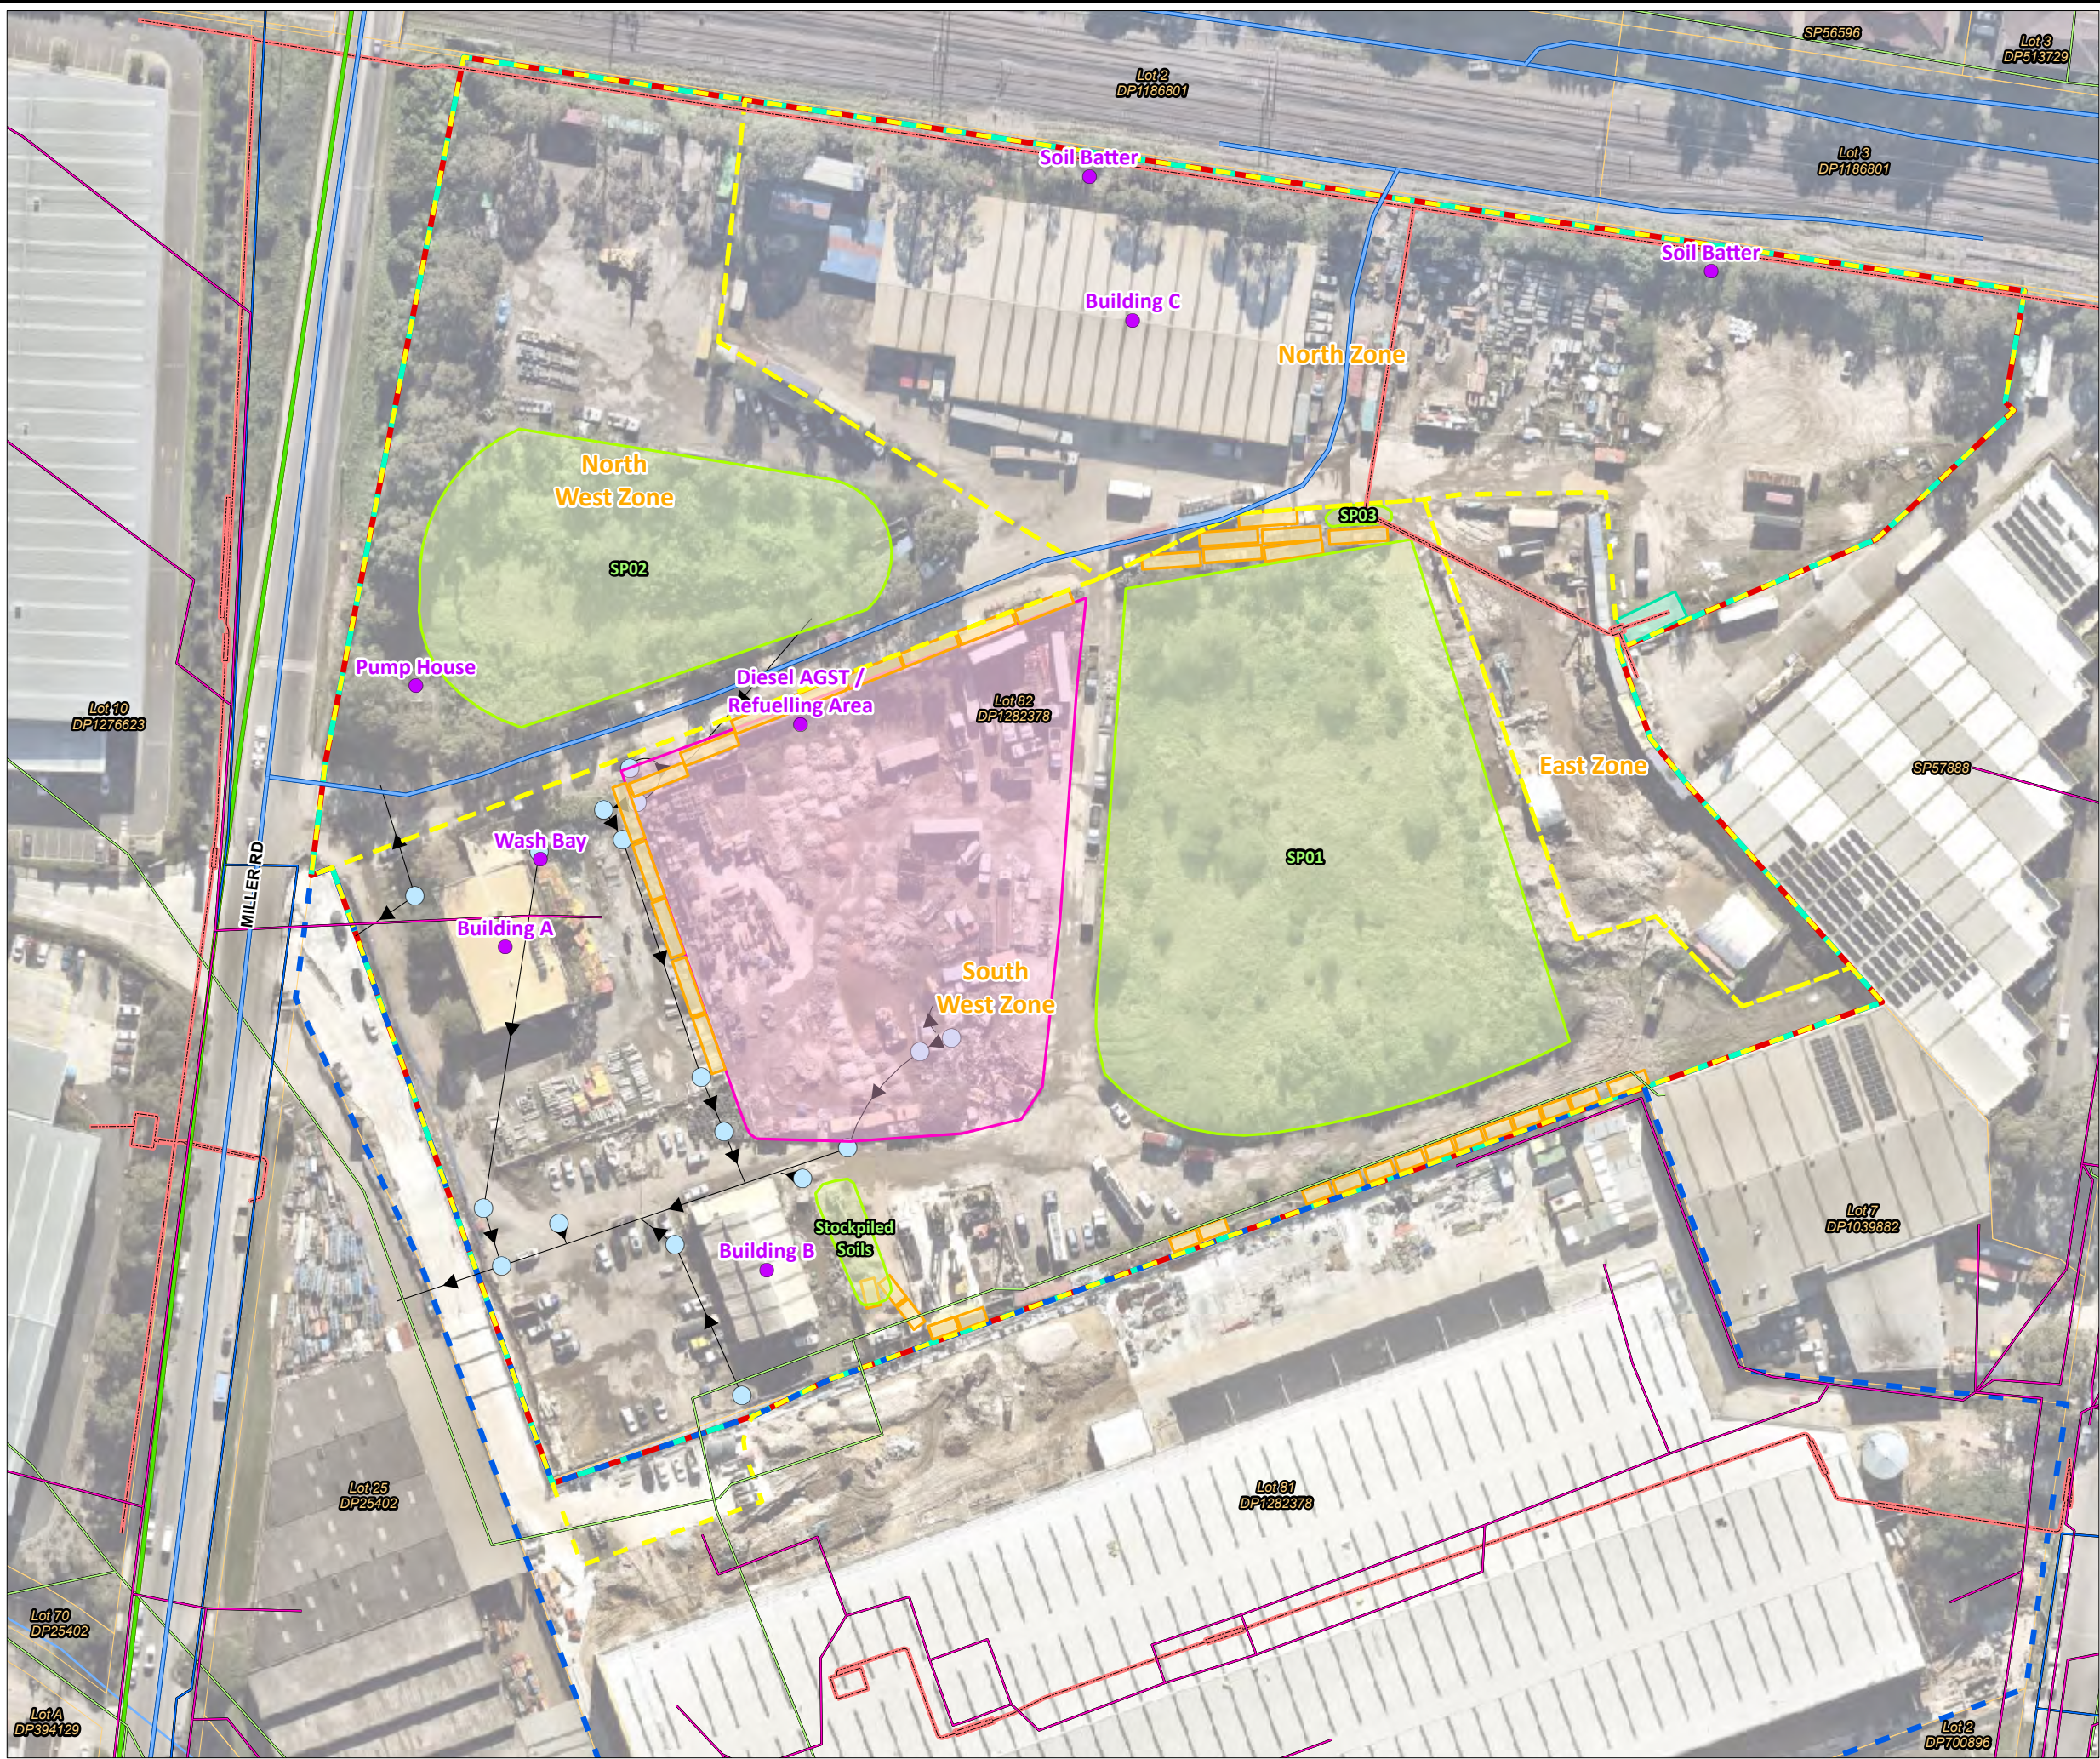
FIGURE 2B

CURRENT SITE LAYOUT

Of further note, the three large stockpiles (SP01, SP02 and SP03) as previously described in JBS&G (2021c) were observed to still be present and appeared undisturbed, with extensive vegetation now present across the surfaces. In addition, various stockpiles of soil materials were noted within the waste processing yard (in central portion) and in the southern portion. It is unknown at this point, whether the current operators will remove these stockpiles prior (except SP01-SP03 which will remain) to redevelopment of the site – as such, these stockpiled materials have not been assessed in previous investigations completed for the site – but provision is provided in this RAP to assess these materials if they are still present on site when remedial works commence / tenancies cease.

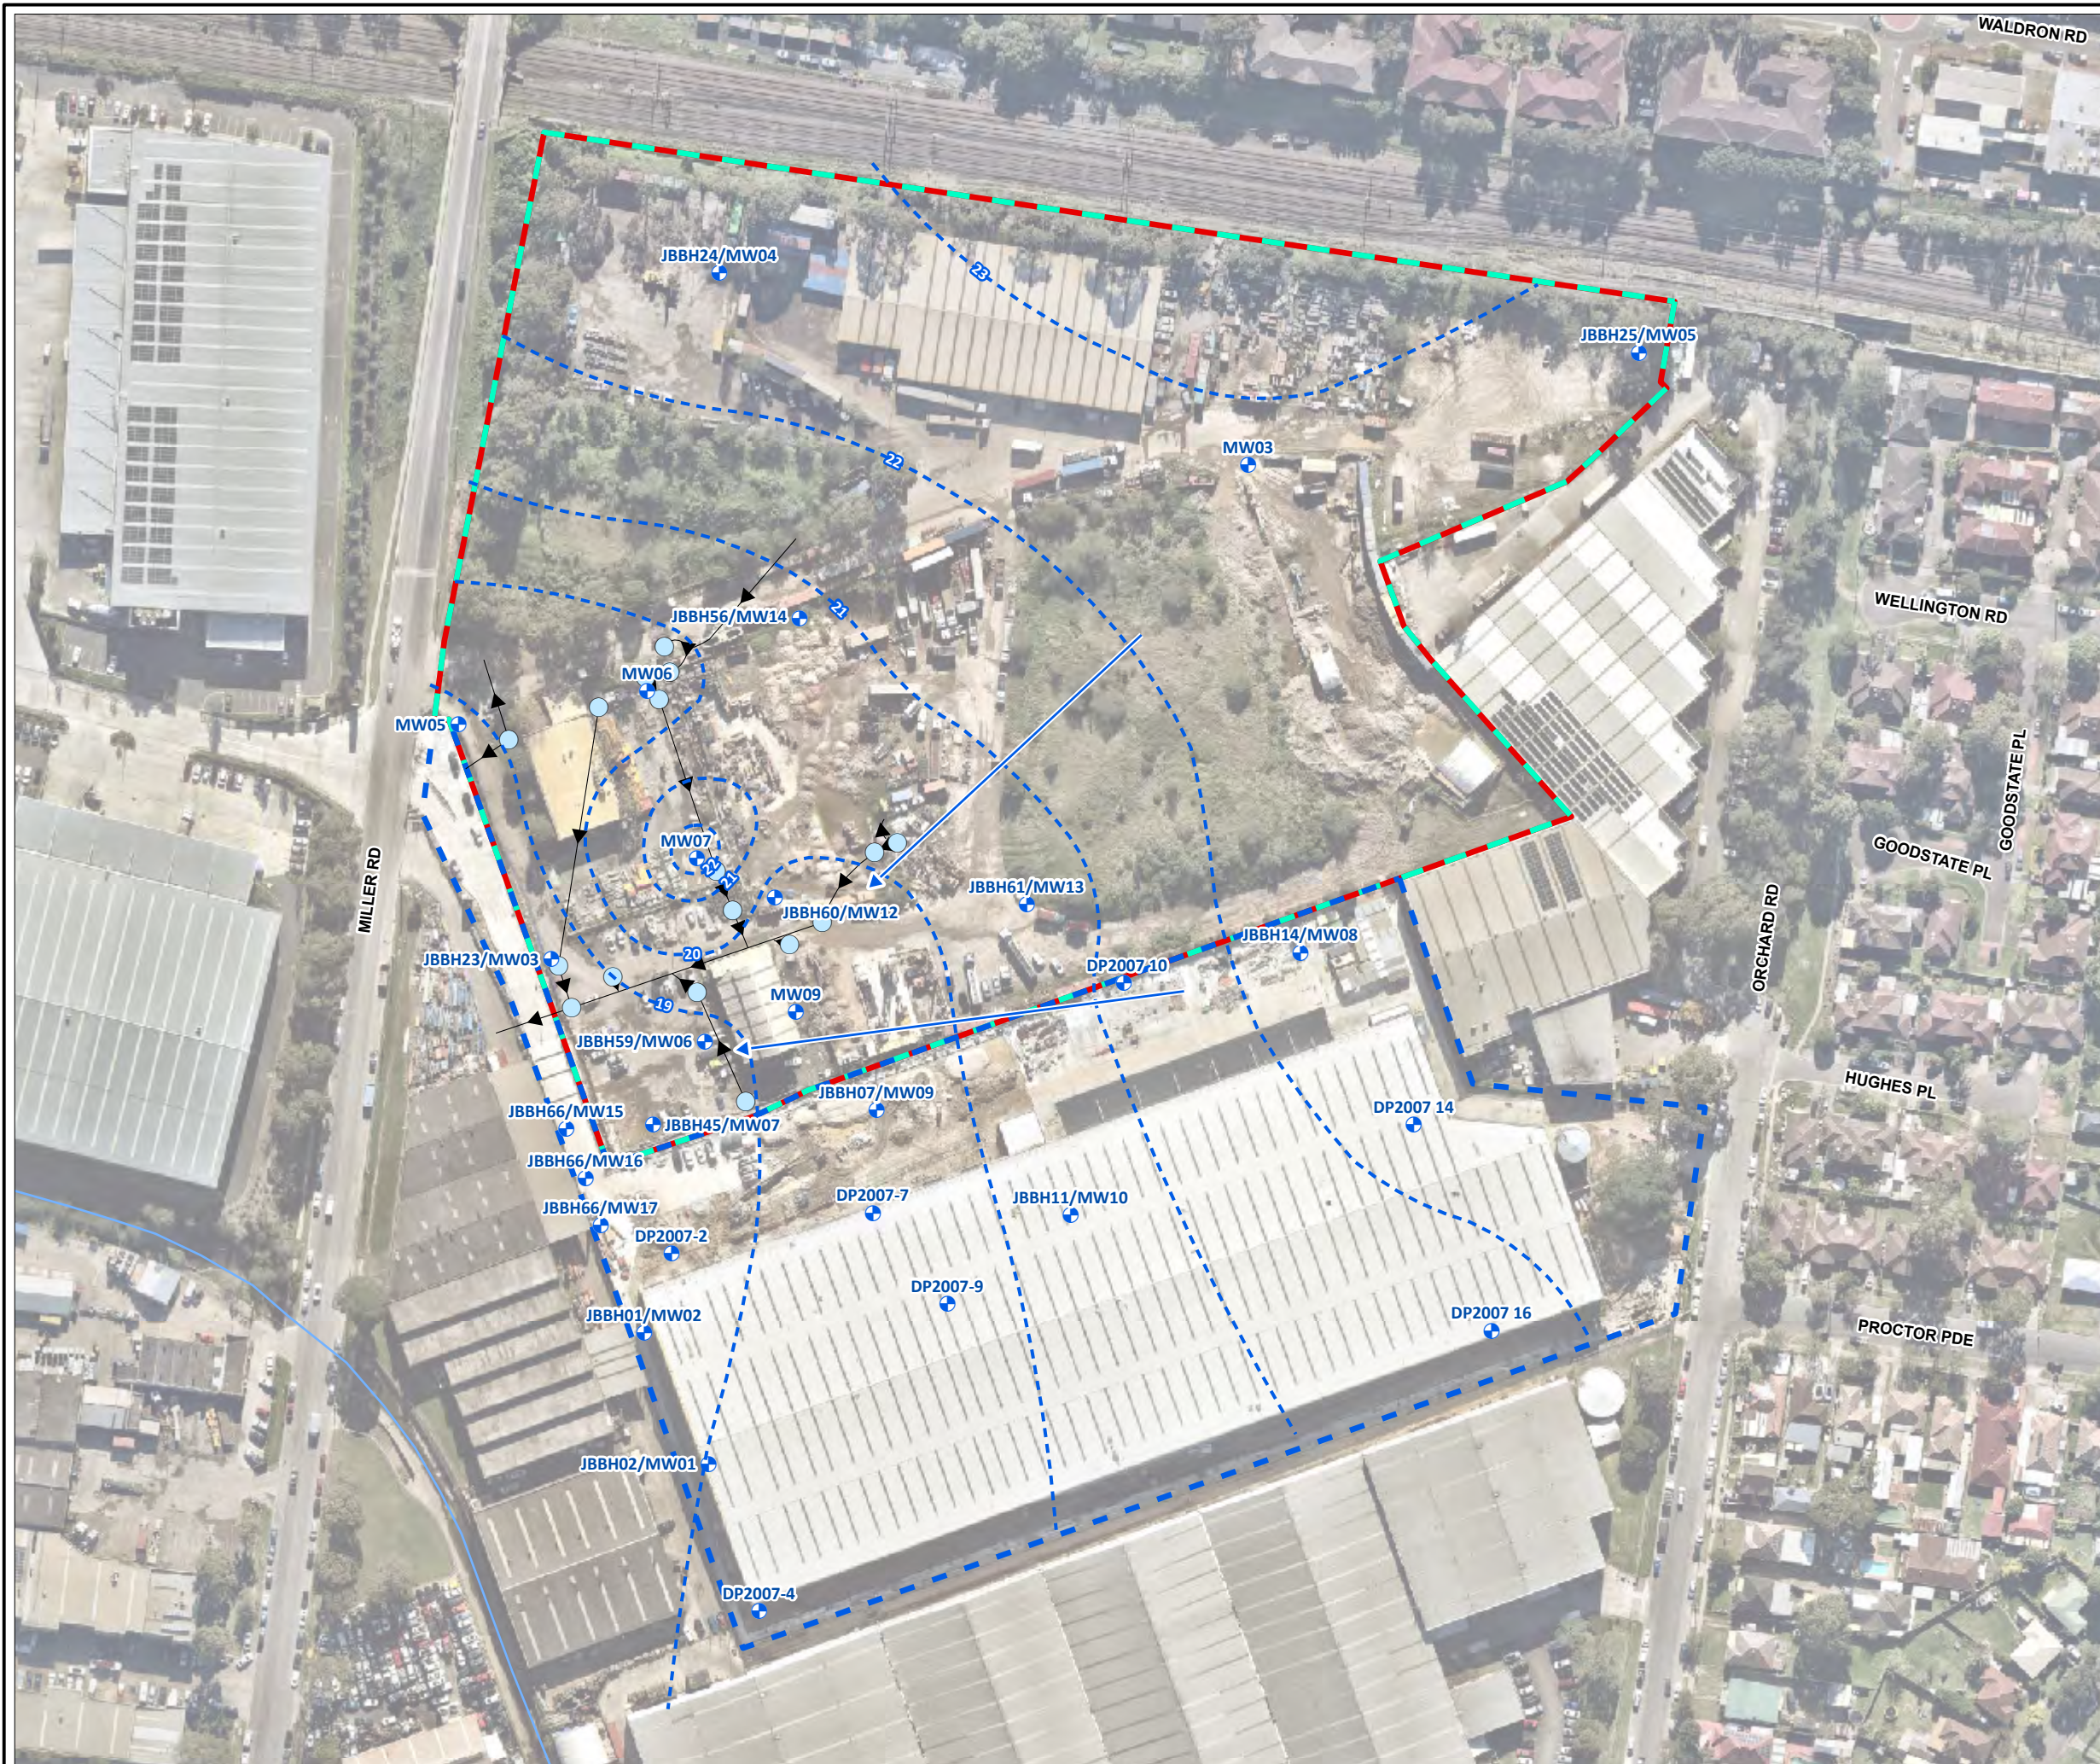
FIGURE 3A-1

HISTORICAL GROUNDWATER LOCATIONS -  
CONTOURS

- **Groundwater Elevation:** Standing groundwater levels (corrected to m AHD) and interpolated groundwater contours of the shallow aquifer are shown on **Figures 3a-i** and **3a-ii**. Groundwater levels range from 19-23 m AHD with flow occurring in a west/south-westerly direction towards the box culvert/open stormwater channel (Byrnes Creek Channel). There is some localised groundwater mounding in the vicinity of MW07, which suggest this is an area of localised groundwater recharge, where the site has been observed to flood in periods of heavy rainfall.

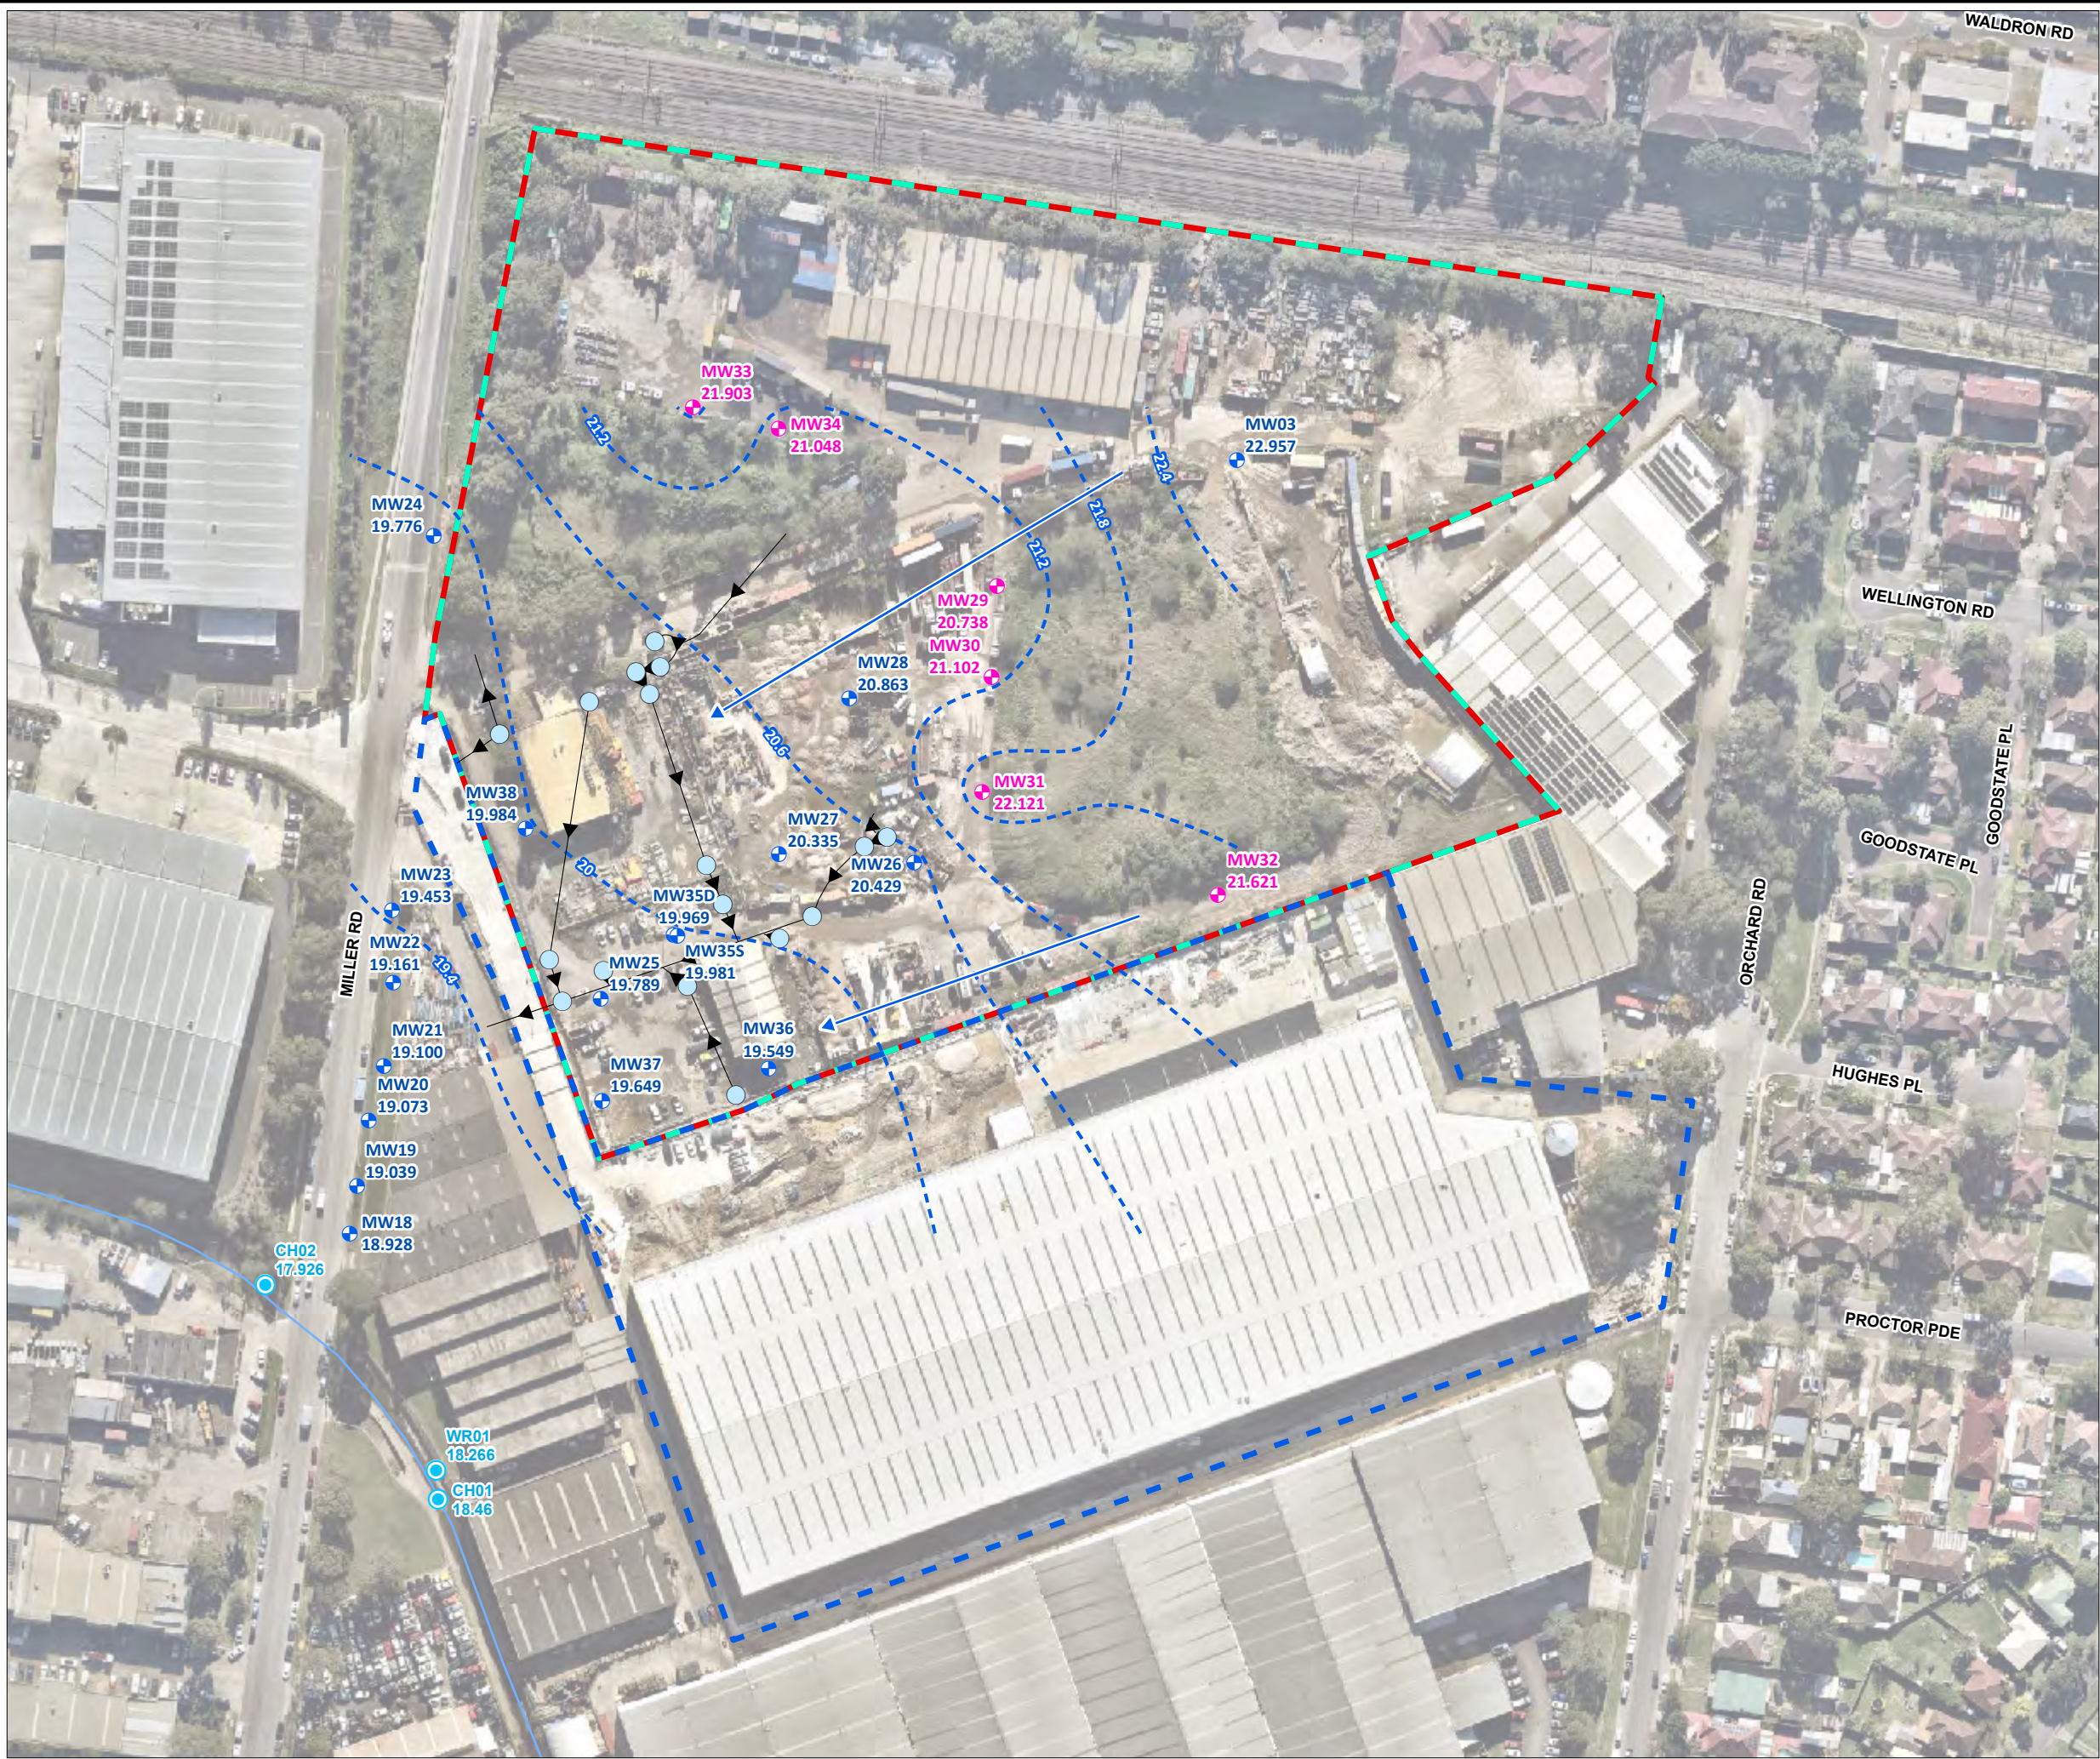
FIGURE 3A-II

**CURRENT GROUNDWATER LOCATIONS -  
CONTOURS**

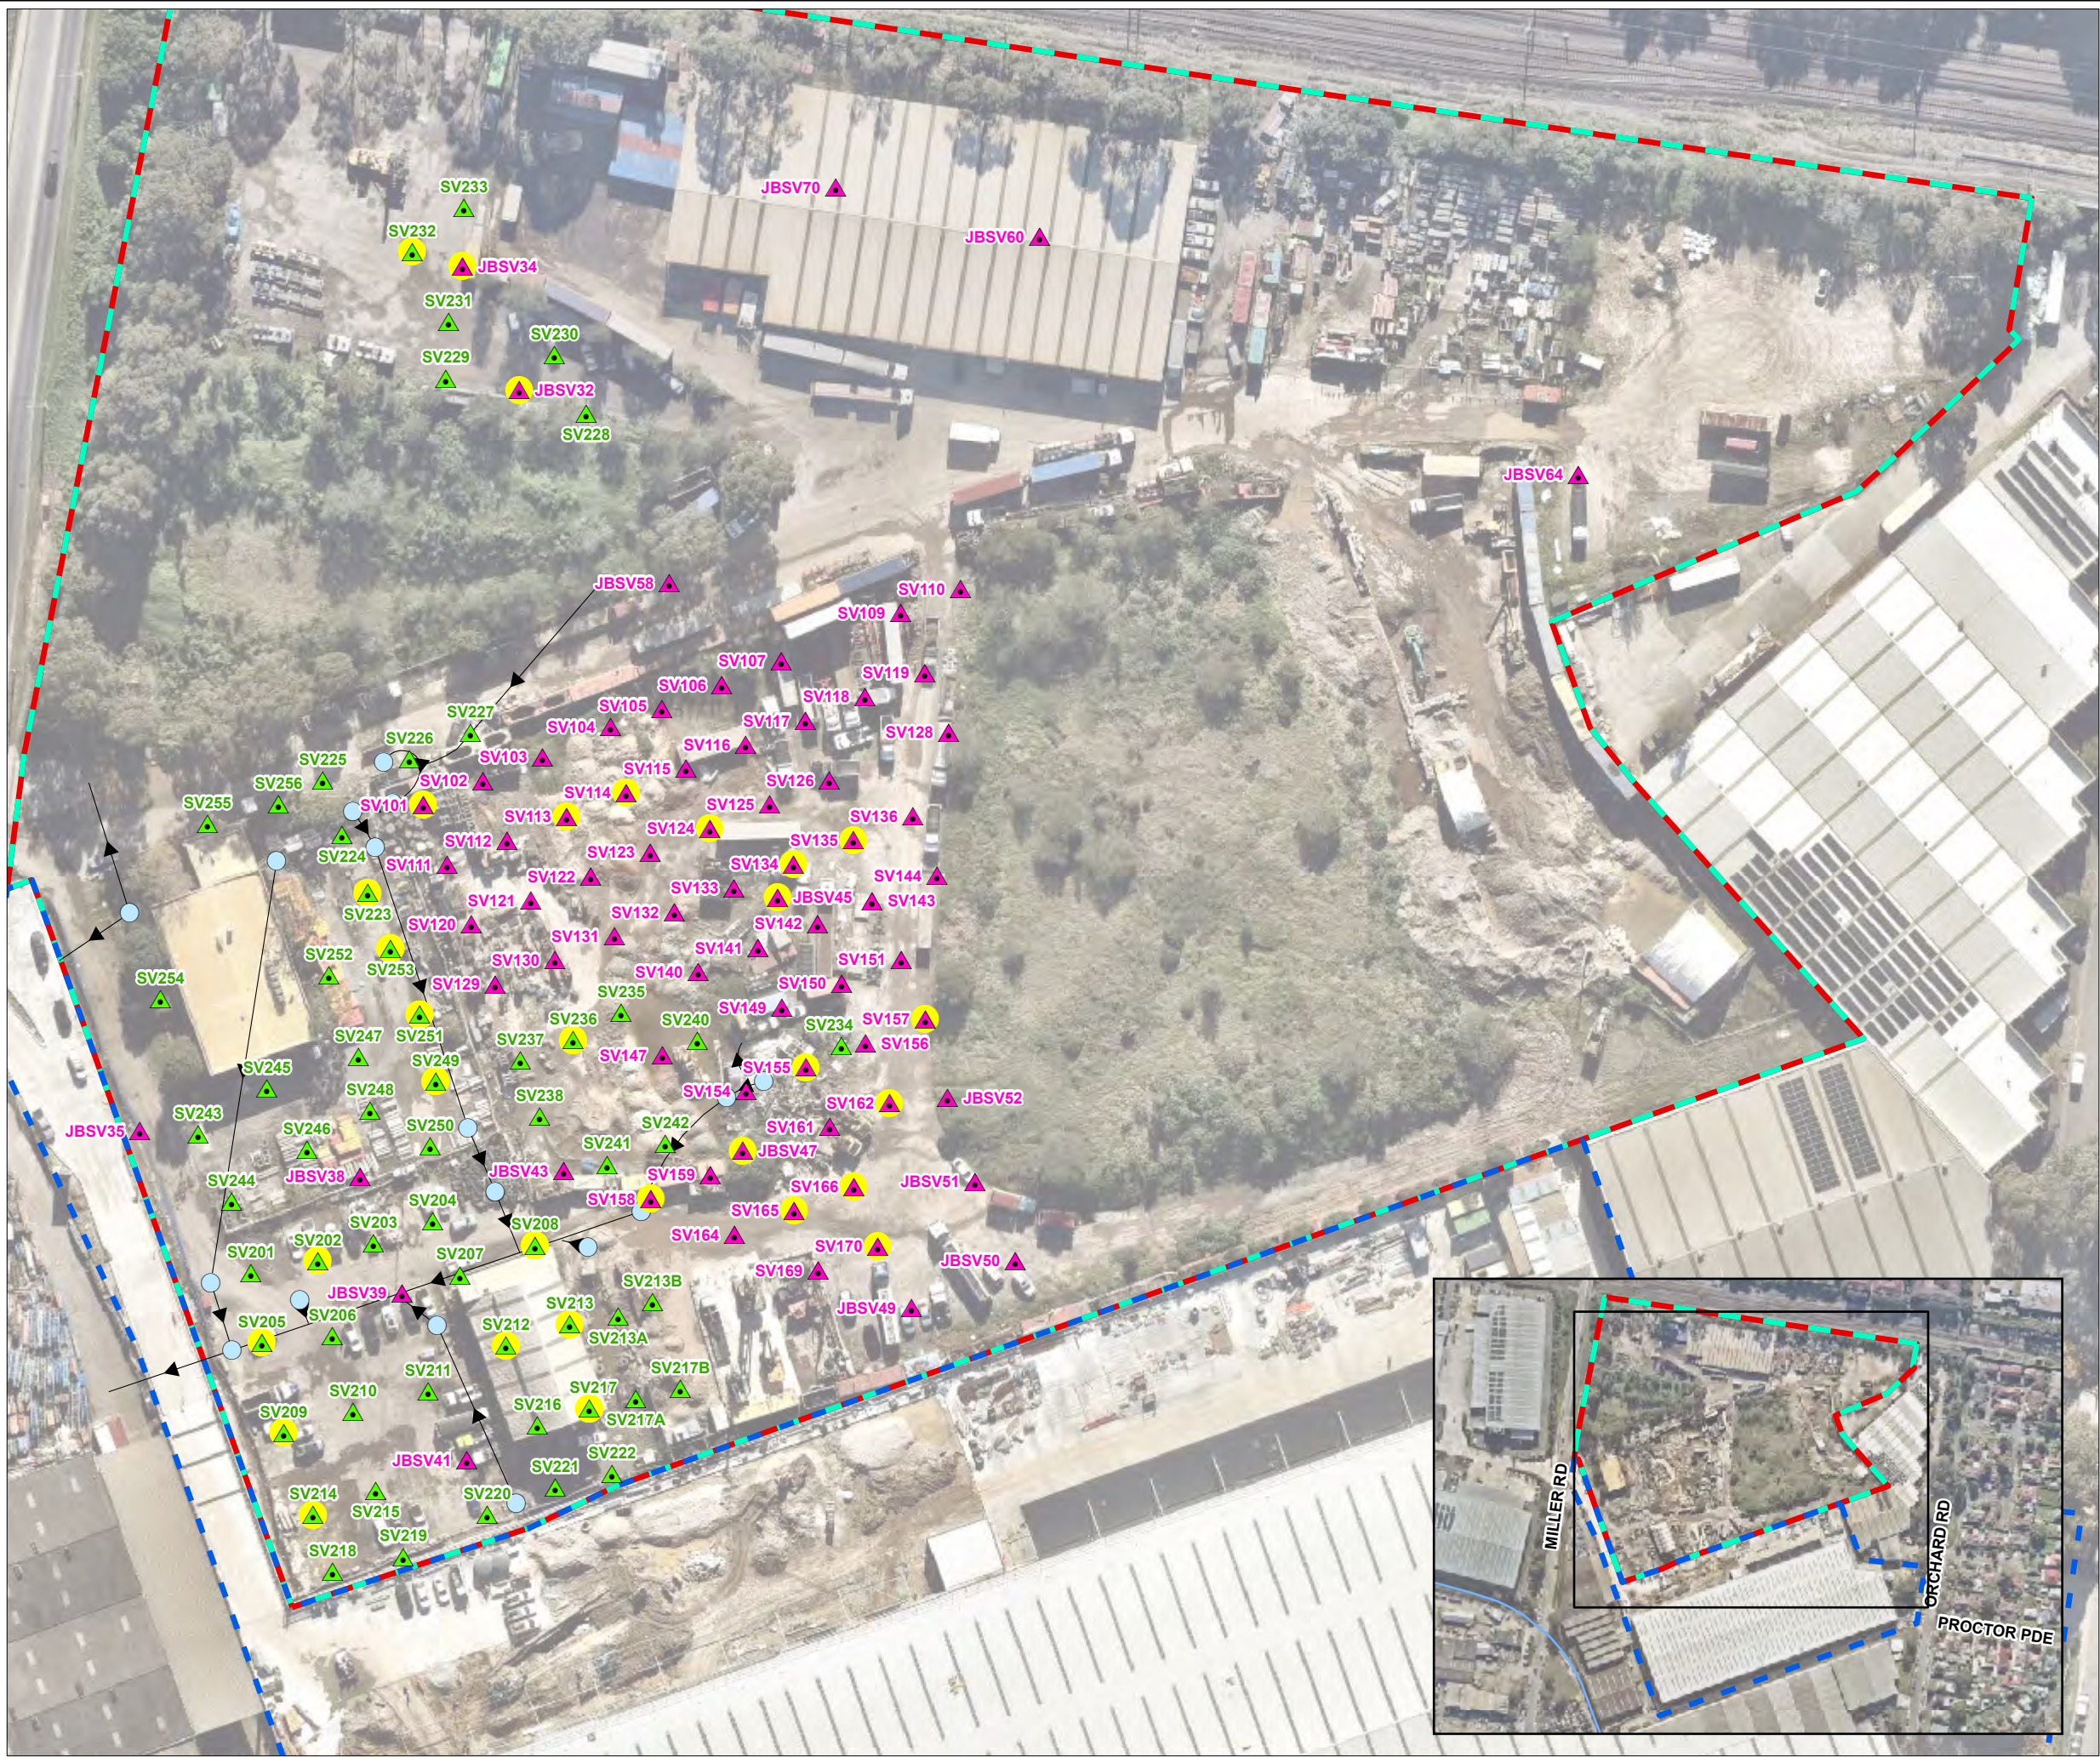
FIGURE 4A

**SOIL VAPOUR LOCATIONS - CURRENT AND HISTORICAL**

| Source and Mechanism of Contamination | Location and Depth/ Volume | Primary Medium | Ancillary Media | COPCs | Anticipated Distribution | Status |
|---|---|---|---|---|---|---|
| <b>AEC 8</b> (Source 15, JBS&G 2021a)<br>Potential presence of HGG generation sources (JBSV51, JBSV52, JBSV103, JBSV123, JBSV128, JBSV156 and JBSV157) | Various locations<br><b>Figures 4.</b> | Shallow soils | Ground Gas<br>Enclosed air | Methane and trace gases | Attenuating outward from source | <b>Potential</b> – Preliminary HGG data is indicative of low risk conditions. Source of methane within SP01 and SP02 also likely to be organic material. Worst-case conditions unlikely to have been captured as part of current monitoring. <b>[Data Gap]</b> |

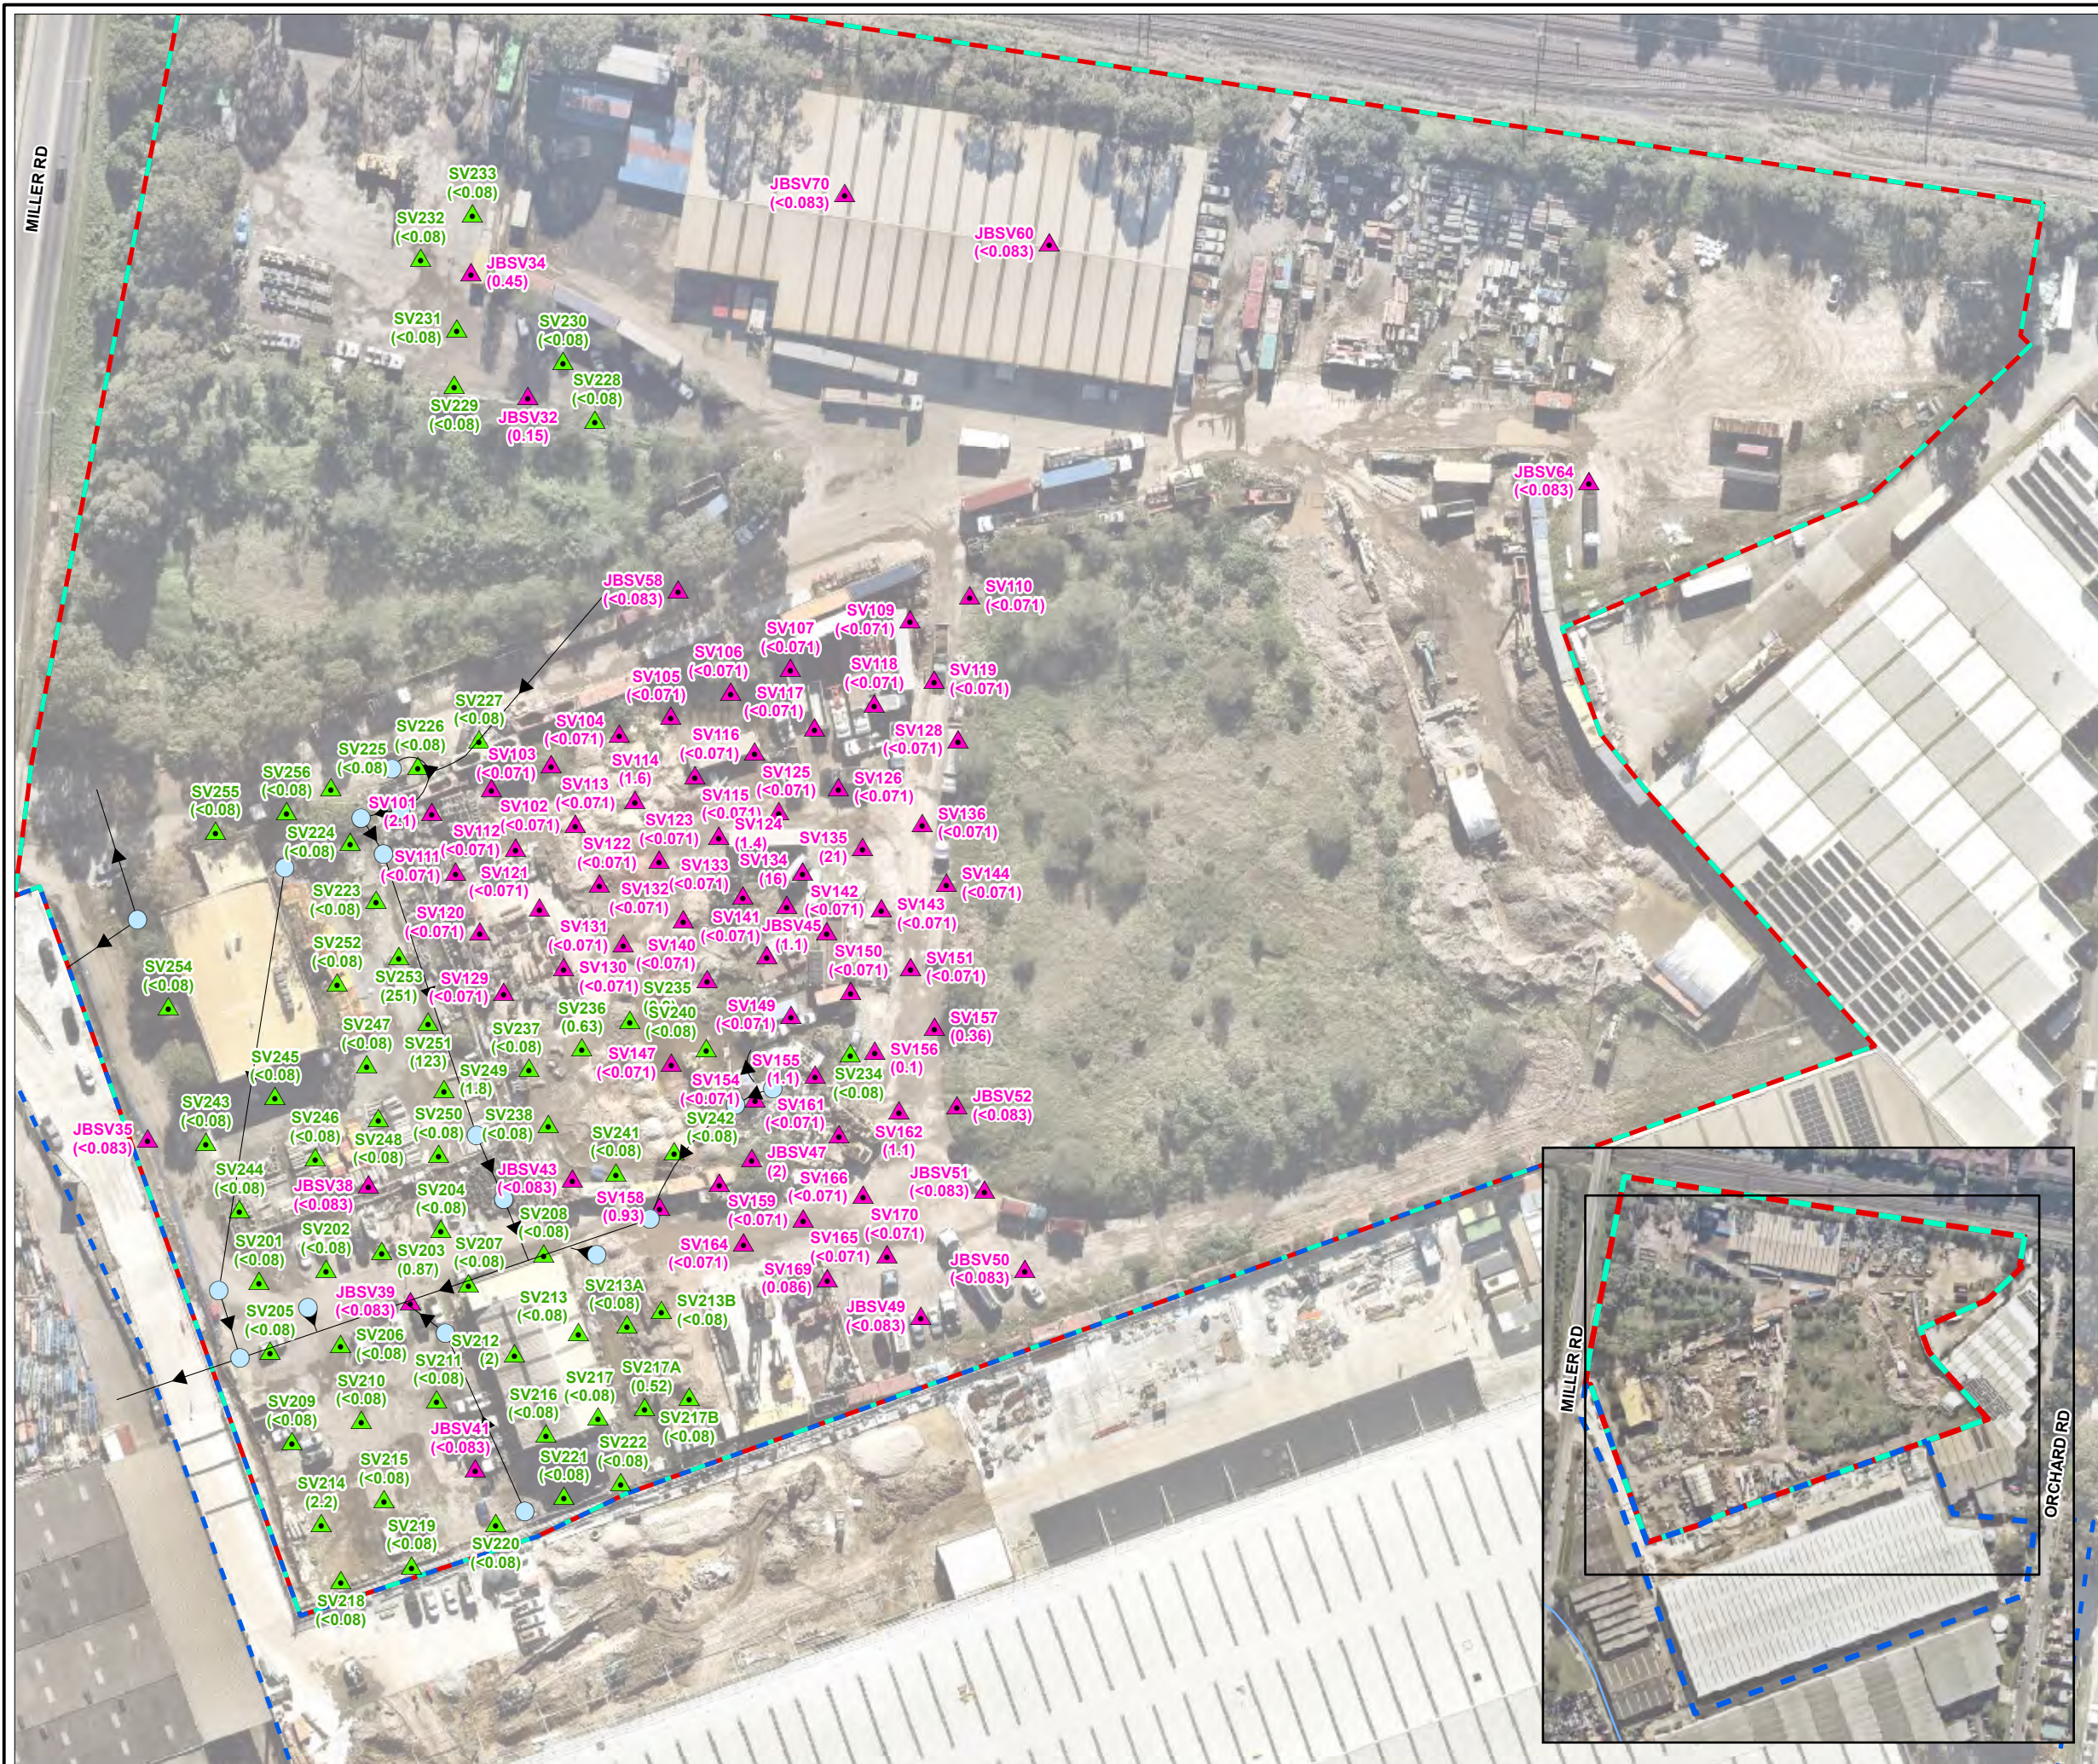
**FIGURE 4D**

**HISTORICAL SOIL VAPOUR**  
(1,2-DCE IN CONCENTRATION OF MG/M3),  
**CURRENT SOIL VAPOUR**  
(1,2-DCE IN CONCENTRATION OF MG/M3)

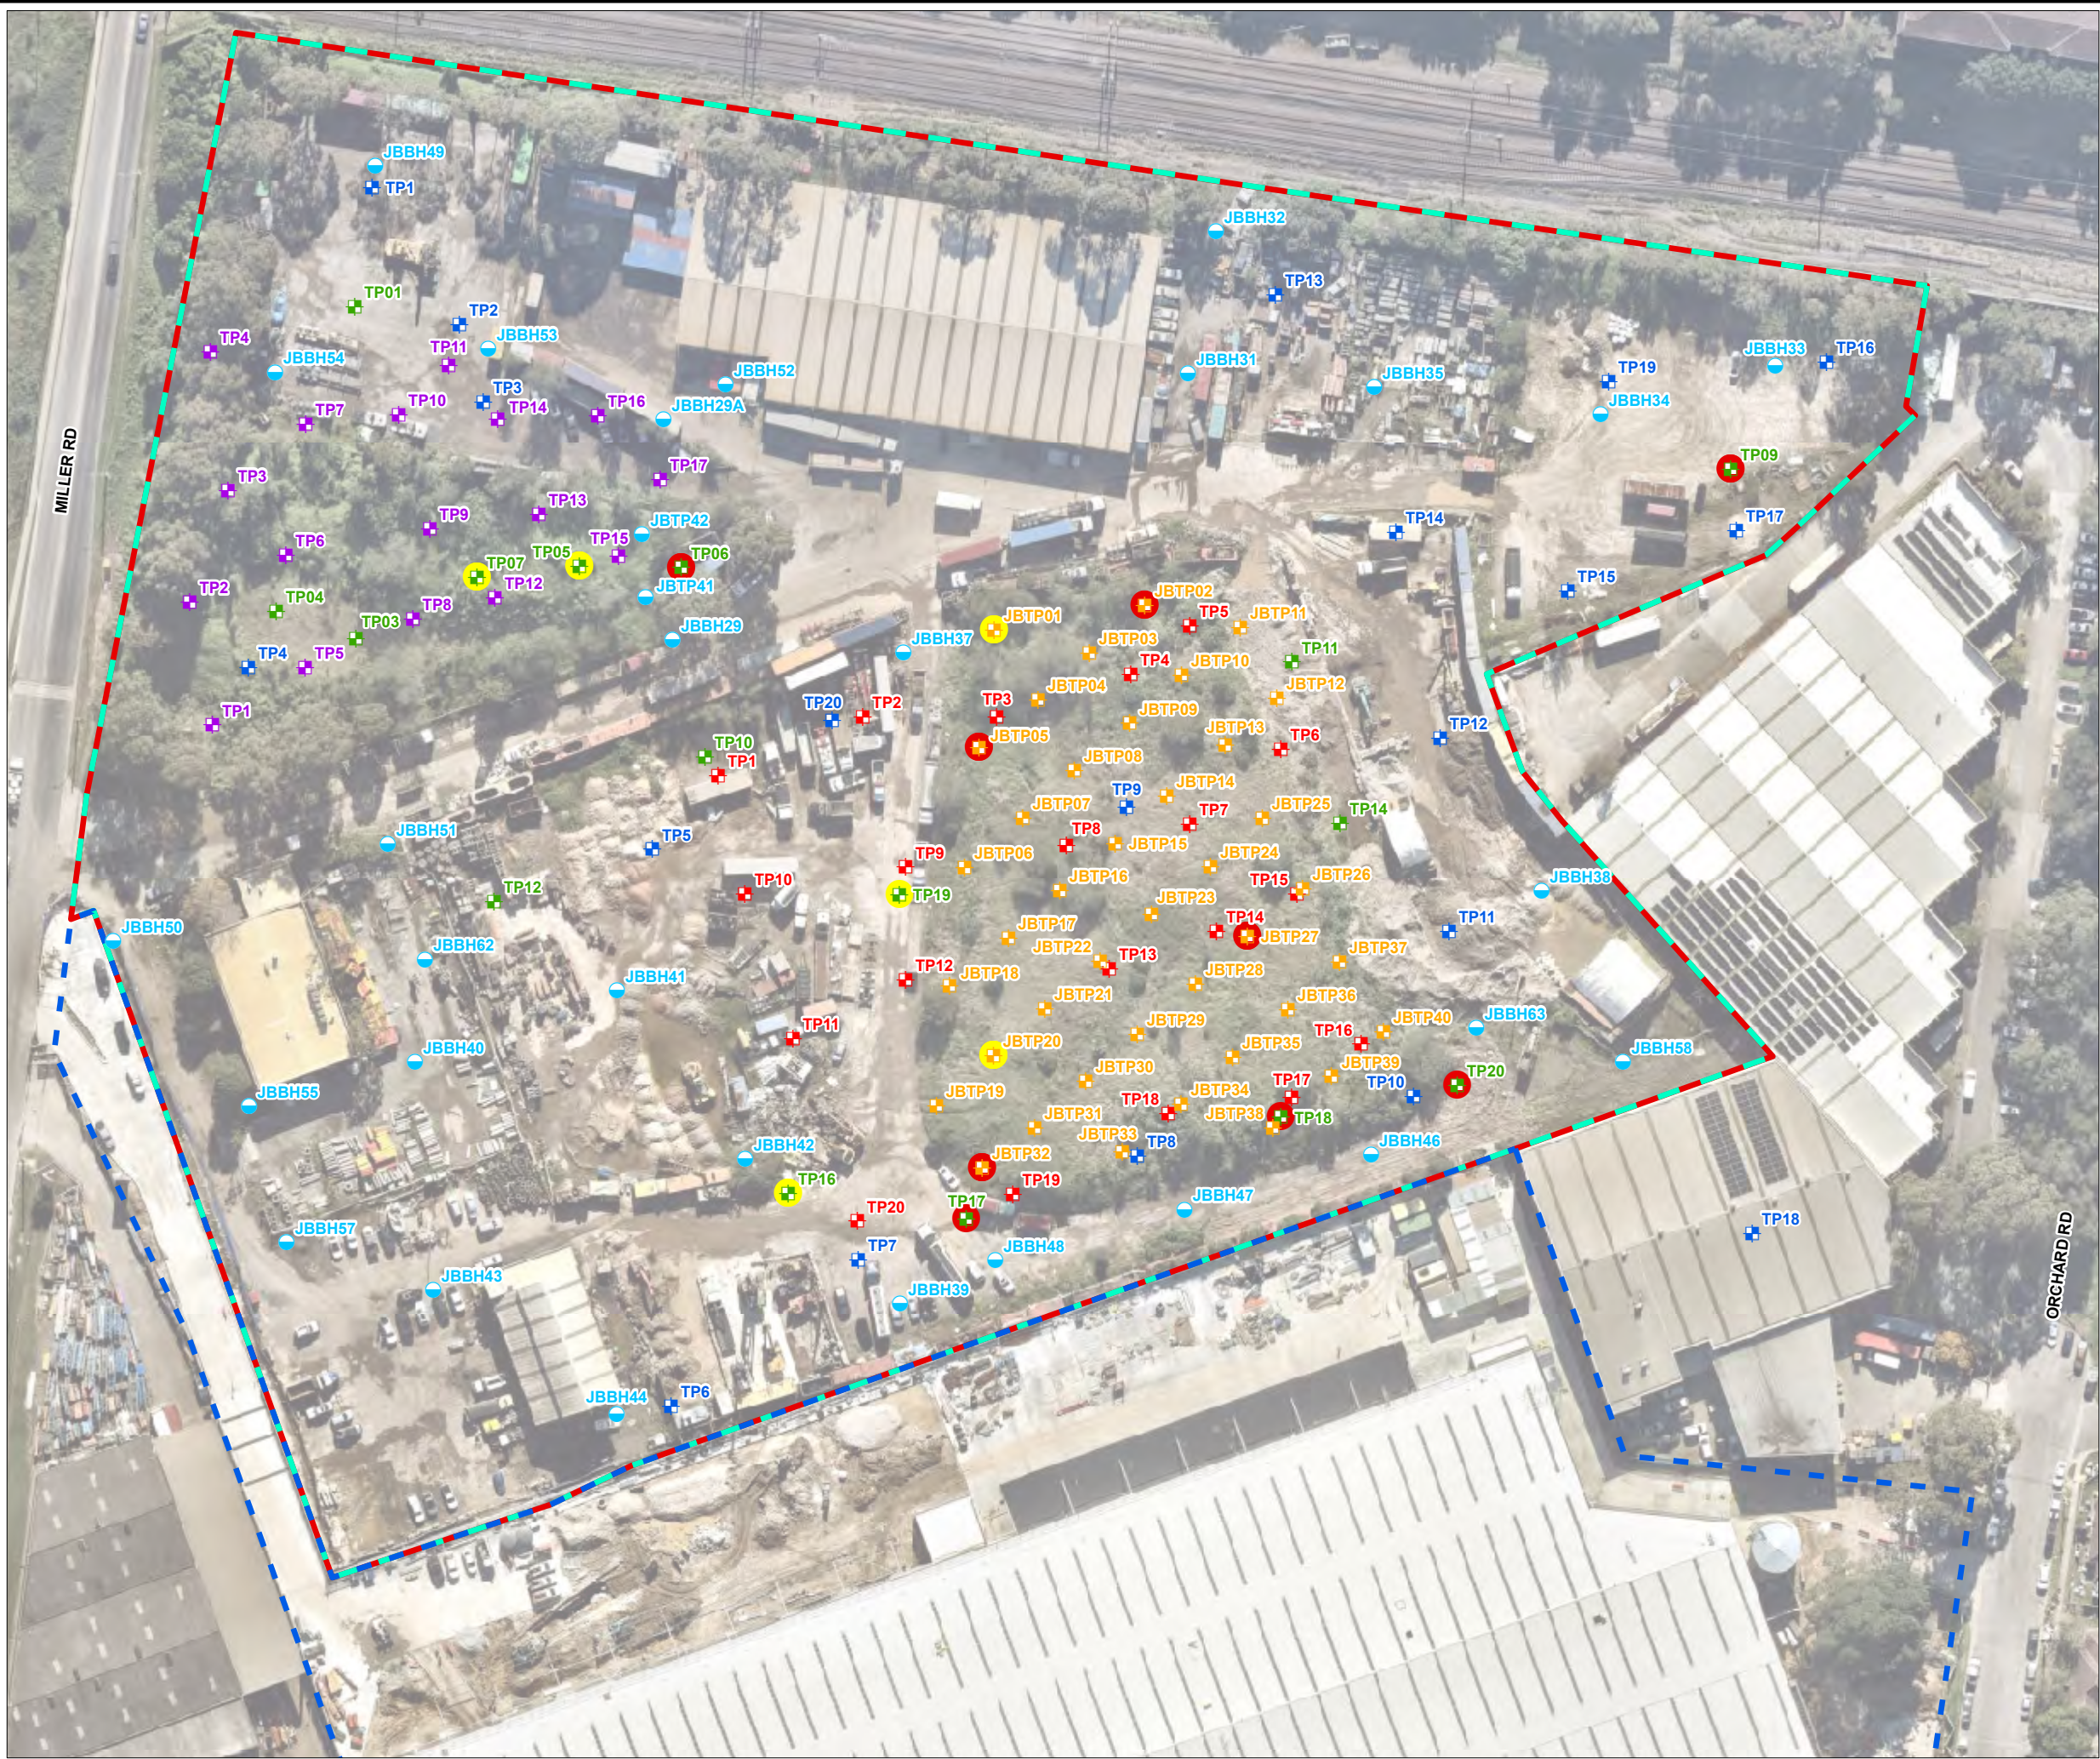
FIGURE 5B

**SOIL RESULTS - ASBESTOS**
