# Site Audit Statement

Site audit statement no. 0301-2522

| Address | 191 Miller Road | | |

**JBS&G 70509 | 171,715 Rev A**

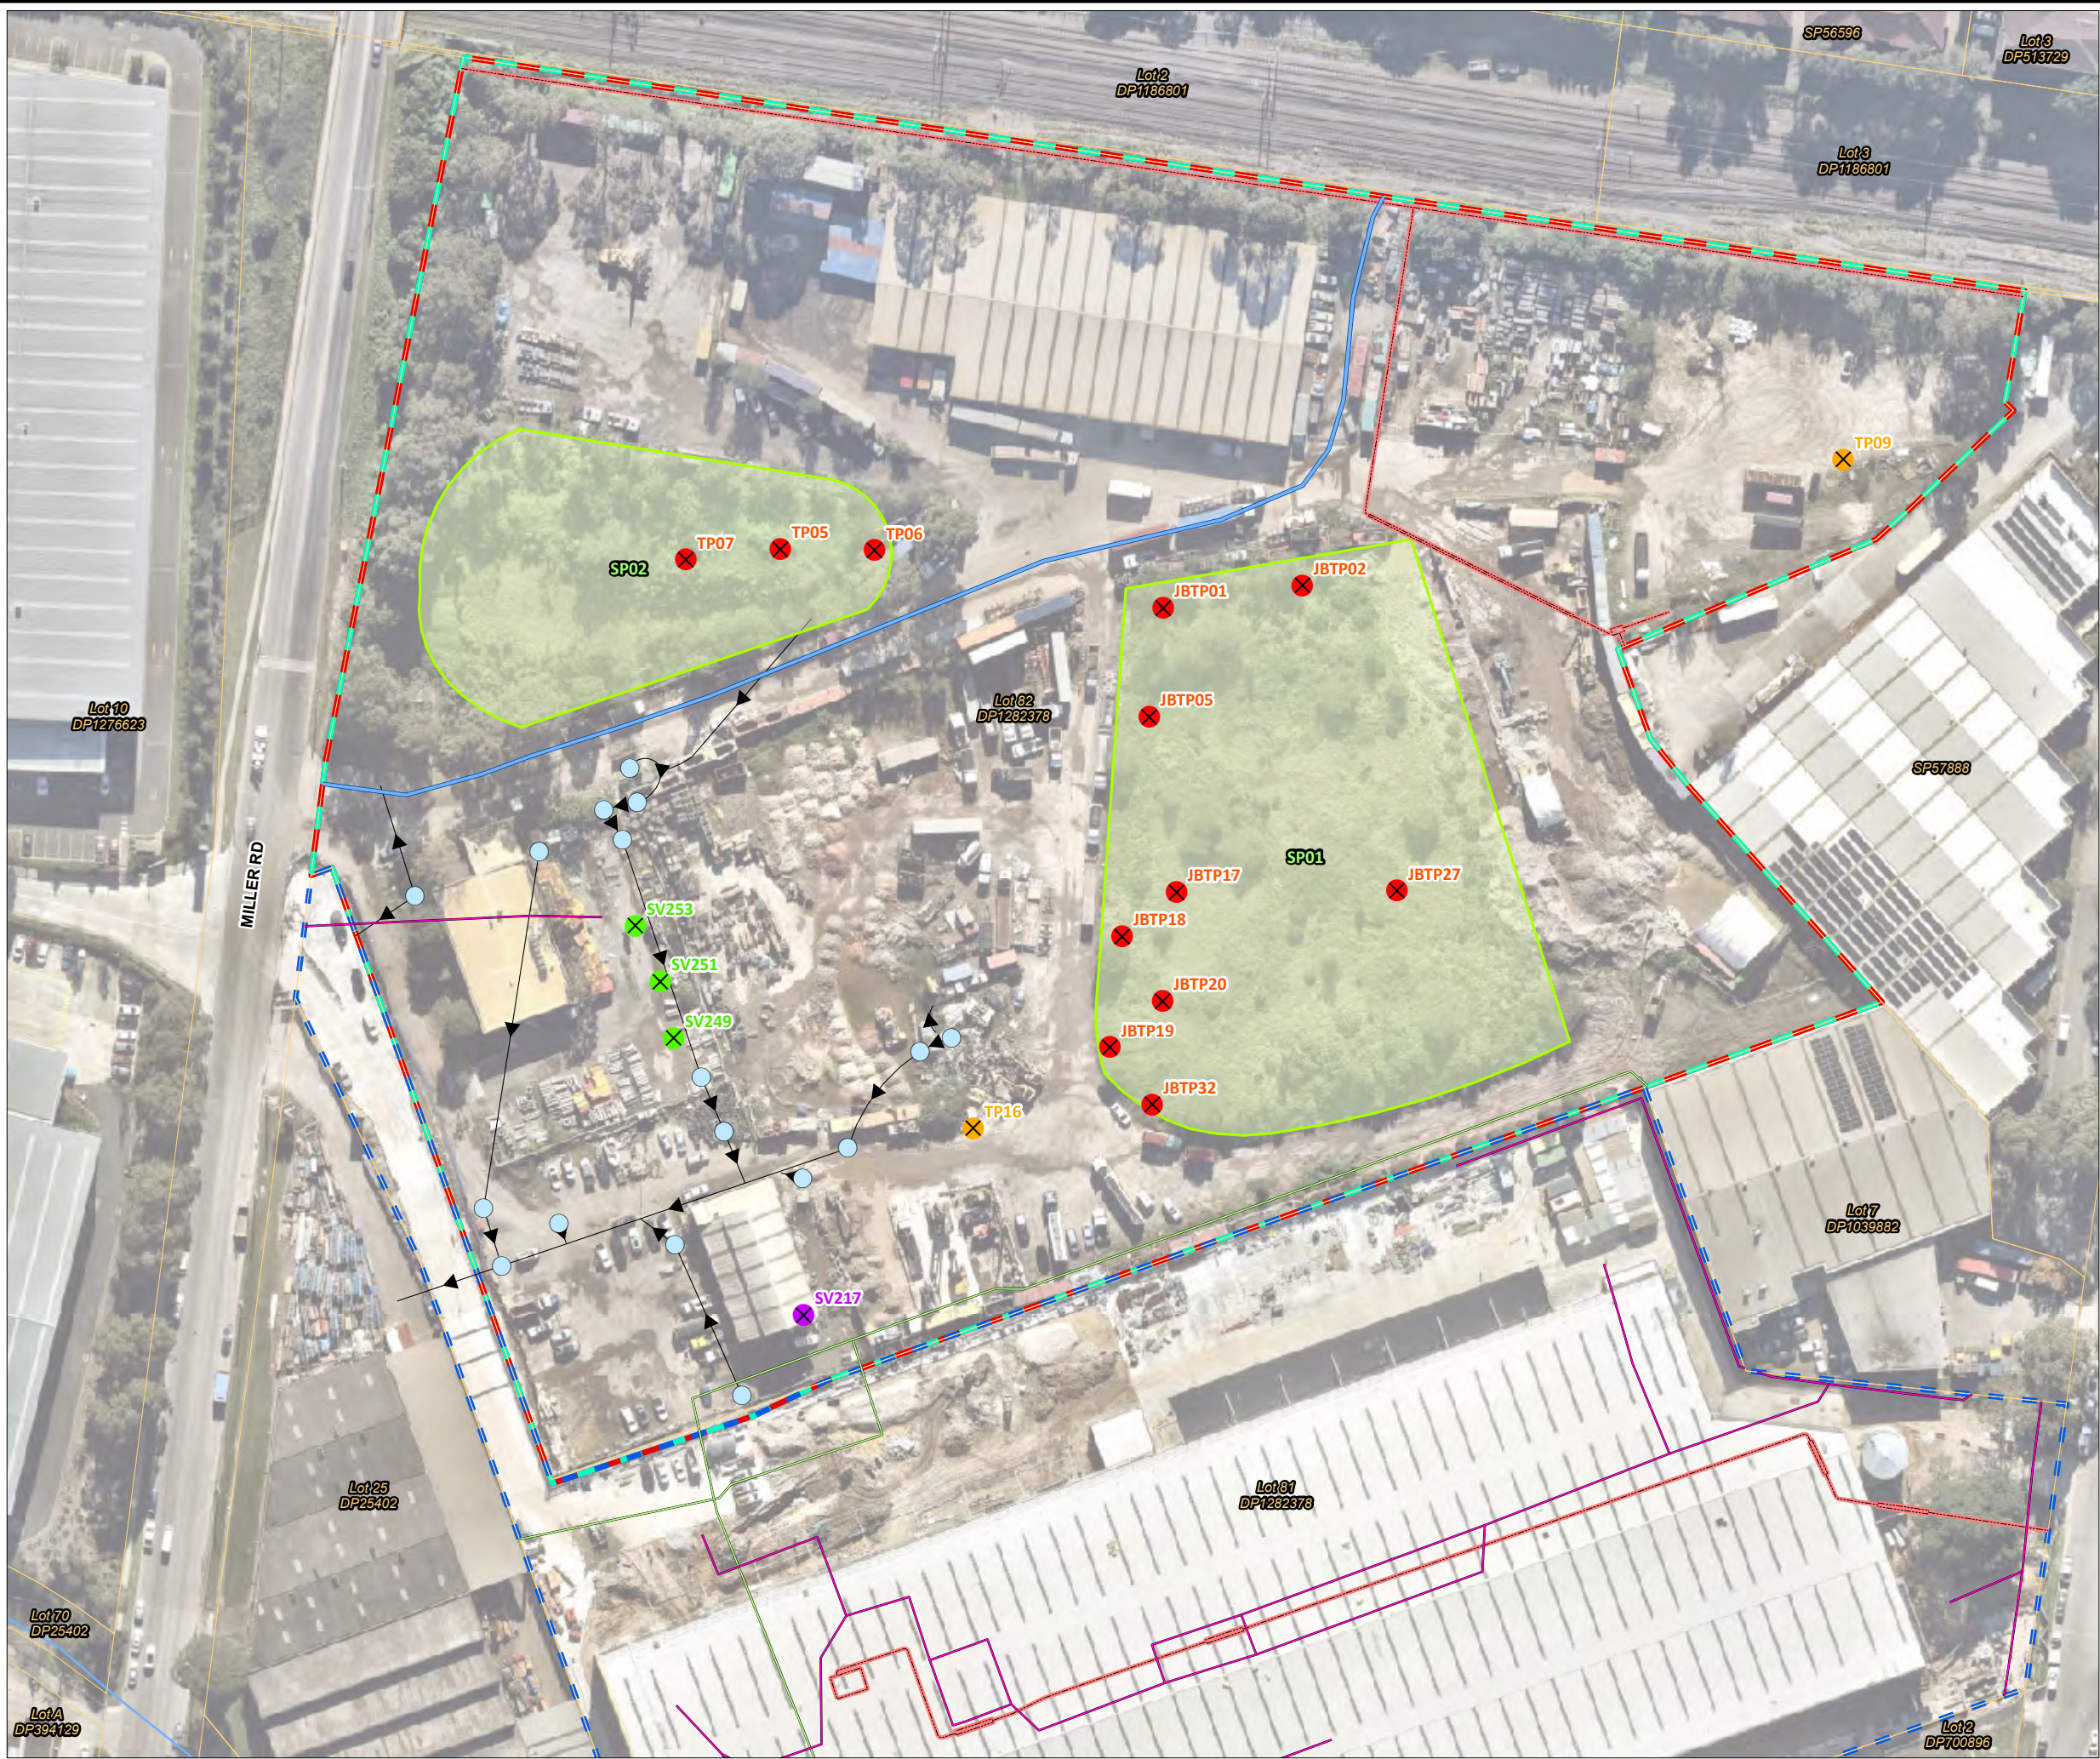
FIGURE 5B

Figure 5b: Asbestos Detections in Soils

**SOIL RESULTS - ASBESTOS**

| Source and Mechanism of Contamination | Location and Depth/ Volume | Primary Medium | Ancillary Media | COPCs | Anticipated Distribution | Status |
|---|---|---|---|---|---|---|
| <b>AEC 4</b> (Source 5, JBS&G 2020c)<br>Localised instances of <i>In-situ</i> fill soils containing AF/FA | <b>Figures 5.</b><br>Lateral extent unknown, limited to depth of fill<br><b>[Data Gap]</b> | Fill soils | None known | Asbestos as AF/FA | Heterogenous within fill soil profile | <b>Known</b> – Investigation conducted as part of JBS&G (2021a) confirmed the presence of AF/FA at elevated concentrations in soil at various locations. |
