# Former Shoalhaven Anglican School Site - Geotechnical Investigation

Prepared for:  
NSW Department of Education

Prepared by:  
Stantec Australia Pty Ltd

Project/File:  
305001663-GEO-008

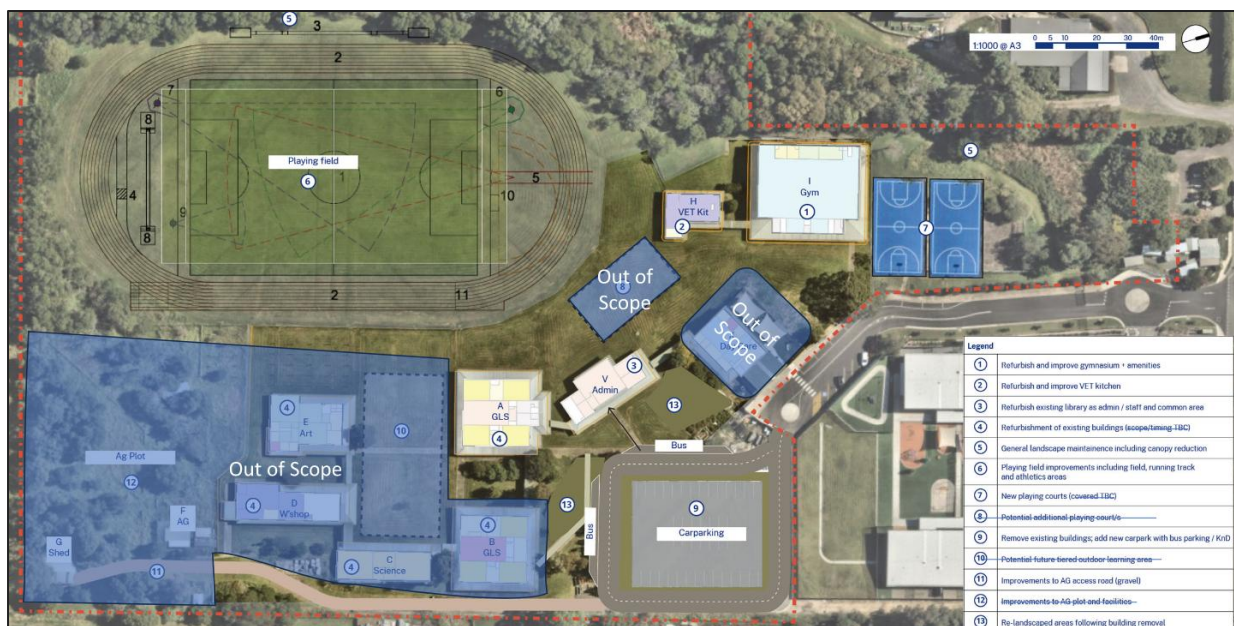
Figure 1-1: Site Plan presenting investigation scope work localities

The proposed scope of works in which the investigation was targeted towards is presented in Figure 1-1 below.

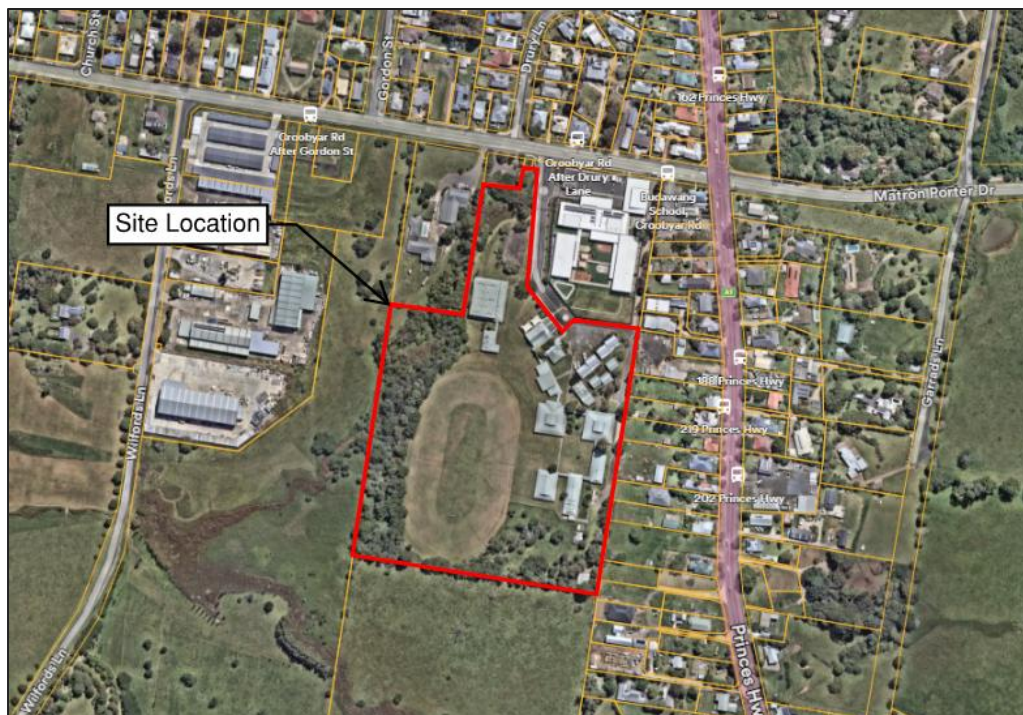
The former Shoalhaven Anglican School site has a natural sloping gradient, typically 3° in a westerly direction towards a shallow creek which borders the western perimeter of the site boundary. The site encompasses a playing field is present toward the south of the site, it is understood the field has been constructed using inferred site-won cut and fill, with cutting visible on the eastern side.

Figure 2-1: Former Shoalhaven Anglican School, Imagery courtesy of Nearmap, dated 23 Feb 2025

The investigation area is presented in Figure 2-1 below with the indicative topography of the site area showing the sports field cut/fill presented in Figure 2-2.

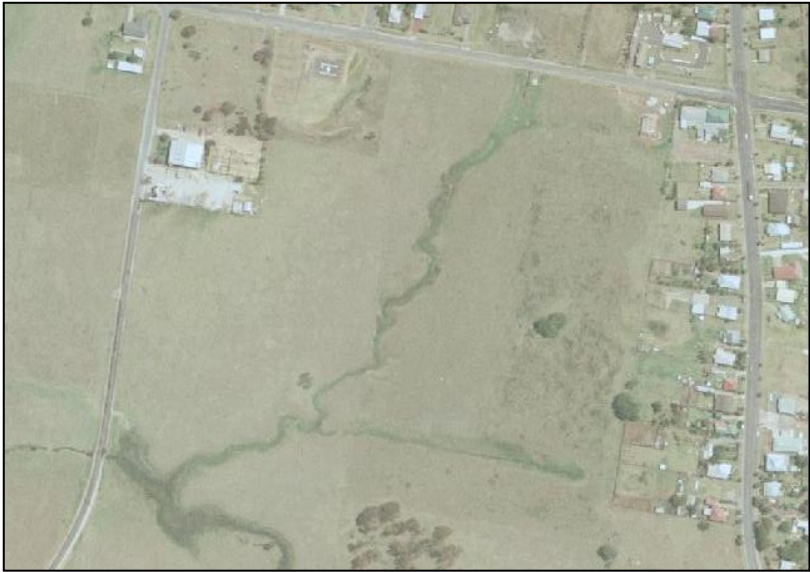
| Date/Year | Description |
|---|---|
| 25 Nov 1991 | <div></div> <p>The site can be seen within the original landform, prior to school establishment, at the eastern side of the main creek alignment and a smaller alluvial gully system to the south.</p> |

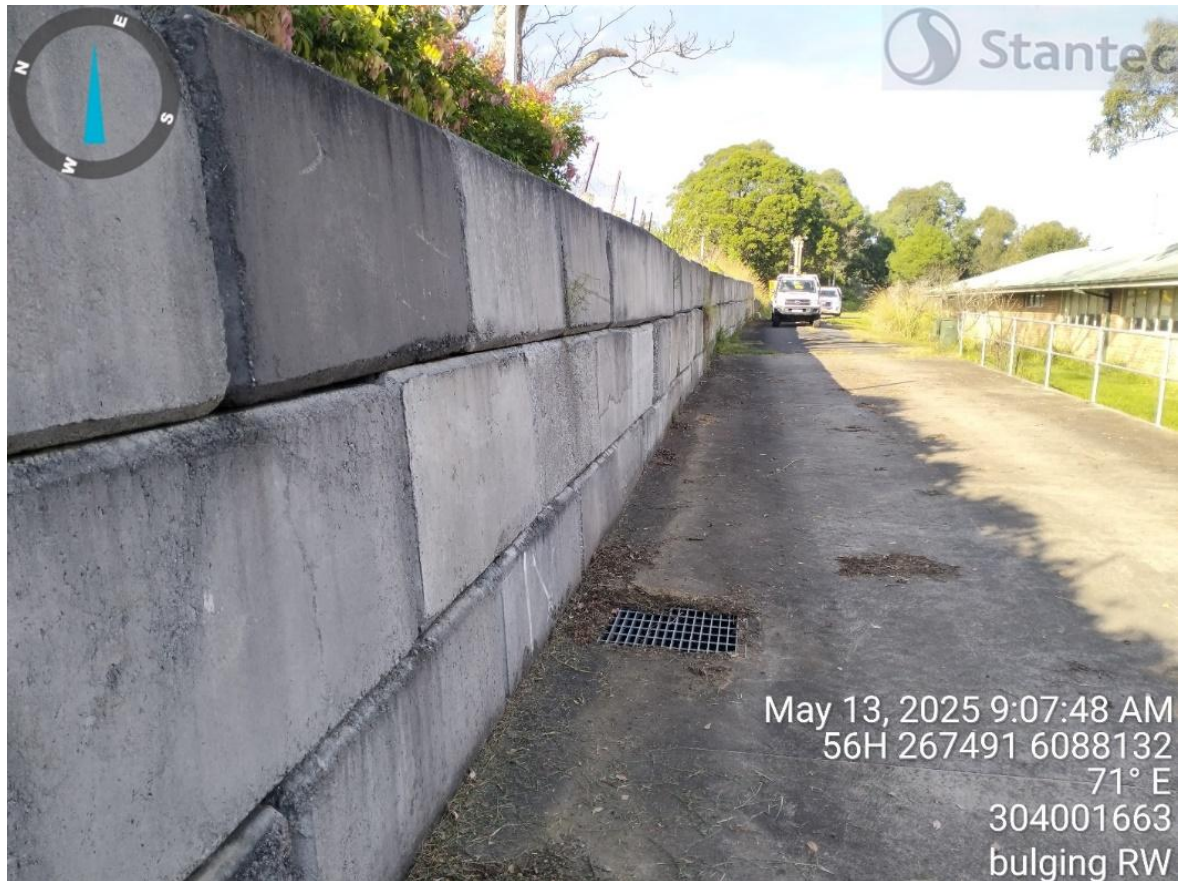
Figure 5-1: Concrete Block Retaining Wall

- Alluvial soils were observed at locations adjacent to the creek.
- Fill was encountered throughout the majority of the site
- A concrete retaining wall of up to about 1.8m height was observed on the eastern edge of the school. Wall construction comprised of concrete blocks approx. 600mm in height per block, with evidence of drainage installed behind the wall. No structures were identified within a 1:1 H:V above the retaining wall. Some bulging and overturning were observed, however it is unclear of the condition of the retaining wall at the time of construction.

Groundwater was encountered at BH10 was likely due to close proximity of the adjacent waterway, and BH11 from inferred seepage from the adjacent concrete block retaining wall that was approximately 1.8m tall. Groundwater was also encountered in Douglas Partners boreholes 101, 104 and 107 between 2.7 and 3.5 mbgl. It should be noted that groundwater levels are likely to fluctuate with variations in climatic and site conditions. Reference should be made to the engineering logs presented in Appendix B, together with explanatory notes.
