## **Proposed Poultry Farm**

**182 & 755 Warrah Ridge Road, Warrah Ridge**

**Geotechnical Assessment**

RGS34752.1-AA

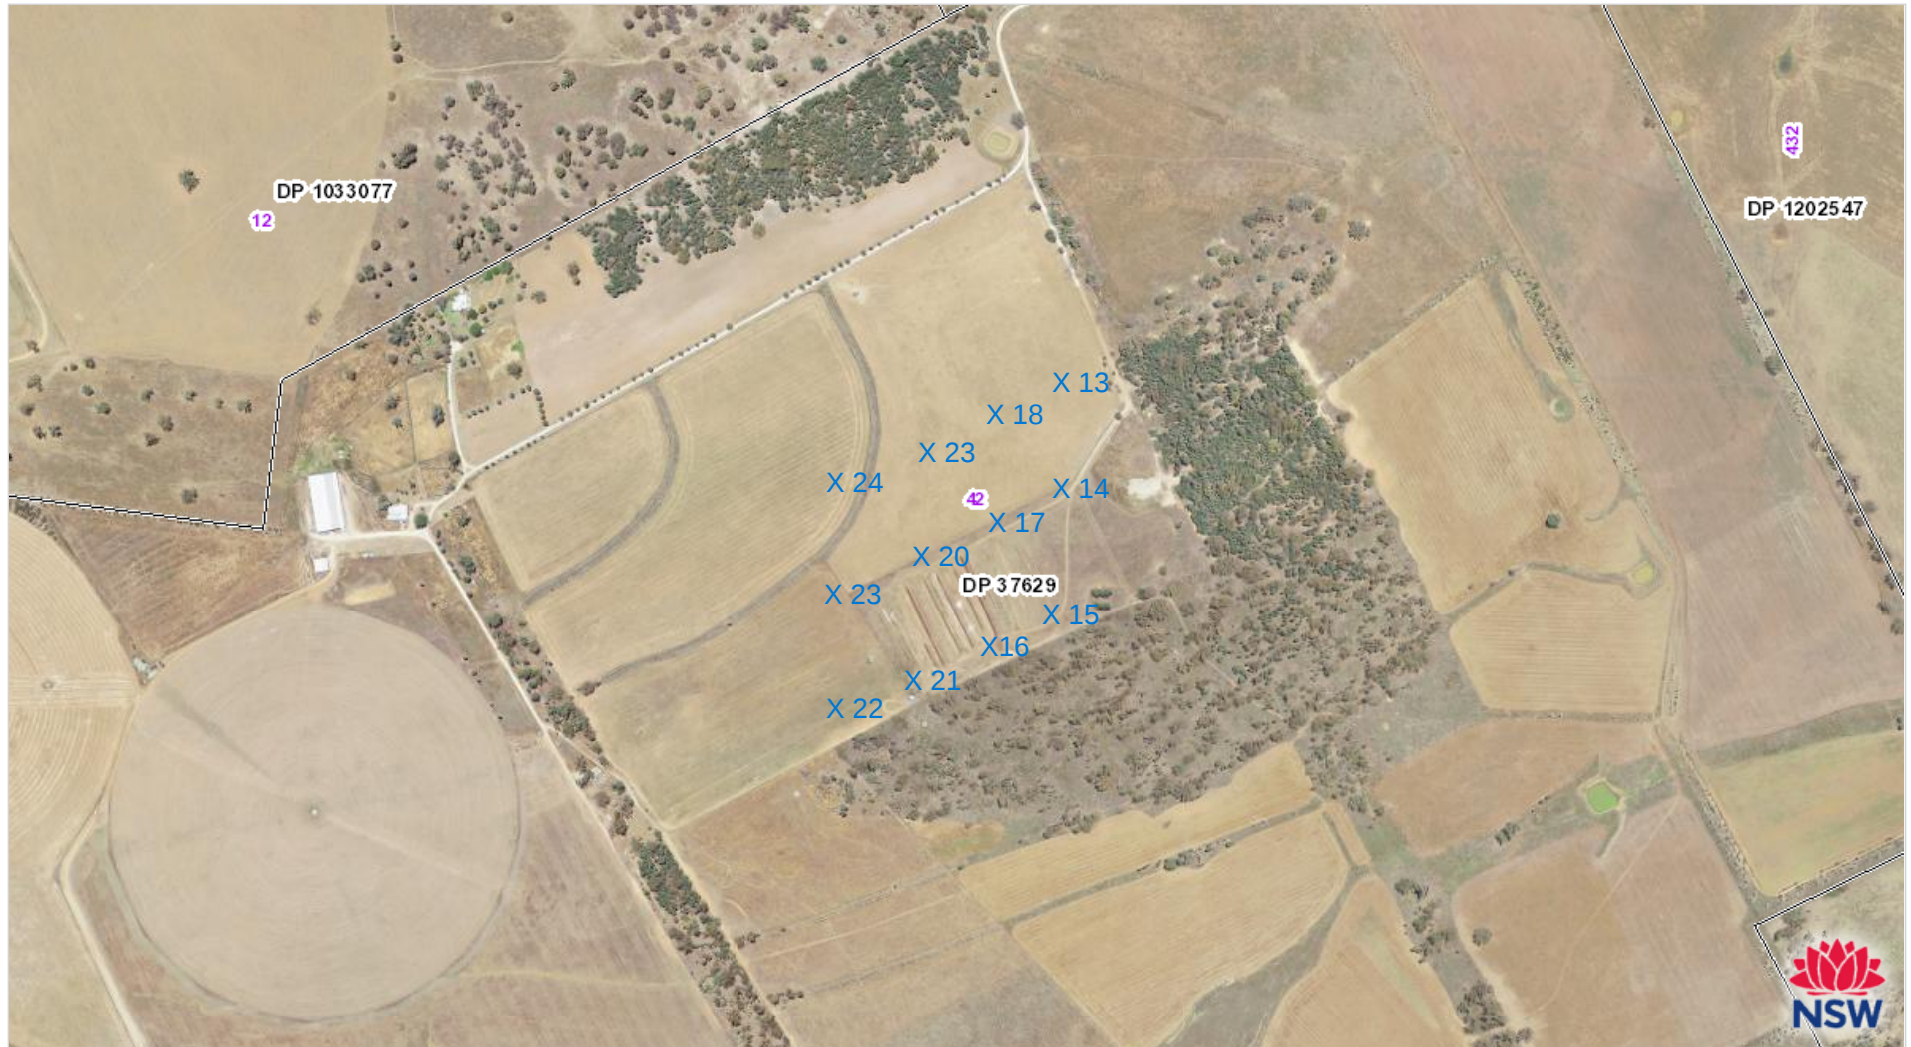
## Site 2

775 Warrah Ridge Road

The site investigation work and laboratory testing were undertaken by GSG, the results of which are presented in the attachments. The investigations included the drilling of twenty four boreholes at the locations illustrated on the attached figure.
