**Report on Preliminary Geotechnical  
Investigation and Effluent Disposal  
Assessment**

**Vacy Village South Stage 5 Residential  
Subdivision**

**598 Gresford Road, Vacy NSW**

**Project 91432.06**

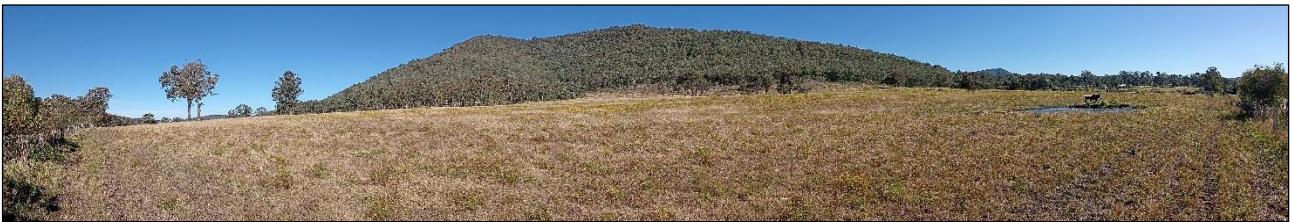
**Figure 1: Looking west from the eastern corner of the site, Mt Johnstone in the background**

- Site vegetation mainly consisted of grass with sporadic mature trees (refer Figure 1 and Figure 2 below, and Photos 1 to 18);
- Sandstone was observed outcropping in the western and southern portions of the site (Photos 9 and 11);

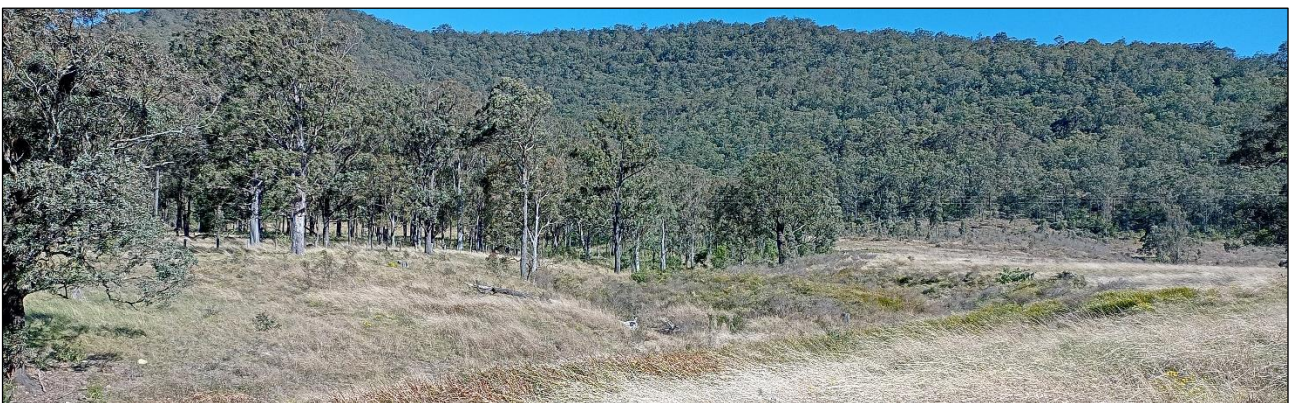
**Figure 3: Looking south-west along the major gully on the south-eastern site boundary**

- A third gully from Mt Johnstone follows the south-eastern site boundary (refer deep blue lines on Drawing 1 (R.002) in Appendix D and Figure 3 below);

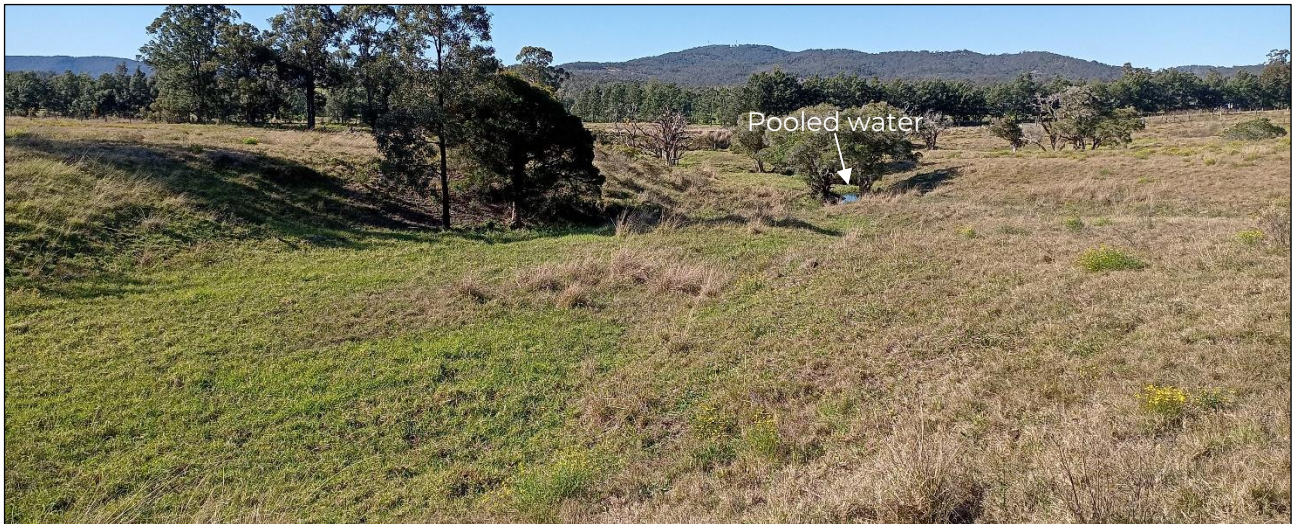
**Figure 4: Looking north-east along the gully in the northern part of the site (defined banks, pooled water and change in vegetation evident). Photo taken from Proposed Lot 507**

- Two incised drainage channels or gullies were observed within the northern and central, northern parts of the site. Both gullies slope down to the north and north-east, joining at the northern corner of Proposed Lot 505, where an existing culvert crosses Gresford Road, refer dark blue lines on Drawing 1 (R.002) in Appendix D, Figure 9 and Figure 10. The incised drainage channels or gullies showed evidence of erosion and contained pooled water (in parts) during the site walkover (refer Figure 4 to Figure 6 and Photos 10 to 13). Mature eucalyptus trees were observed along the banks of the incised drainage channels / gullies;

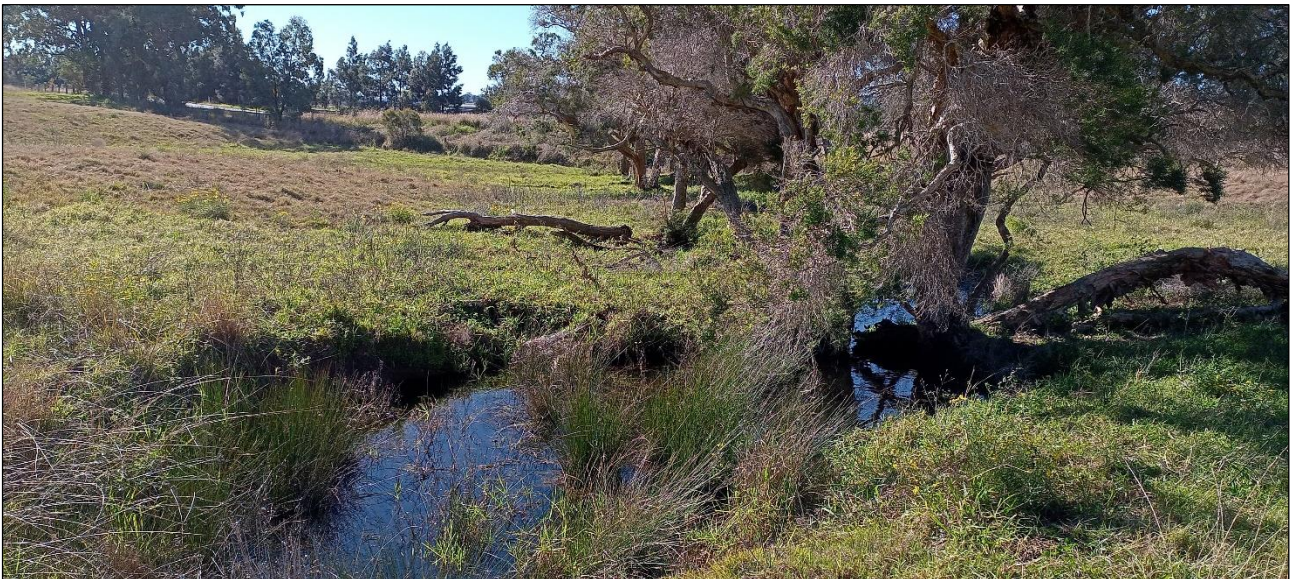
**Figure 5: Looking north-east across the gully in the central, northern part of the site. Photo taken from Proposed Lot 505. Gresford Road in background**

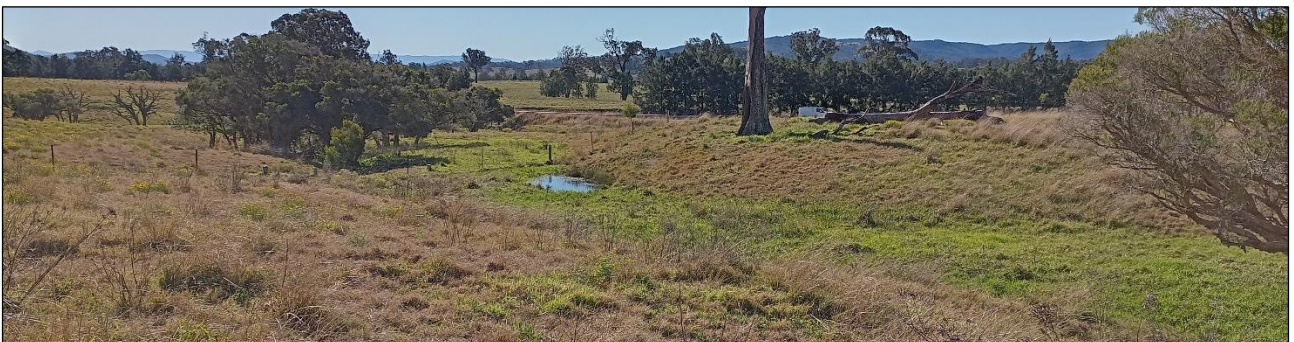
**Figure 6: Looking north along the gully in the central, northern part of the site. Photo taken from Proposed Lot 517. Gresford Road in background**

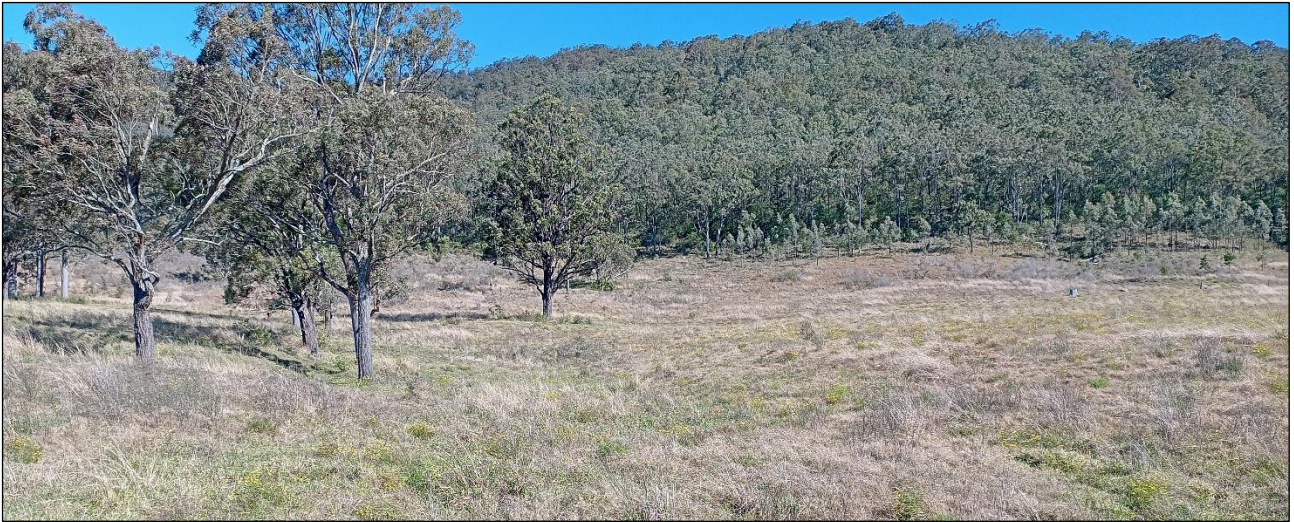
**Figure 7: Looking south-west along a drainage depression in the central part of the site. Photo taken from Proposed Lot 511**

- Several localised and shallow drainage depressions (less than 0.3 m deep) were observed within the central part of the site (refer light blue lines on Drawing 1 (R.002) in Appendix D, Photo 8, Figure 7 and Figure 8). The surface within these drainage depressions generally fell towards a gully in the central, northern part of the site. During the site walkover, it was noted that some areas within these drainage depressions were damp, with increased vegetation;

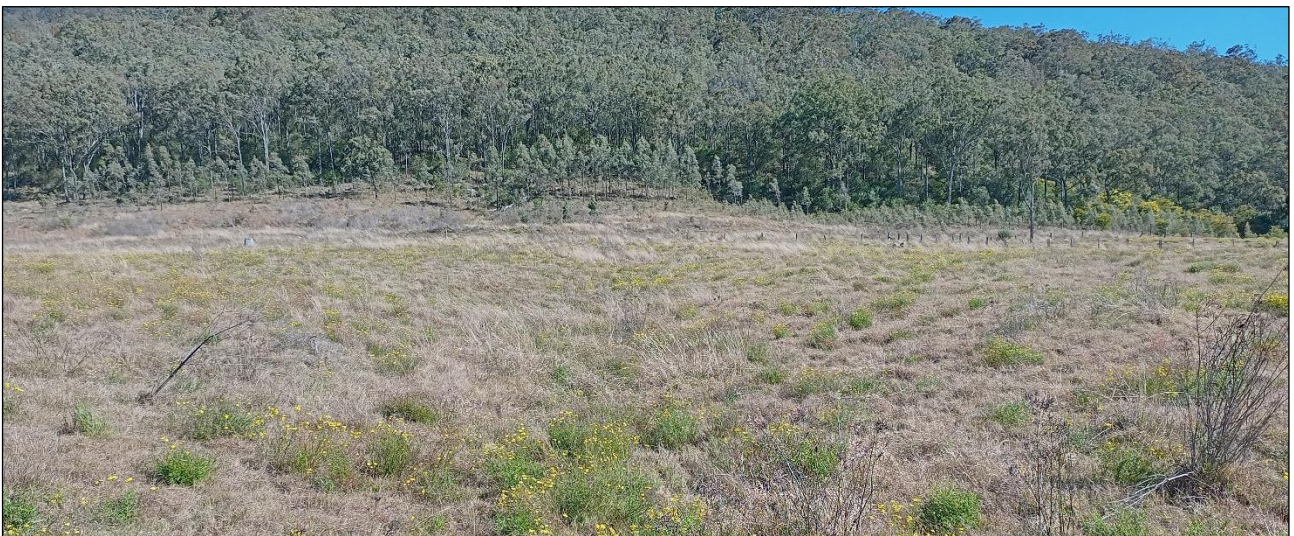
**Figure 8: Looking south-west along a drainage depression in the central part of the site. Photo taken from Proposed Lot 510**

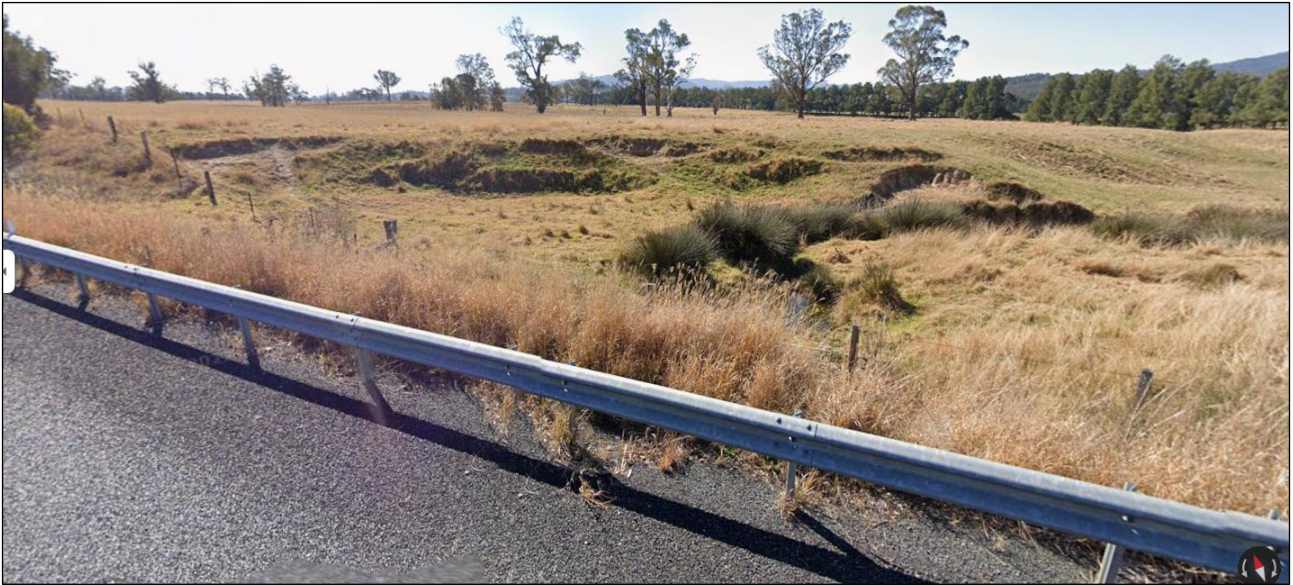
**Figure 10: Looking north-east from the culvert crossing on Gresford Road. Significant erosion downstream of the culvert (image from Google Maps street view dated Aug 2023)**

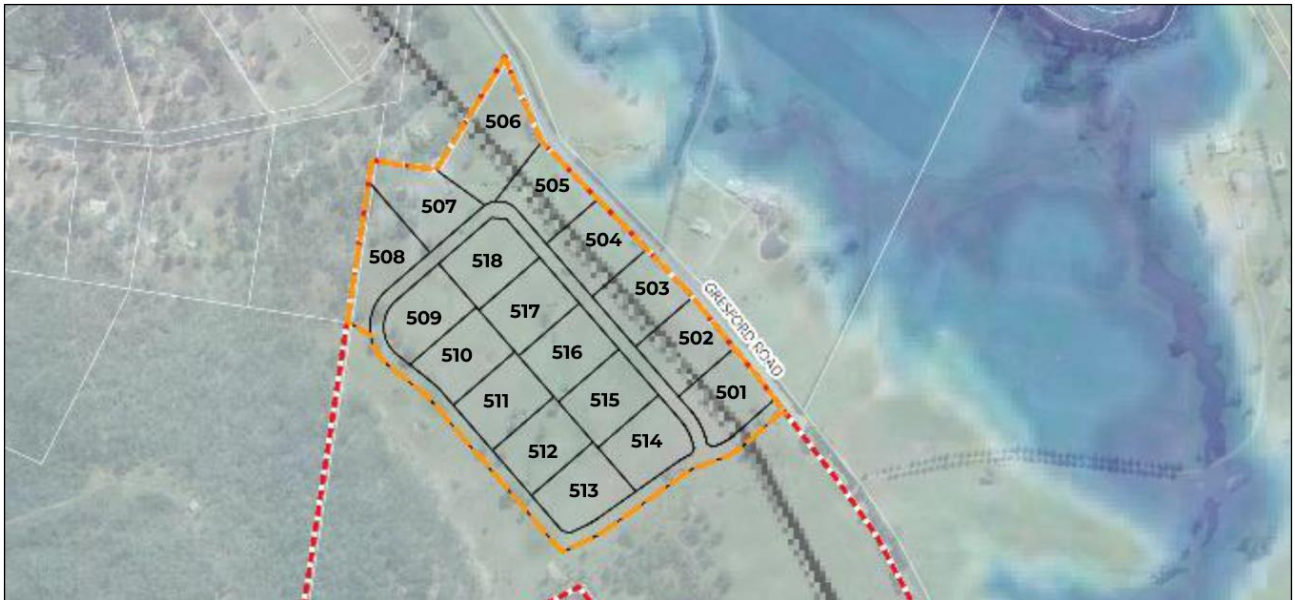
**Figure 11: 1% AEP flooding extent (excerpt from IDC (2026))**

- Flooding at Vacy is associated with long-duration riverine behaviour and forecast-driven warning conditions. Councils Patterson River Flood Study identifies the 36-hour duration as the critical 1% annual exceedance probability (AEP) event and the 72-hour duration as critical for the probable maximum flood (PMF) event;
- The proposed lots are primarily flood free for the modelled 1% AEP flood event (refer Figure 11 below); and
- Proposed Lots 504 to 506 are partially impacted along the north-eastern lot boundary and Gresford Road for the modelled PMF event (refer Figure 12 below). Estimated flood depths ranged between 0 m and 2 m.

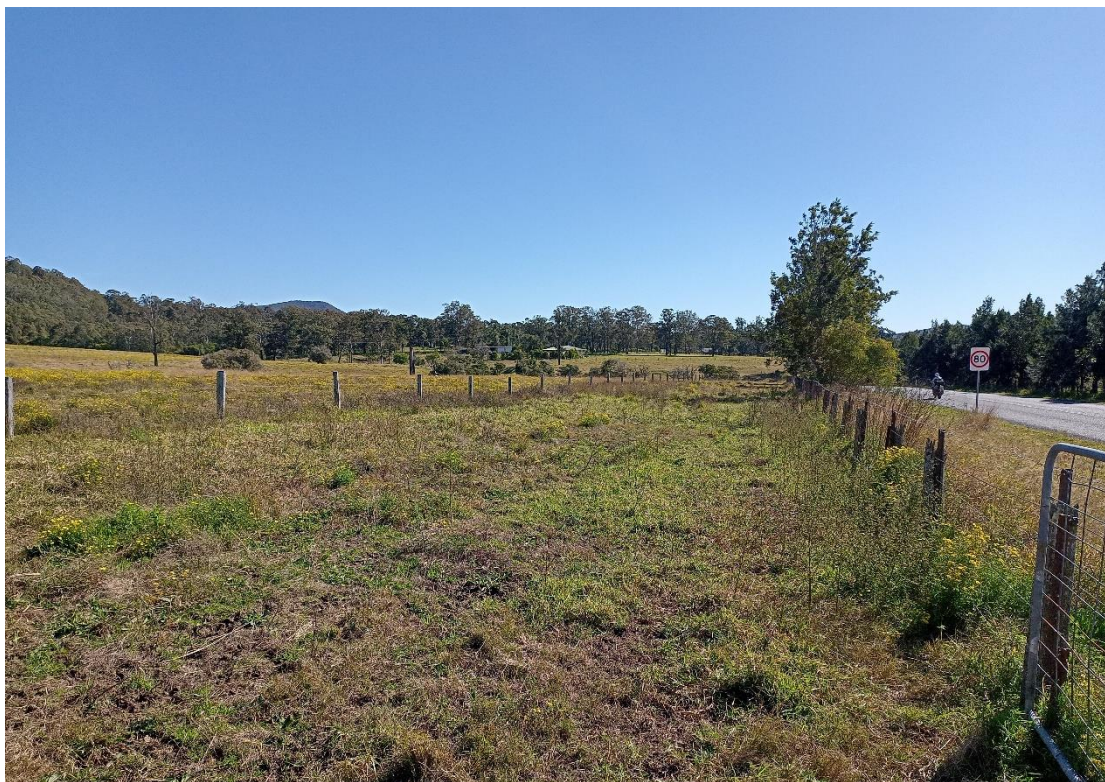
Photo 1: Looking north-west along the eastern boundary of the site from Proposed Lot 513.

- Boggy / saturated ground conditions were observed predominantly within lower lying areas in the north-eastern portion of the site, along the north-eastern site boundary (Photo 1) and locally within the shallow drainage depressions in the central part of the site;

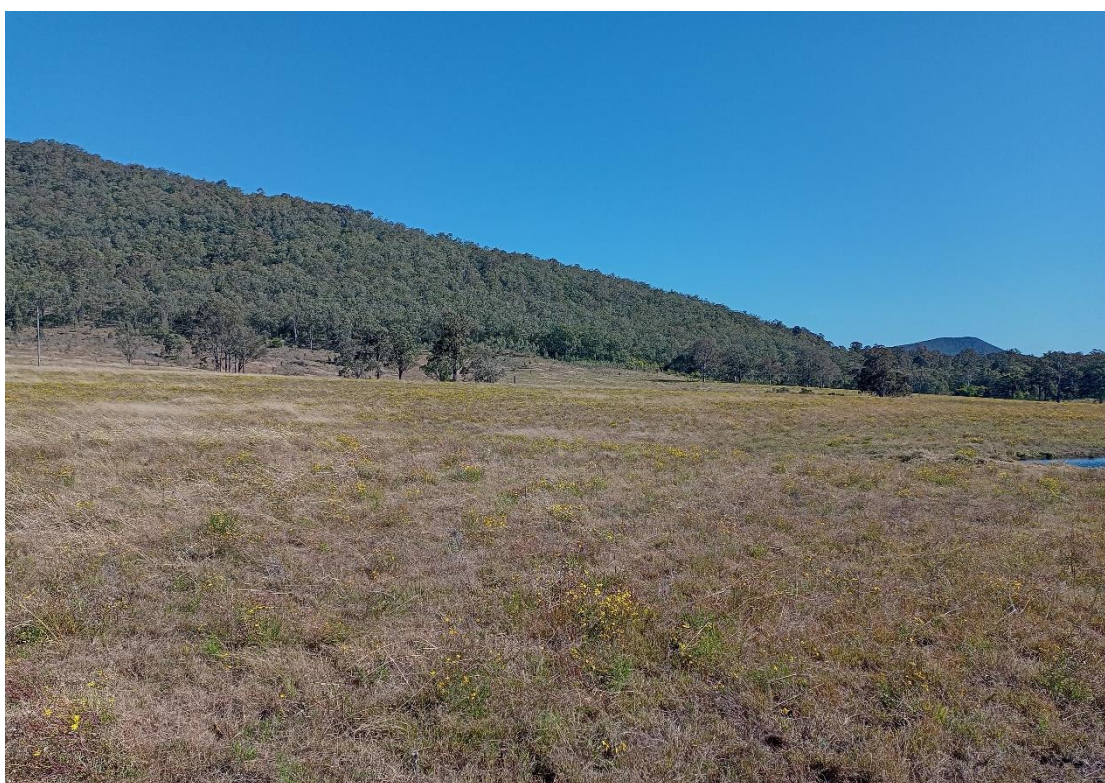
Photo 2: Looking south-west across the site from the eastern corner of Proposed Lot 502.

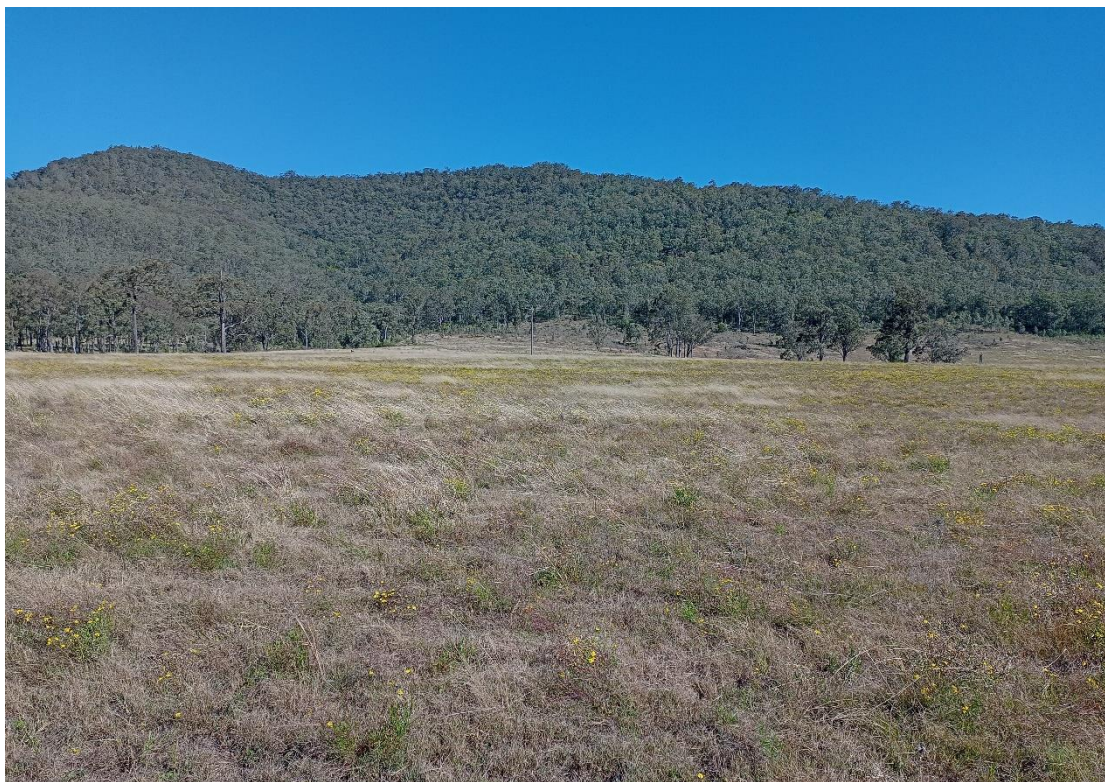
Photo 3: Looking west across the central portion of the site from the eastern corner of Proposed Lot 502.

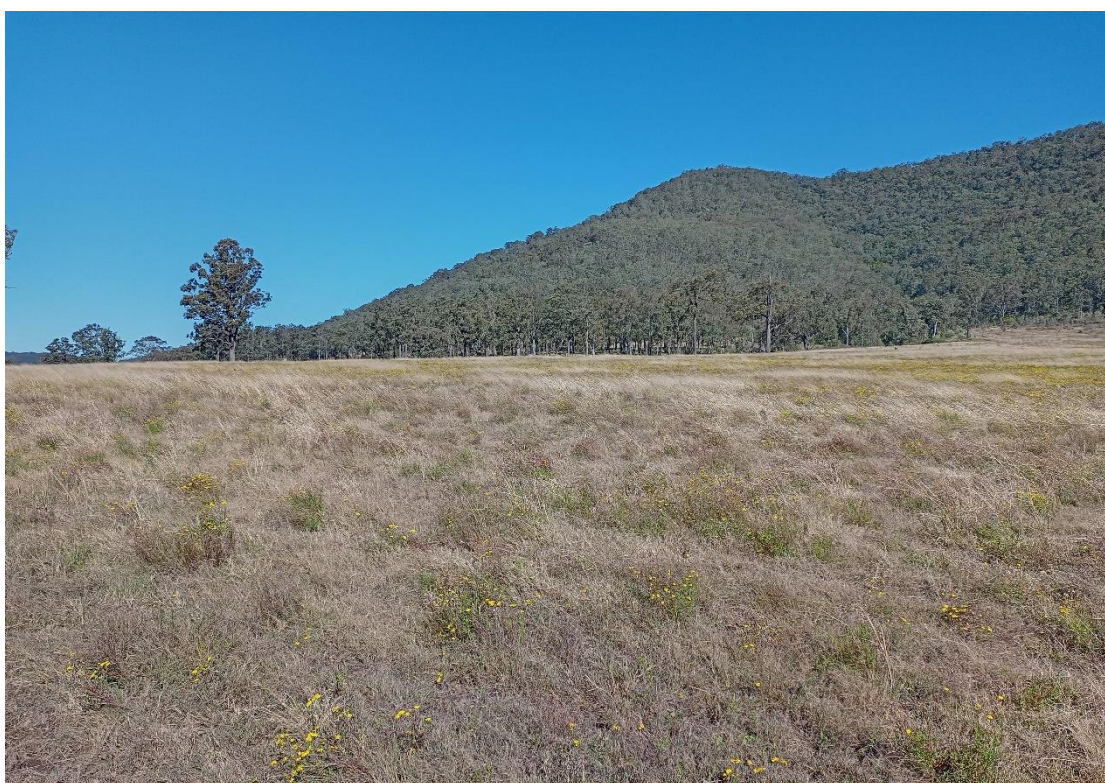
Photo 4: Looking south-west across the site from the eastern corner of Proposed Lot 502.

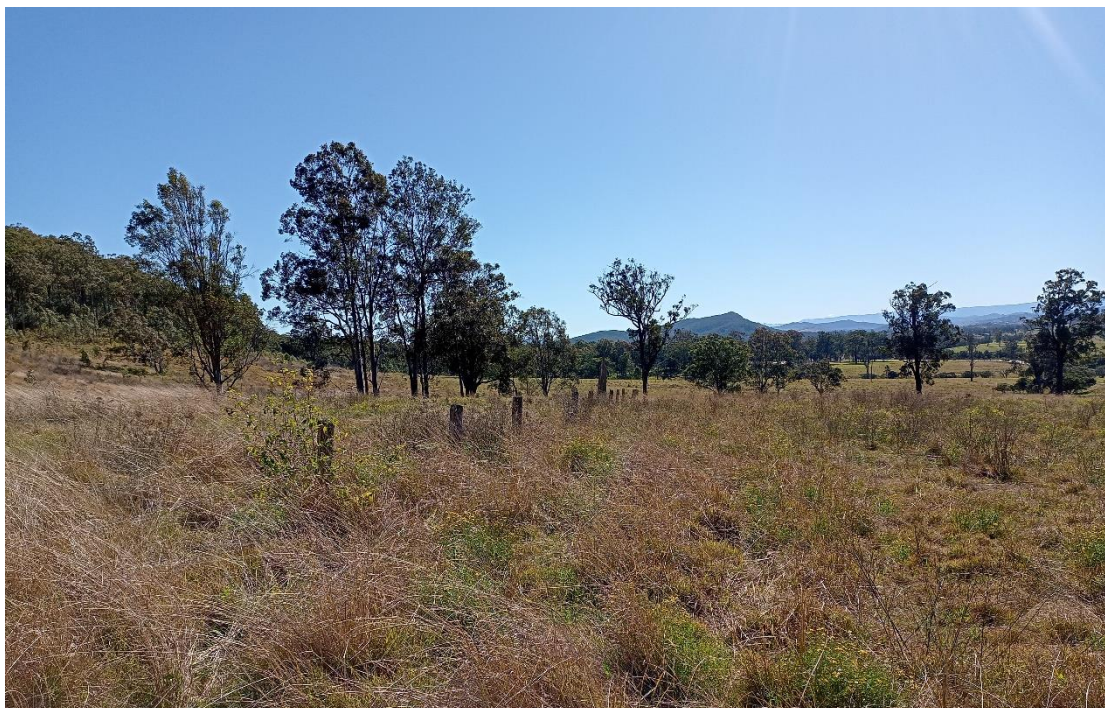
Photo 5: Looking north-west across the site from the southern corner of Proposed Lot 513. Remnant fence posts observed

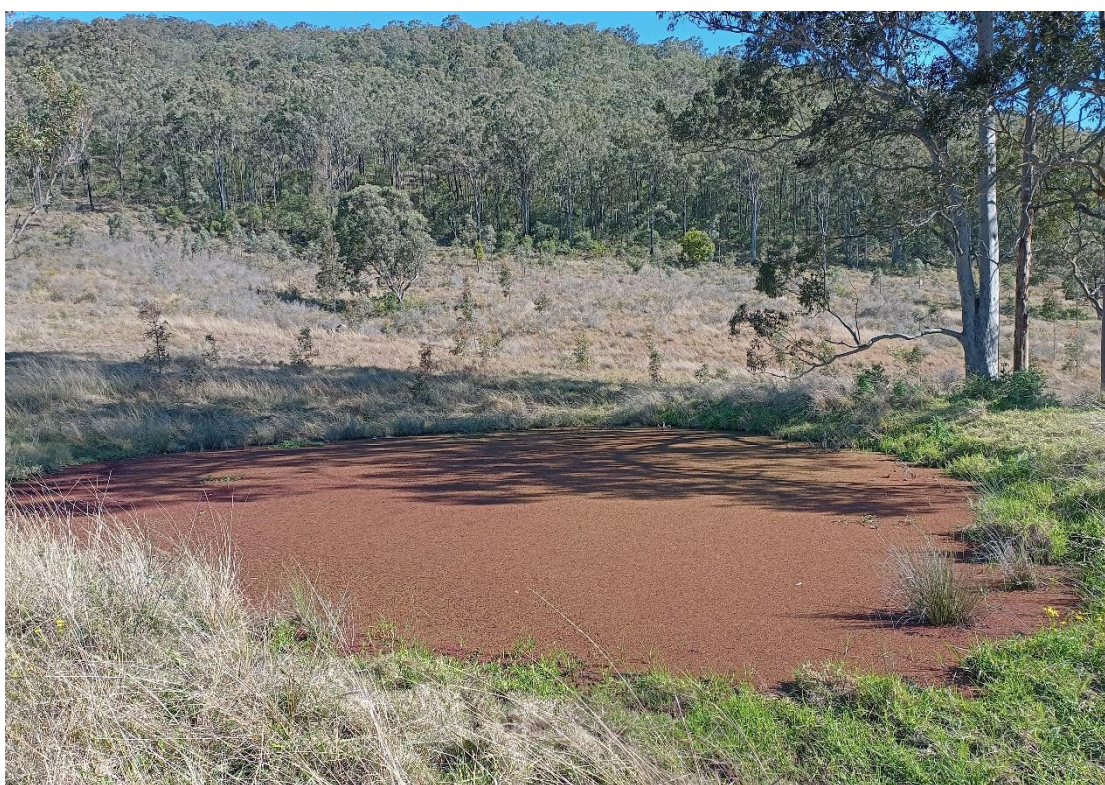
Photo 6: Looking across Dam 3 along the south-western boundary of the site from Proposed Lots 512 and 513.

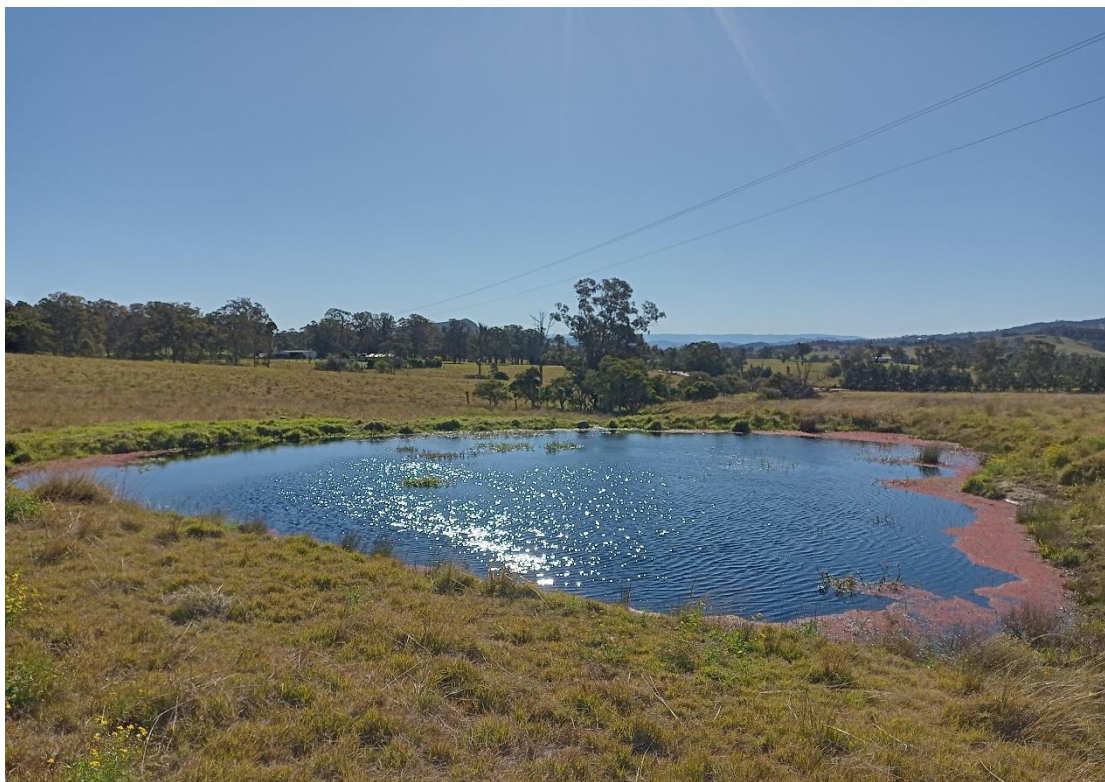
Photo 7: Looking north-west across Dam 5 from the western corner of Proposed Lot 515.

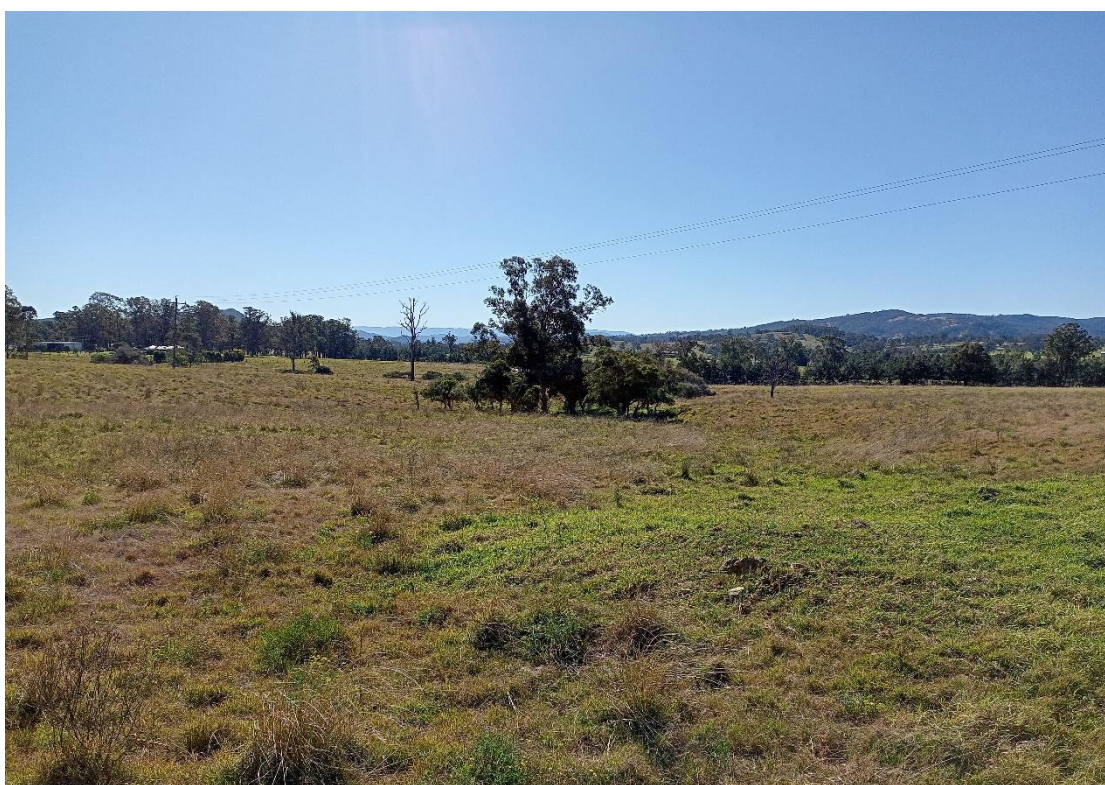
Photo 8: Looking north-east along a localised drainage depression within Proposed Lot 511.

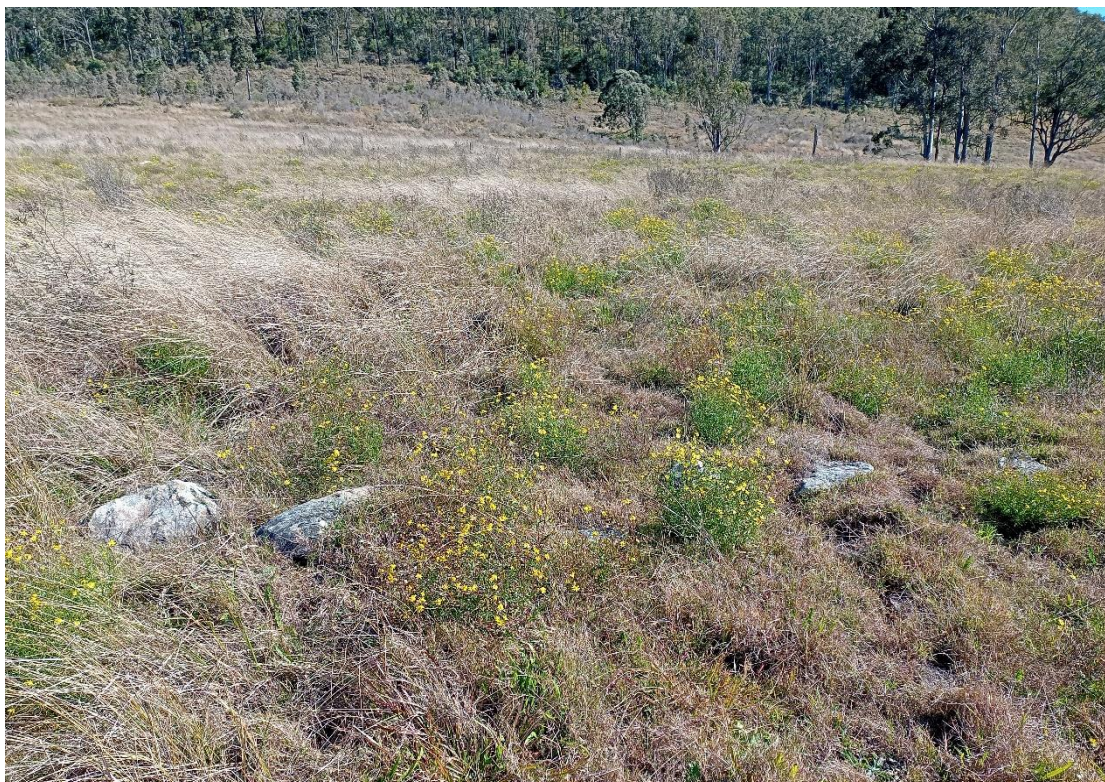
Photo 9: Sandstone boulders observed at the surface along proposed Road No. 1 (adjacent Proposed Lot 510)

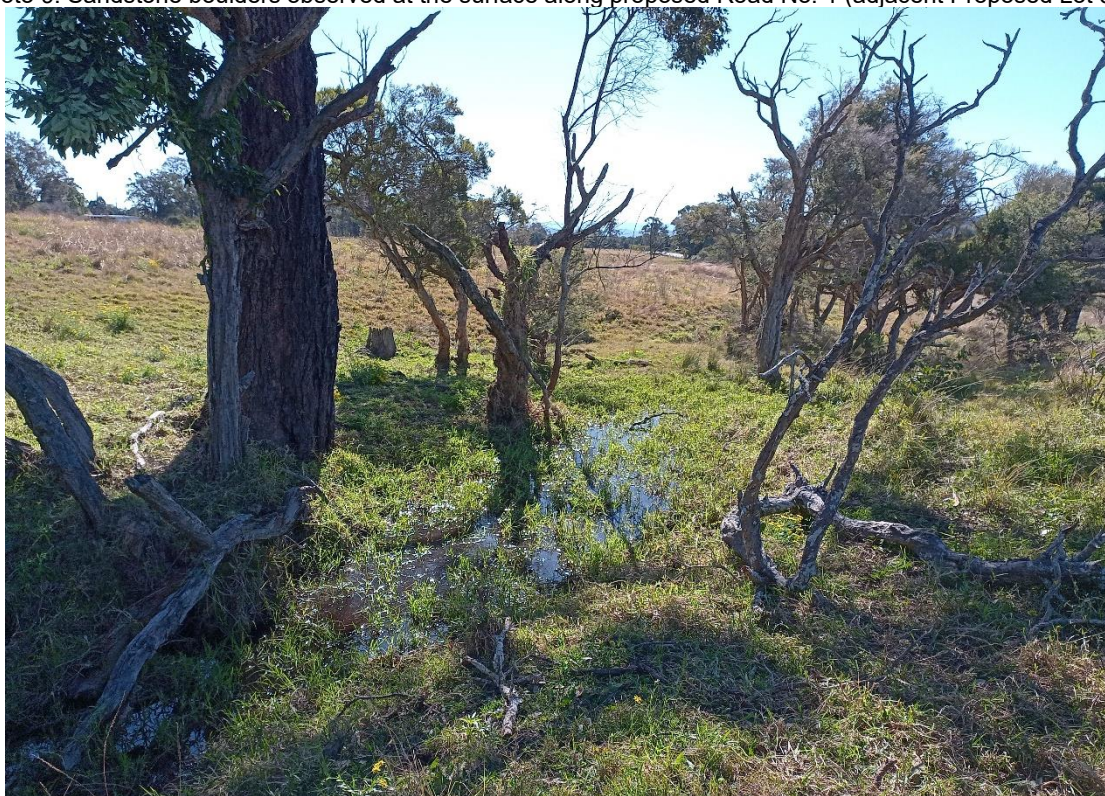
Photo 10: Looking approximately north-east along an intermittent watercourse in the central, northern part of the site (Proposed Lot 516). Pooled surface water observed.

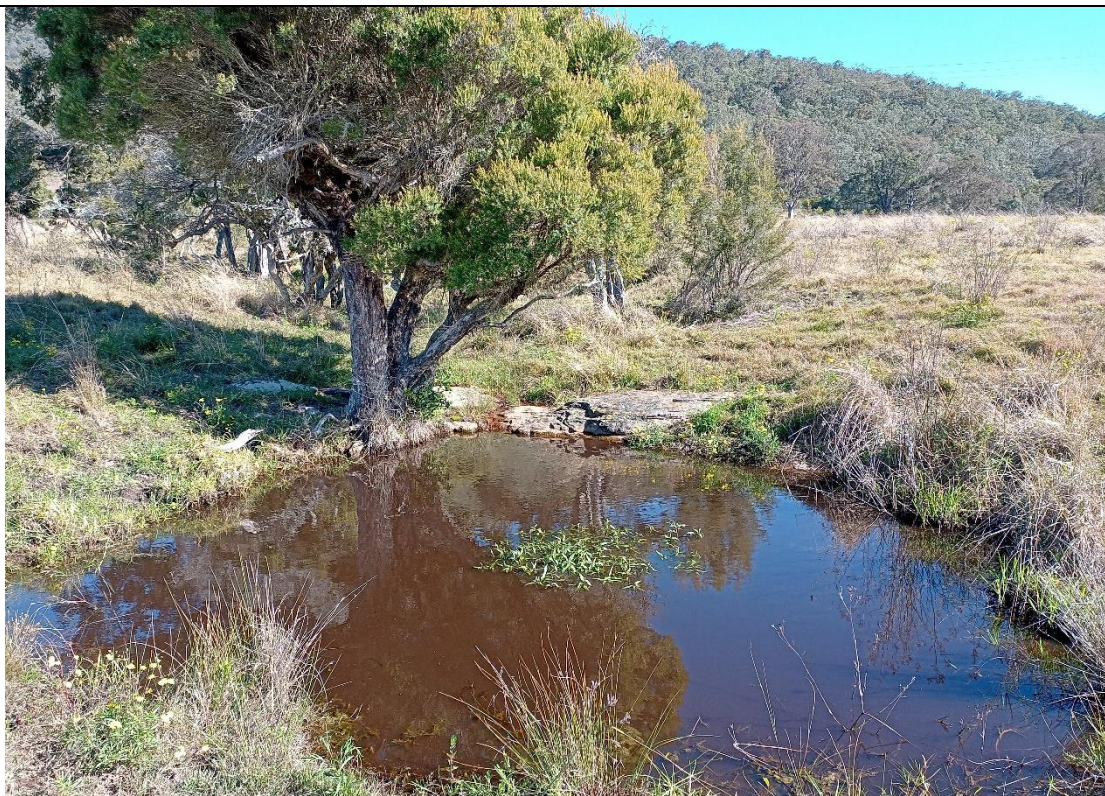
Photo 11: Pooled surface water observed within the intermittent watercourse in the central portion of the site (Proposed Lot 517).

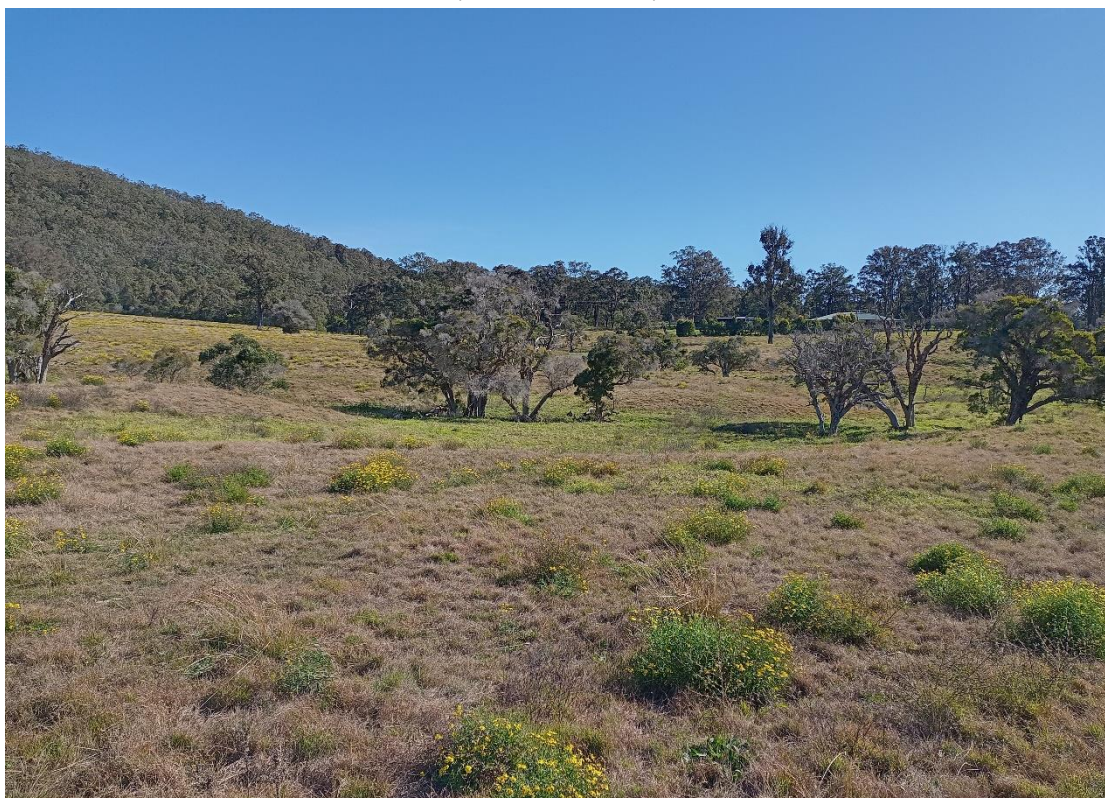
Photo 12: Looking west across the site from the north-eastern portion of the site (Proposed Lot 505). Intermittent watercourse in the background

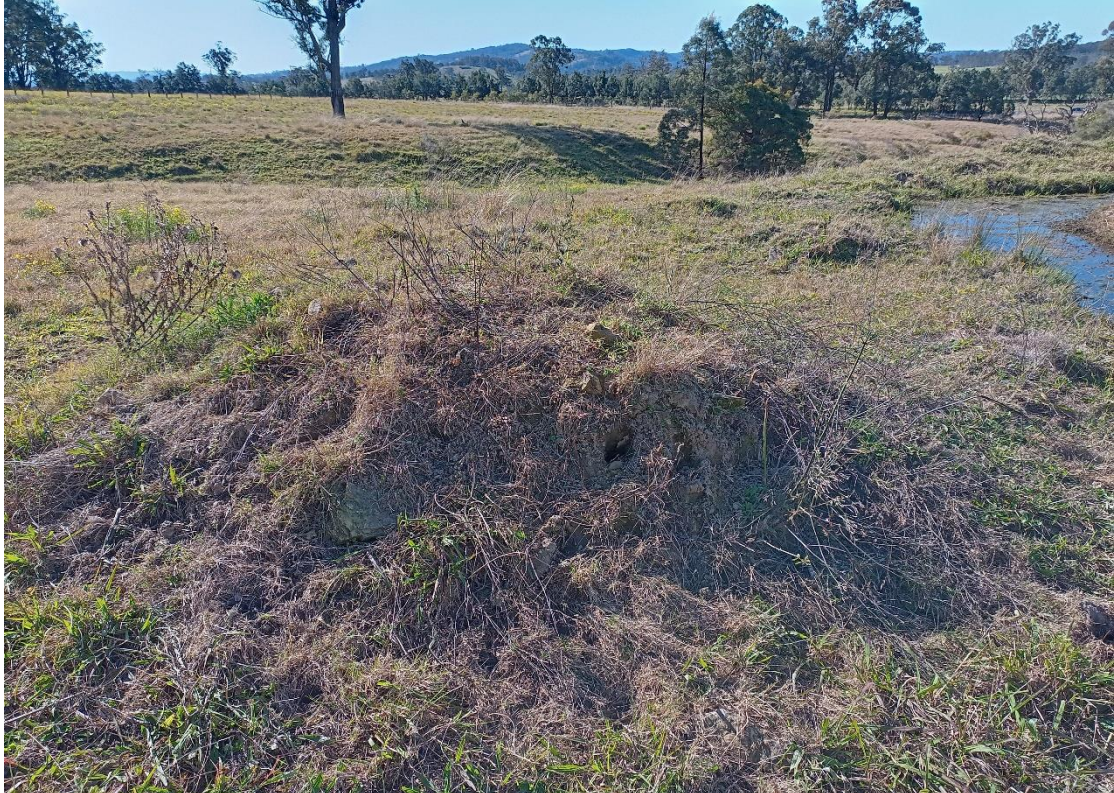
Photo 13: Stockpiled materials located directly adjacent Dam 9 (right of photo) within Proposed Lot 507. Intermittent watercourse in background.

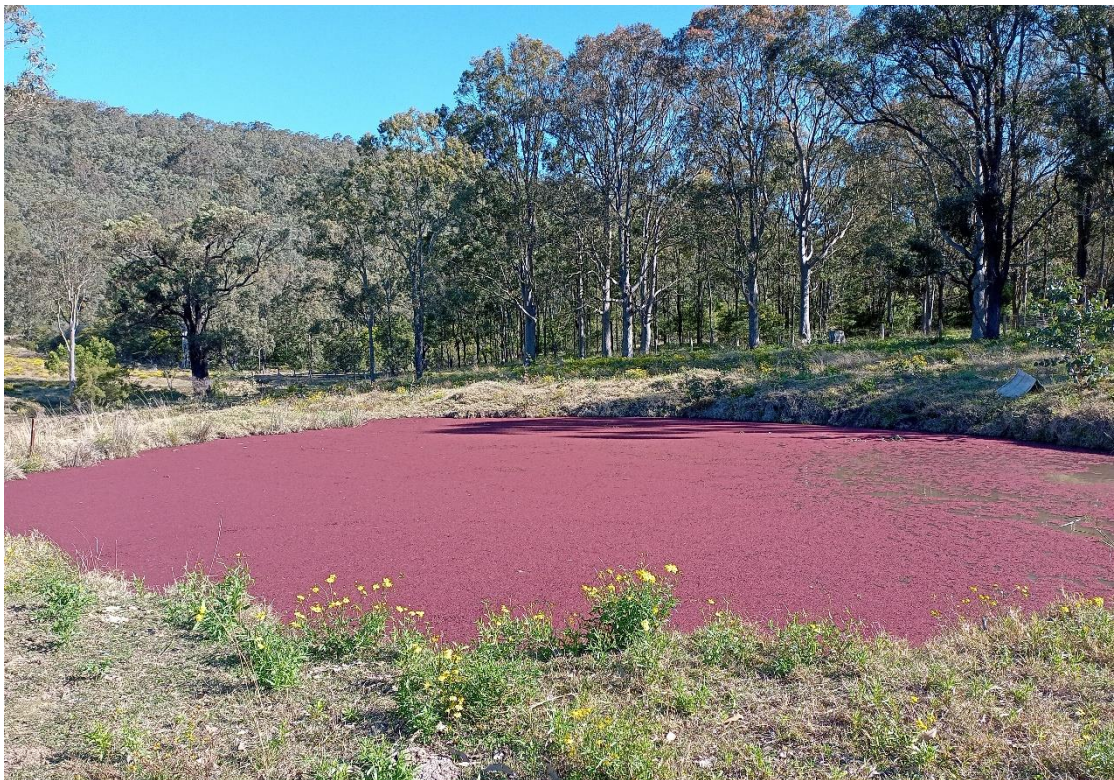
Photo 14: Dam 9 located in the north-western corner of the site,

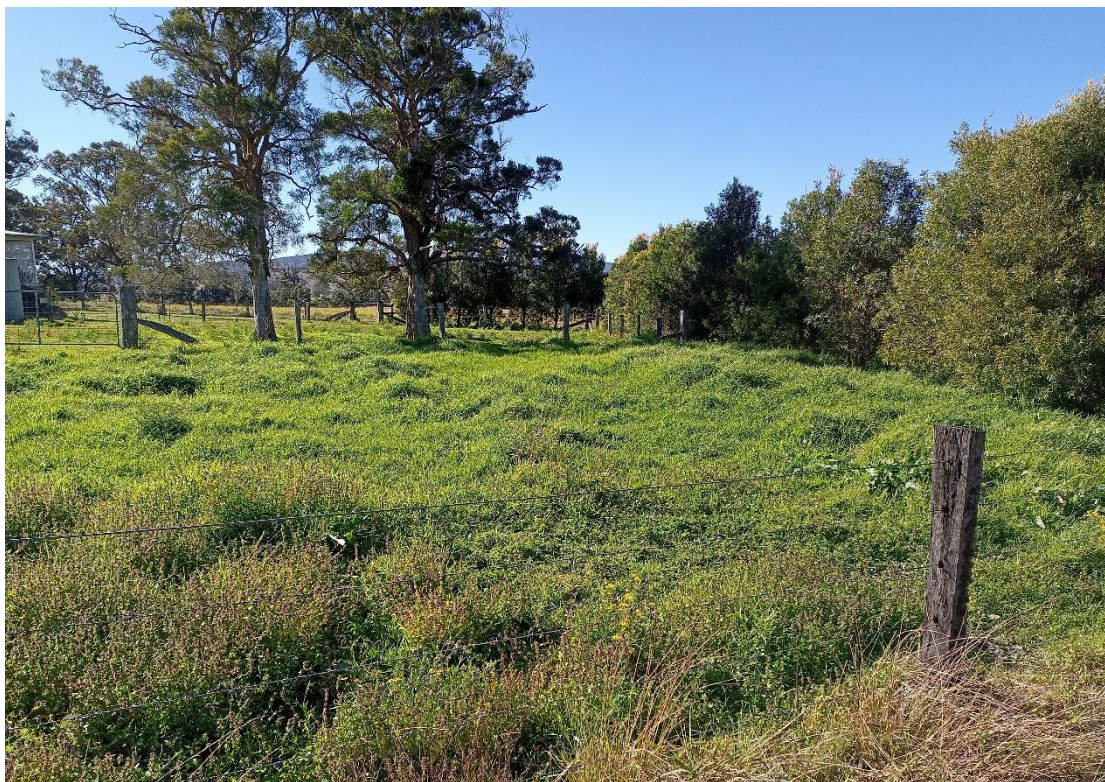
Photo 15: Possible residential effluent disposal area on adjacent property north of the site.

- A ninth dam is situated on approximately 30 m south-west of the south-western site boundary (refer Drawing 1 (R.002) in Appendix D); and
- A bright green grassed area (possible effluent disposal area) was observed in the backyard of the residential property located directly adjacent the north-western boundary of the site (Photos 15 and 16).

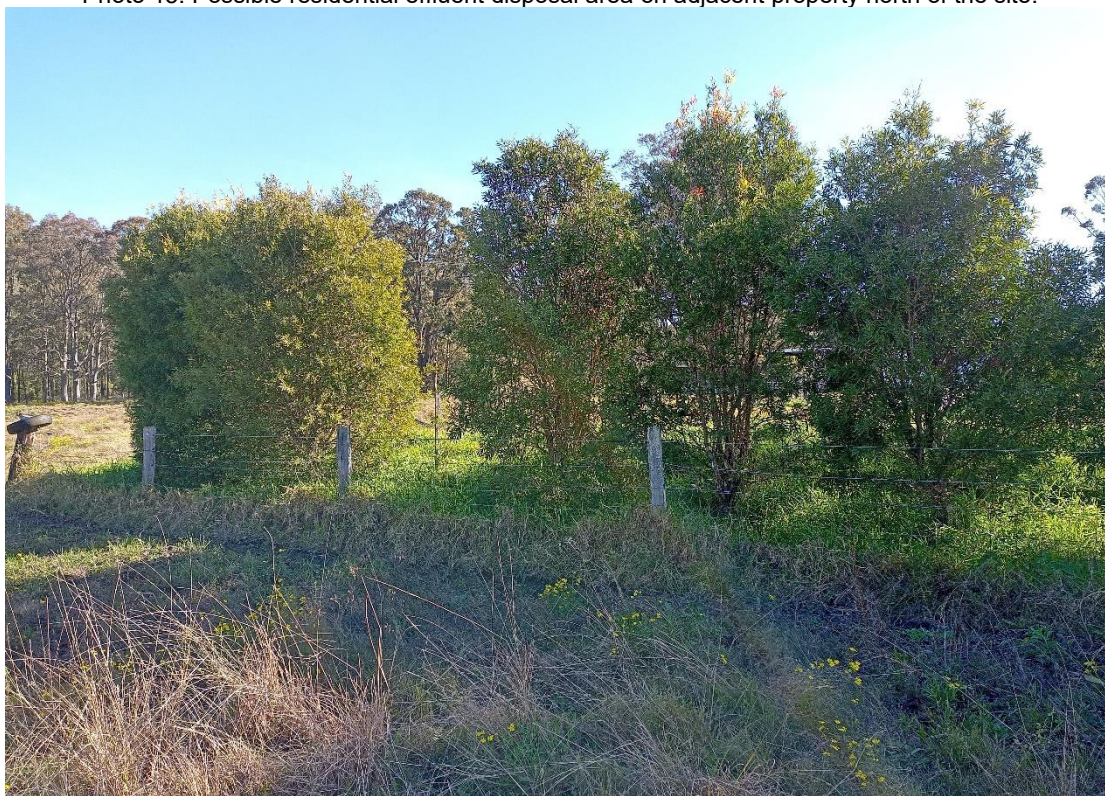
Photo 16: Bright green grass located adjacent the northern boundary within a residential property (possible effluent disposal area).

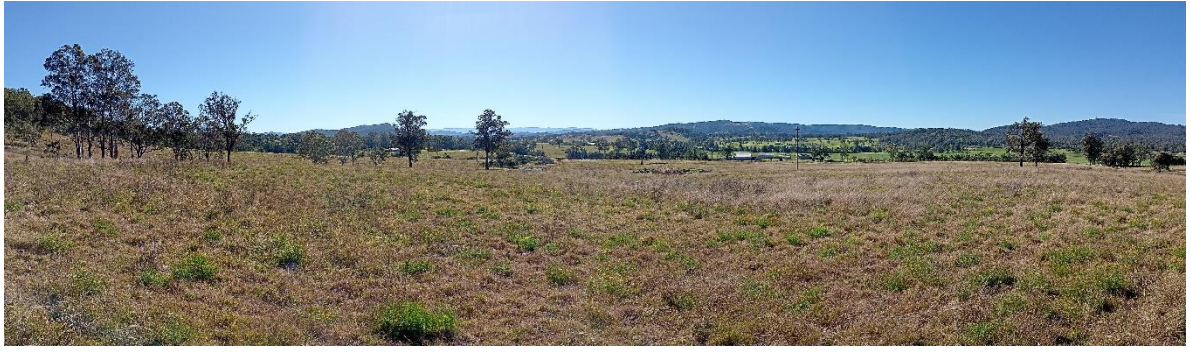
Photo 17: Looking east across the site from the western boundary.

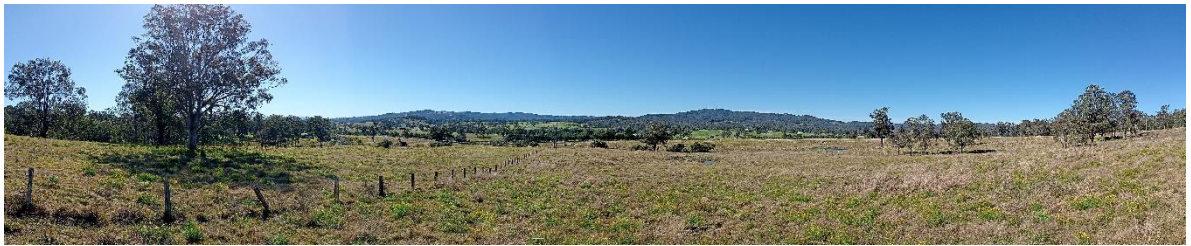
Photo 18: Looking east from the south-western site boundary across the central portion of the site.
