**Report on Preliminary Geotechnical  
Investigation and Effluent Disposal  
Assessment**

**Vacy Village South Stage 5 Residential  
Subdivision**

**598 Gresford Road, Vacy NSW**

**Project 91432.06**

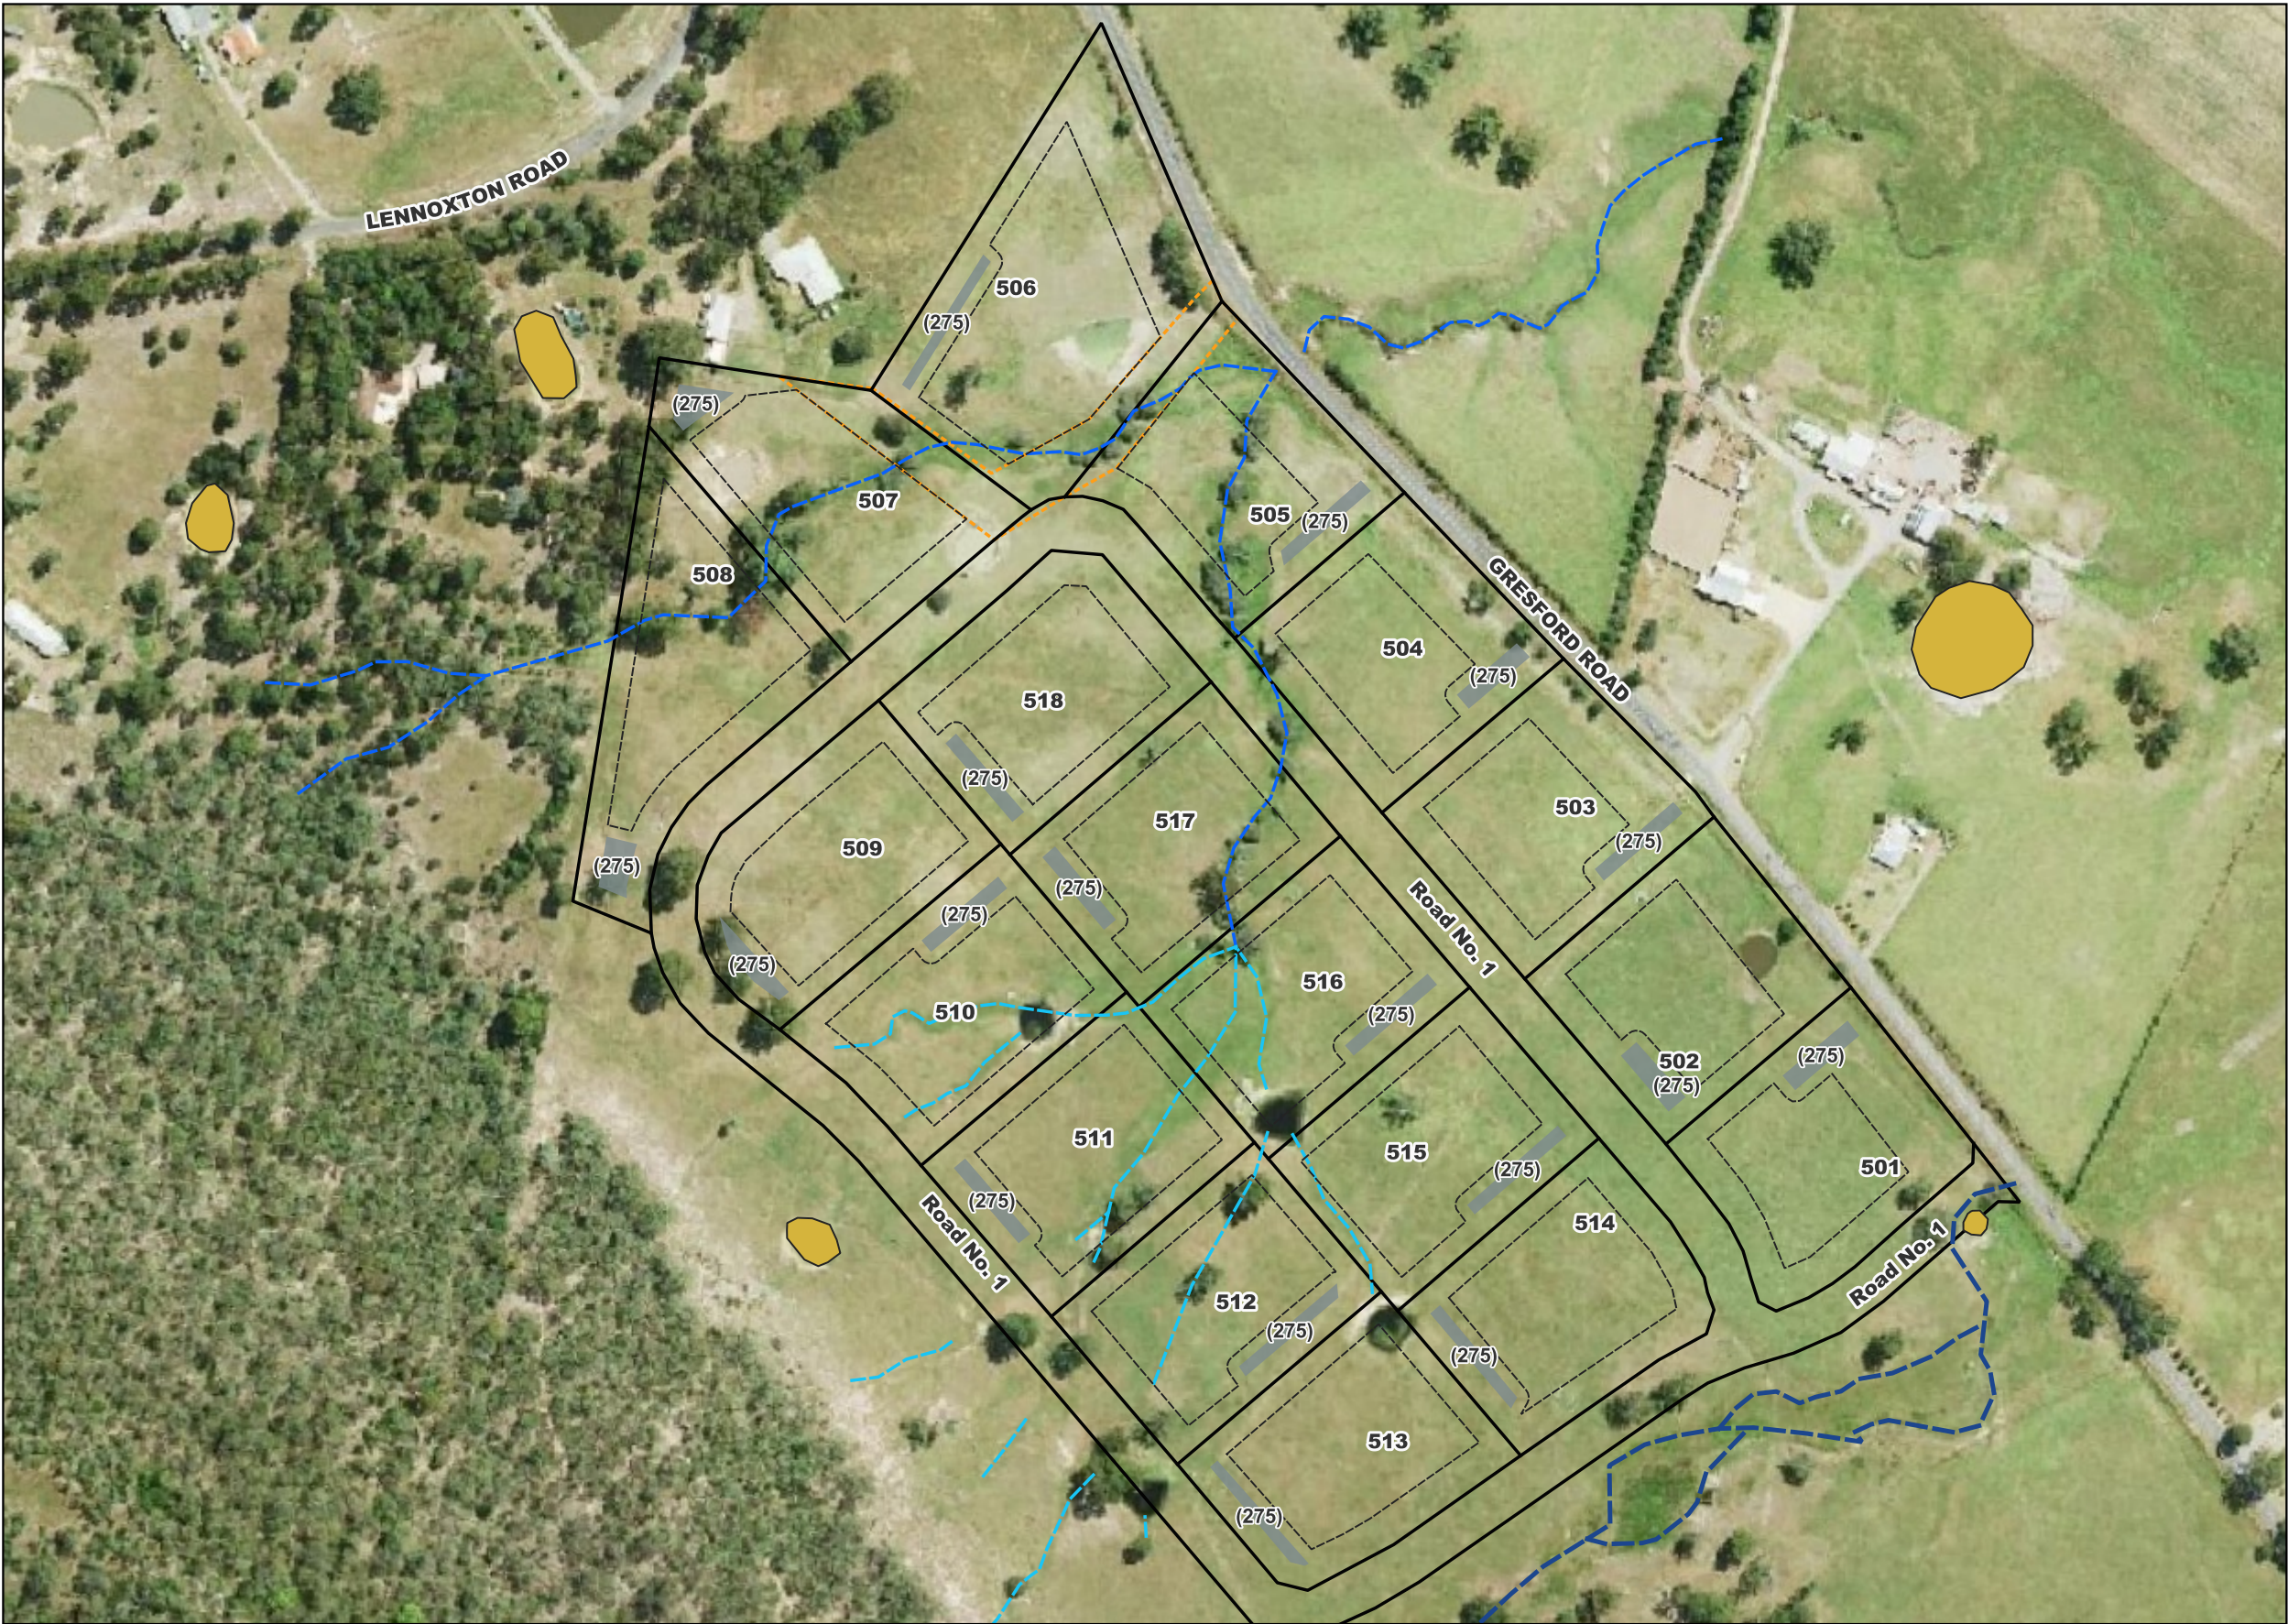
PROJECT: 91432.06  
DRAWING No: 5 (R.002)  
REVISION: 0

TITLE: **Recommended Effluent Application Areas - Greywater**  
**Vacy Village South Stage 5 Residential Subdivision**  
**598 Gresford Road, Vacy NSW**

Drawing 5 (R.002) - Recommended Effluent Application Areas – Greywater

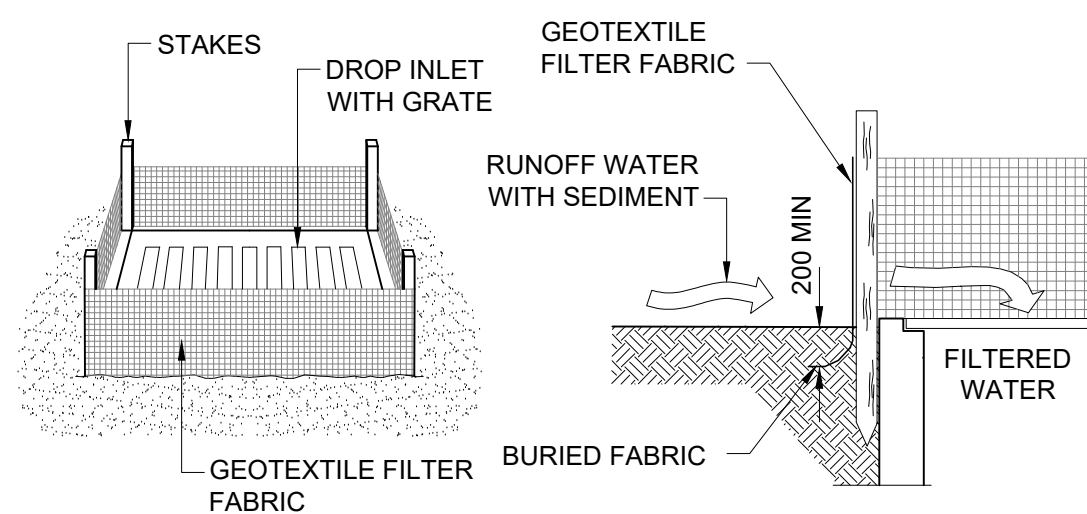
SEDIMENT TRAP FOR DROP INLET  
(GEOTEXTILE FILTER FABRIC)

- THE TEMPORARY ACCESS SHALL BE MAINTAINED IN A CONDITION THAT PREVENTS TRACKING OR FLOWING OF SEDIMENT ONTO PUBLIC RIGHTS OF WAY.
- THIS MAY REQUIRE PERIODIC TOP DRESSING WITH ADDITIONAL GRAVEL AS CONDITIONS DEMAND AND REPAIR AND/OR CLEANOUT OF ANY MEASURES USED TO TRAP SEDIMENT.
- ALL SEDIMENT SPILLED, DROPPED, WASHED OR TRACKED ONTO PUBLIC RIGHTS OF WAY MUST BE REMOVED IMMEDIATELY.

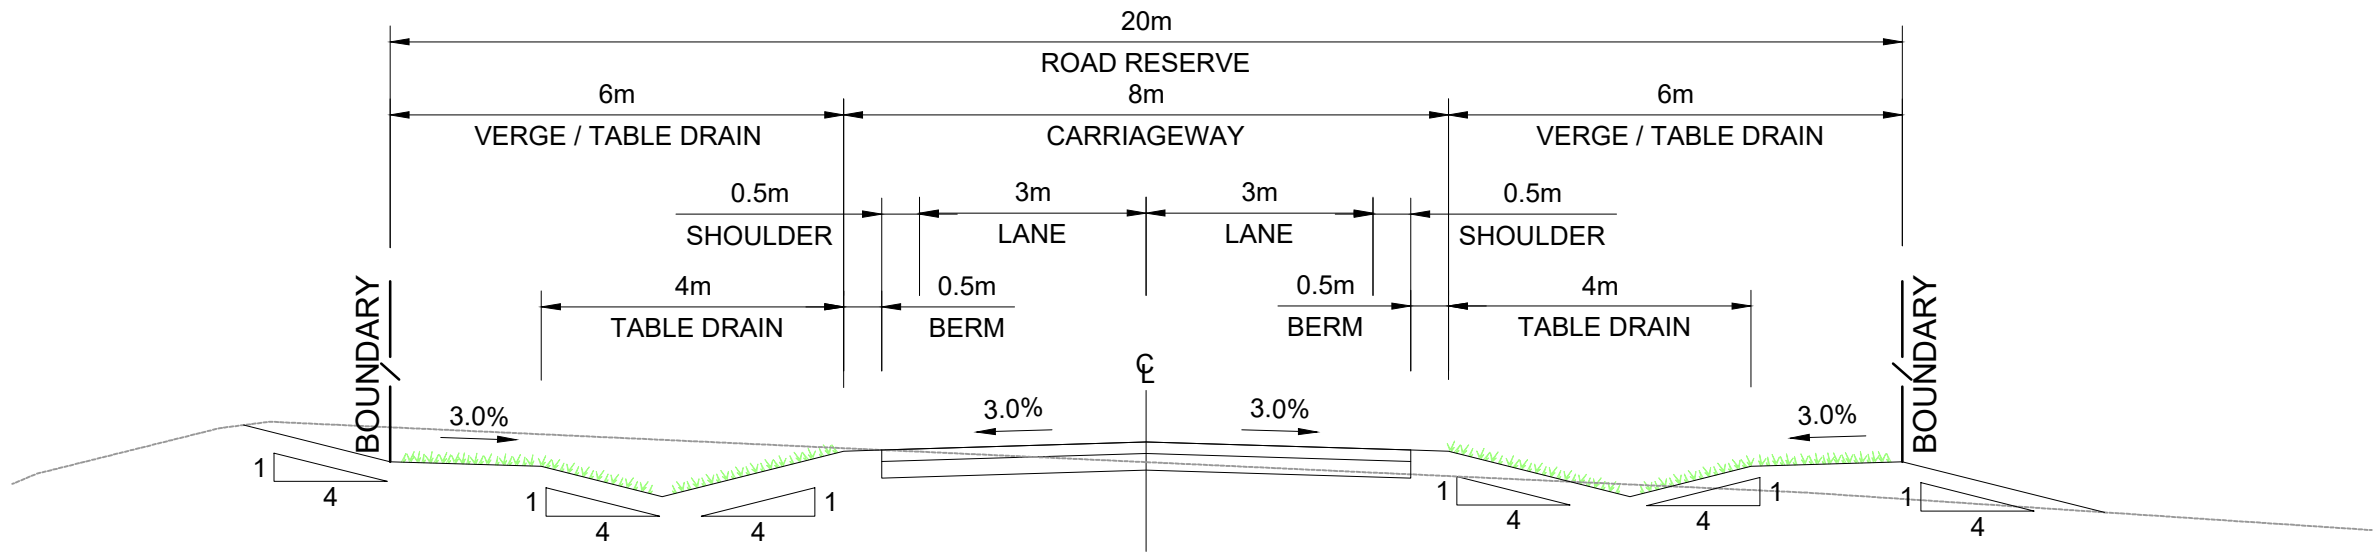
20m LOCAL ROAD  
ROAD 1  
1:100

PAVEMENT PROFILE\*  
WEARING COURSE = 30mm AC10 OR SPRAY SEAL  
BASE COURSE = 150mm DGB20 COMPACTED TO 98% MDD  
SUB BASE COURSE = 220mm CRUSHED SANDSTONE TO 95% MDD  
SUBGRADE = 200mm SELECT FILL (CRUSHED SANDSTONE) TO 100% SDD  
TRAFFIC ESA = 1 x 10<sup>6</sup>

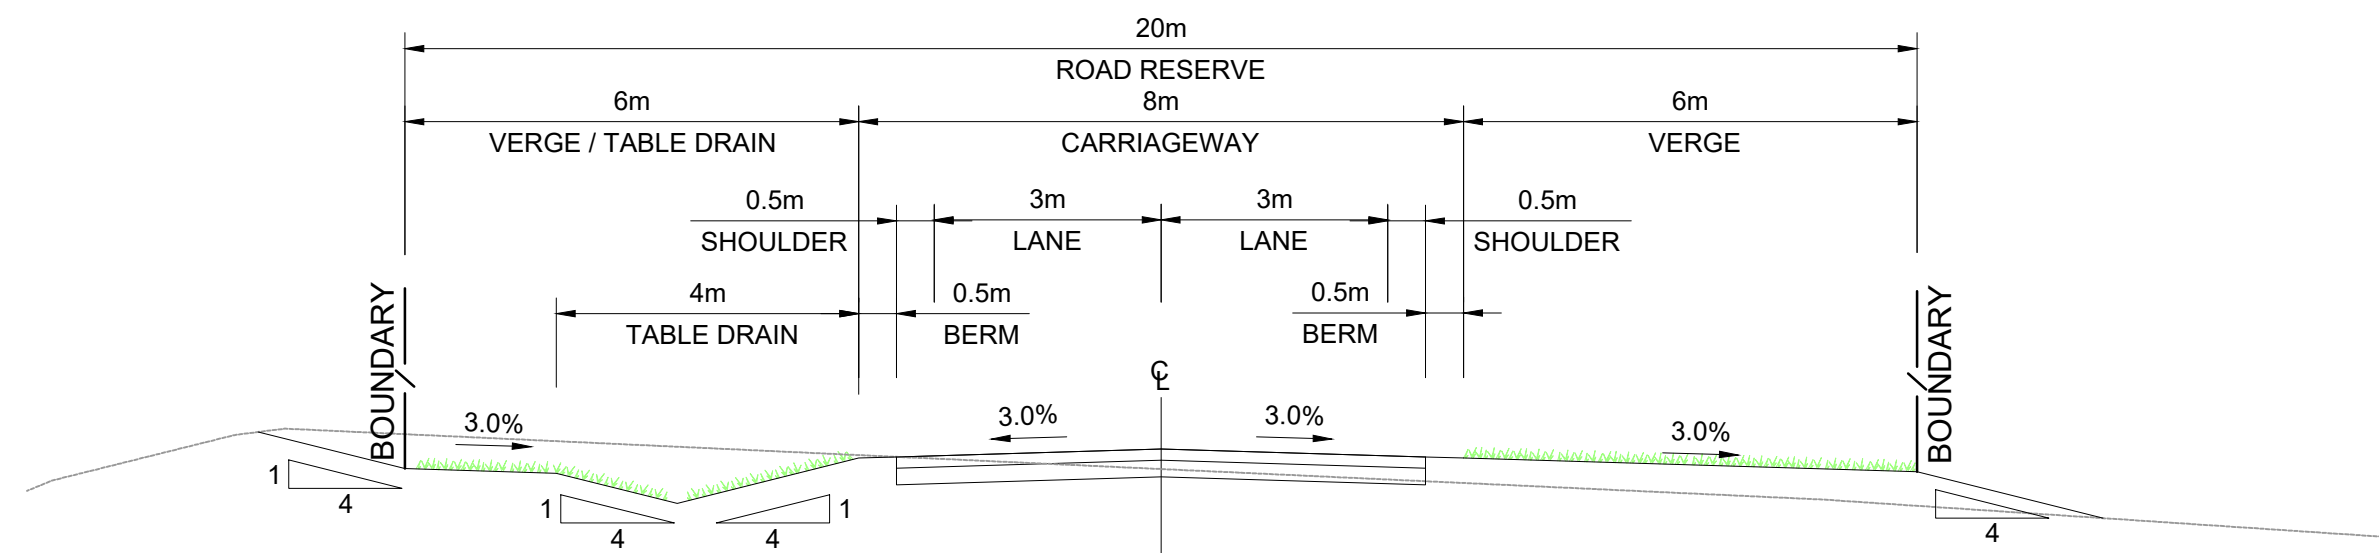
20m LOCAL ROAD  
ROAD 1  
(SWALE UPSTREAM ONLY)  
1:100

PAVEMENT PROFILE\*  
WEARING COURSE = 30mm AC10 OR SPRAY SEAL  
BASE COURSE = 150mm DGB20 COMPACTED TO 98% MDD  
SUB BASE COURSE = 220mm CRUSHED SANDSTONE TO 95% MDD  
SUBGRADE = 200mm SELECT FILL (CRUSHED SANDSTONE) TO 100% SDD  
TRAFFIC ESA = 1 x 10<sup>6</sup>

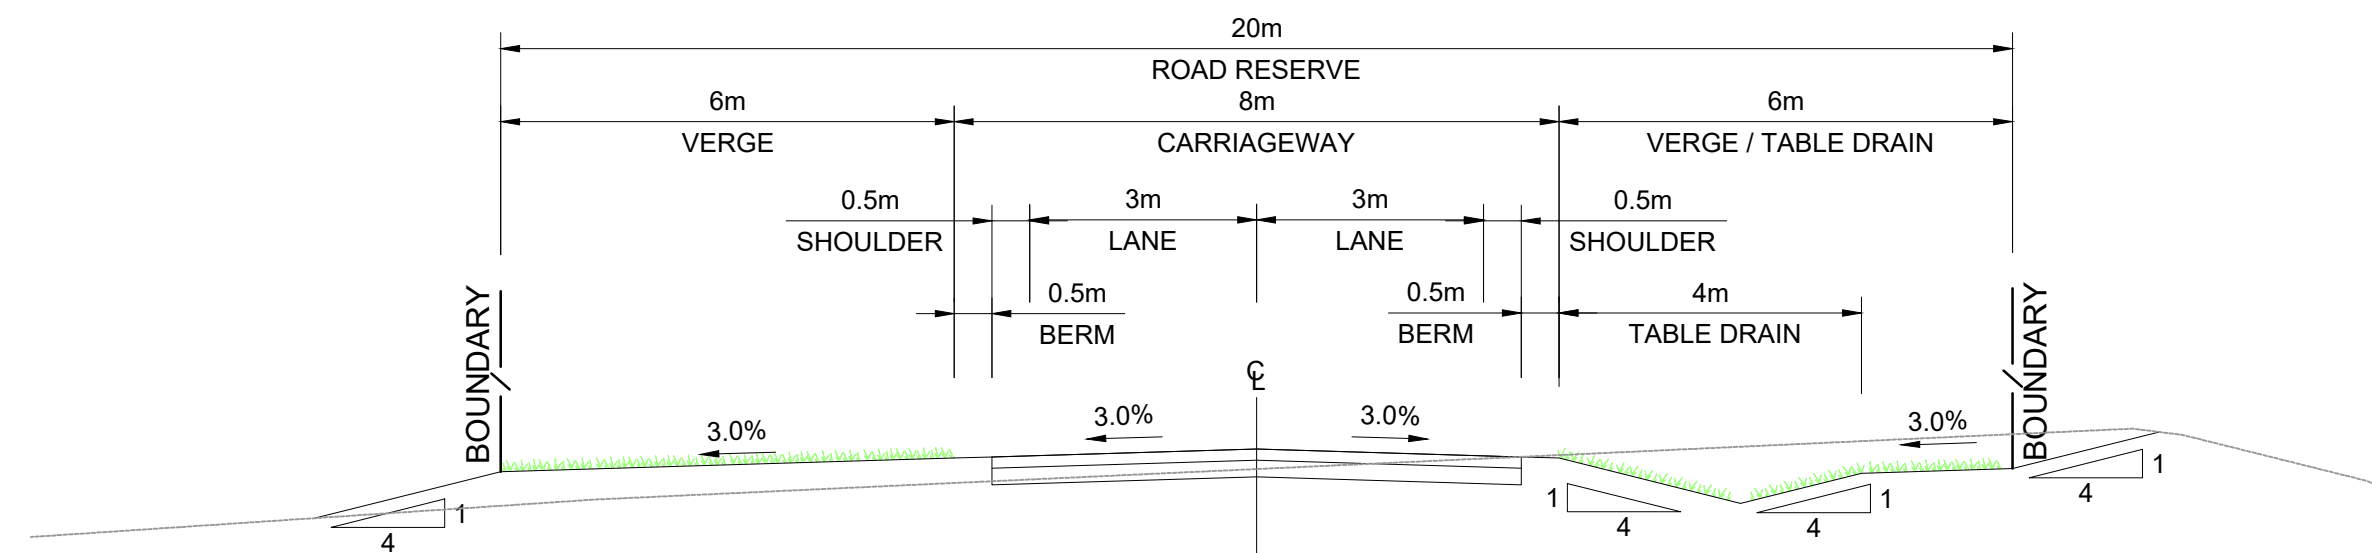
20m LOCAL ROAD  
ROAD 1  
(SWALE DOWNSTREAM ONLY)  
1:100

PAVEMENT PROFILE\*  
WEARING COURSE = 30mm AC10 OR SPRAY SEAL  
BASE COURSE = 150mm DGB20 COMPACTED TO 98% MDD  
SUB BASE COURSE = 220mm CRUSHED SANDSTONE TO 95% MDD  
SUBGRADE = 200mm SELECT FILL (CRUSHED SANDSTONE) TO 100% SDD  
TRAFFIC ESA = 1 x 10<sup>6</sup>
