# Preliminary Site Investigation

## SUPAGAS CARBON DIOXIDE PLANT

**MAY 2026**

Prepared for: Onward Consulting Pty Ltd on behalf of Supagas Pty Ltd

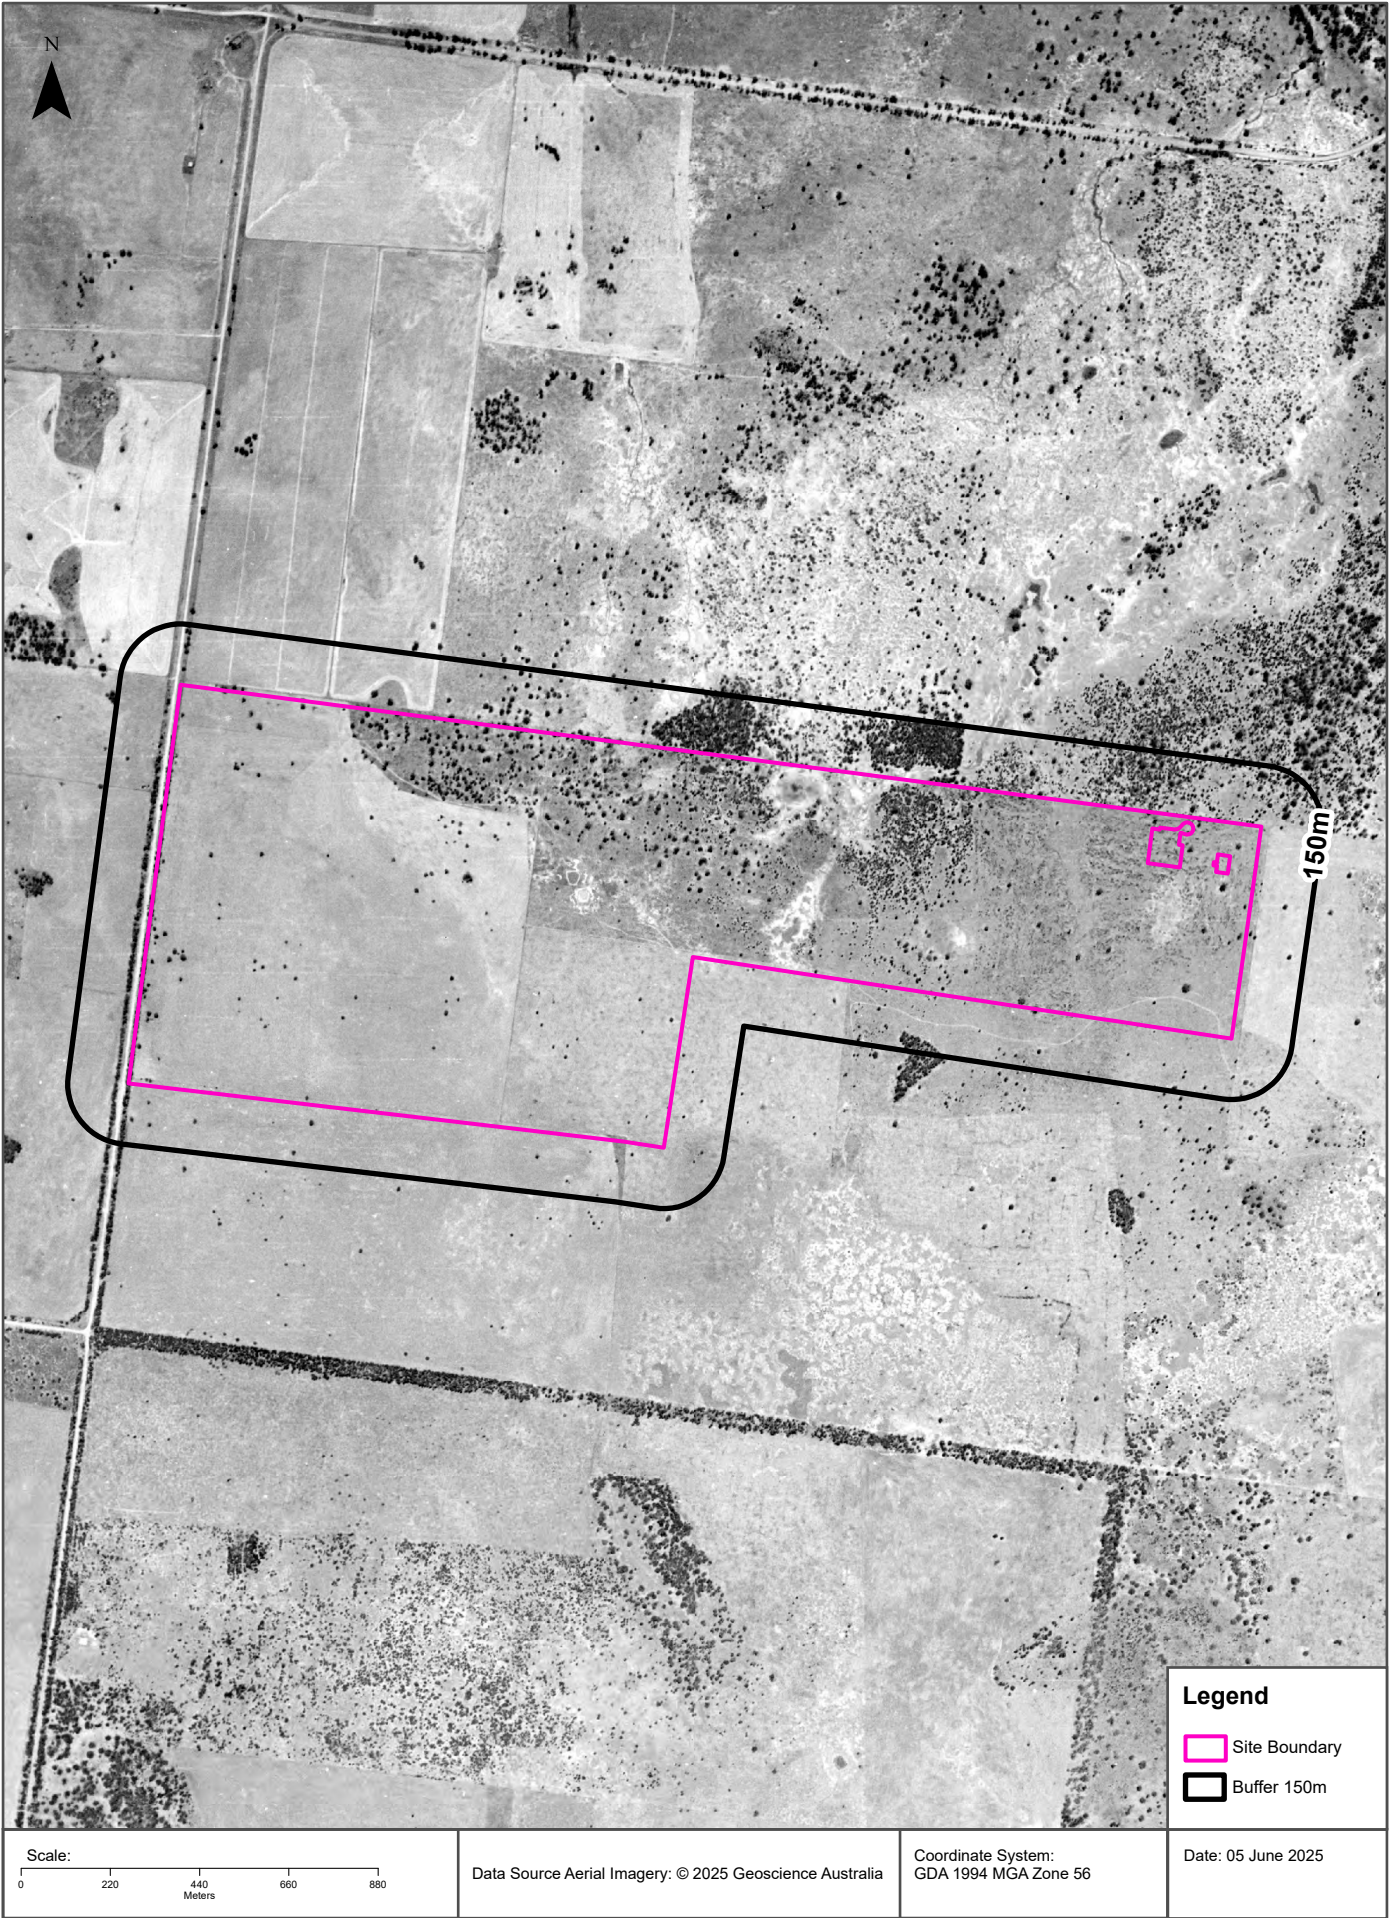
Aerial Imagery 1967

| Imagery source | Date | Comments |
|---|---|---|
| Lotsearch | 1967 | Disturbance Footprint: The Disturbance Footprint is predominantly grassland with few trees.<br><br>Surrounding area: Fewer trees are observed in the 1967 photograph. |

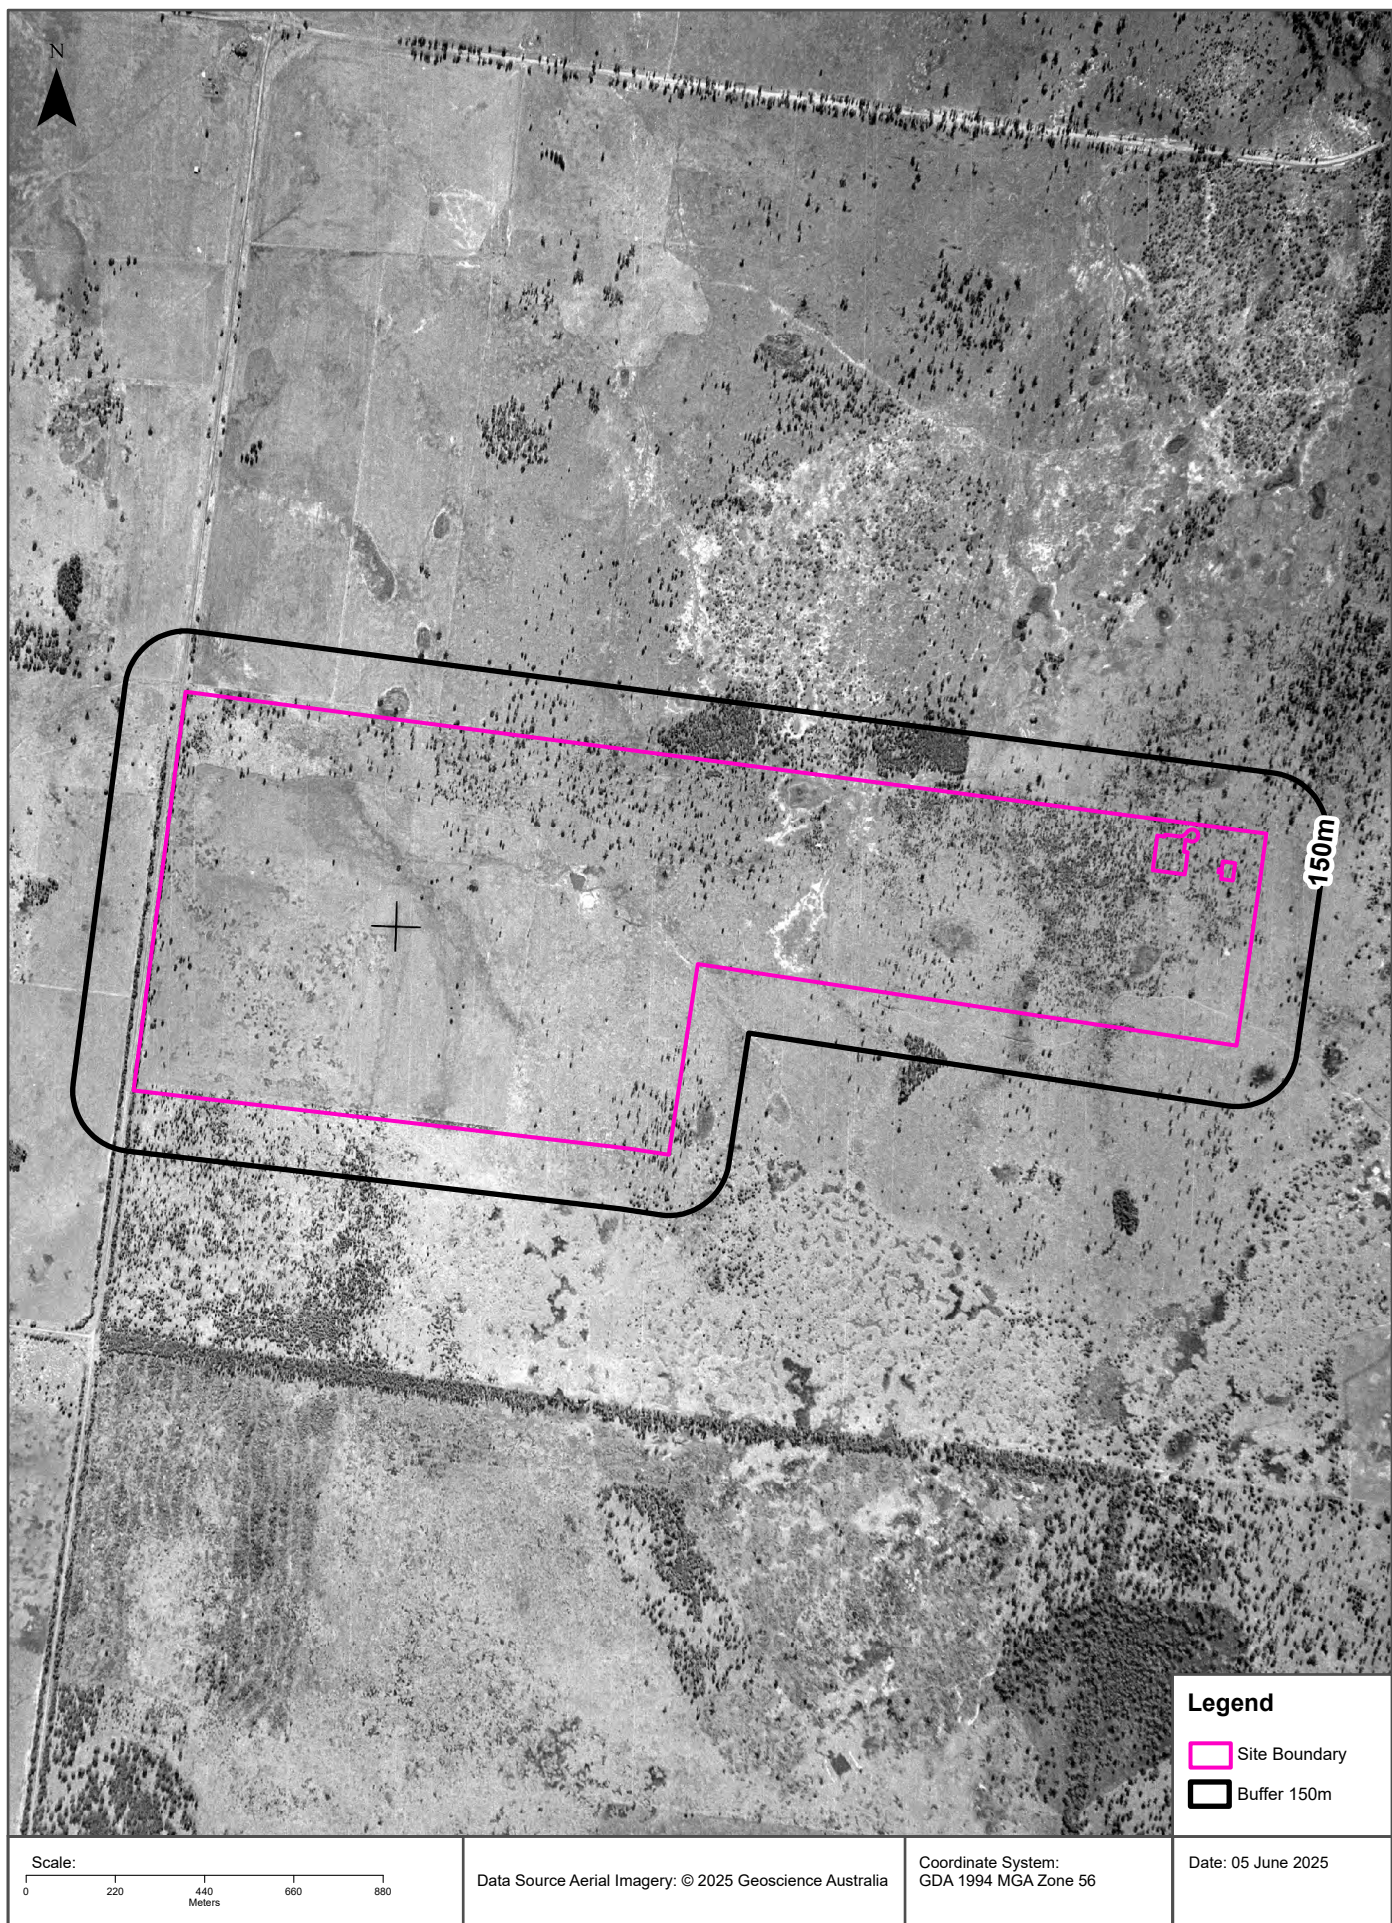
Aerial Imagery 1956

| Imagery source | Date | Comments |
|---|---|---|
| Lotsearch | 1956 | Disturbance Footprint: Some scattered trees and grasslands can be observed in the 1956 photograph.<br><br>Surrounding area: Some scattered trees, grasslands, dams and unsealed roads can be observed in the 1956 photograph. |
