# GEOTECHNICAL INVESTIGATION REPORT

## Proposed Dual Occupancy Development

**Project Address:**  
**16 Carinya Road**  
**Picnic Point NSW 2213**

**Prepared By:**  
**Stratatek Geotechnical Solutions Pty Ltd**

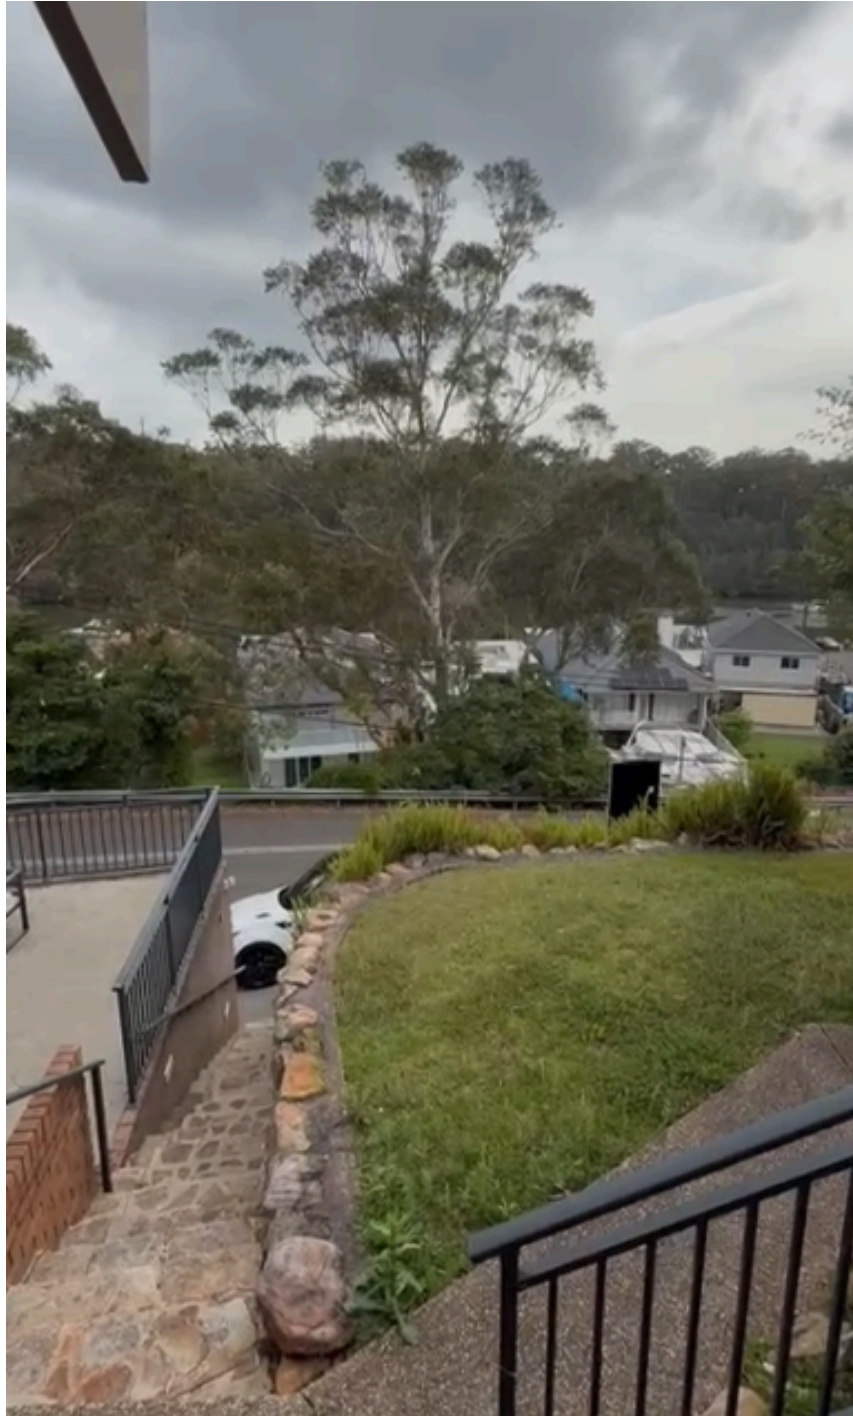
**Figure 1 – View Looking Downslope Across the Site**

Overall view of the subject site looking downslope towards the south-west, illustrating the existing topography, moderate to steep site gradient, surrounding residential development and established vegetation. The image demonstrates the natural fall of the land and the relationship between the site and adjacent properties.

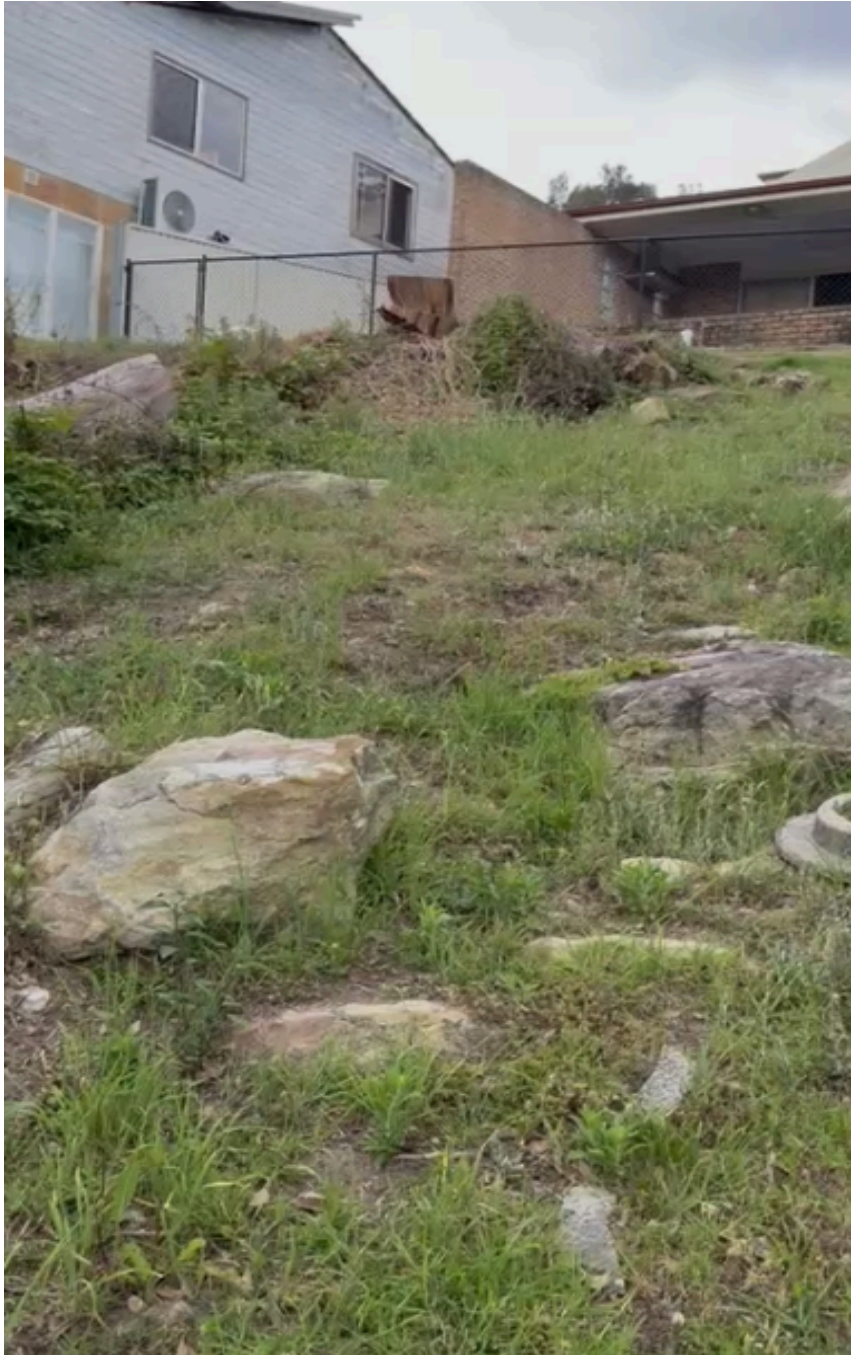
**Figure 2 – Existing Ground Conditions**

View of the central portion of the site showing exposed residual soils, sandstone outcrops and scattered surface rock. The photograph illustrates the natural ground conditions and variable weathered rock profile encountered across the allotment.

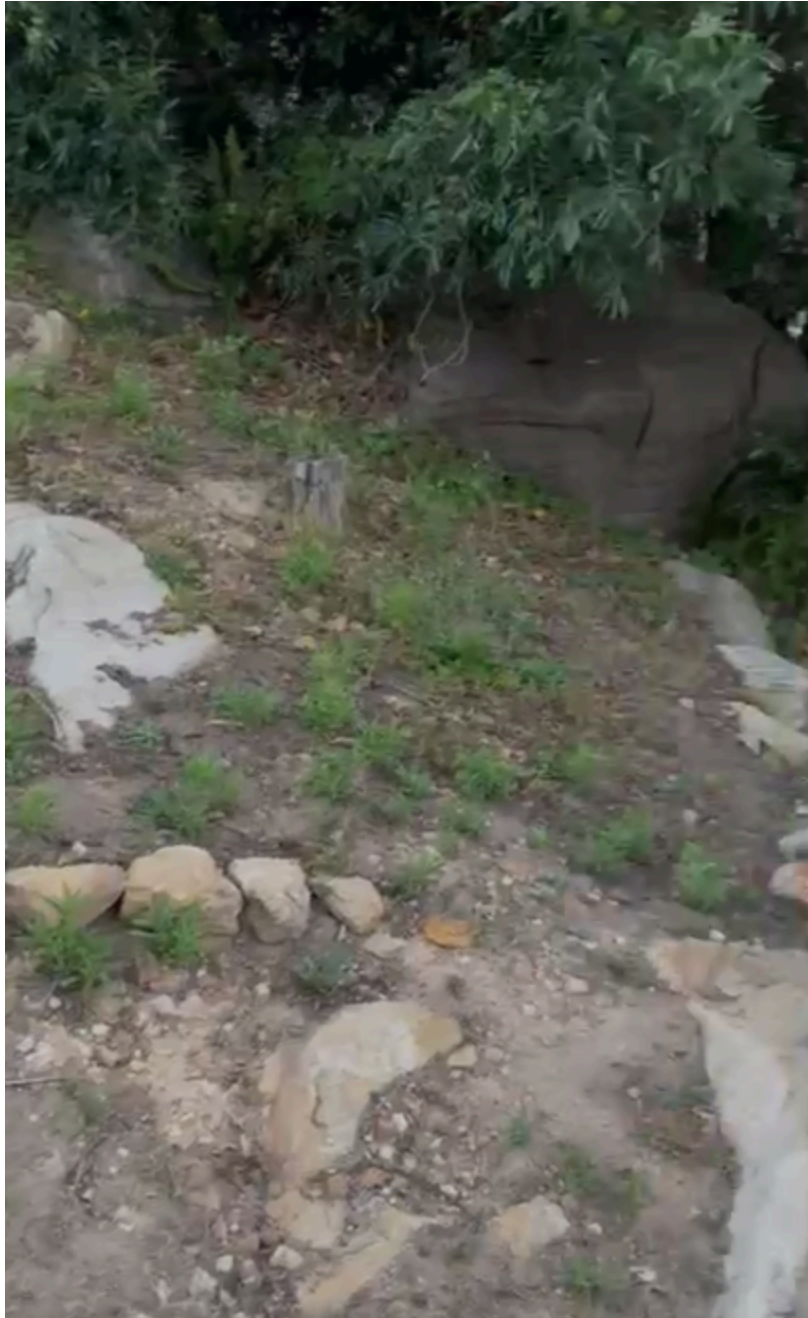
**Figure 3 – Existing Rock Outcrops**

General view of existing sandstone outcrops distributed across the site. The image highlights the shallow rock profile and natural surface geology, which will influence excavation methods, footing design and retaining wall construction associated with the proposed development.
