**GEOTECHNICAL  
INVESTIGATION REPORT**

263-267 CANTERBURY ROAD, CANTERBURY, NSW

PREPARED FOR MING LI  
REPORT ID: G18042CAN-R01F

**Date:** 23<sup>rd</sup> August 2018

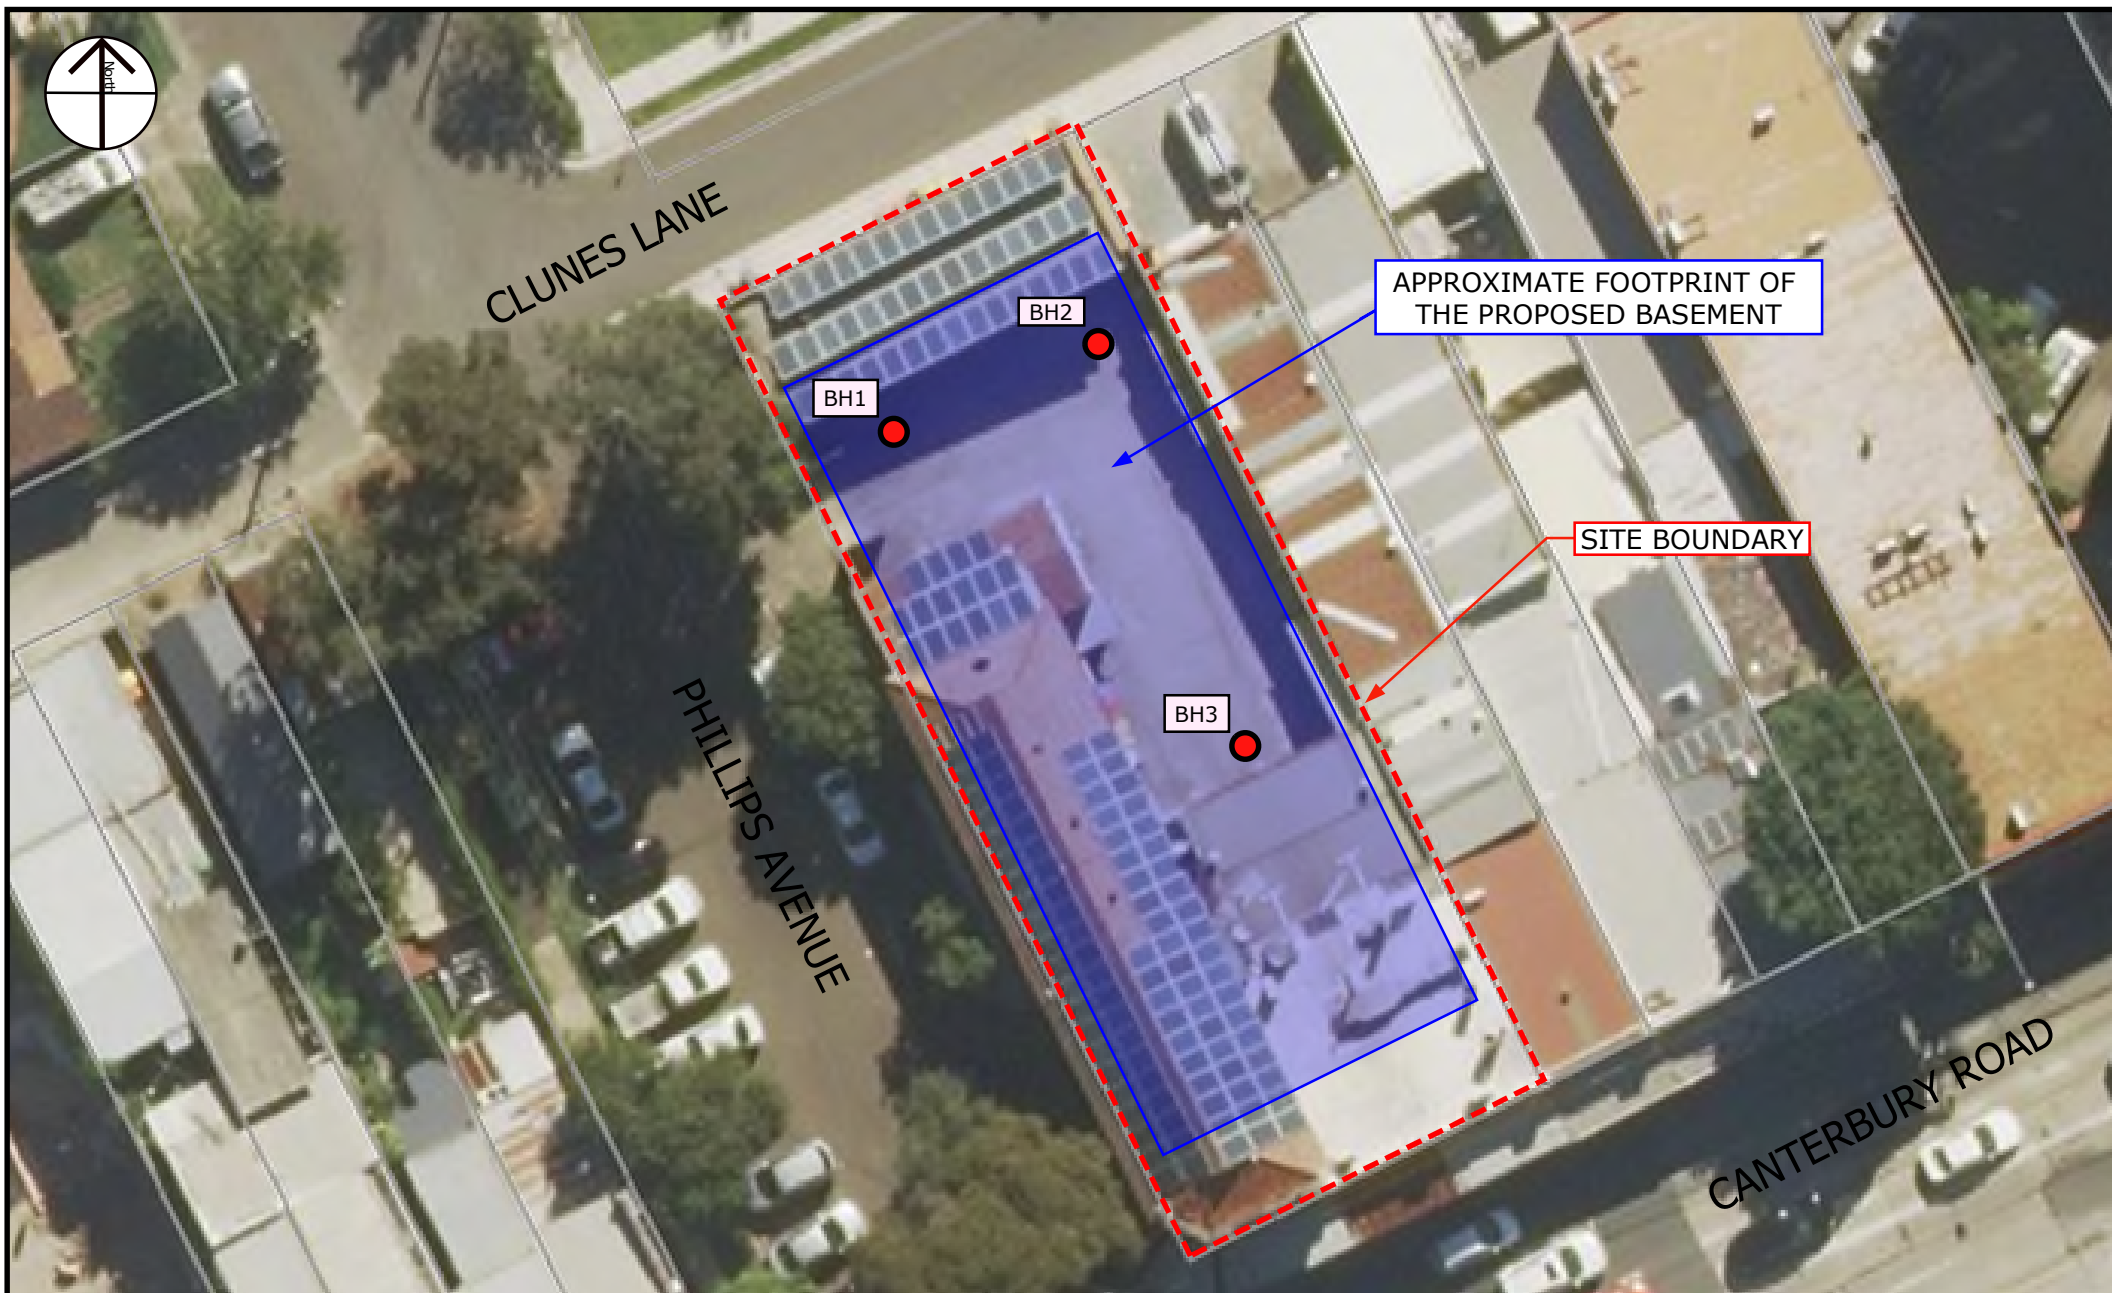
1 – Site Plan

Aerial image: provided by SIXmaps (NSW LPI) - Image dated 06/04/2016

- ◇ The drilling and logging of three boreholes (BH1 to BH3) in accessible areas of the site to assess the soil conditions and depth to bedrock,
- ◇ The performance of SPTs within each borehole to assess the consistency and/or relative density of the soil profile,
- ◇ The collection of representative soil samples for the preliminary assessment of soil salinity and aggressivity,
- ◇ Collection and analysis of rock samples from borehole BH3 for the preliminary assessment of rock strength, and
- ◇ The installation of a groundwater monitoring well within borehole BH3 to assess the depth to groundwater and rate of inflow.
