# **GEOTECHNICAL INVESTIGATION REPORT**

## **PROPOSED METAL RECYCLING FACILITY 88 MURRAYS FLAT ROAD, TOWRANG NSW**

Prepared for **Sincorp Properties Pty Ltd**

Ref: DRM P24.1039.V01-R01

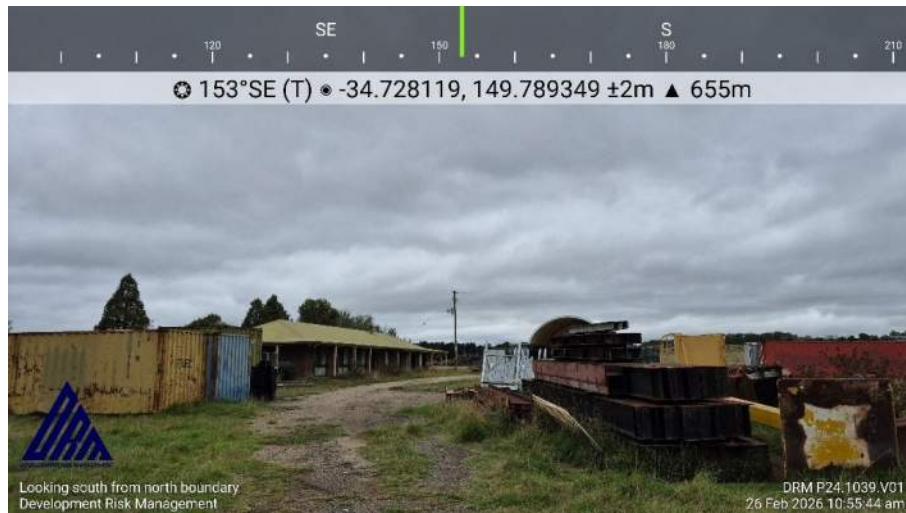
Figure 1: Photo taken near north boundary looking south

The site photographs taken during the Geotechnical Investigation are shown on Figure 1 to 3.

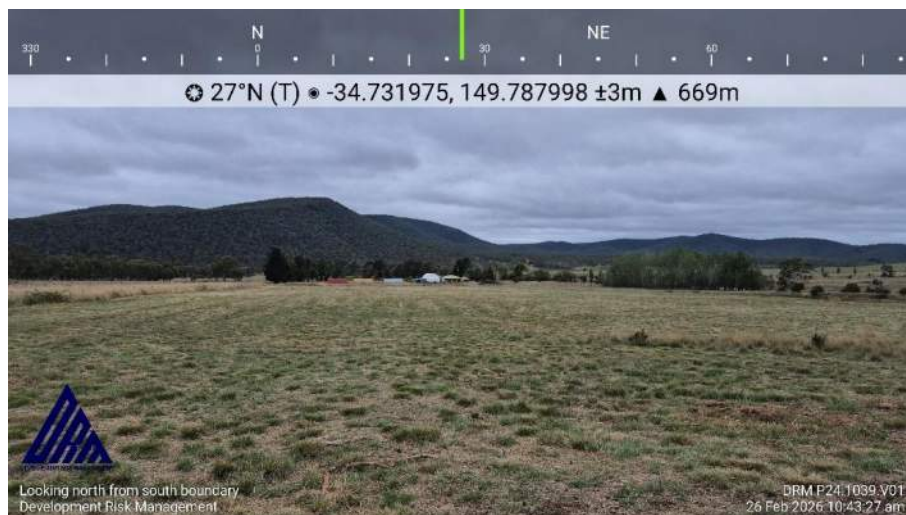
Figure 2: Photo taken near south boundary looking north

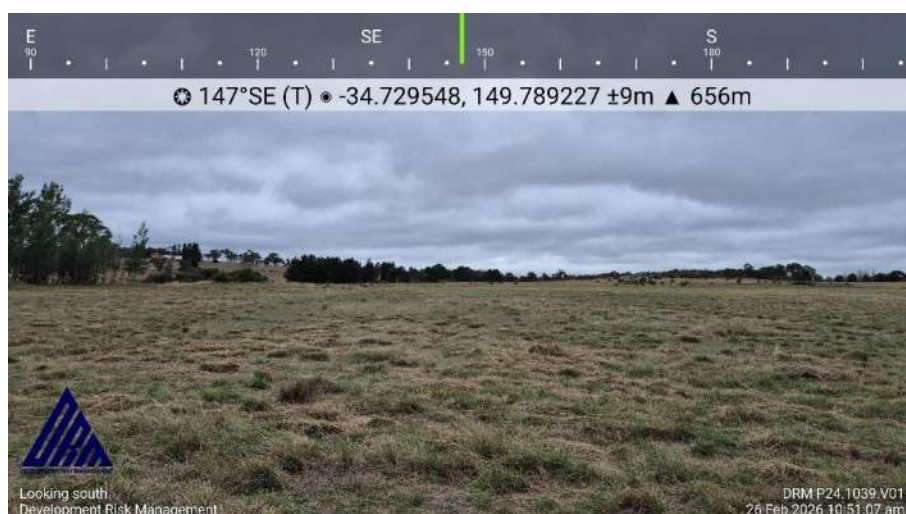
Figure 3: Photo taken at the middle of the site looking south

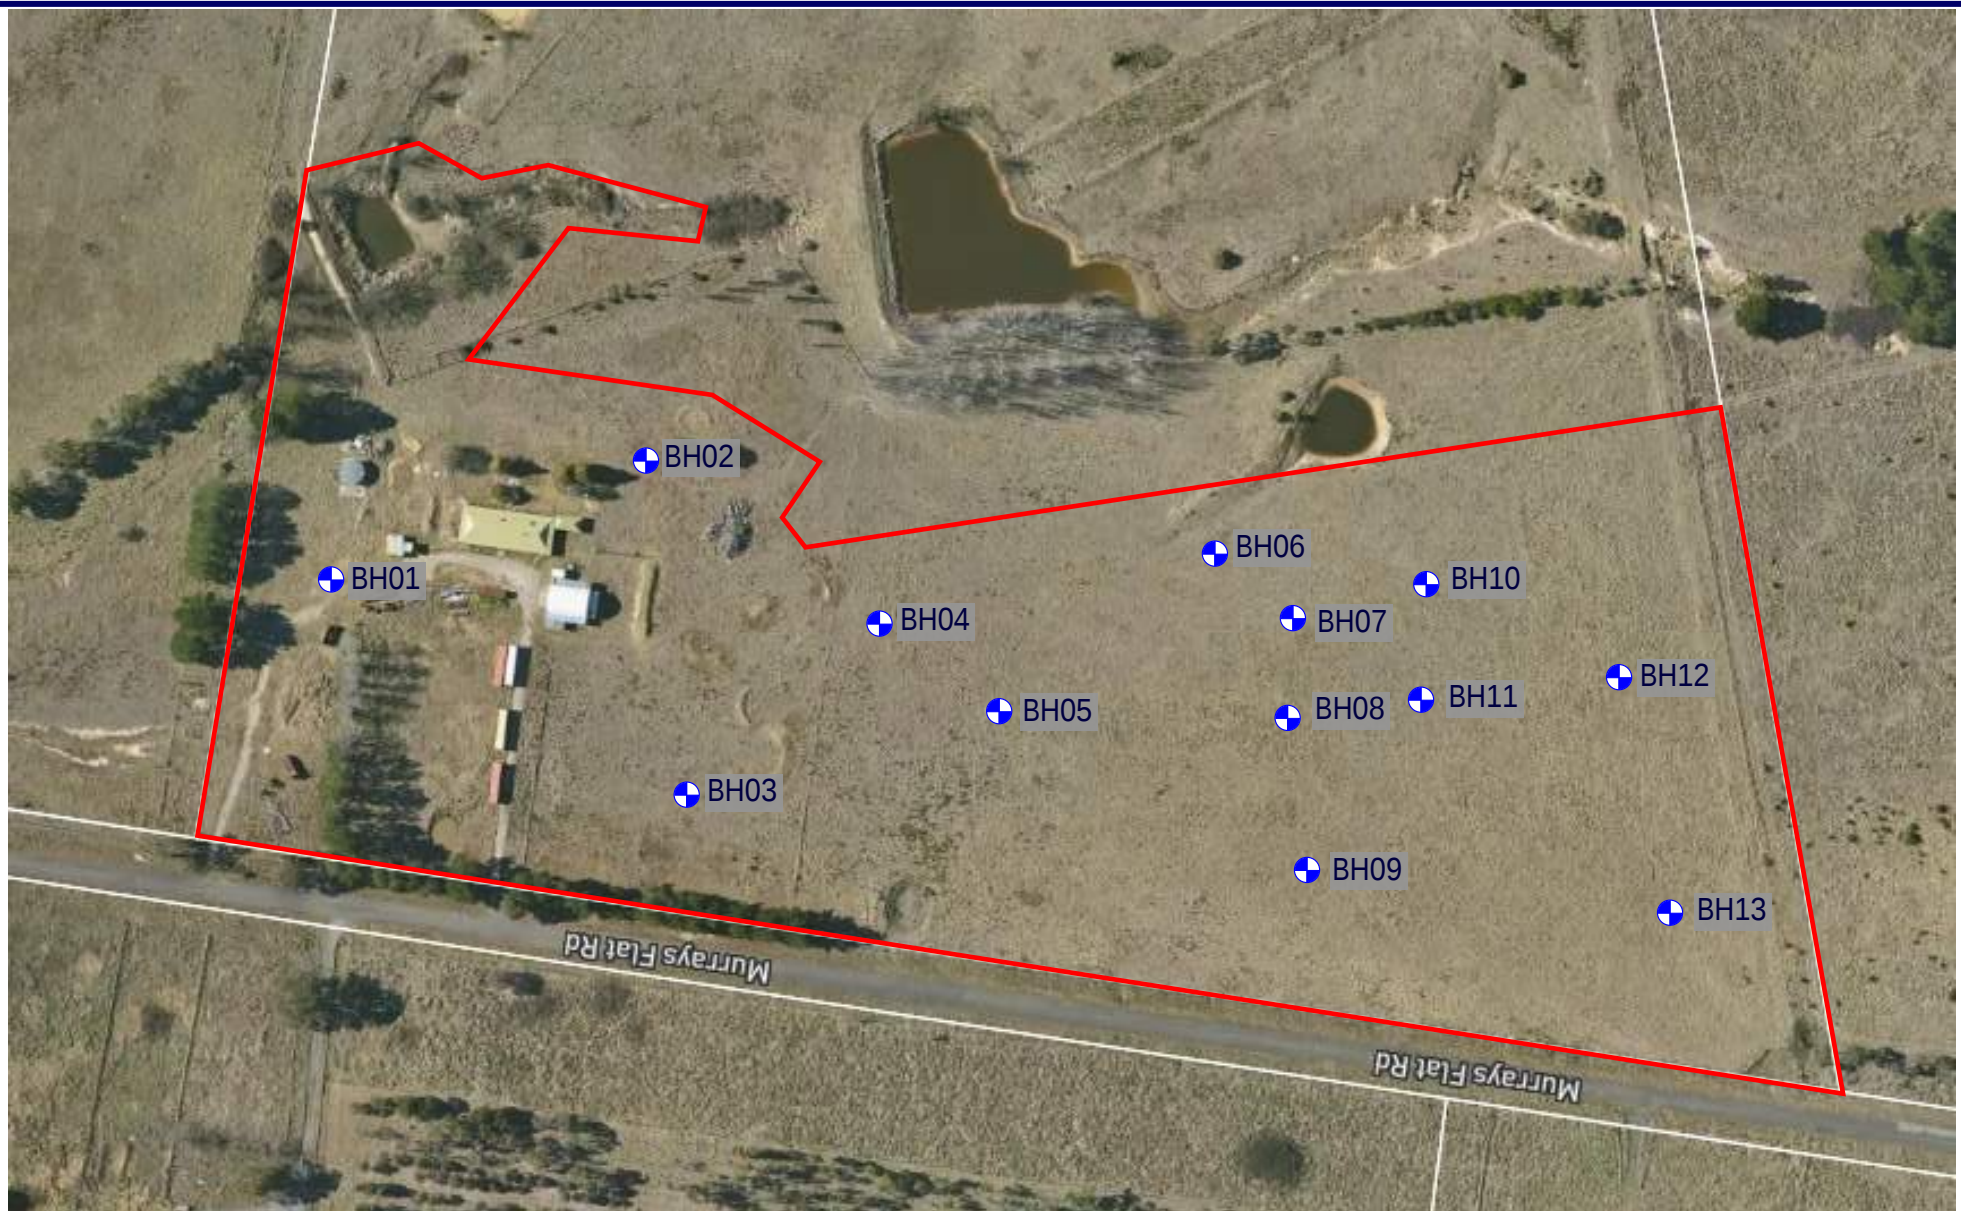
- ▭ Approximate development area extent
- Approximate borehole Locations

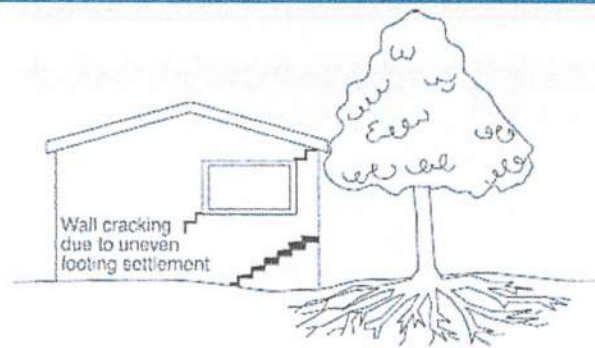
### Trees can cause shrinkage and damage

As the weather pattern changes and the soil begins to dry out, the external footings will be first affected, beginning with the locations where the sun's effect is strongest. This has the effect of lowering the external footings. The doming is accentuated and cracking reduces or disappears where it occurred because of dishing, but other cracks open up. The roof lines may become convex.
