**RE: 6 Monthly Groundwater Inspection Results – August 2025**

Please find enclosed the results for your 6 monthly Groundwater Monitoring Visual Inspection, conducted at the **Duri Fuels Service Station**, on 29 August 2025.

**GROUNDWATER MONITORING TEST RECORD SHEET - 6 MTH VISUAL INSPECTION - AUG 2025**

**SITE NAME:** Duri Fuels South Tamworth

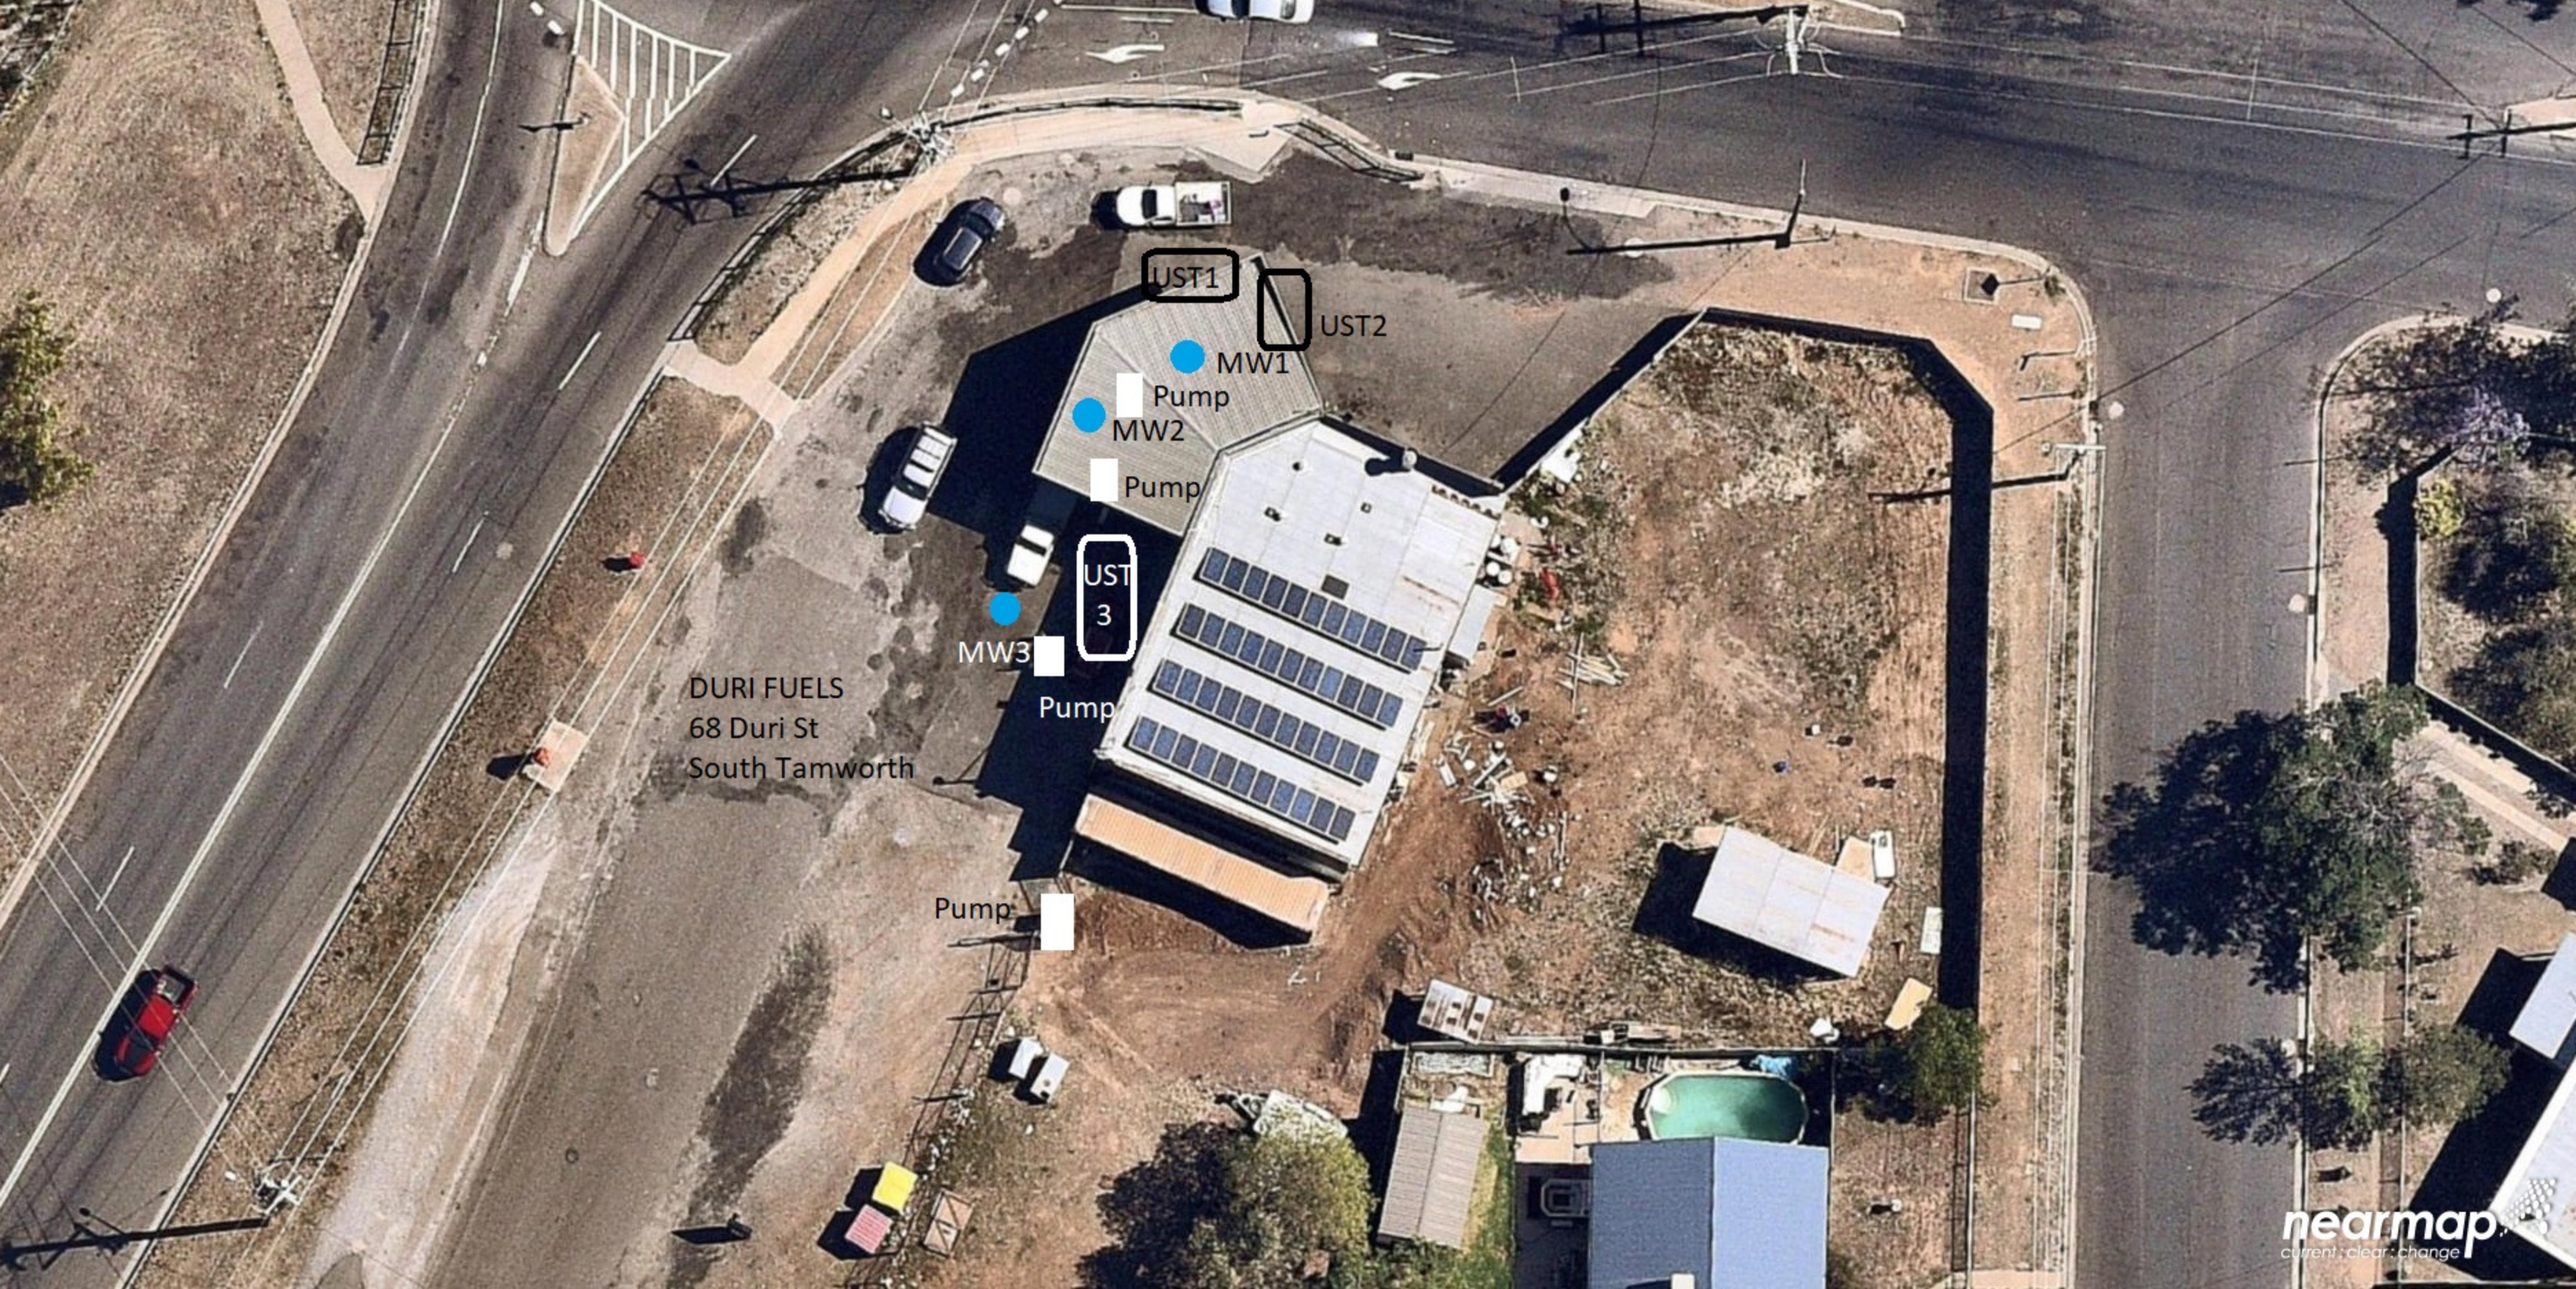
DURI FUELS  
68 Duri St  
South Tamworth

The testing found monitoring wells MW1 and MW3 contained clean water, with no evidence of petroleum hydrocarbon impact. Monitoring well MW2 was unable to be opened due to the bolts having been concreted over during recent line replacement works. The bolts need to be cleared using a power drill which was not possible at the time of inspection. Please ensure the bolts are cleared prior to the next inspection.

All gauging and visual inspection data has been attached to this letter, including an aerial photo indicating the location of the wells within the site. The next scheduled groundwater testing is due for completion at your site in **February 2026**.
