Statement of Environmental Effects Cowal Gold Operations Accommodation Village

VOLUME 2 – APPENDIX D TO J

Prepared for Evolution Mining (Cowal) Pty Limited
April 2021

CONSTRUCTION MANAGEMENT PLAN

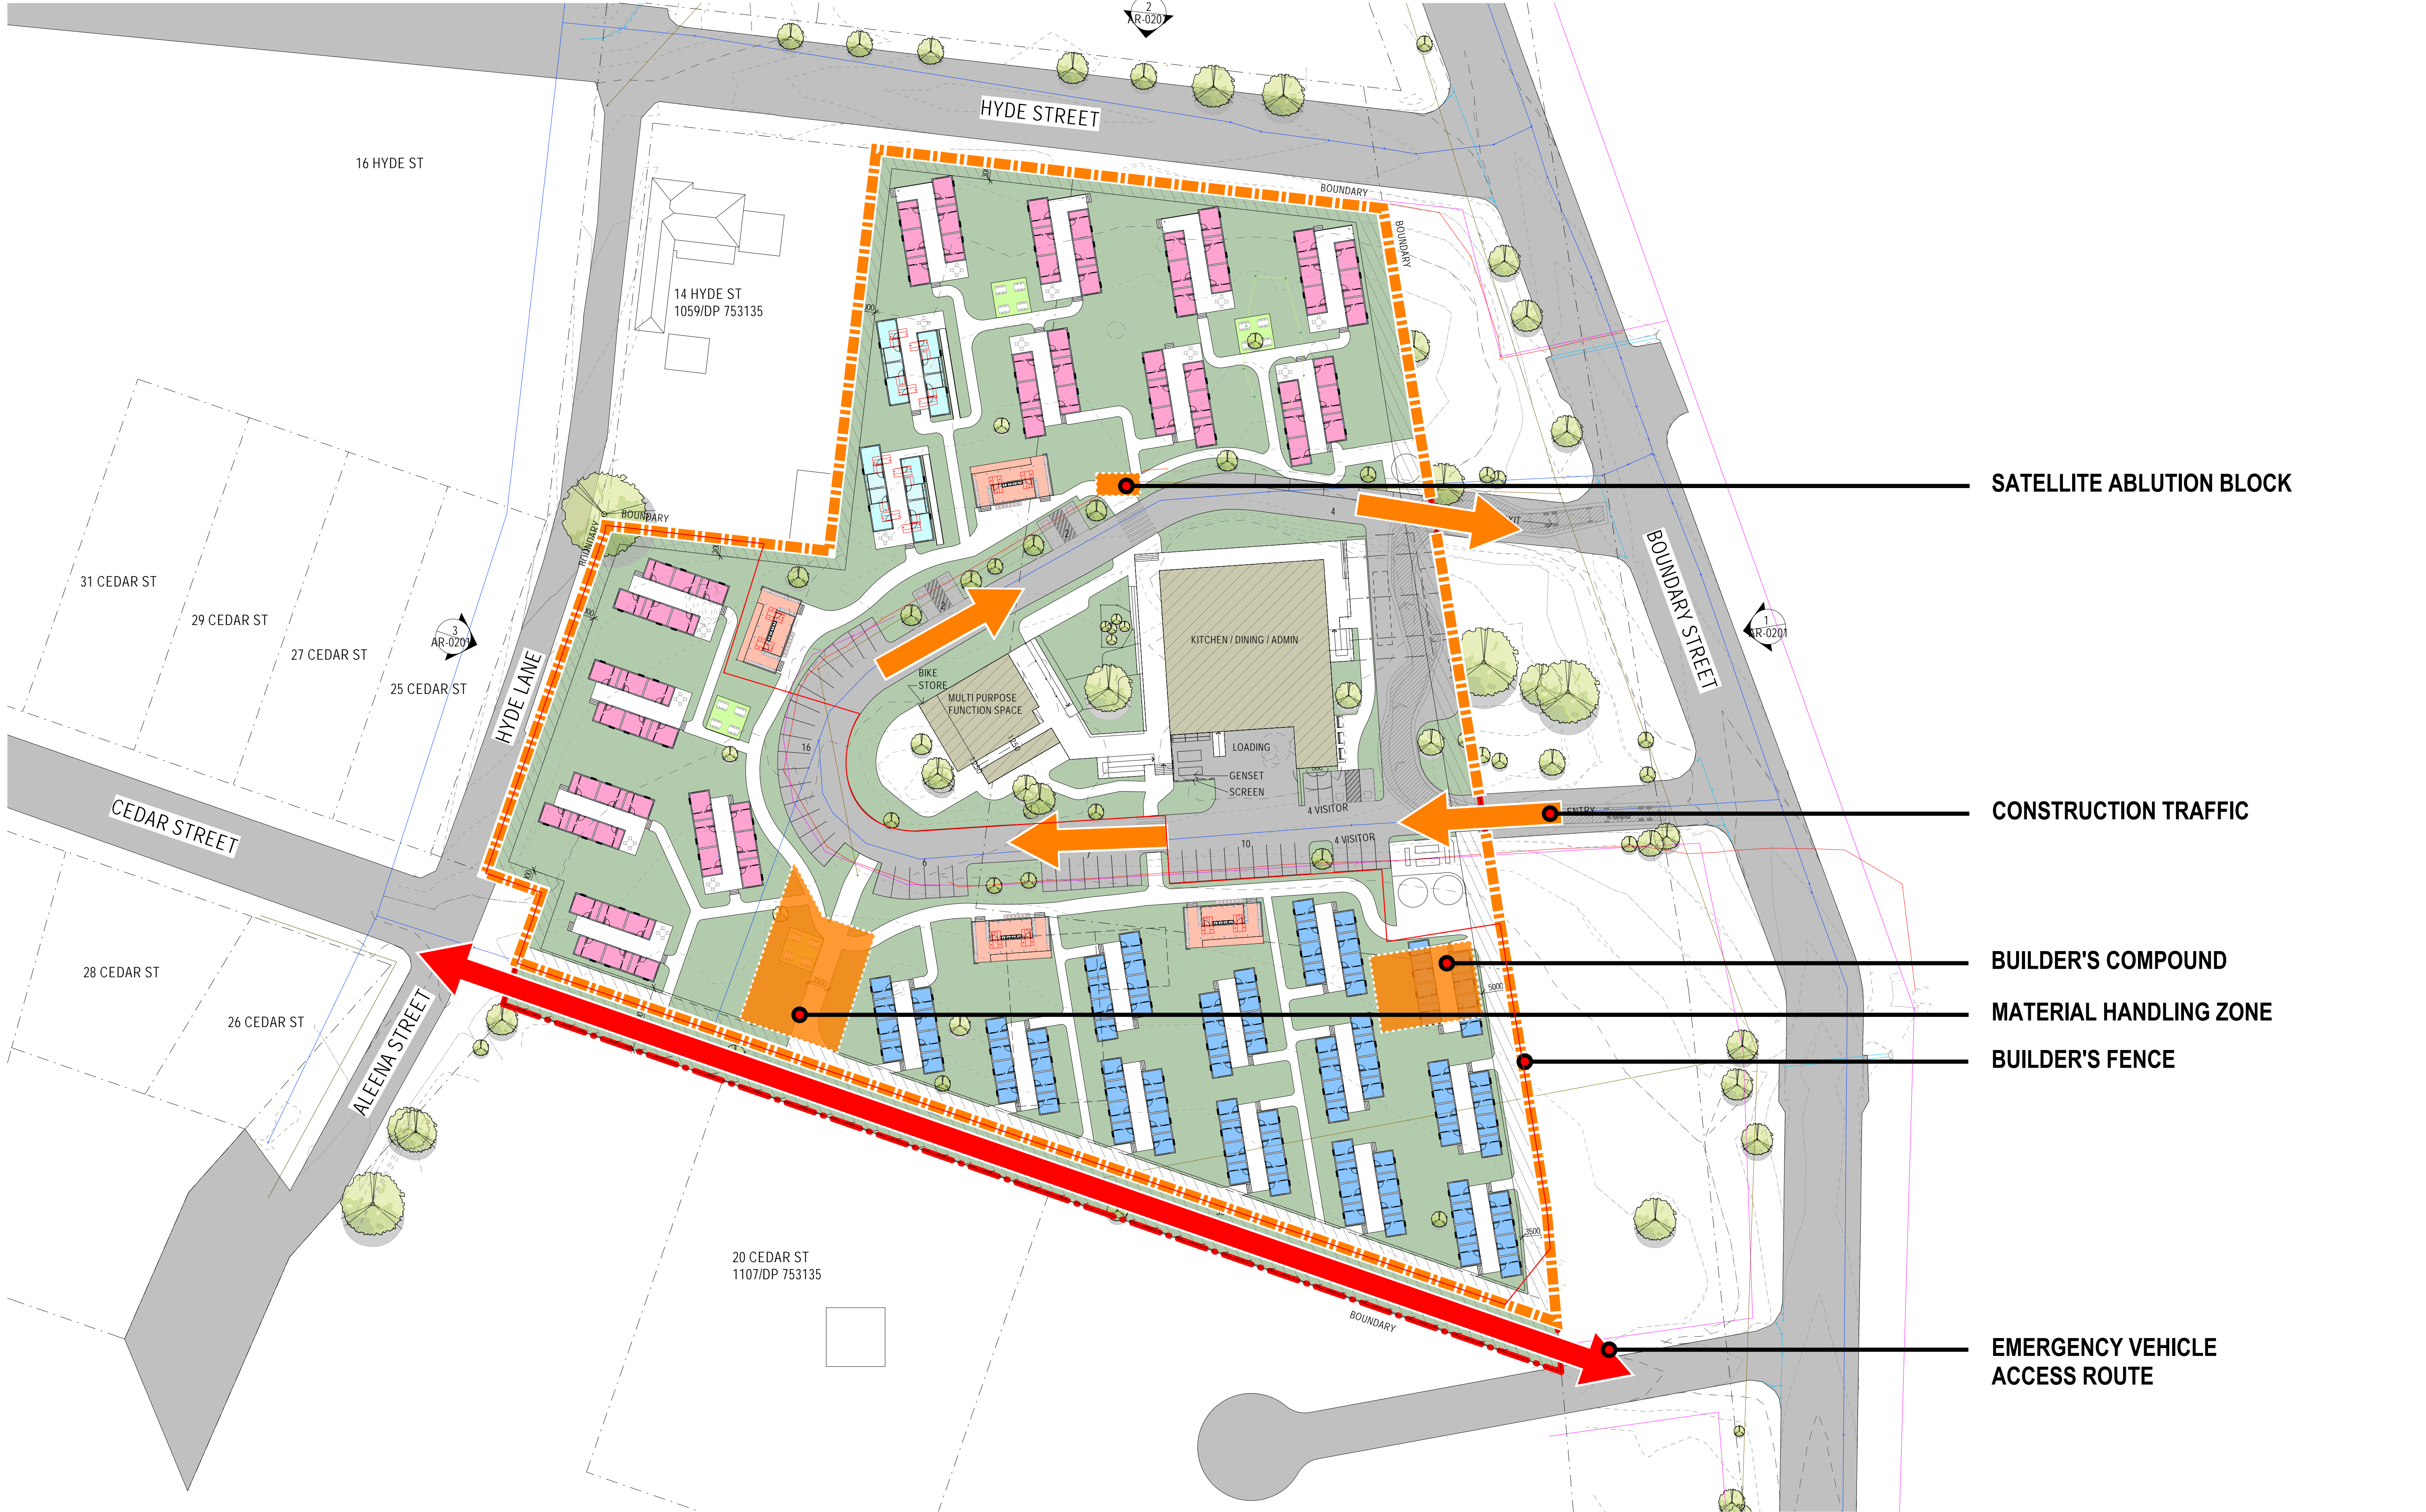
SITE ESTABLISHMENT PLAN - STAGE 1

6.1. Appendix 1 Site Establishment Plan – Stage 1

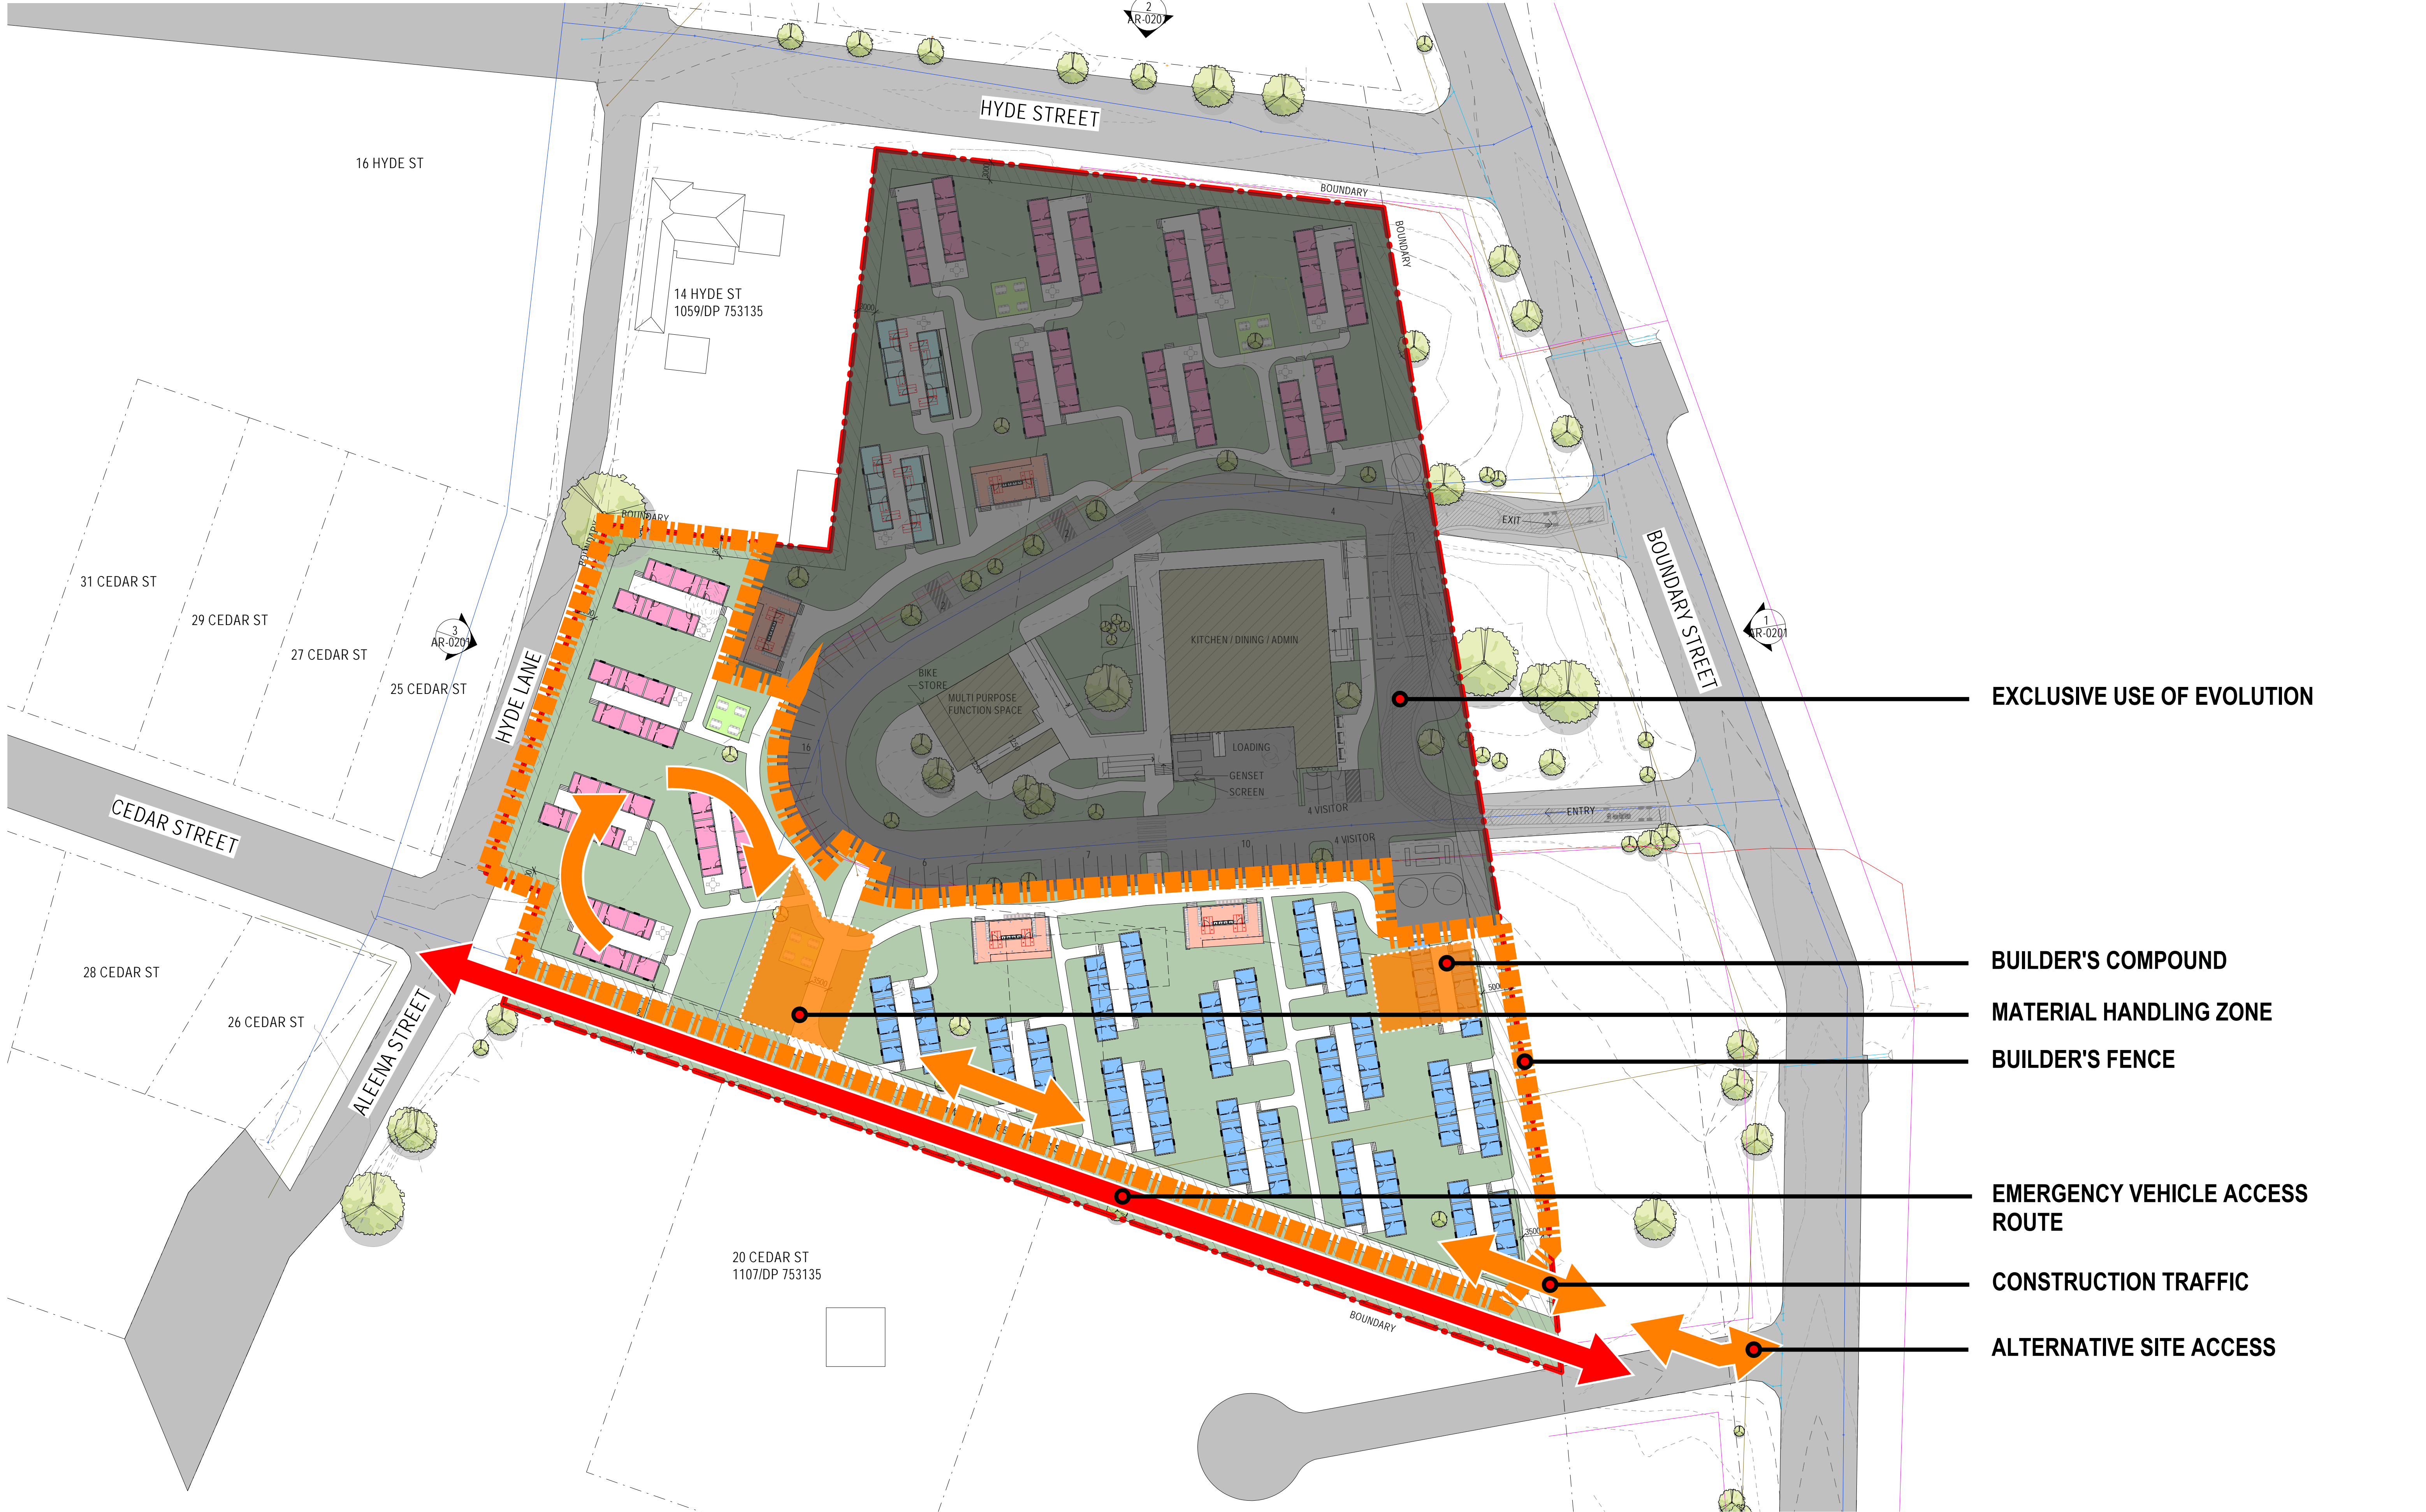
6.2. Appendix 2 Site Establishment Plan – Stage 2 and 3

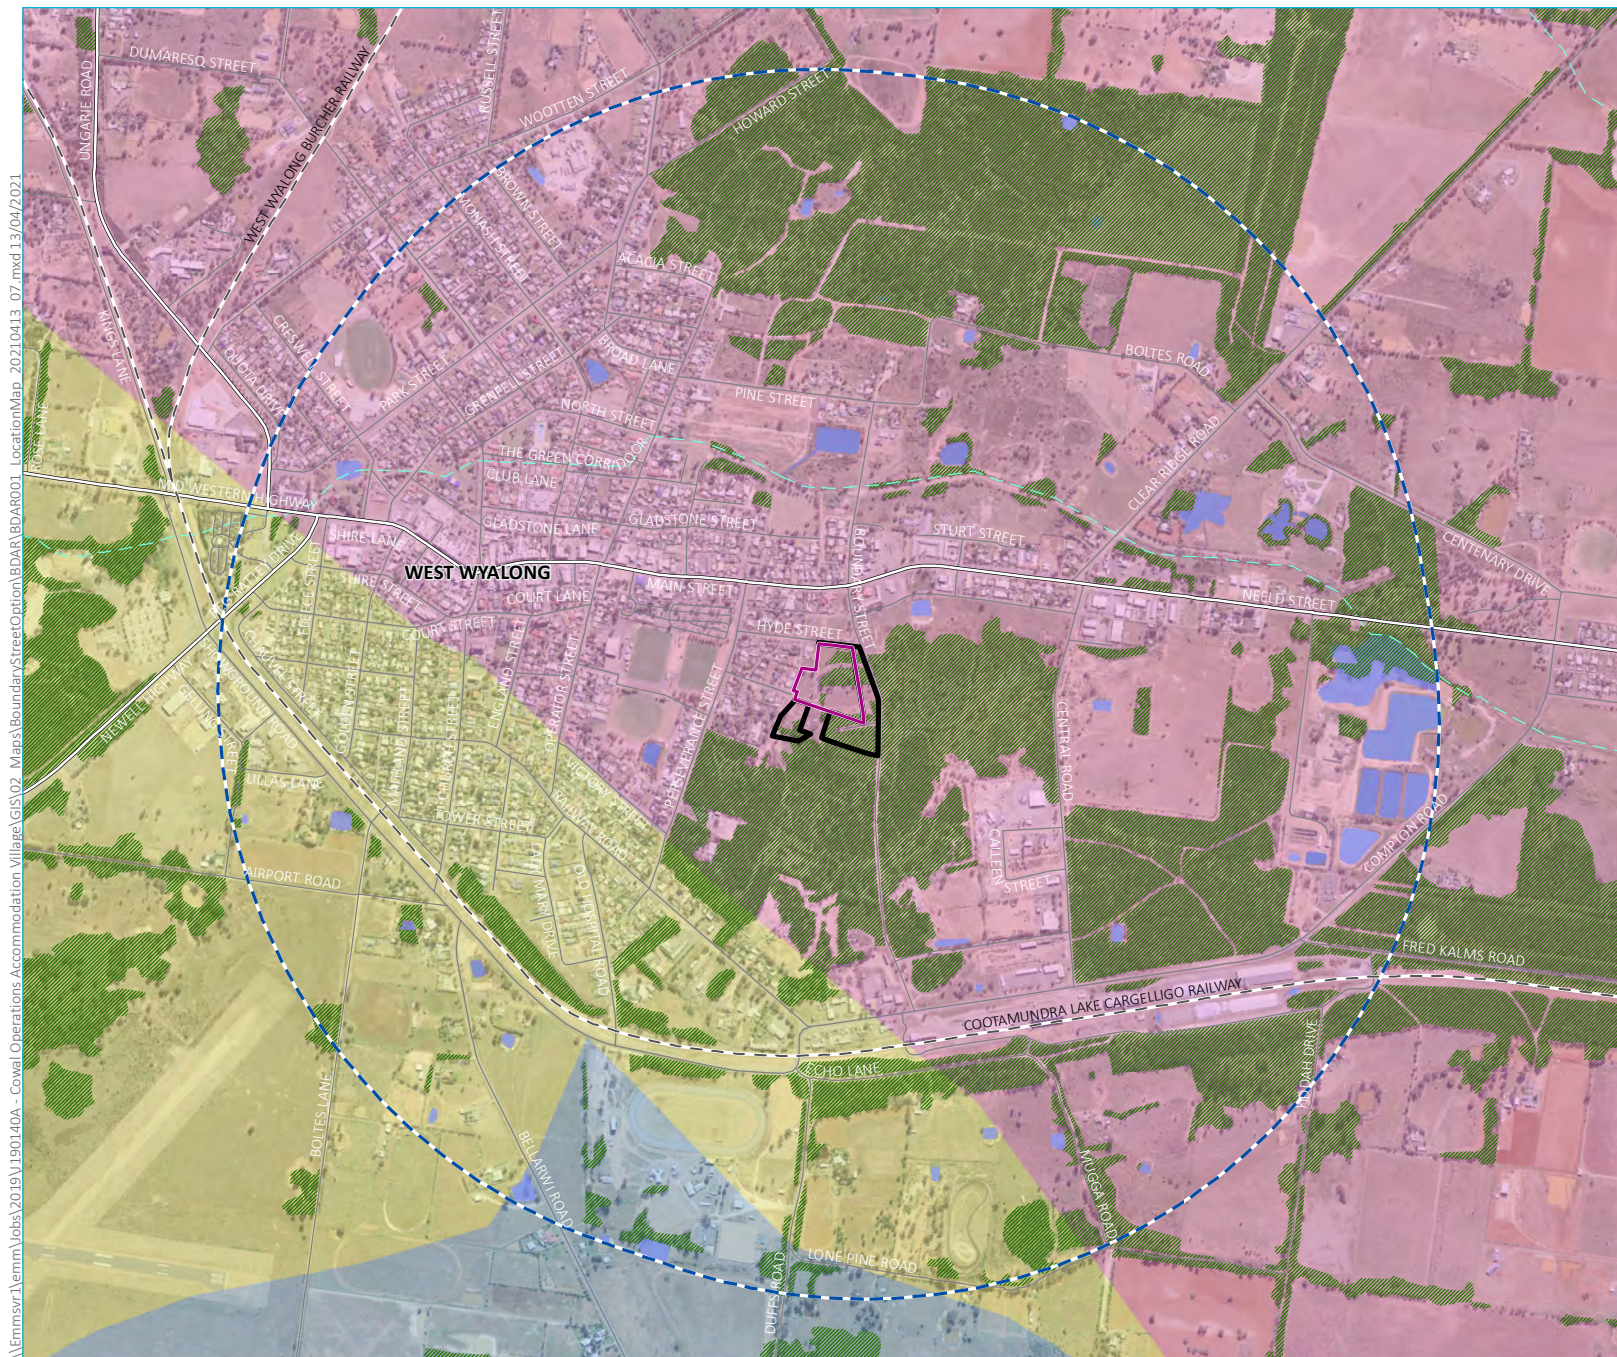
Location map

- KEY**
- Site boundary
 - Subject land
 - 1500 m buffer
 - Rail line
 - Main road
 - Minor road
 - Strahler 1st order stream
 - Dam/artificial wetland
 - Native vegetation cover
- BioNet NSW landscapes (Mitchell landscapes)
- Ardlethan Hills
 - Bimbi Plains
 - Manitoba Hills and Footslopes
- Note:**
 IBRA Bioregion - NSW South Western Slopes
 IBRA subregion - Lower Slopes

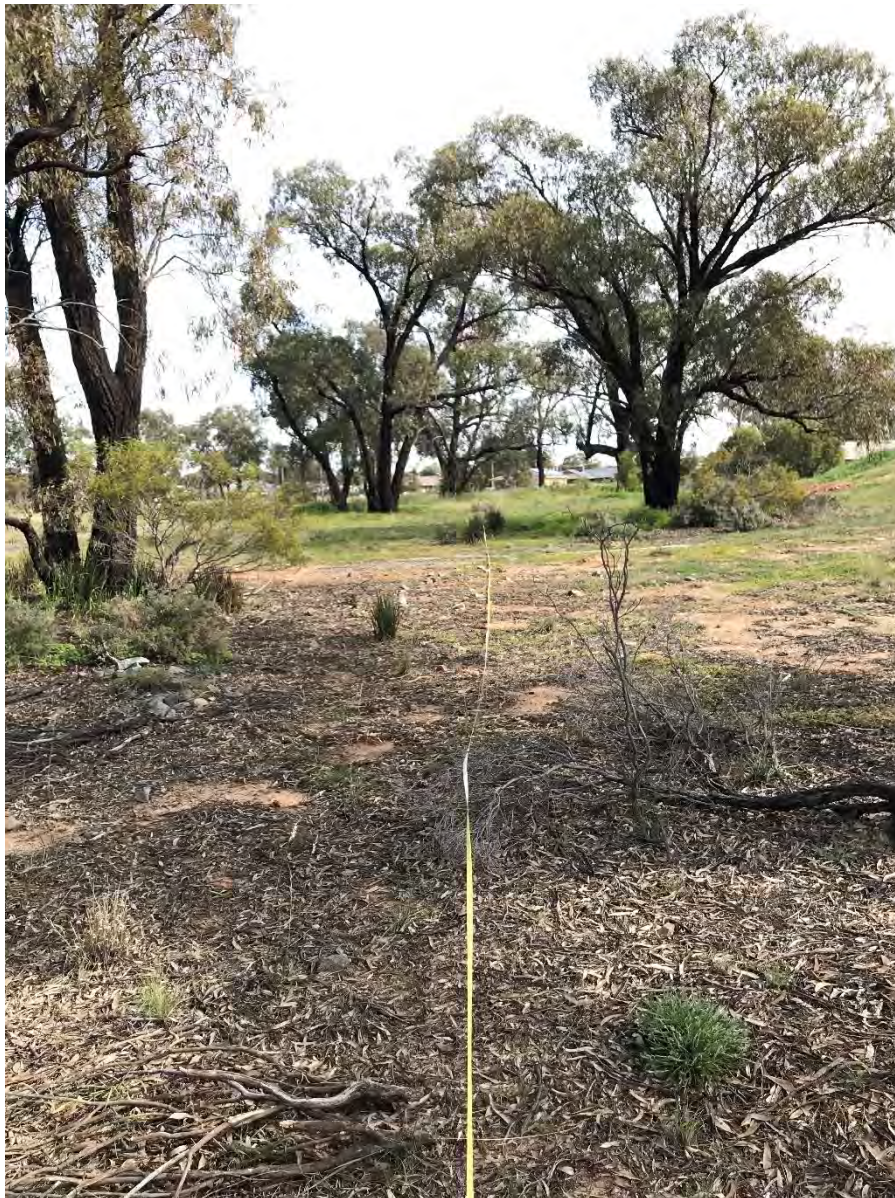
Photograph 4.1 **PCT 217 Medium**

Vegetation Zones 1 and 2 – Mugga Ironbark - Western Grey Box - cypress pine tall woodland on footslopes of low hills in the NSW South Western Slopes Bioregion (PCT 217)

The vegetation integrity score of 58.8 for vegetation zone 1 reflects the moderate condition of these areas, particularly considering past disturbance. Vegetation zone 2 gave a vegetation integrity score of 8.5, reflecting the high level of past and on-going disturbance. This score is below the threshold for requiring offsets under the BAM.

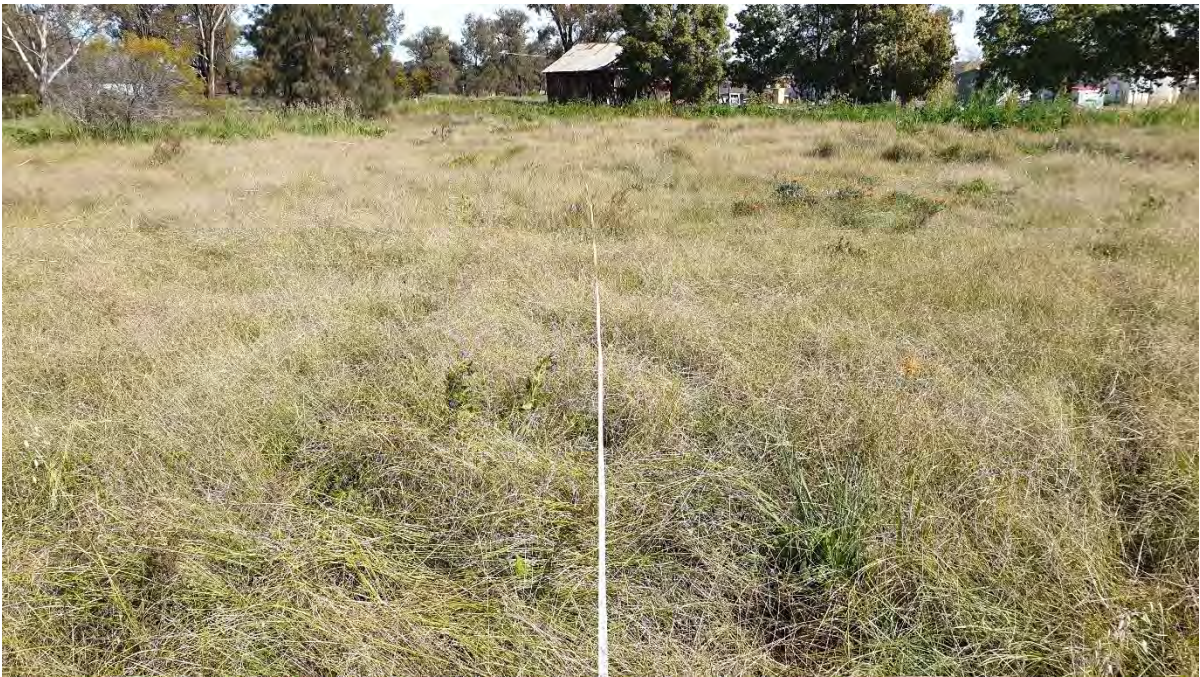
Photograph 4.2 PCT 217 Poor

Vegetation Zones 1 and 2 – Mugga Ironbark - Western Grey Box - cypress pine tall woodland on footslopes of low hills in the NSW South Western Slopes Bioregion (PCT 217)

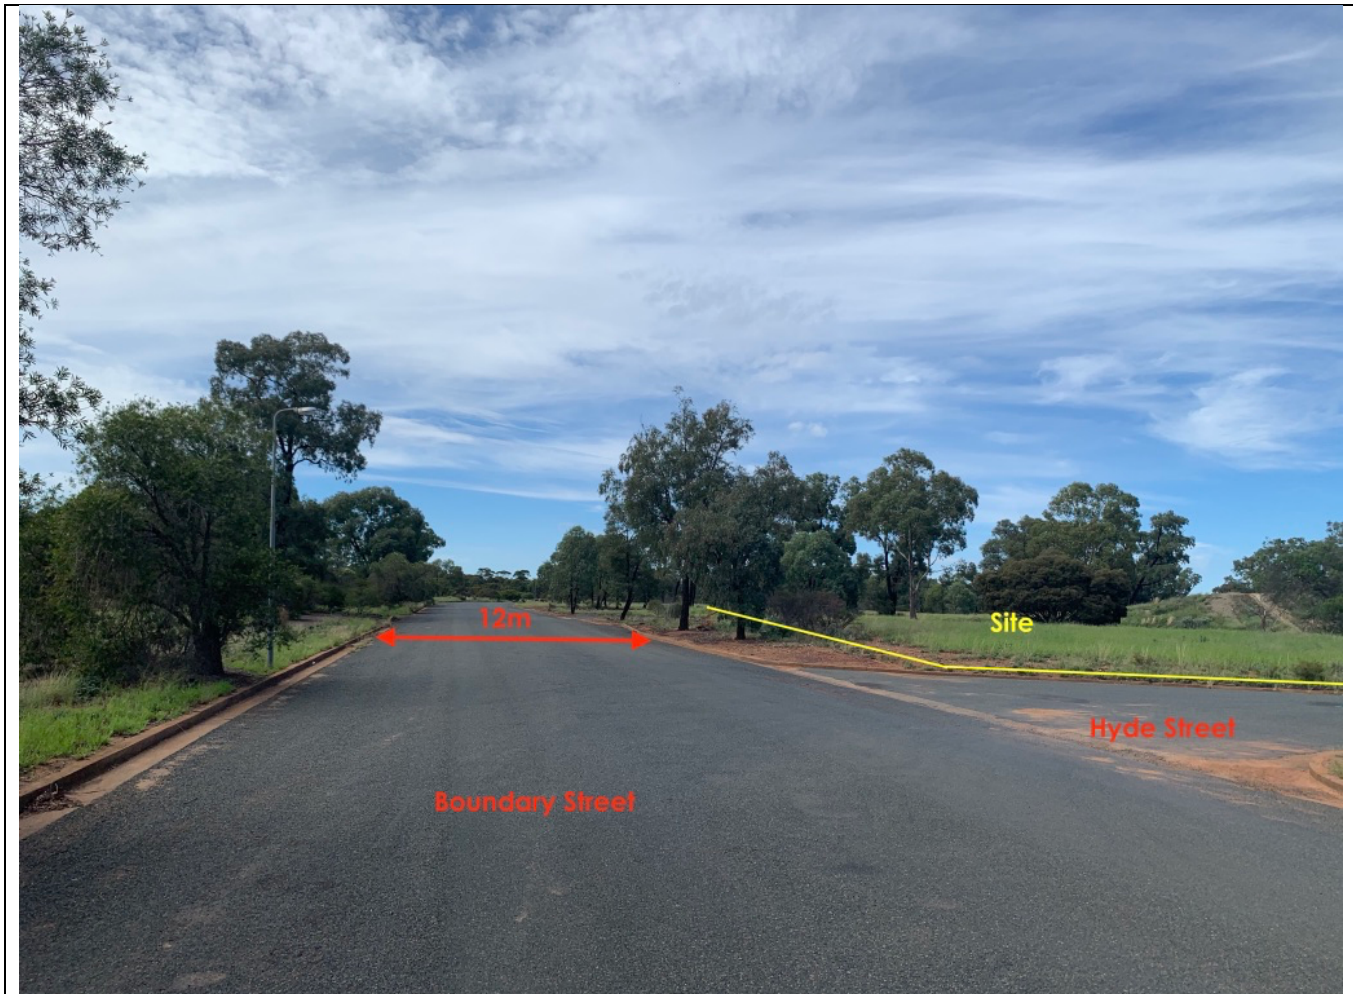
Photo 1 Looking south from the corner of Boundary Street and Hyde Street showing the site. Boundary Street is 12m kerb to kerb.

The site is to the right of the photograph and is cleared of native vegetation and has been prepared for development. The site has some remnant eucalyptus trees that are well separated and do not form a continuous canopy, The site currently has grassland following recent rains. No mid storey vegetation is within the site.

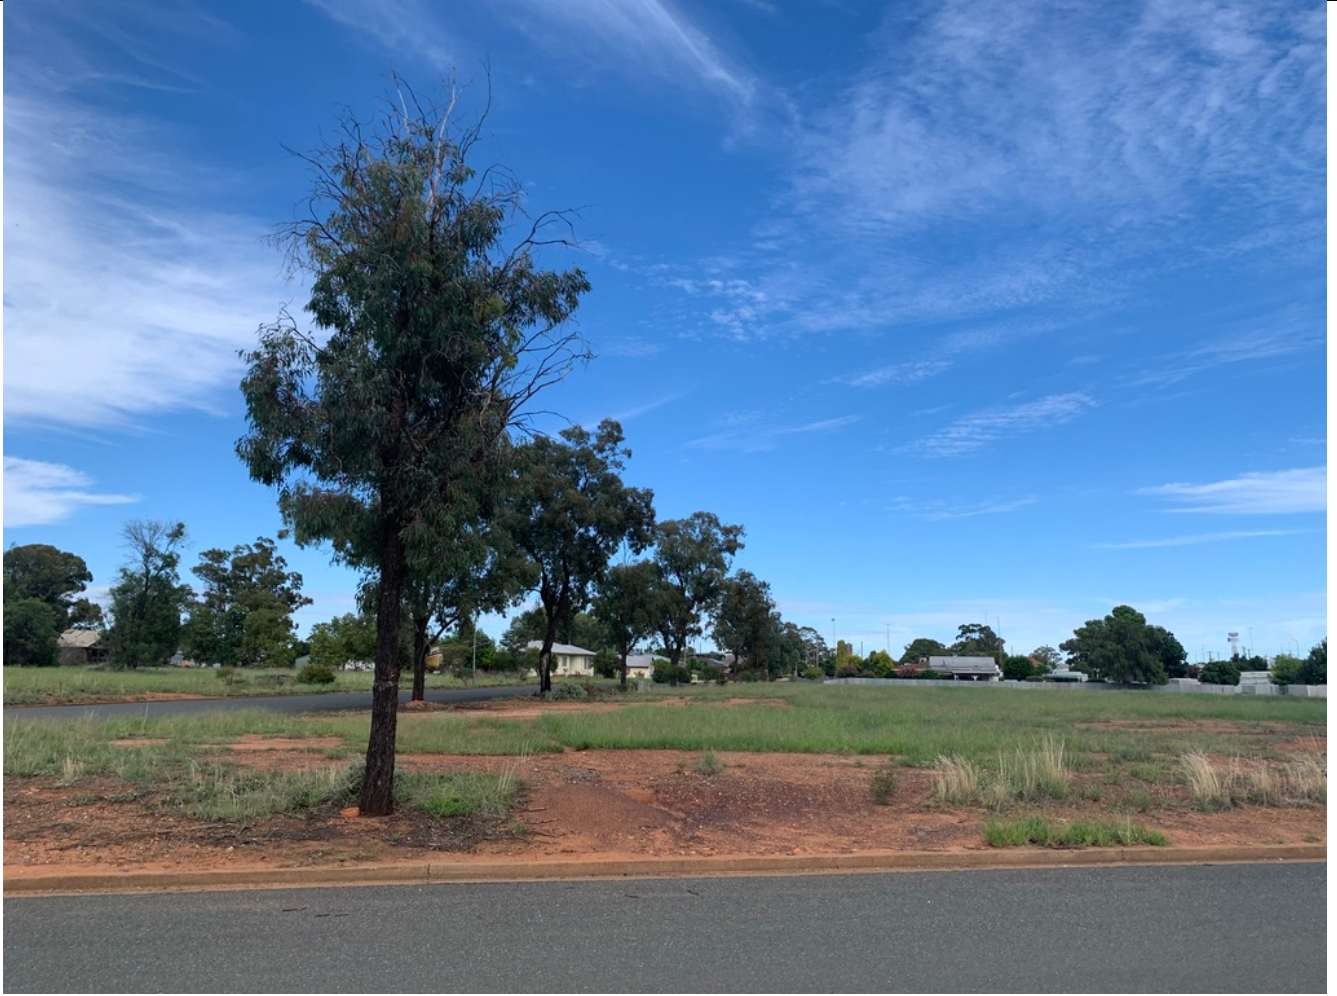
Photo 2 shows the cleared block to the north of Hyde Street with separated eucalypts along the road verge. The block currently has low grassland vegetation.

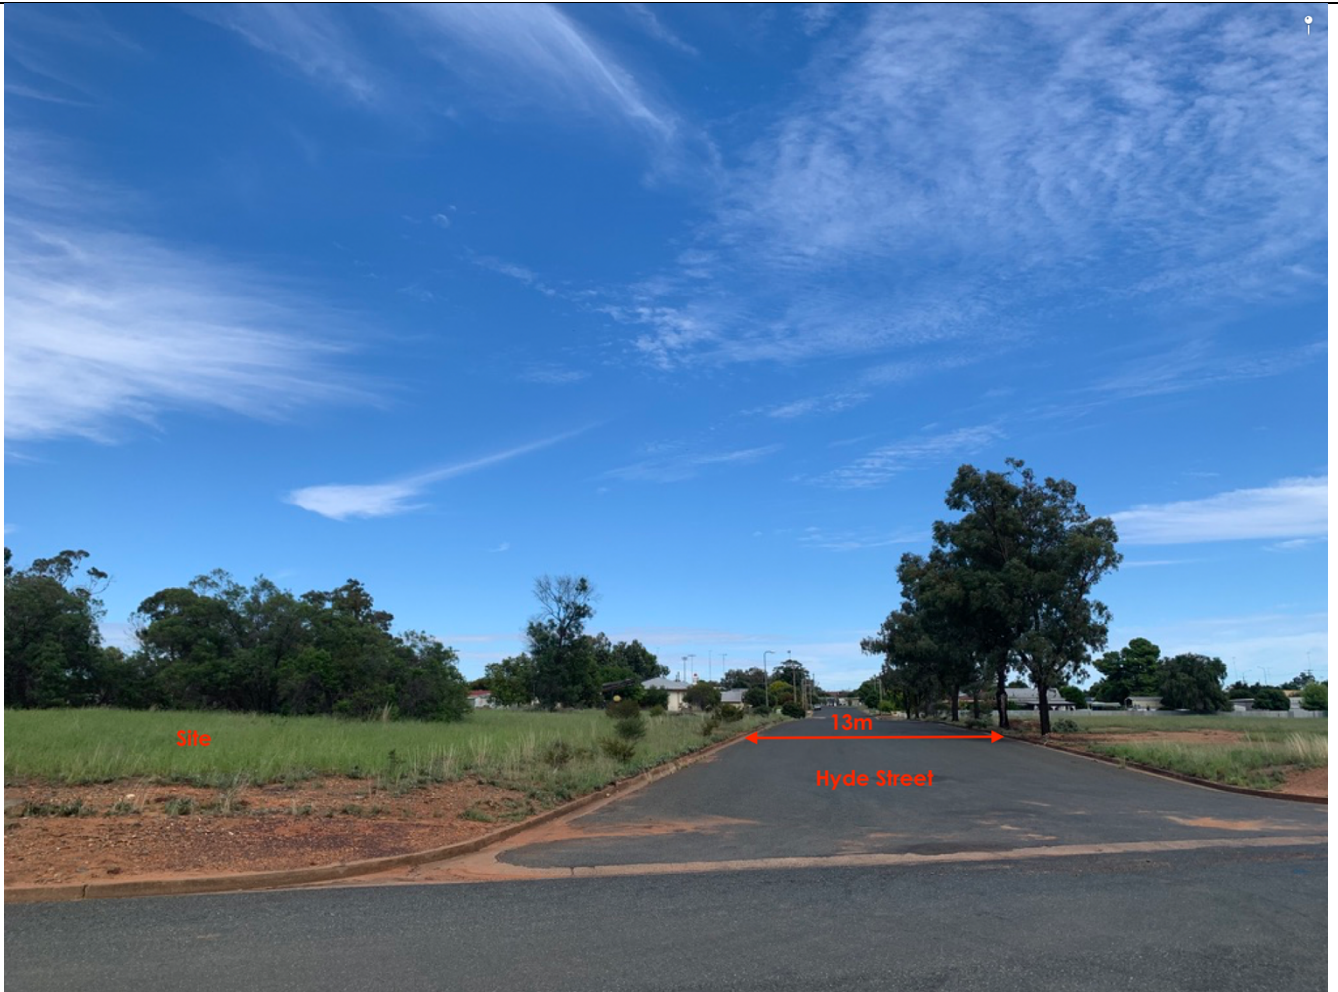
Photo 3 looking west from the intersection of Boundary Street into Hyde Street. Hyde Street is 13m wide kerb to kerb. The site is to the left of photograph.

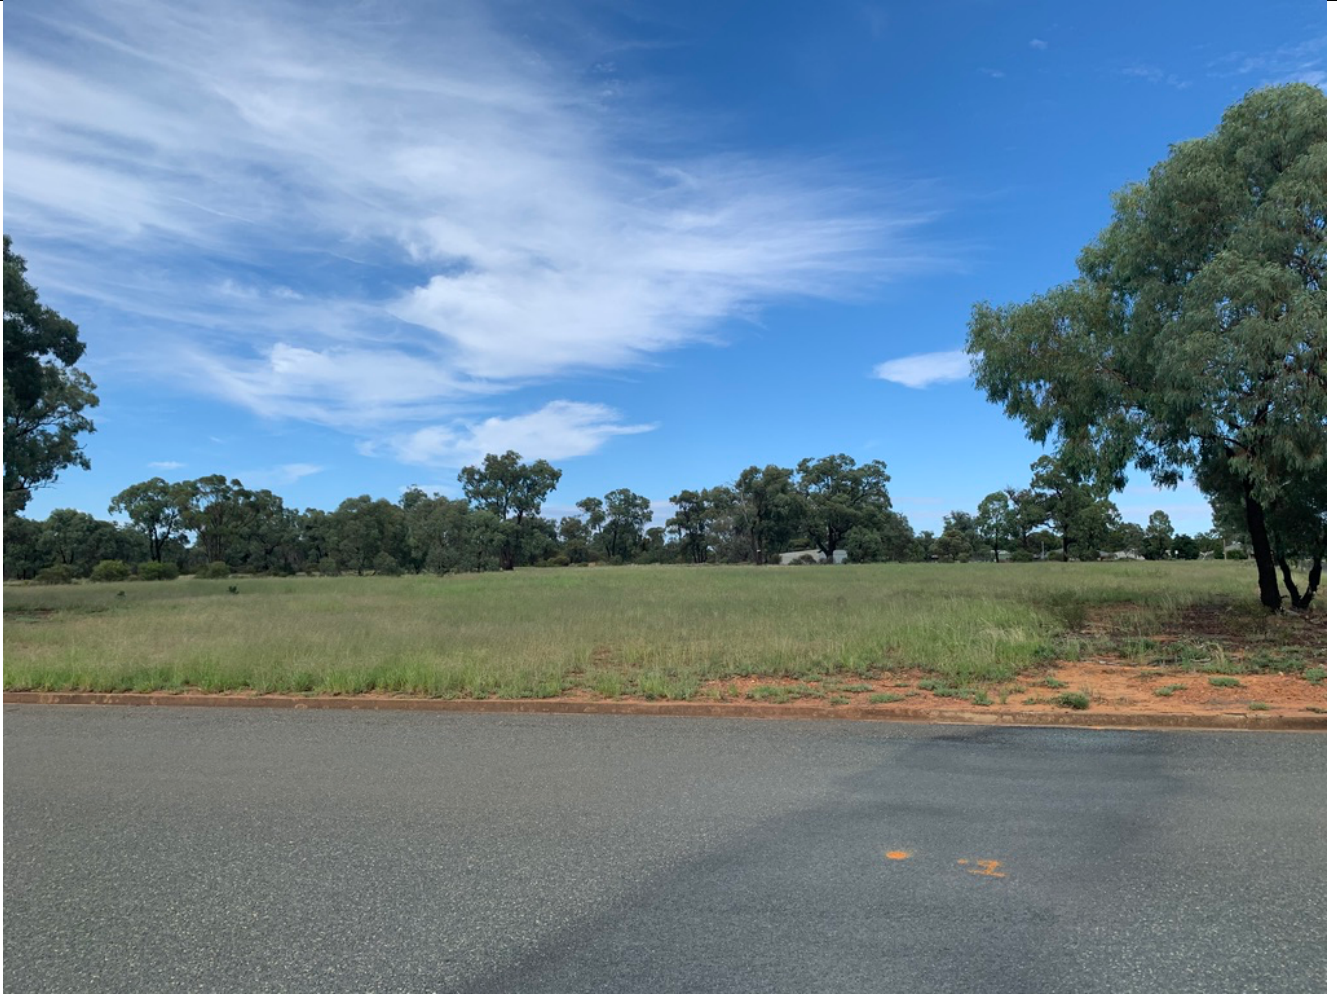
Photo 4 looking west from Boundary Street into the site. The site is extensively cleared of vegetation with grass within the main parts of the site.

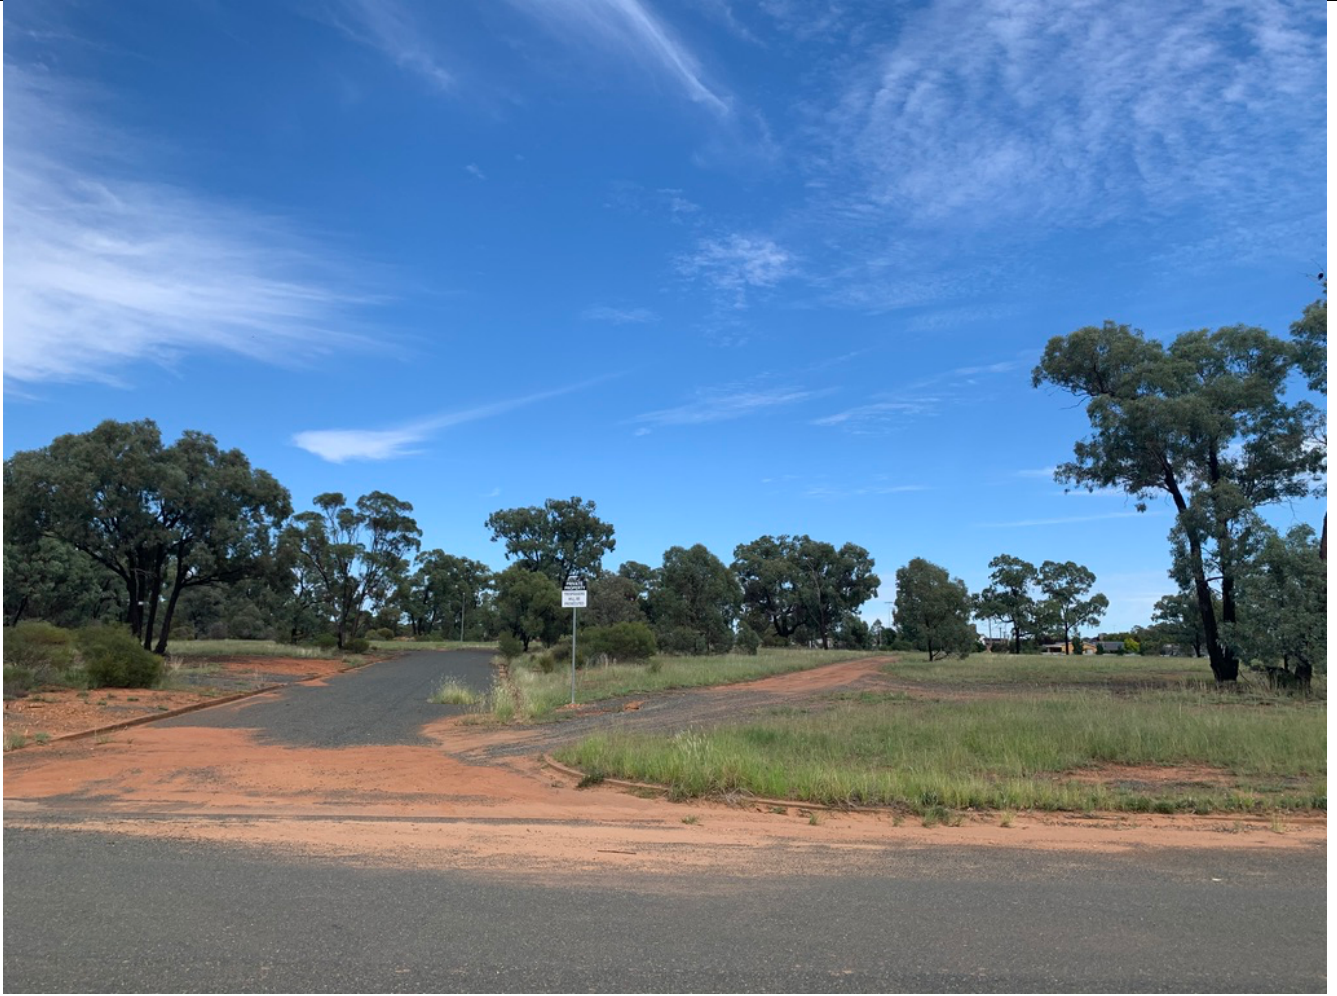
Photo 5 looking into the south eastern corner of the site showing Boundary Street and the dead end Gunters Close to the south of the site. The existing dirt track that runs along the southern boundary can be seen in the centre of the photo.

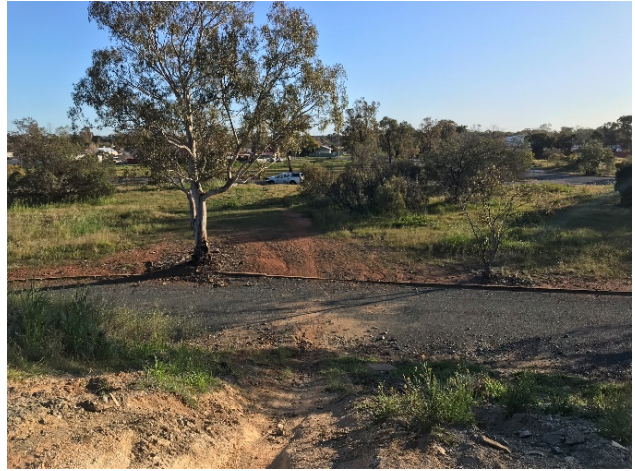
Plate 4.2 View from stockpile on northern portion of study area, showing high levels of ground disturbance from established road and previous accommodation village, view north.

The study area has been subjected to high levels of ground disturbance from the construction and development of the previous accommodation village at the study area (developed by Barrick Gold). Visual inspection of the study area revealed bitumen roads, soil stockpiling, rubbish heaps, and access tracks. The study area is situated within a wholly disturbed landscape, which is described further in Section 5 of this report (refer Plate 4.1 to Plate 4.6).

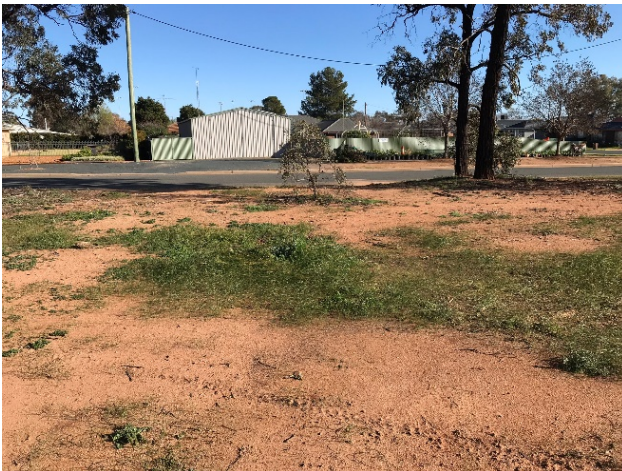
Plate 4.3 Photograph from the south-west portion of the study area showing visibility, exposure and ground disturbance, view west.

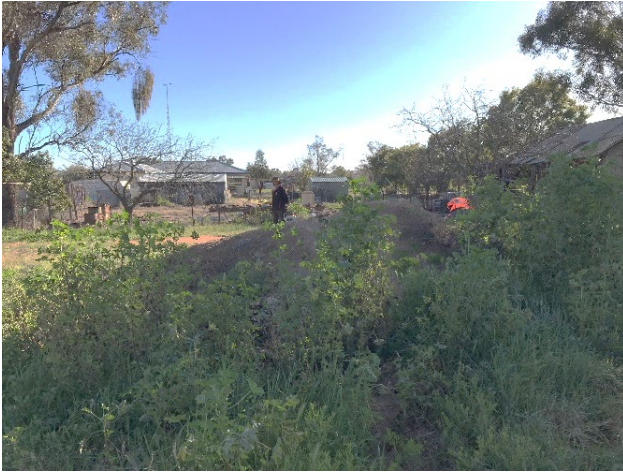
Plate 4.5 Showing low visibility and ground disturbance from stockpile in north-western portion of study area, view west.

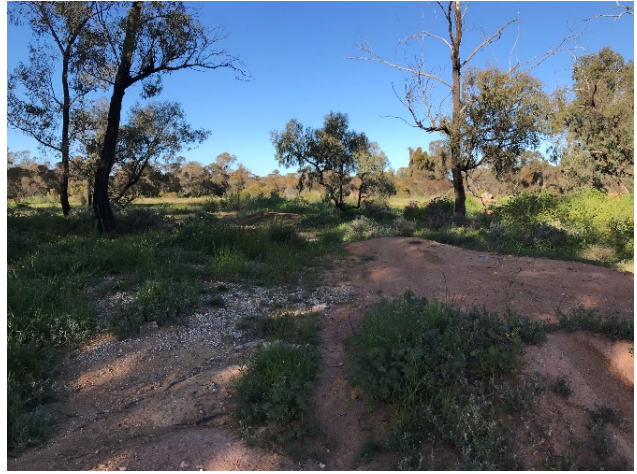
Plate 4.6 Showing ground disturbance from construction of bike jumps with imported materials in the south-western portion of study area, view east.

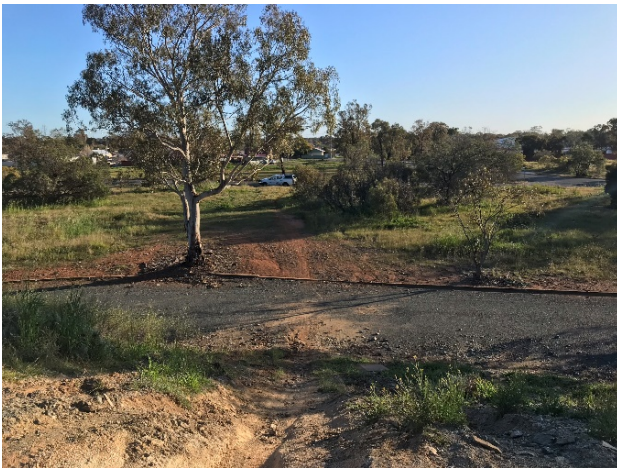
Plate 3.1 View from imported stockpile on northern portion of study area, established road from previous accommodation village, view north.

The site inspection did not locate any previously unidentified relics or cultural landscapes within the study area, and confirmed the high levels of ground disturbance from the previous accommodation village rendering it unlikely any subsurface relics or cultural material exist (refer Plate 3.1 to Plate 3.4).

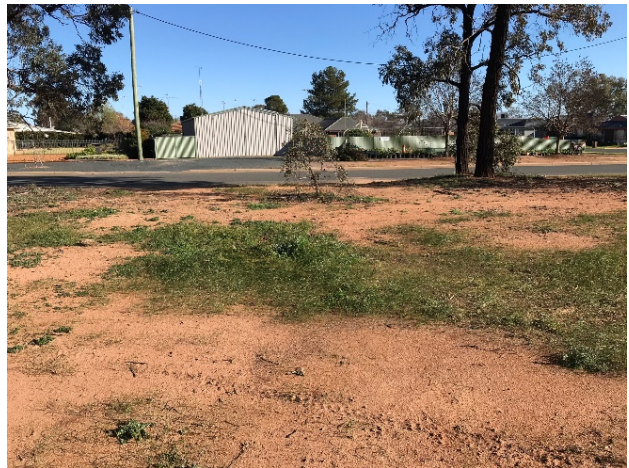
Plate 3.2 Photograph from the south-west portion of the study area showing visibility, exposure and ground disturbance, view west.

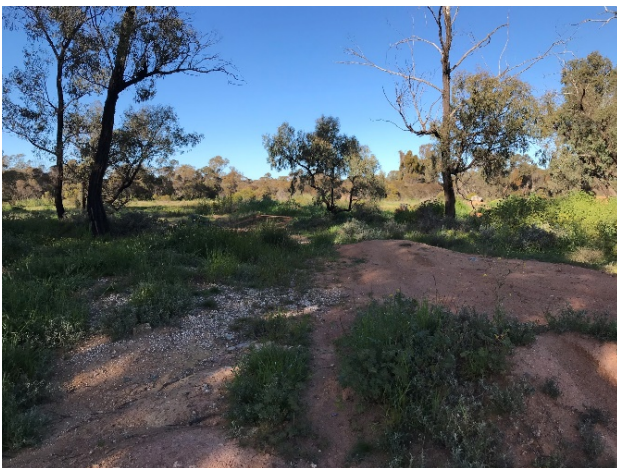
Plate 3.3 Showing ground disturbance from construction of bike jumps with imported materials in the south-western portion of study area, view east.

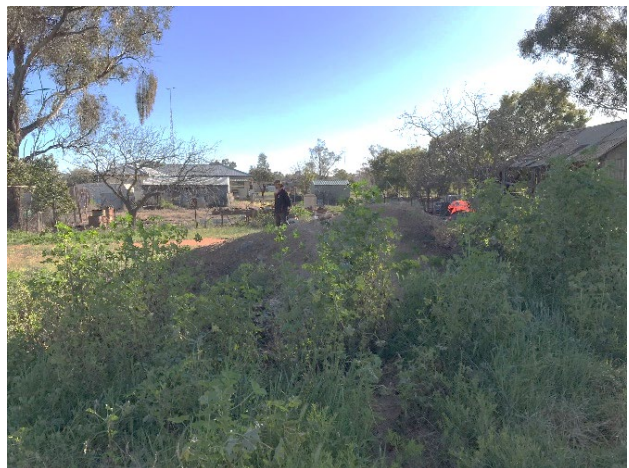
Plate 3.4 Showing vegetation and ground disturbance from stockpile in north-western portion of study area, view west.
