Statement of Environmental Effects Cowal Gold Operations Accommodation Village

VOLUME 2 – APPENDIX D TO J

Prepared for Evolution Mining (Cowal) Pty Limited
April 2021

CONSTRUCTION MANAGEMENT PLAN

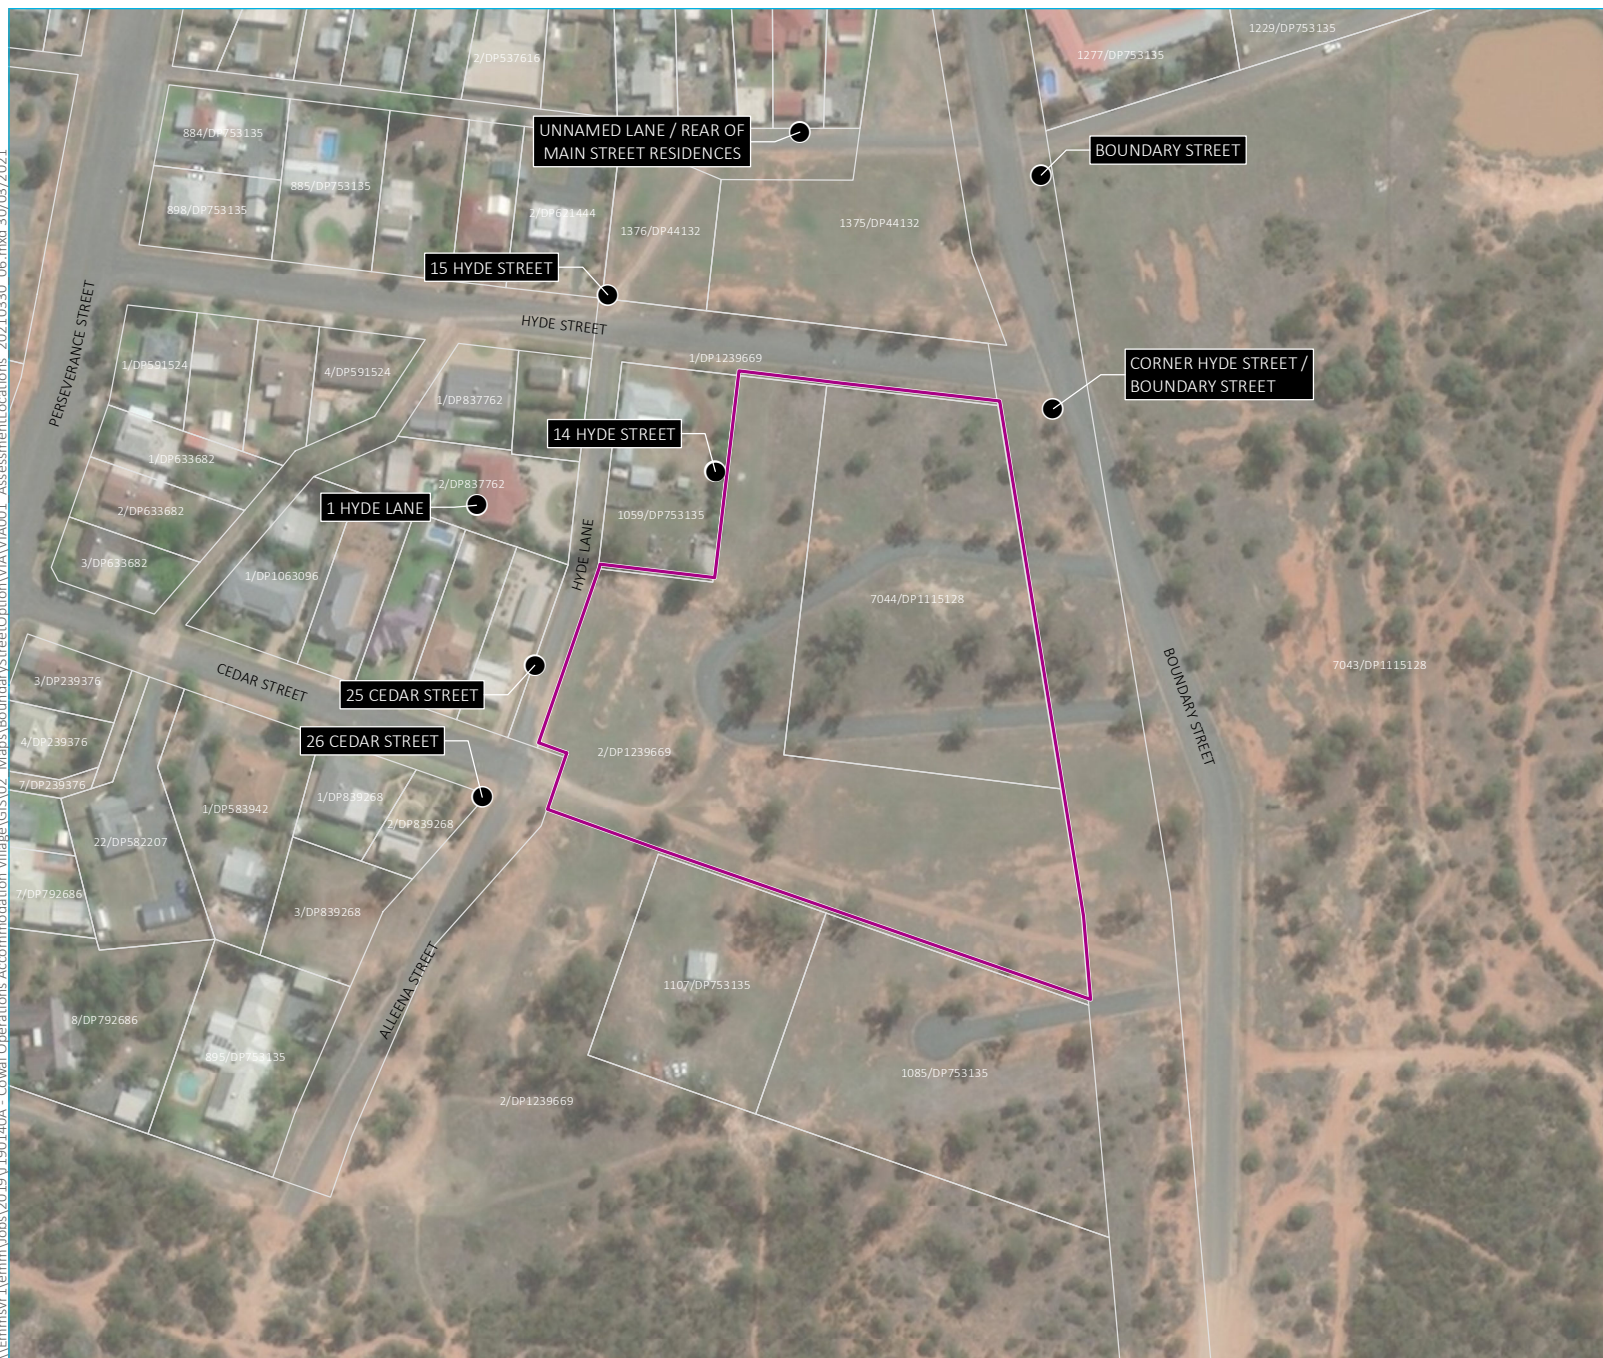
Assessment viewpoints

- KEY
- Assessment viewpoint
 - Site boundary
 - Cadastral boundary

The potential sensitive receptor locations are shown in Figure 4.1.

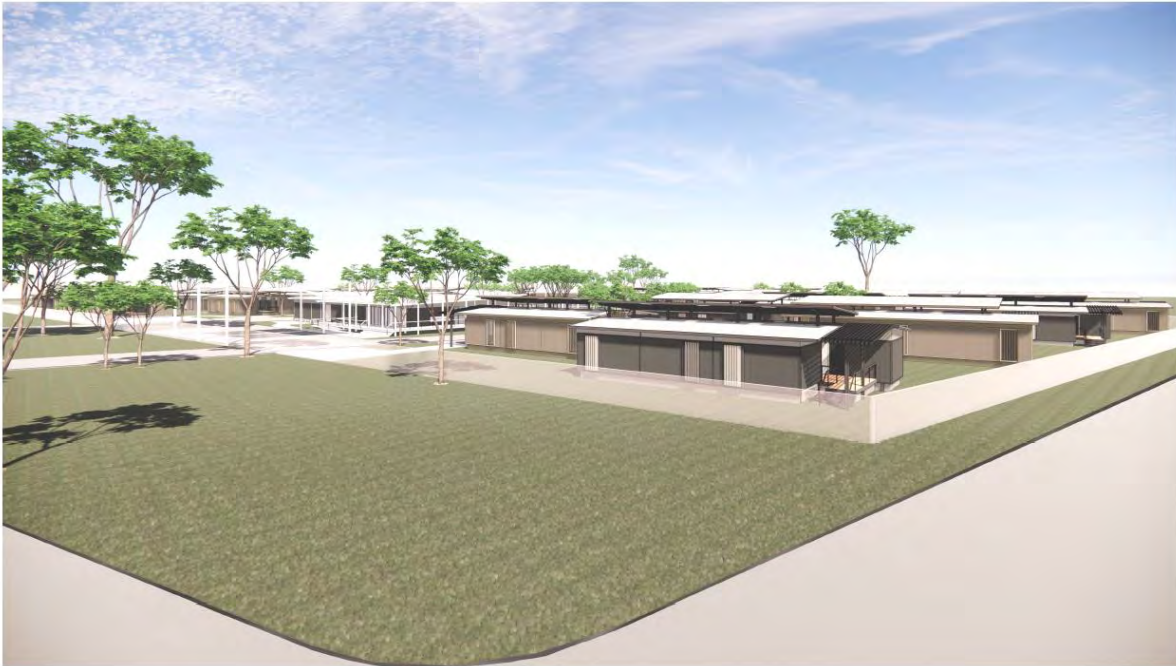
Figure 5.1 3D visualisation of the village looking southwest from the intersection of Hyde Street and Boundary Street

The 3D visualisations of the village are shown in Figure 5.1, Figure 5.2 and Figure 5.3.

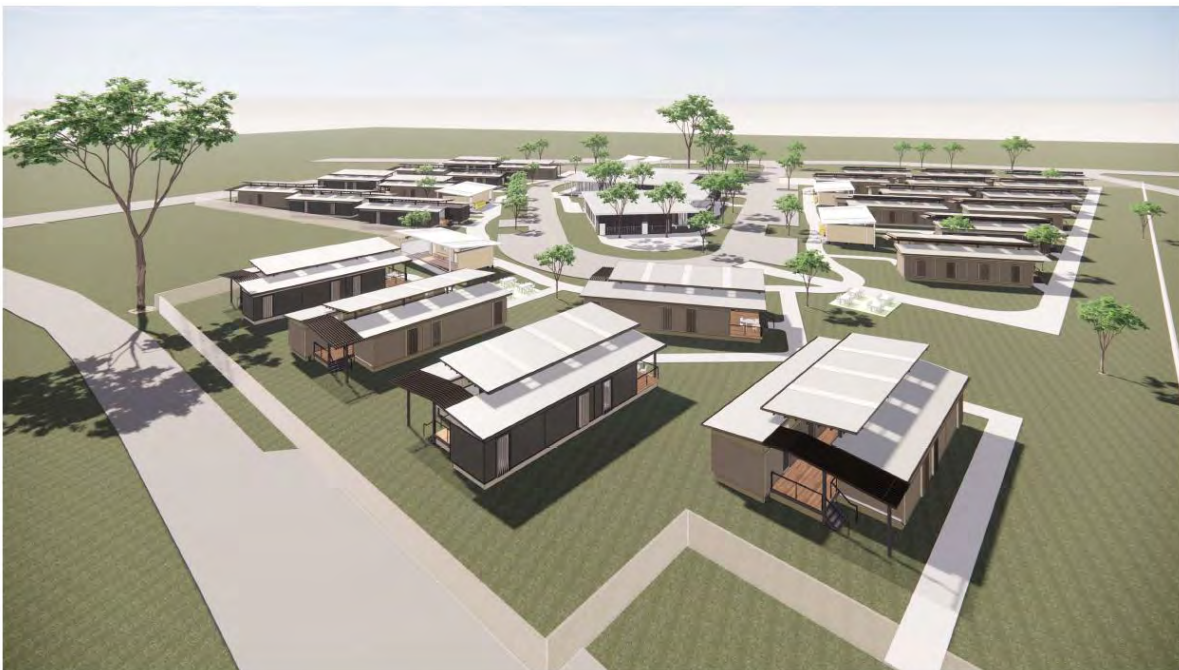
Figure 5.2 3D visualisation of the village looking northeast from the southwestern corner of the site

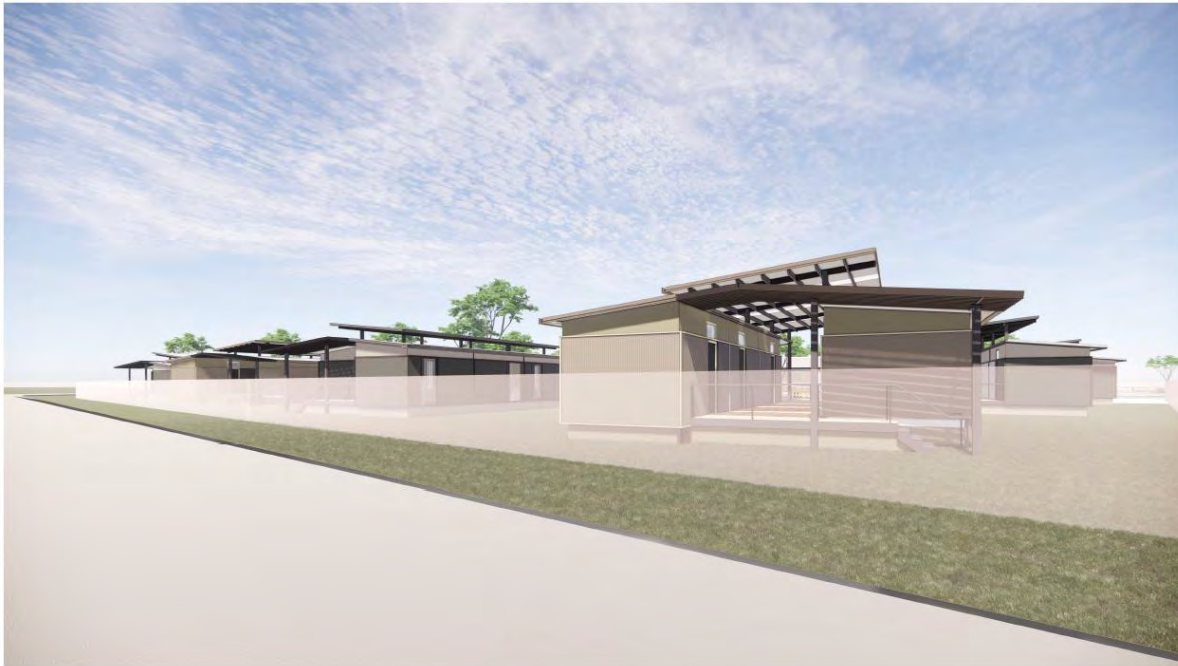
Figure 5.3 3D visualisation of the village looking south from Hyde Street

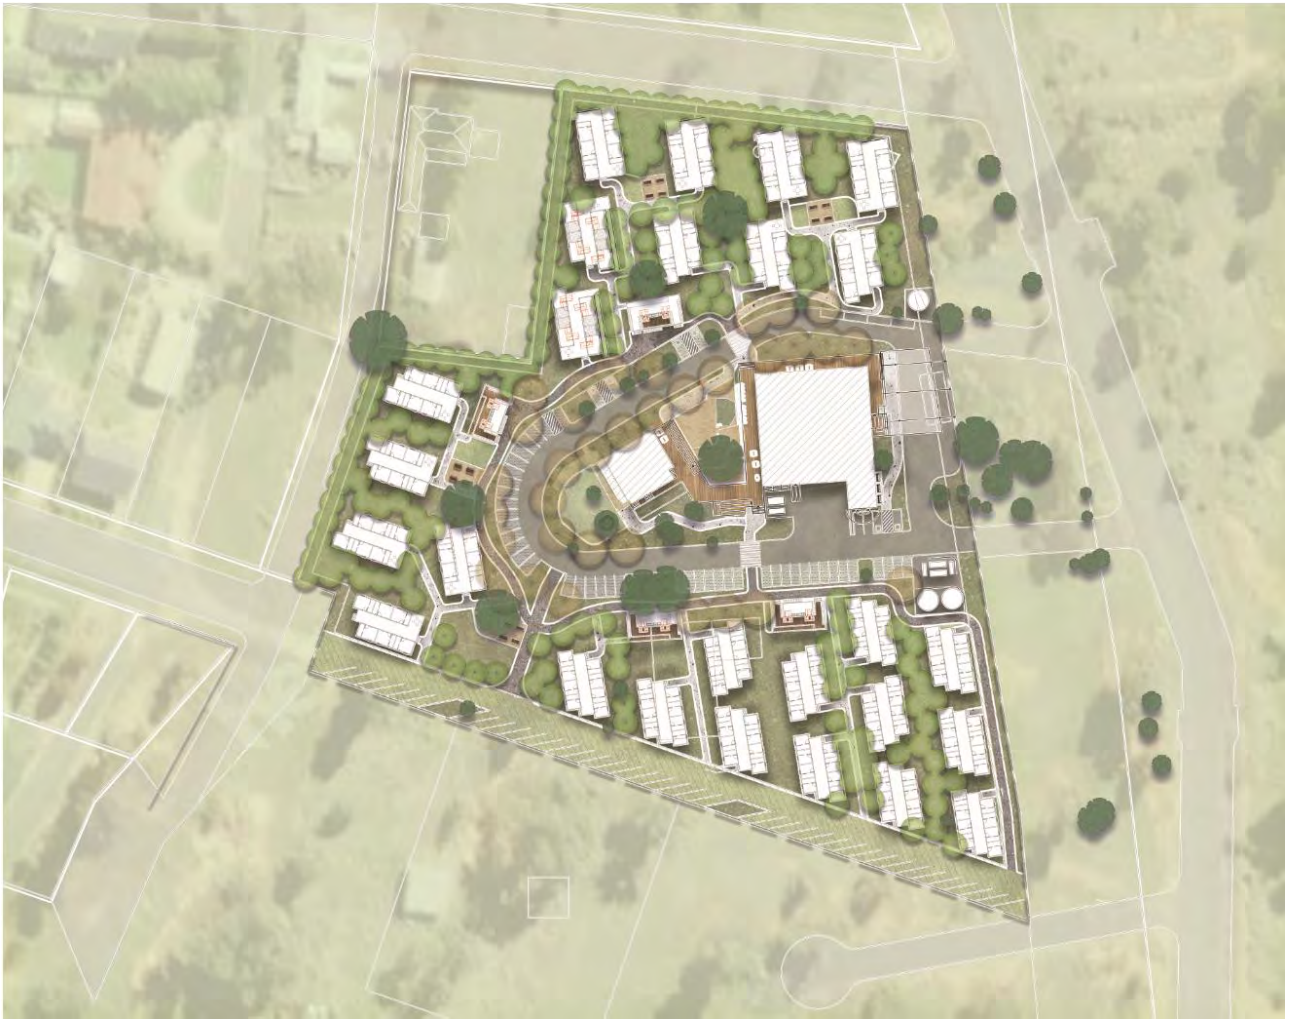
Figure 5.4 **Conceptual landscaping plan**

A conceptual landscaping plan has been prepared for the site which shows the planting and native species that will be used at the site. In general, the planting will be undertaken to provide shading to the structures (in particular outdoor eating spaces) and as infill planting between the structures, subject to meeting bushfire planning guidelines. The landscaping concept plan for the village, prepared by Arcadia, is shown in Figure 5.4.

The landscaping will soften the appearance of the structures and provide visual impact shielding from neighbouring viewpoints.
