Terara Shoalhaven Sand  
C/- Ernest Panucci

# Acid Sulfate Soils Assessment: Proposed Expansion of Sand Dredging Operations at Terara Sands, NSW

P1806743JR02V01  
April 2019

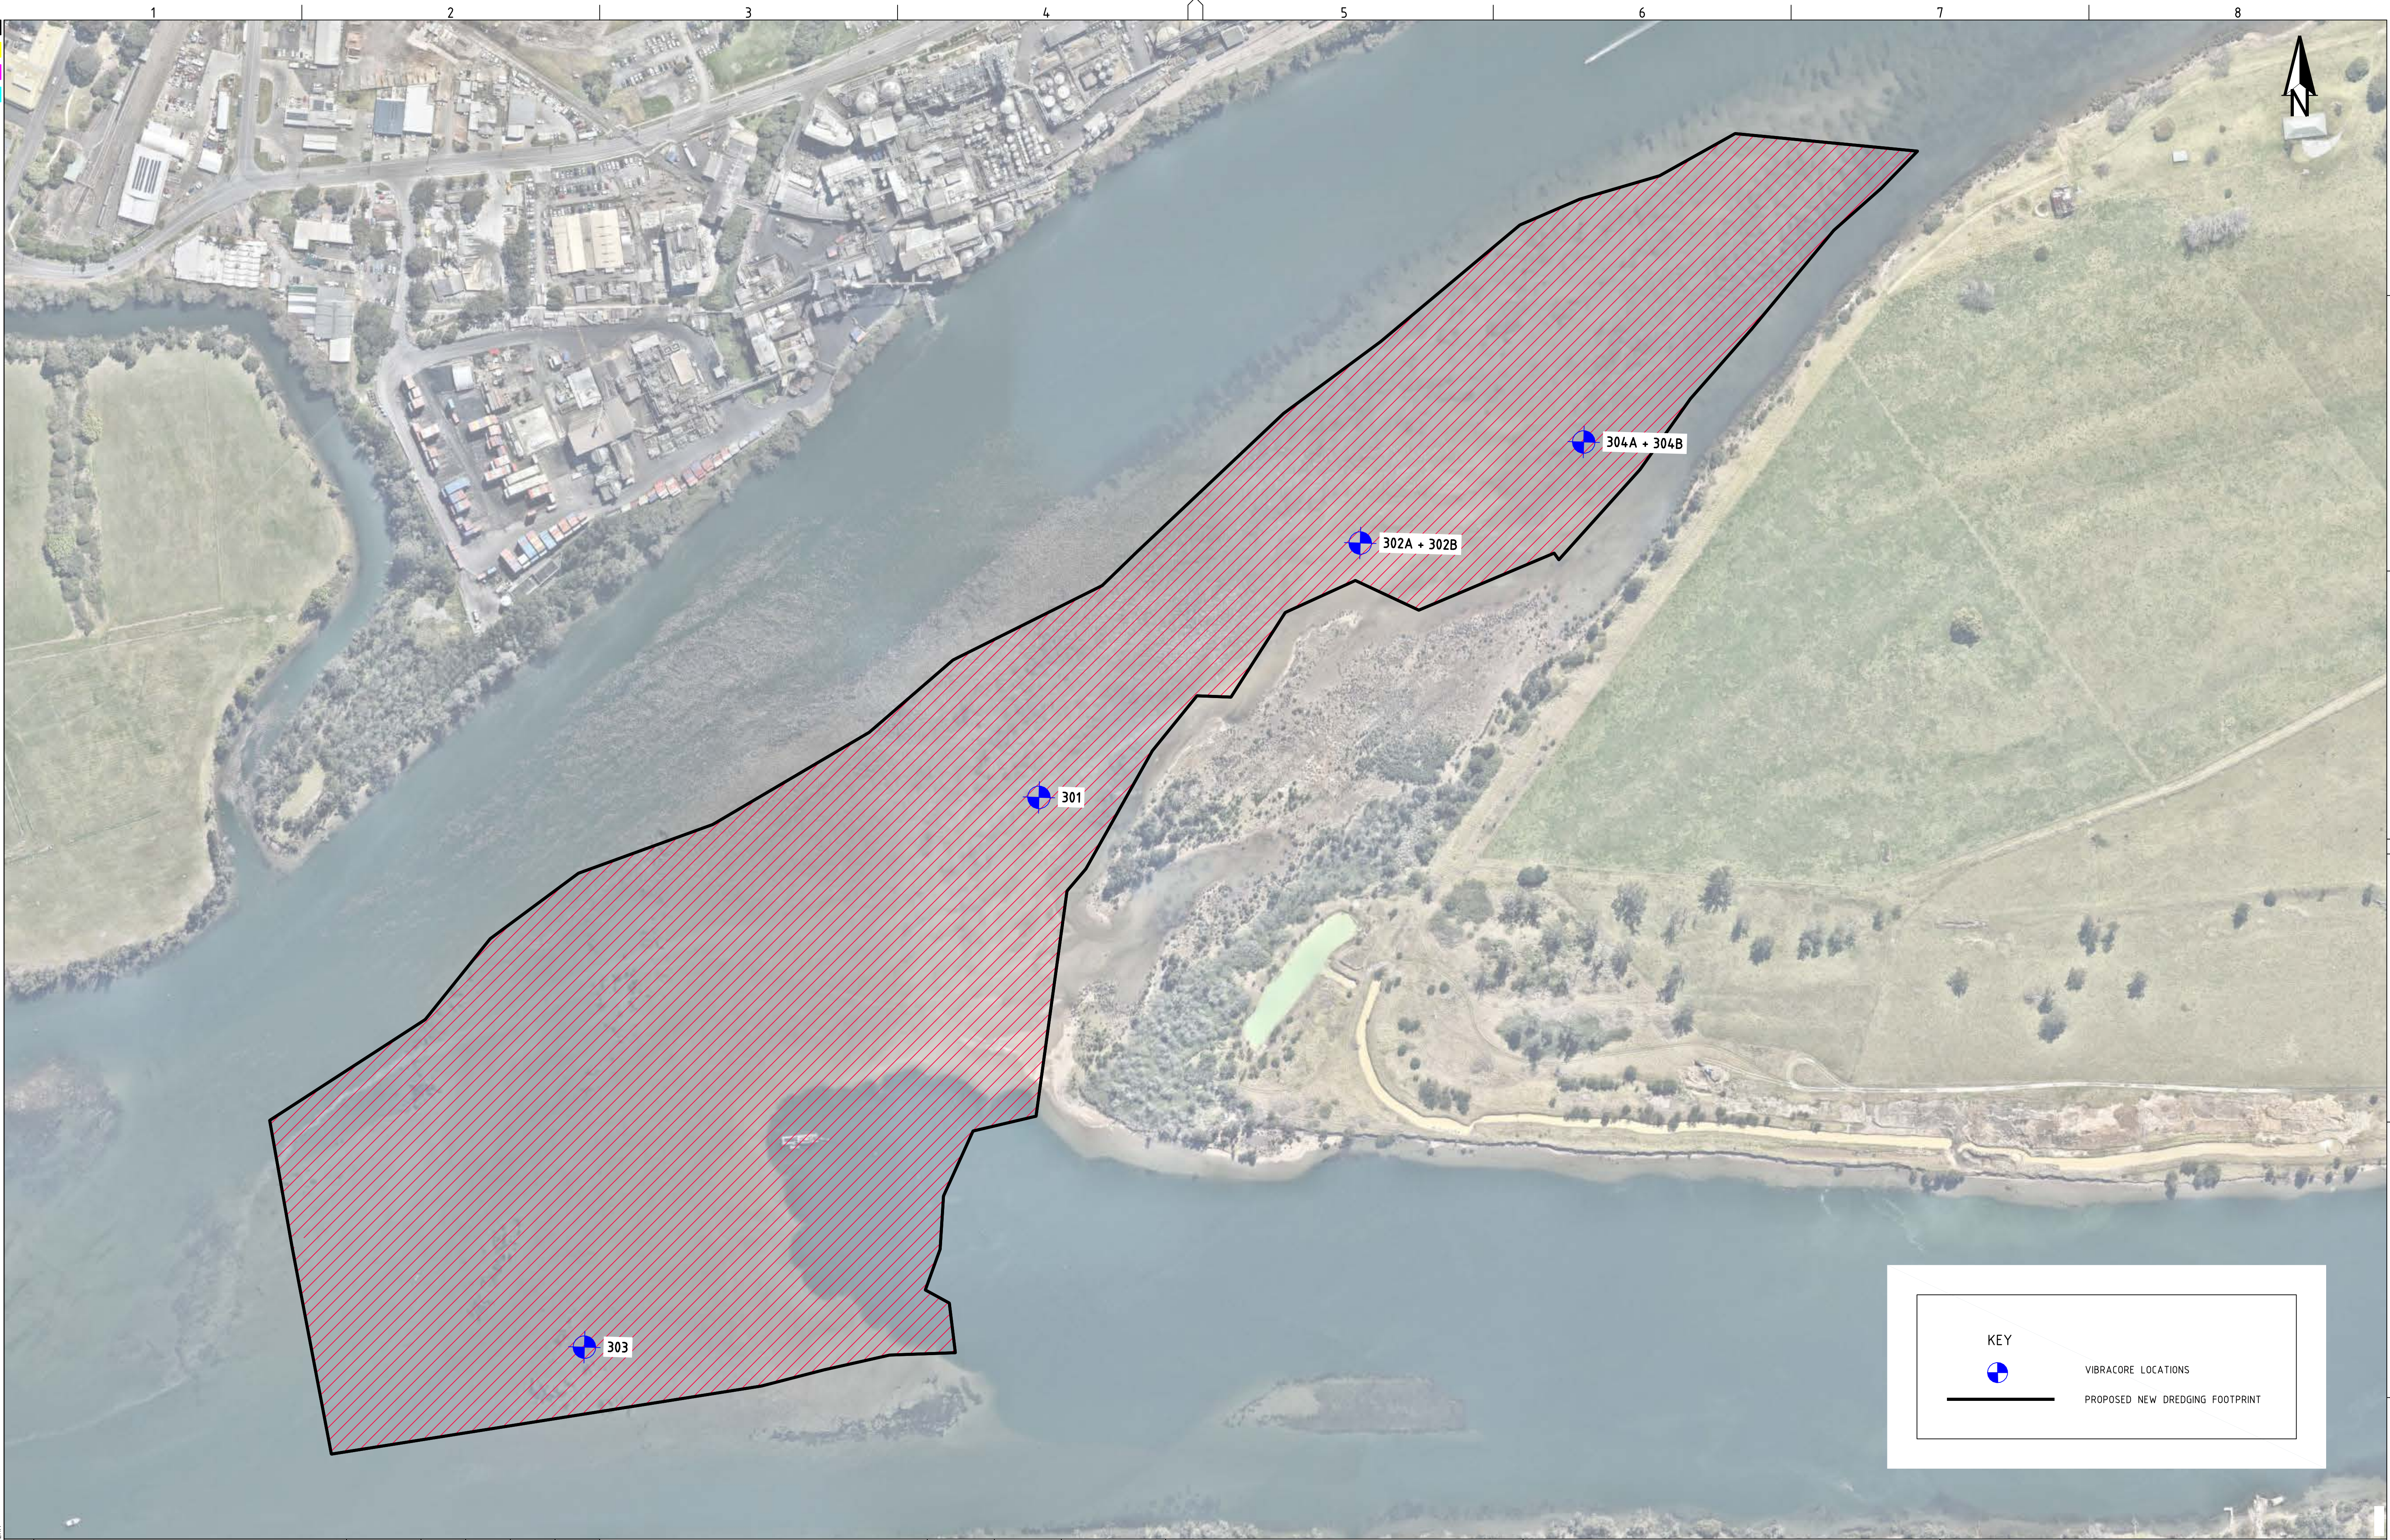
## **6      Attachment B – Vibracore Locations**

Vibracore locations are shown in Attachment B.

VIBRACORE LOCATIONS

PROPOSED NEW DREDGING FOOTPRINT

DRAWING TITLE				
EXTENT OF SAND DREDGING OPERATIONS				
PROJECT NO.	PLANSET NO.	RELEASE NO.	DRAWING NO.	REVISION
P1806743	PS01	R03	PS01-AZ00	C
