Land Resource Assessment:

Proposed Expansion of Sand Dredging  
Operations at Terara Shoalhaven Sand,  
Terara, NSW

P1806743JR07V01  
March 2019

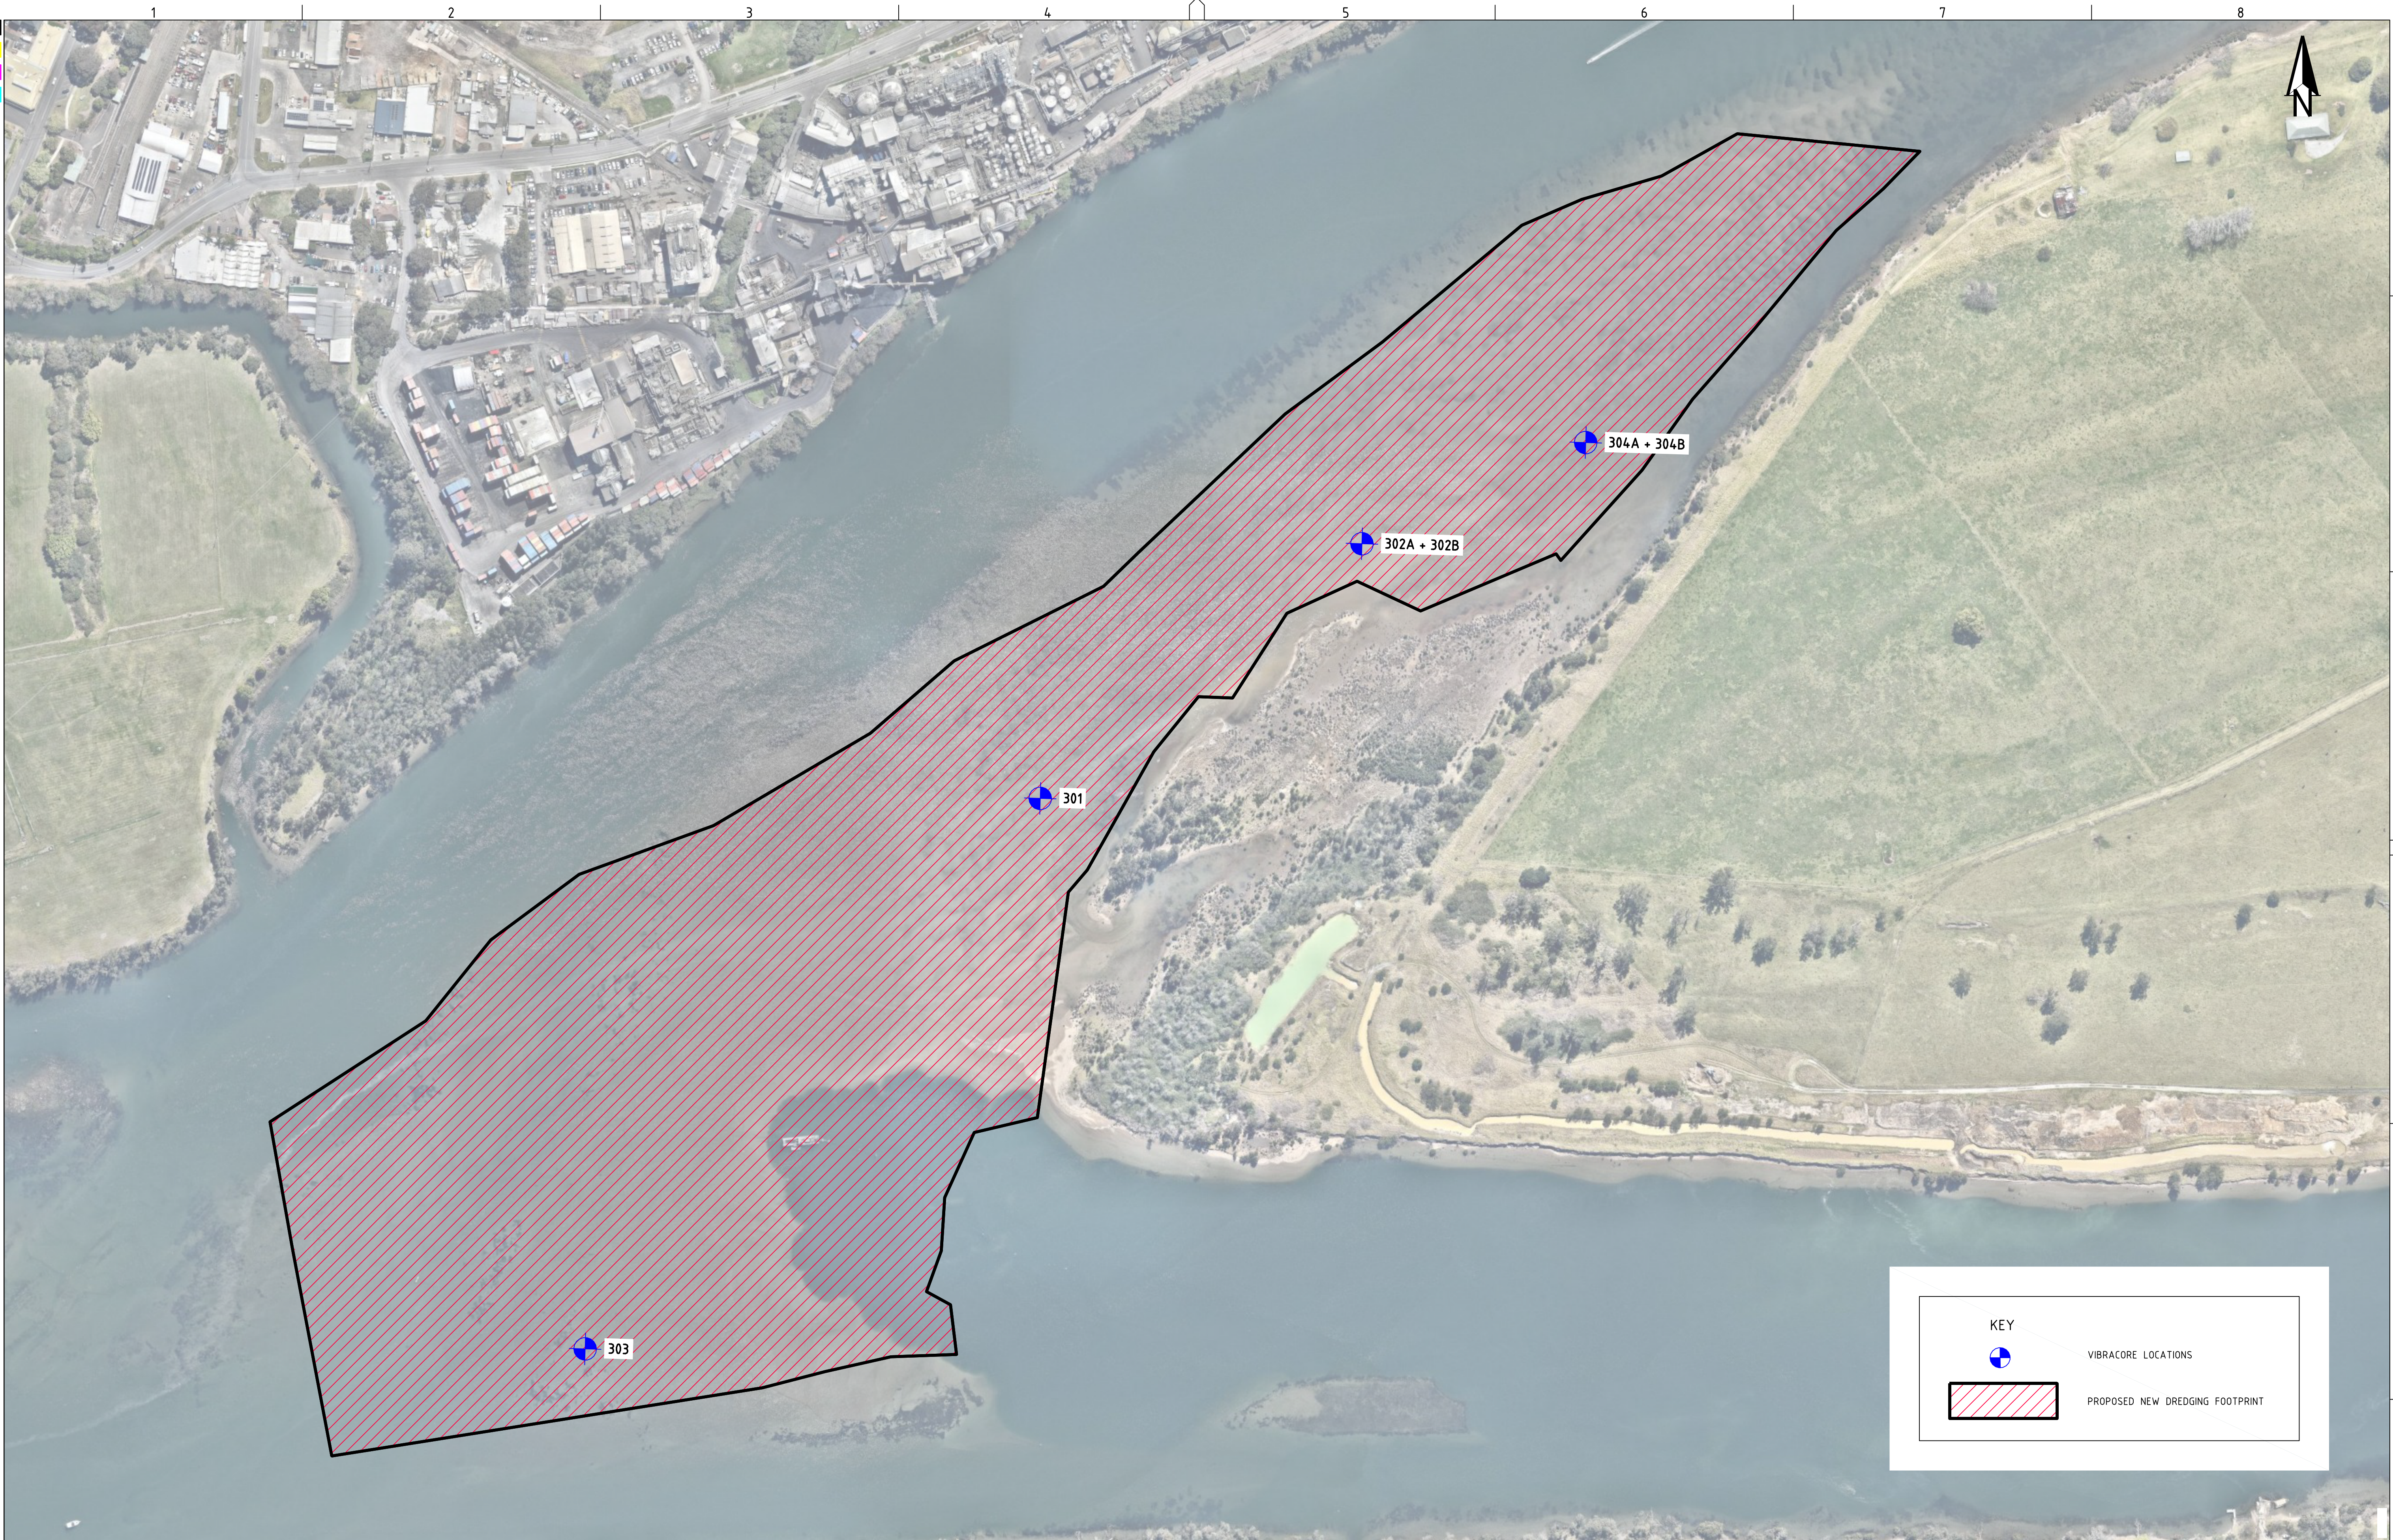
## 11      **Attachment A – Testing Locations**

VIBROCORE LOCATIONS

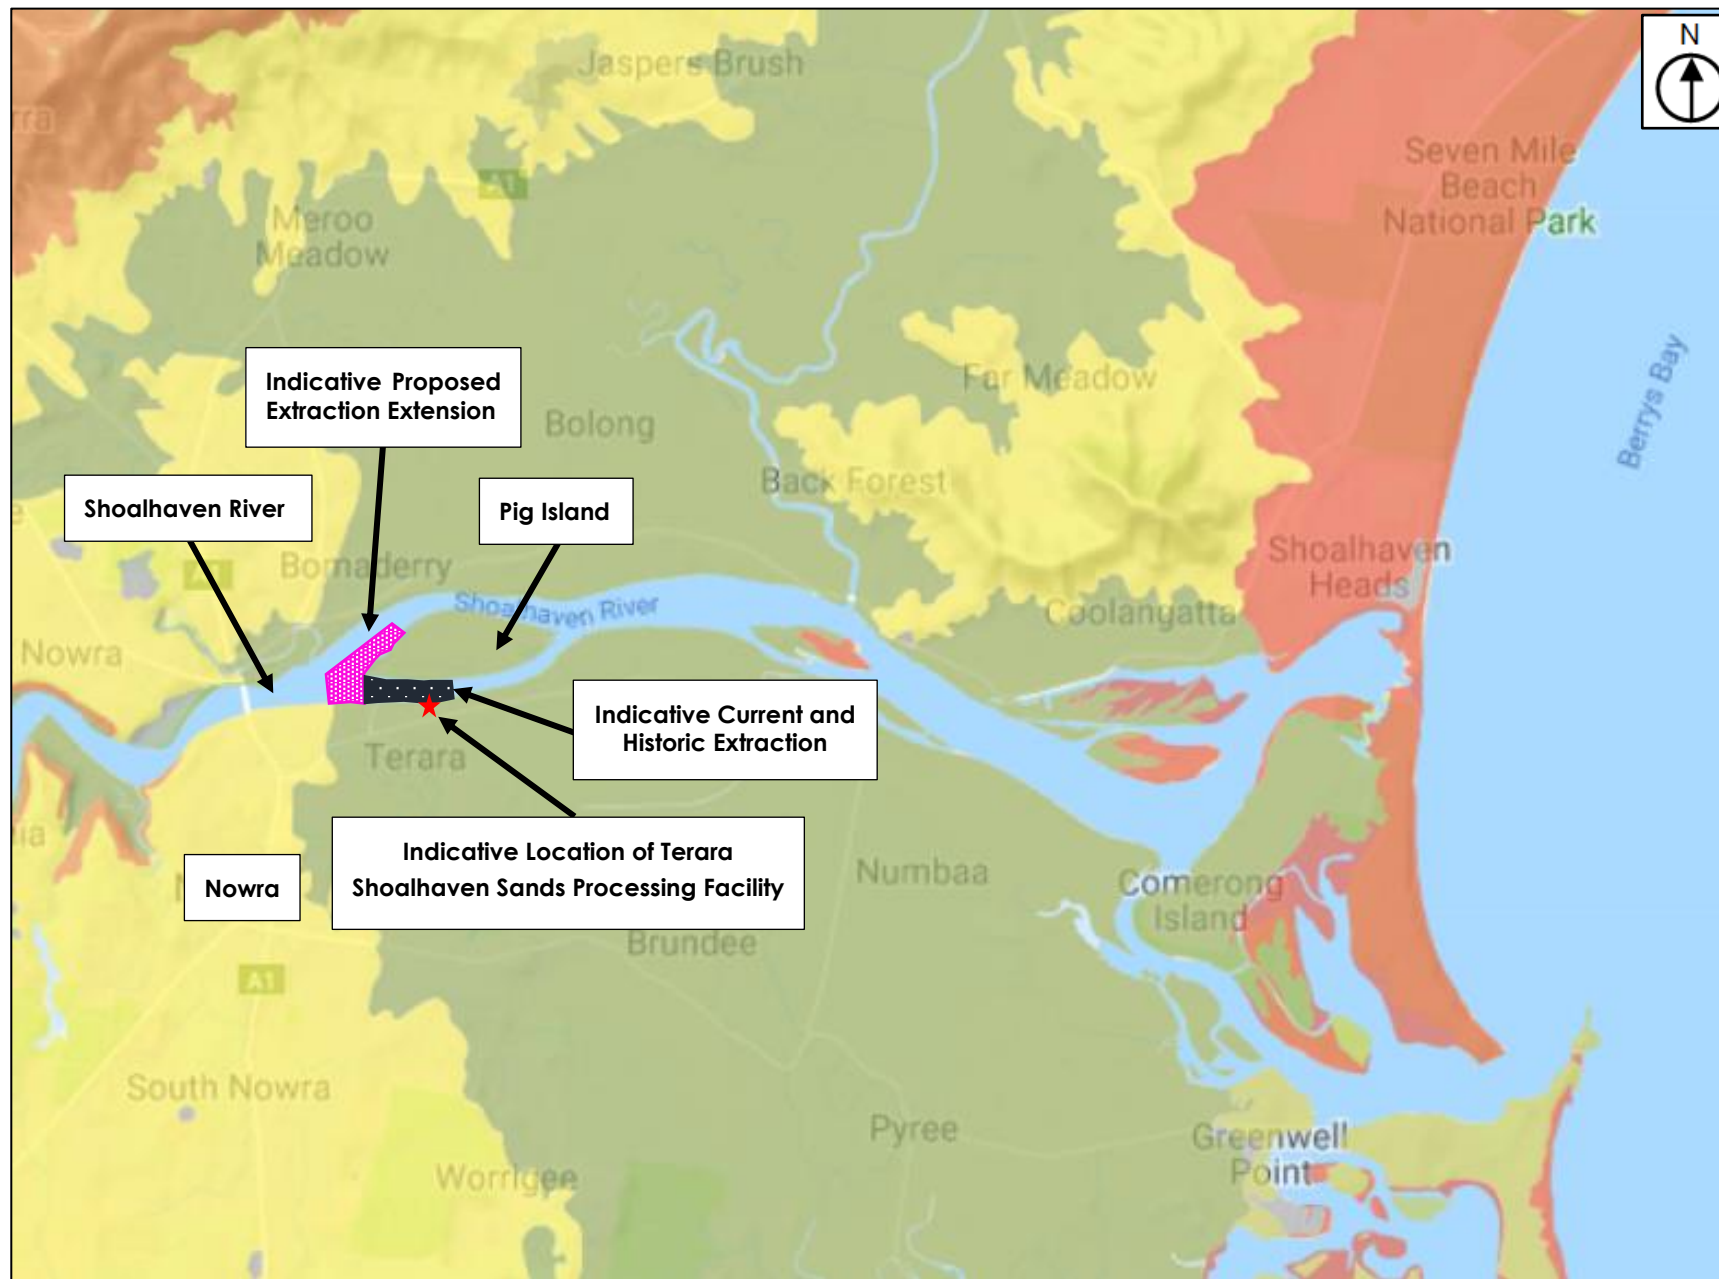
**FIGURE 1**

- Proposed extraction extension zone
- Current and historic extraction (1976 – 2018)
- 1 Very slight to negligible limitations
- 2 Slight but significant limitations
- 3 Moderate limitations
- 4 Moderate to severe limitations
- 5 Severe limitations
- 6 Very severe limitations
- 7 Extremely severe limitations
- 8 Extreme limitations
- Not Assessed
- Water

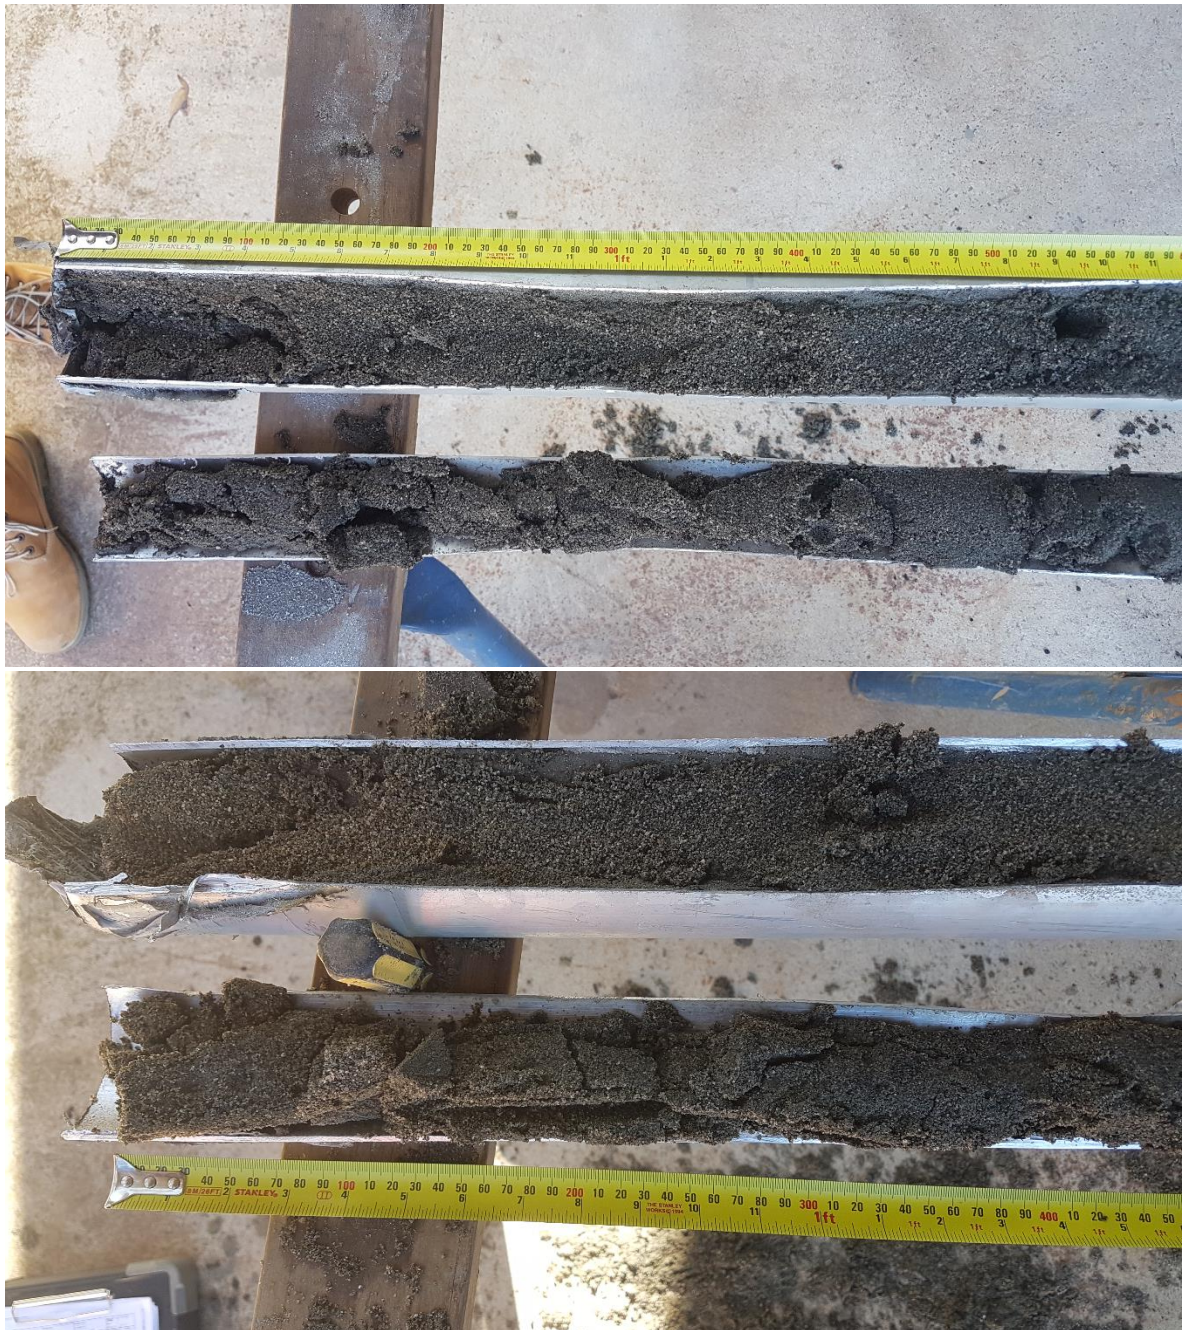
Figure 3: Representative soil unit photos

Encountered conditions are described in more detail on the borehole logs in Attachment C, representative photos in Attachment D, and associated explanatory notes in Attachment I.

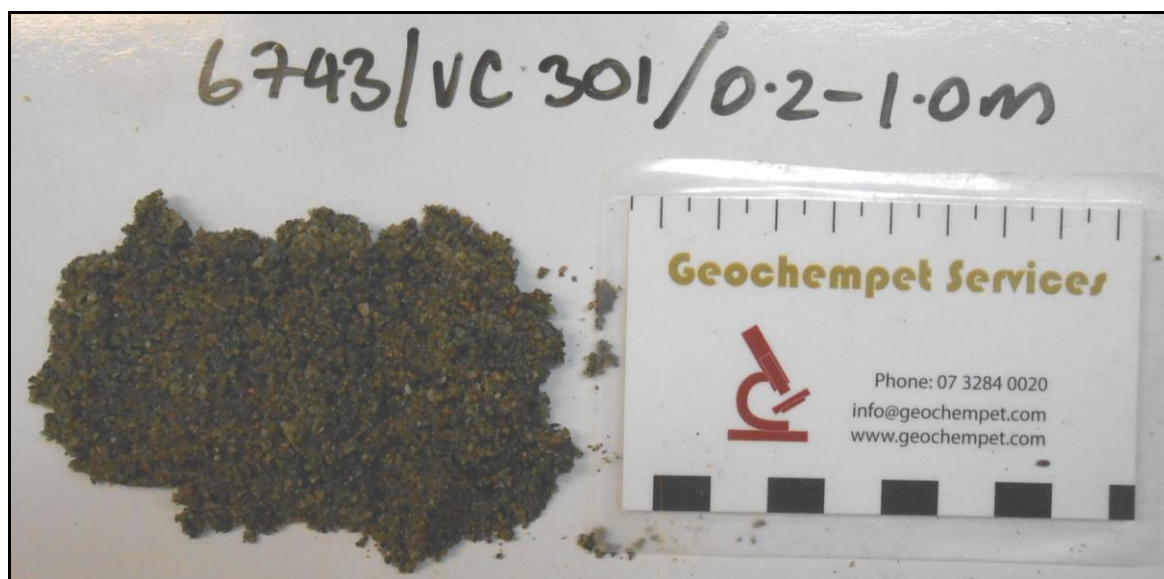
The sample consisted of about 2 kg of dark grey brown, coarse sand, dominated by variously coloured lithic fragments and free quartz grains.

**Figure 1:** Digital image of sub-sample from the supplied sand sample.

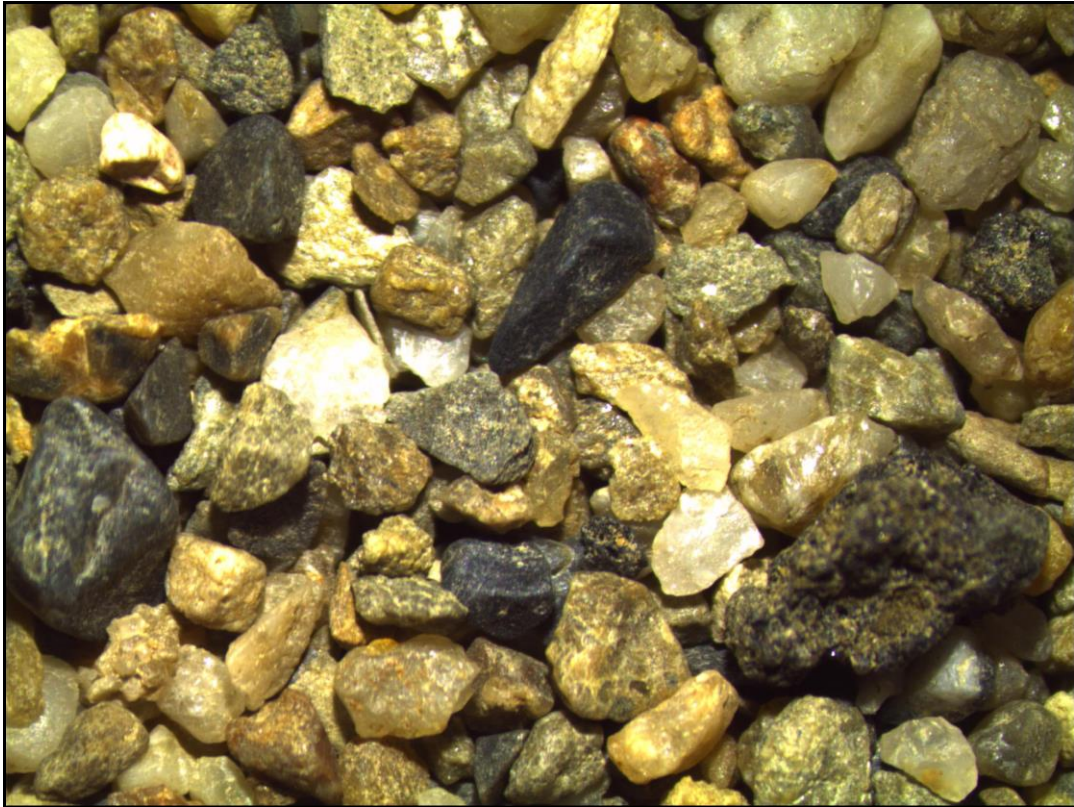
**Figure 3:** Image of coarse sieve fraction showing common quartz and lithic clasts

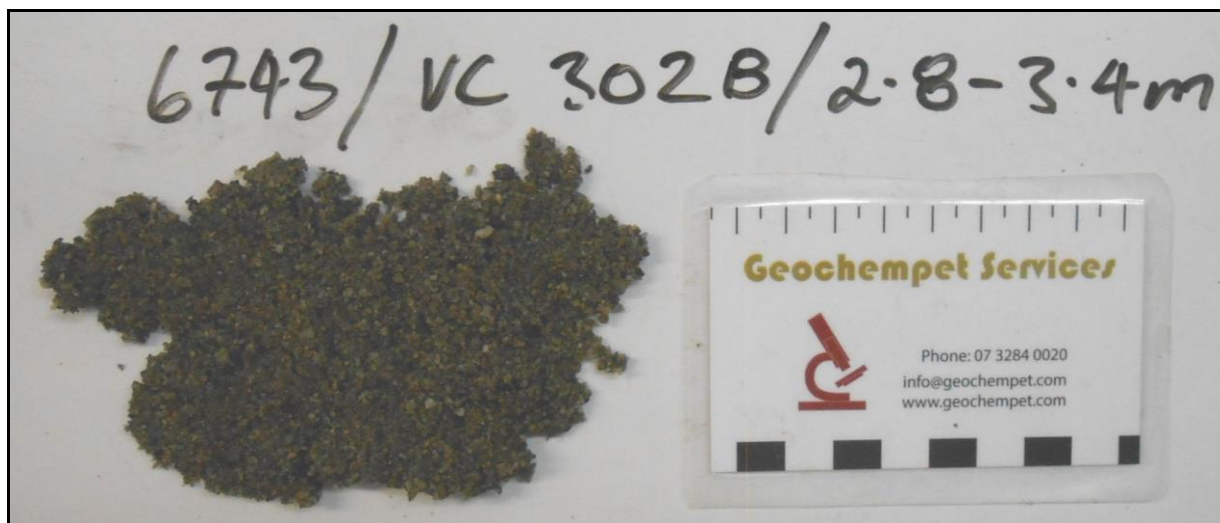
The sample consisted of about 2 kg of dark grey brown, coarse sand, dominated by variously coloured lithic fragments and free quartz grains.

**Figure 1:** Digital image of sub-sample from the supplied sand sample.

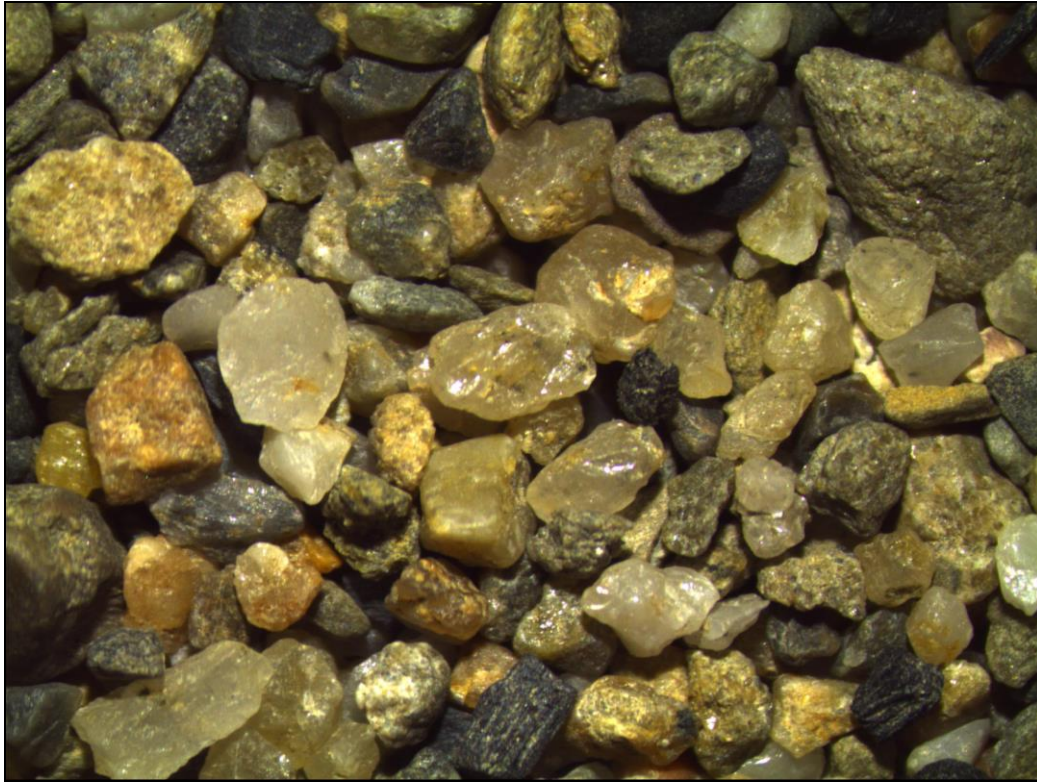
**Figure 3:** Image of coarse sieve fraction showing abundance of quartz grains and lithic clasts.

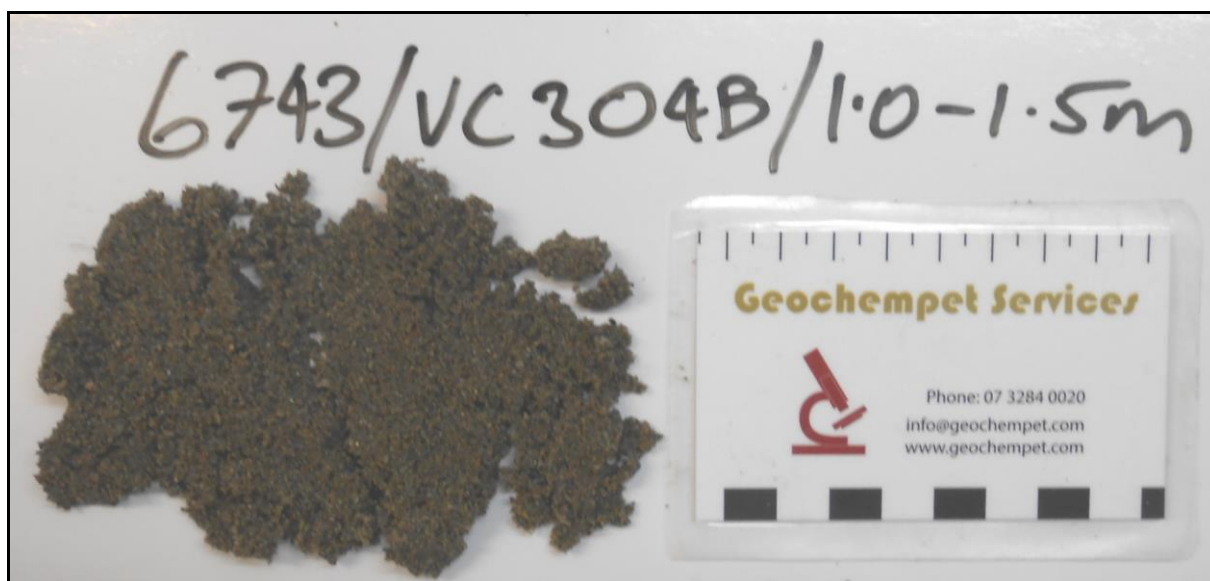
The sample consisted of about 2 kg of dark grey brown, coarse sand, dominated by variously coloured lithic fragments and free quartz grains.

**Figure 1:** Digital image of sub-sample from the supplied sand sample.

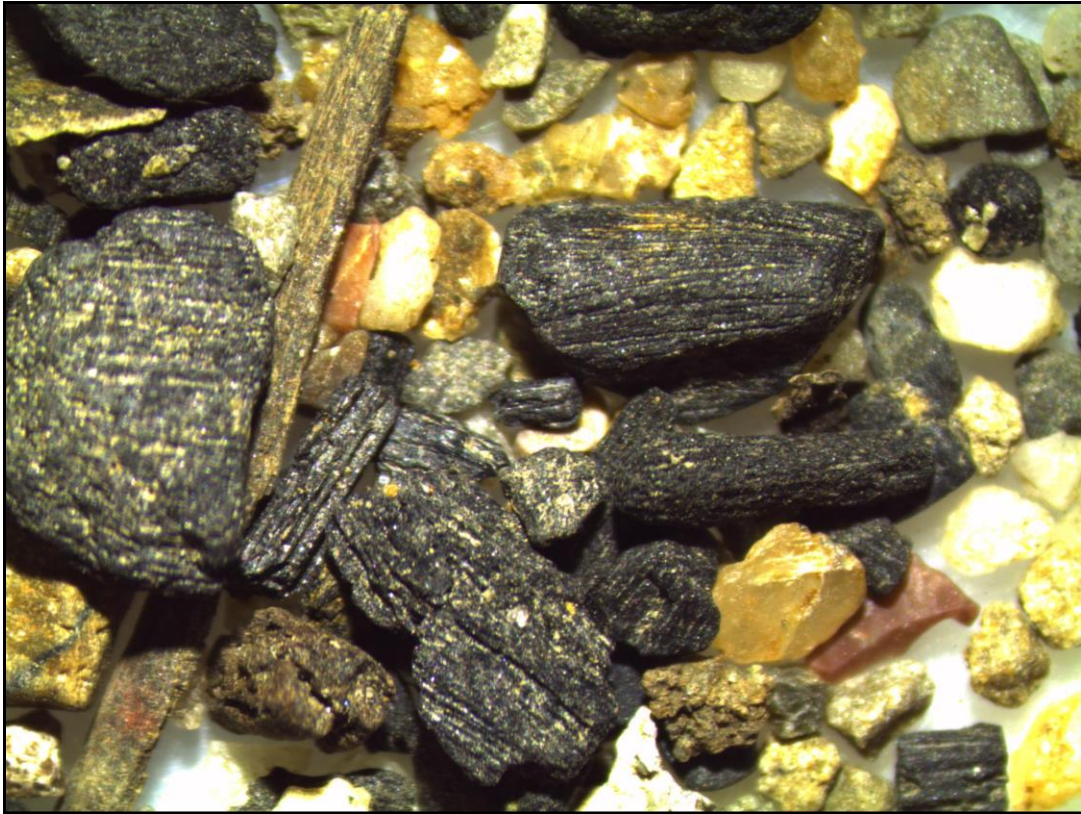
**Figure 3:** Image of coarse sieve fraction showing abundance of quartz grains and lithic clasts. Note the charcoal fragments and plant matter in this fraction.
