GEOTECHNICAL INVESTIGATION:

New Unit Block at **12-14 Ponsonby Parade, Seaforth**

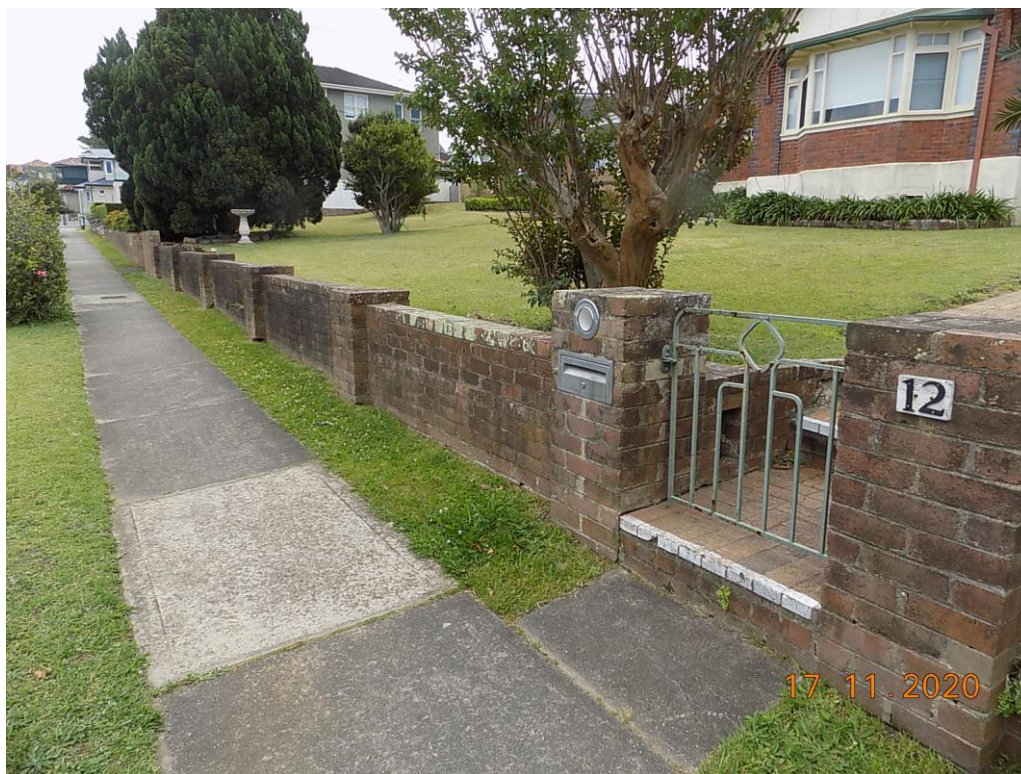
Photo 1

- 2.3 12 Ponsonby Parade** – The cut for Ponsonby Parade is supported by a stable brick retaining wall reaching ~1.1m high (Photo 1). Between the road frontage and the house is a gently sloping lawn (Photo 2). Another gently sloping lawn extends off the uphill side of the house to the road frontage with Ross Street (Photo 3). Competent Medium Strength Sandstone outcrops through this lawn in the NW corner of the

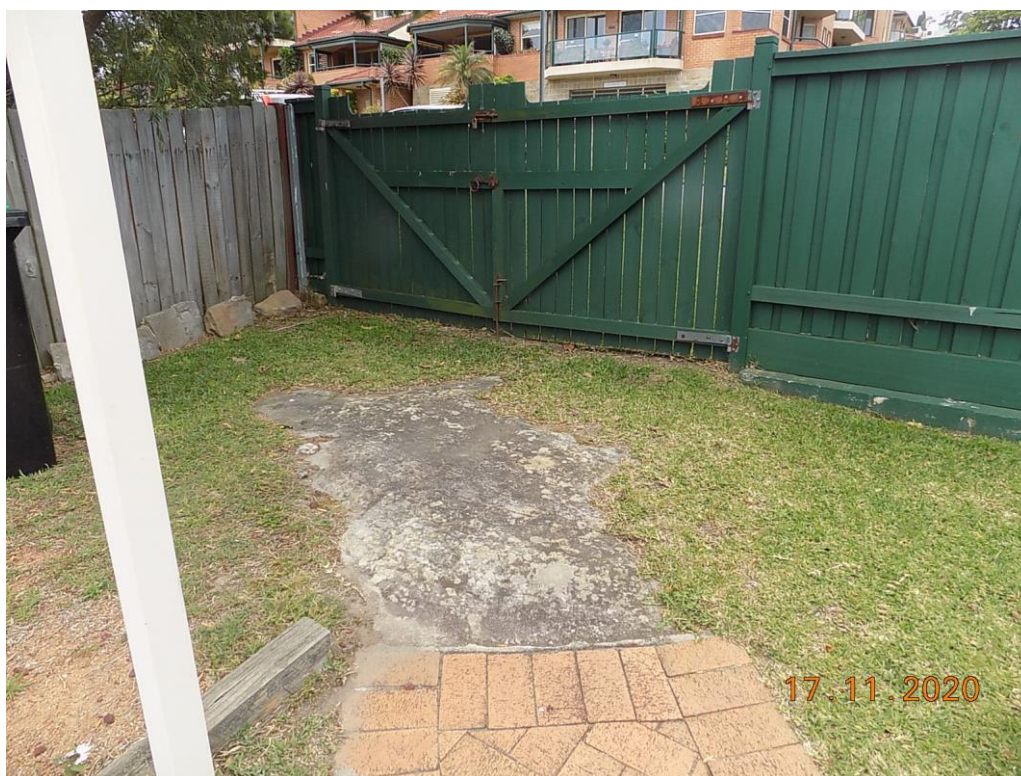
Photo 4

property (Photo 4). A brick garage extends off the road frontage to Ross Street in the NE corner of the property (Photo 5). The garage and house (Photo 6) will be demolished and the site will be cleared as part of the proposed works.

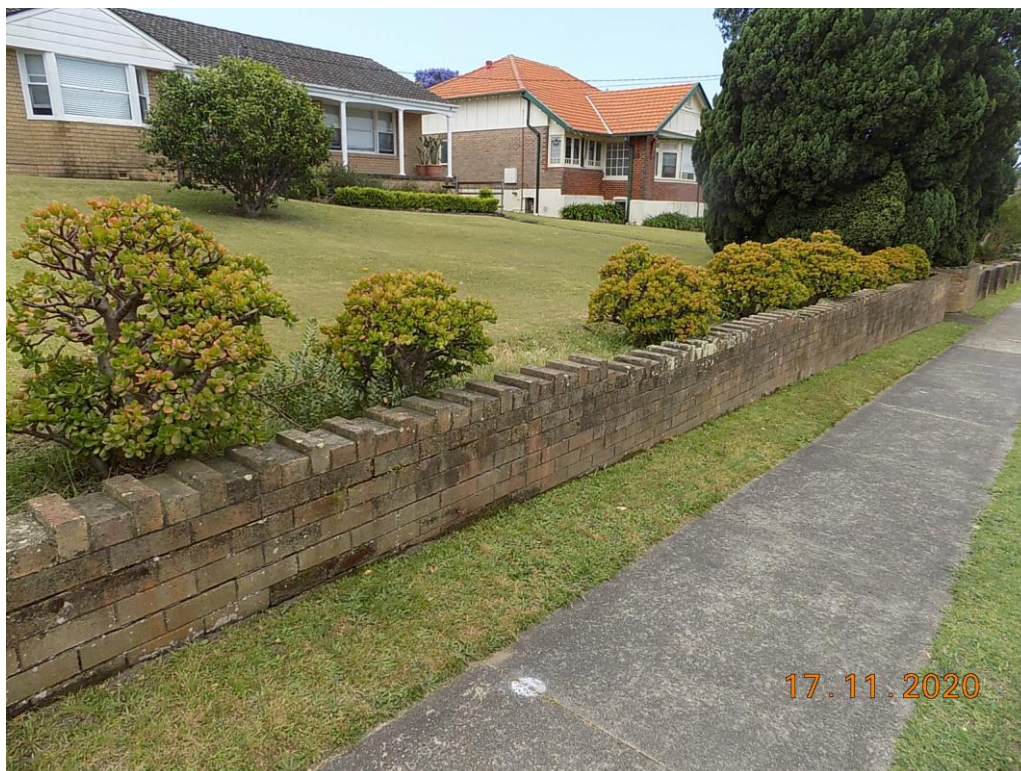
Photo 7

2.4 14 Ponsonby Parade - The cut for Ponsonby Parade is supported by a stable brick retaining wall reaching ~1.1m high (Photo 7). Between the road frontage to Ponsonby Parade and the house is a gently sloping lawn (Photo 8). Another gently sloping lawn extends off the uphill side of the house to the road frontage with Ross Street (Photo 9). A concrete driveway runs from the road frontage to a fibreboard clad garage (Photo 10). At the NE corner of the property is a fibreboard outbuilding and an adjacent brick toilet (Photo 11). The house (Photo 12), garage, outbuilding, and toilet will be demolished and the site will be cleared as part of the proposed works.

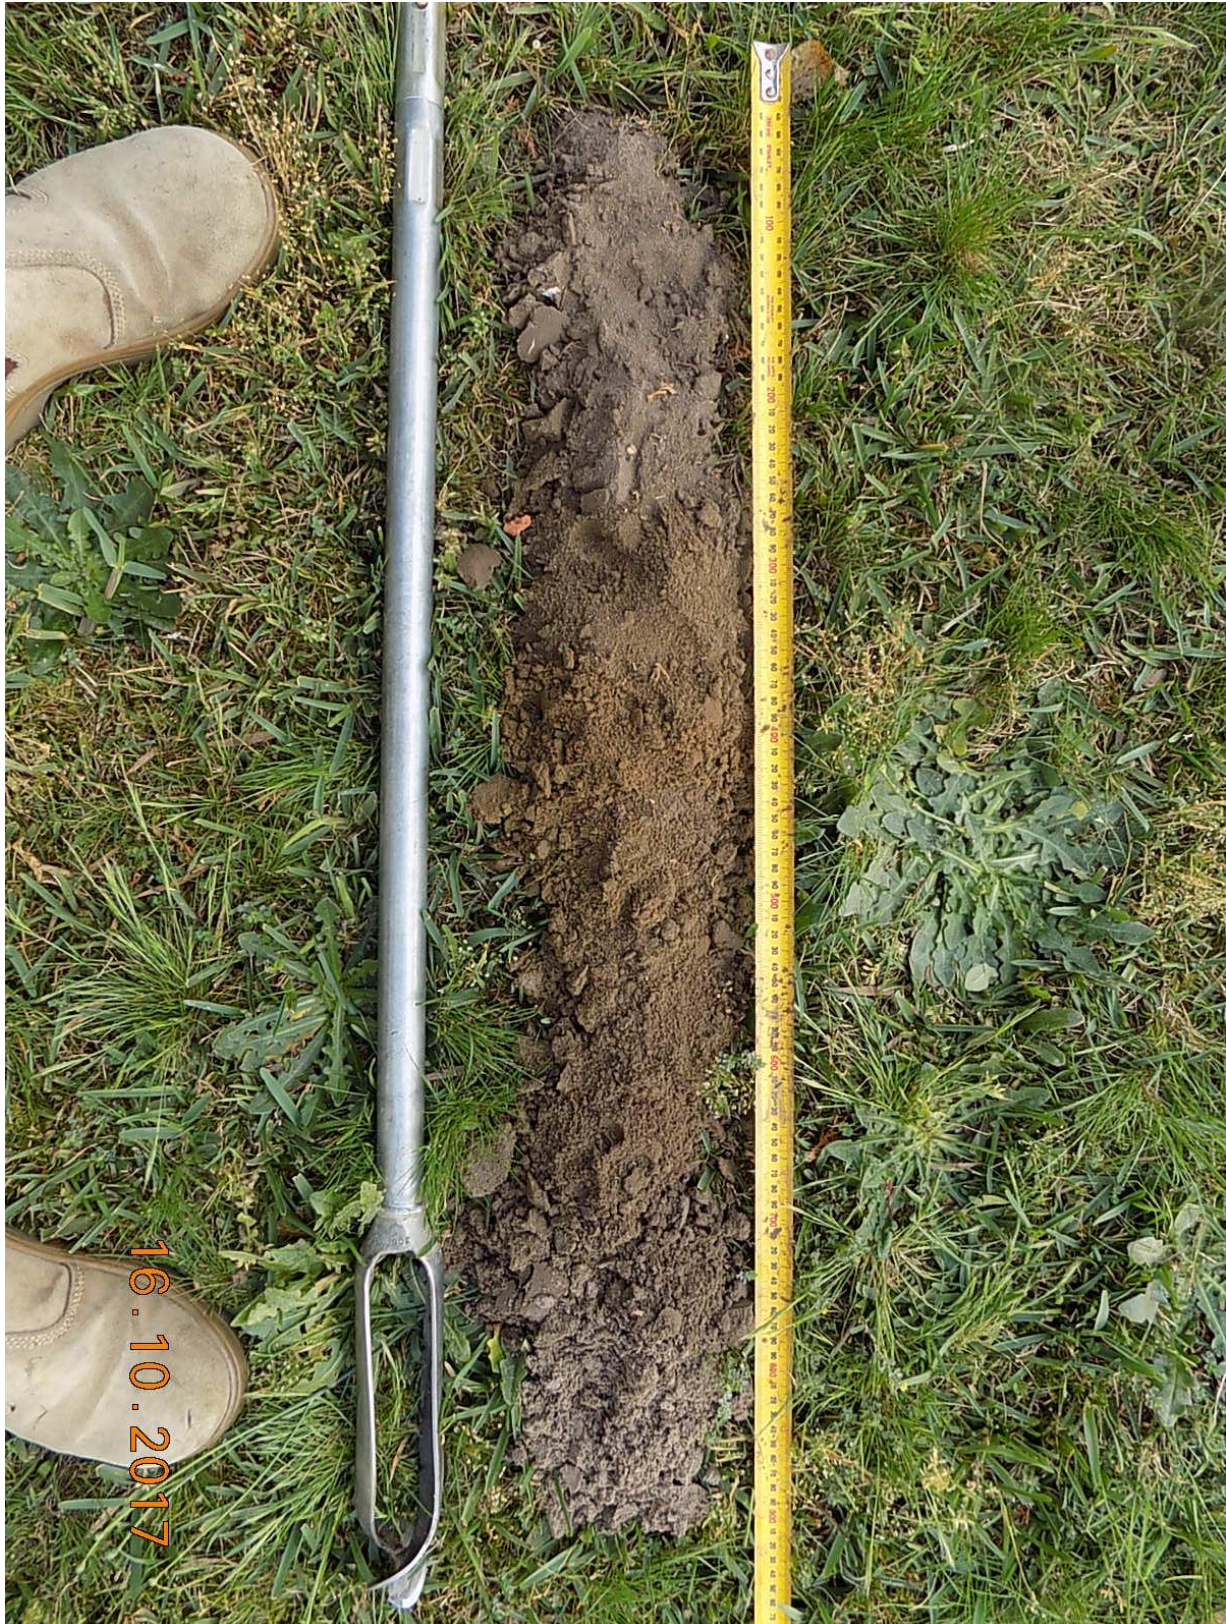
AUGER HOLE 1 (~RL68.5) – AH1 (Photo 13)

Depth (m)	Material Encountered
0.0 to 0.3	TOPSOIL , sandy soil, grey brown, medium dense to dense, fine grained with fine trace organic matter and trace silt.
0.3 to 0.7	SANDY SOIL , brown, medium dense, fine to medium grained with fine trace organic matter.
0.7 to 0.9	VERY LOW STRENGTH SANDSTONE , grey, medium grained with sugary texture.

End of hole @ 0.9m in Very Low Strength Sandstone. No water table encountered.

Photo 13: AH1 – Downhole is from top to bottom.
