HERITAGE IMPACT STATEMENT

Nos. 12-14 Ponsonby Parade, Seaforth

April 2021 | J4705

**Weir
Phillips**
Heritage
and Planning

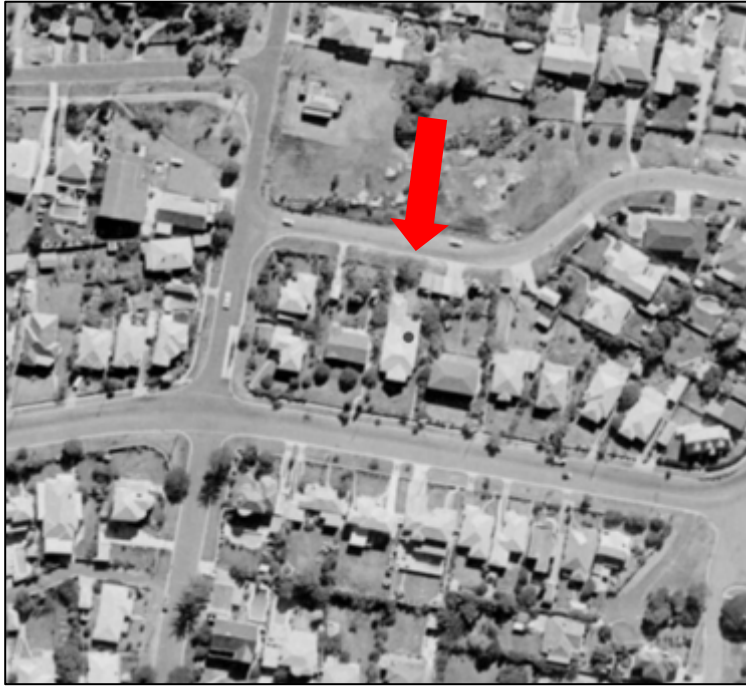
Figure 4: Aerial photograph of Seaforth (1978). The red arrow indicates No. 12 Ponsonby Parade.
NSW Spatial Imagery

As indicated by Figure 4, many of the dwellings on this side of Ponsonby Parade had been replaced with modern dwellings by 1978. This included No. 14 Ponsonby Parade, which forms part of the subject site. No. 12 Ponsonby Parade had also been extended with a rear addition and a new garage constructed. No historic photographs of the dwelling at street level have been located.

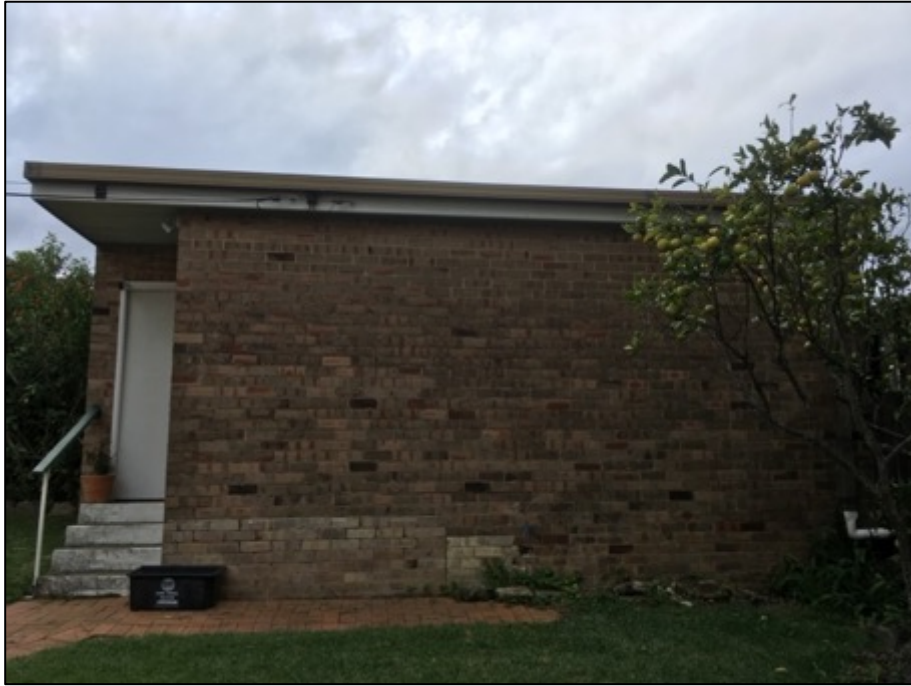
Figure 6: Brick garage at the rear of the site.

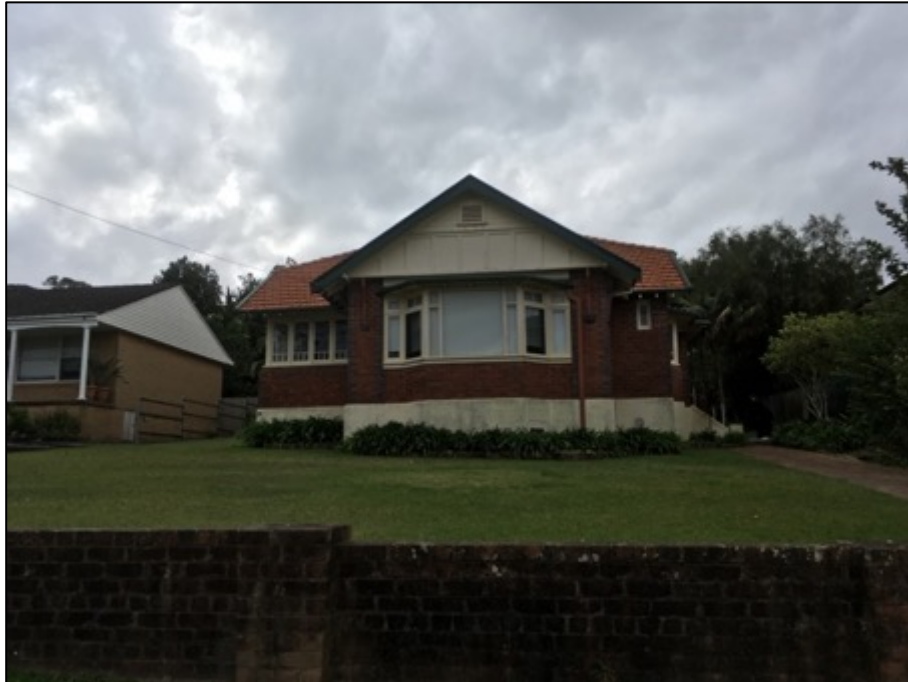
Figure 10: Front elevation to No. 12 Ponsonby Parade.

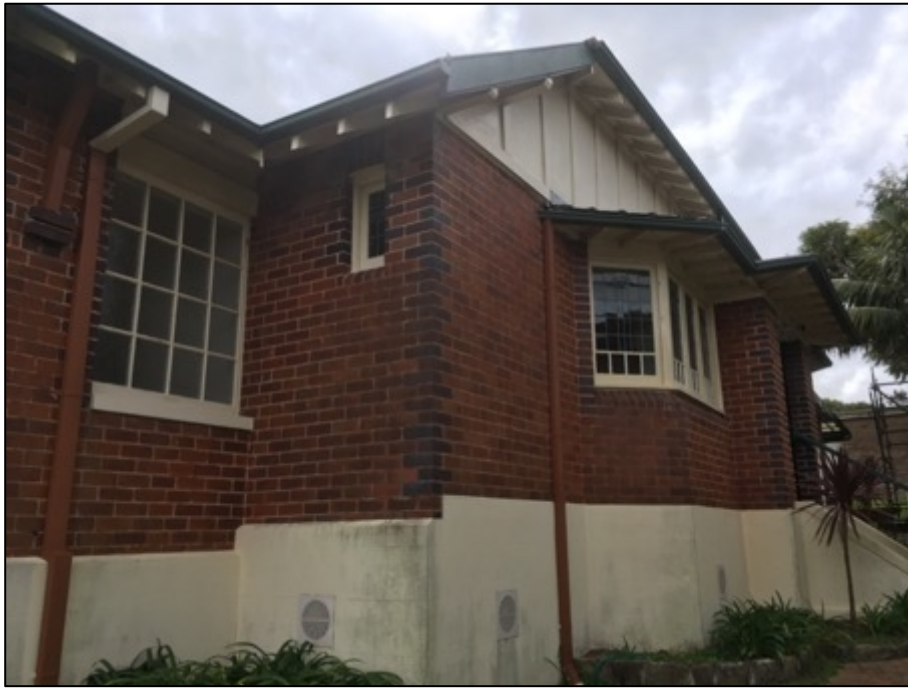
The eastern elevation is constructed from face brick with common brick towards the rear. The front entry is located on this elevation within a semi-enclosed brick porch with a timber-framed bay window with leadlight inserts to either side. It lies under a hipped gable finished in FC with vertical timber battening. The entry porch is accessed by a stair with a modern timber balustrade, terrazzo risers, brick paved treads and rendered and painted brick nosing. The porch is finished in a painted concrete floor and has a painted timber ceiling. The entry is a timber-framed panelled door with stained glass inserts and leadlight sidelights, as well as a modern security gate.

Figure 11: Eastern elevation showing gabled bay.

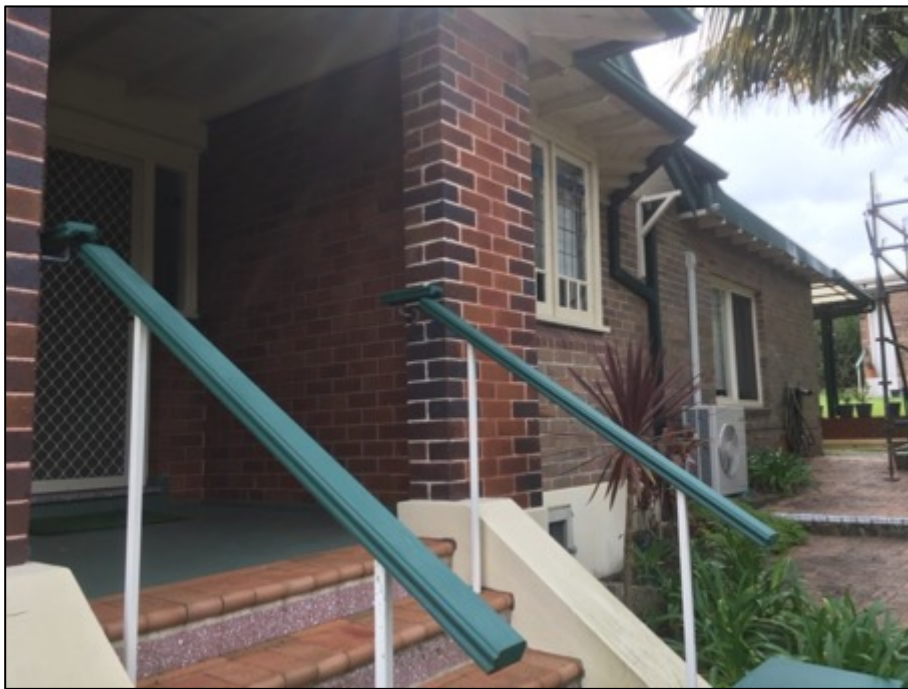
Figure 12: Entry porch.

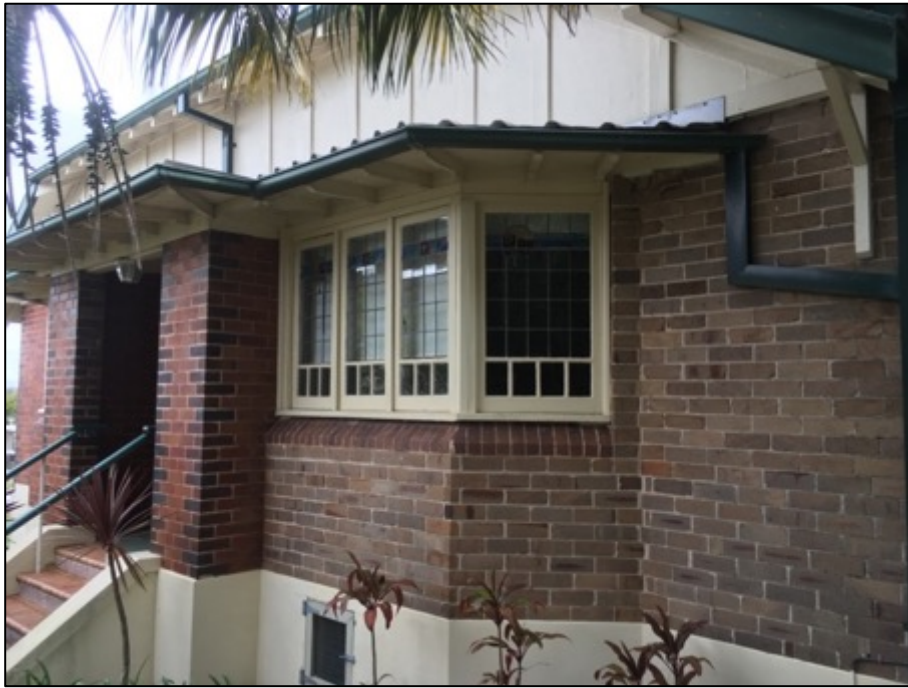
Figure 13: Eastern elevation, showing a bay window adjacent to entry porch.

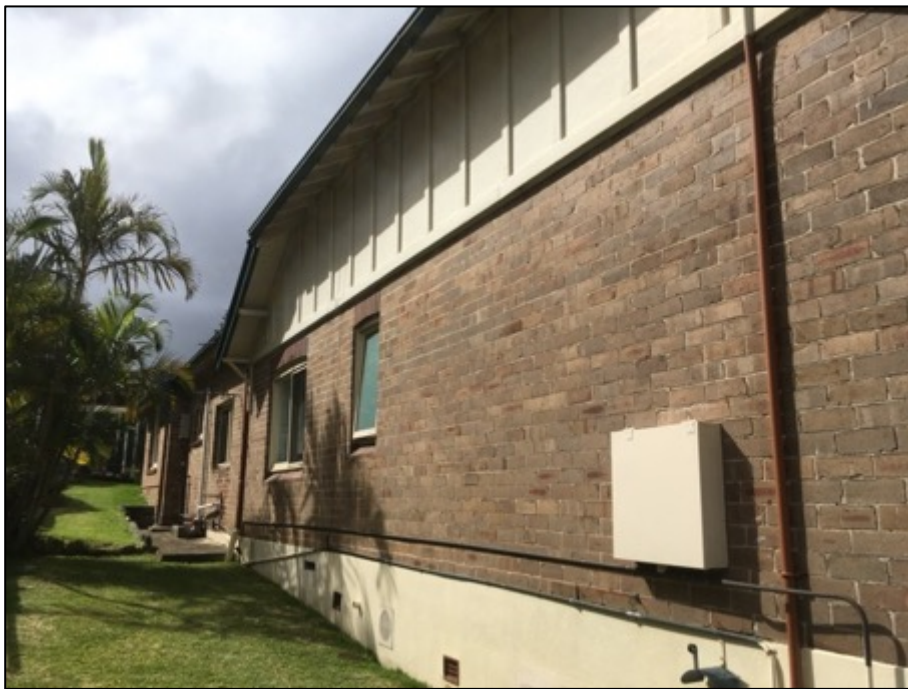
The western elevation is constructed from common brick and has wide lined eaves and timber-framed window openings. The rear elevation of the principal building has a verandah with timber posts and a separate roof clad in polycarbonate sheeting. There is an L-shaped addition at the rear constructed from brick with a hipped roof clad in terracotta tiles and timber-framed awning windows.

Figure 14: Western elevation, looking towards the rear of the dwelling.

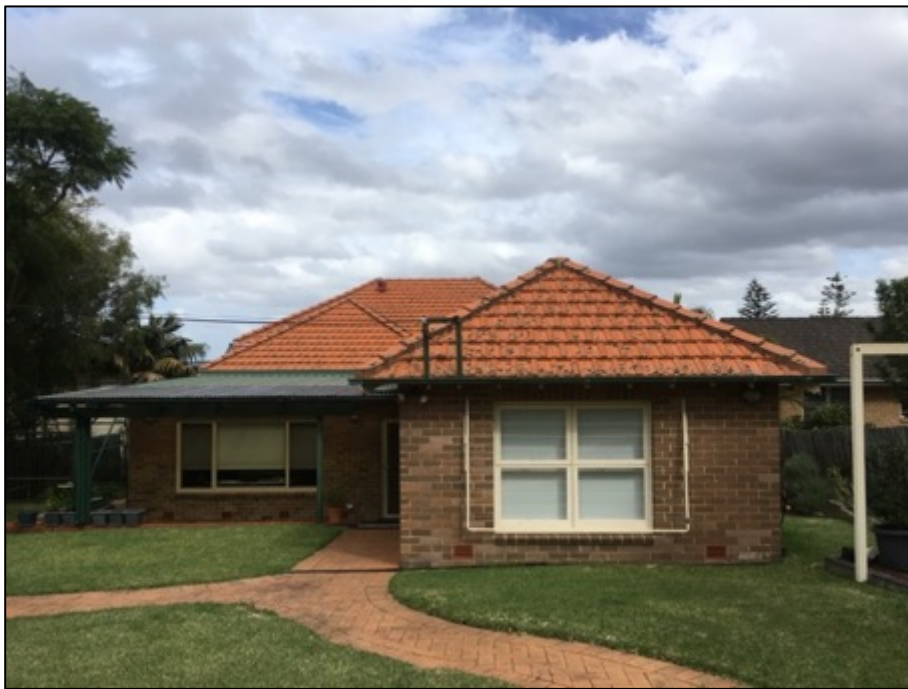
Figure 16: Rear elevation, showing later additions.

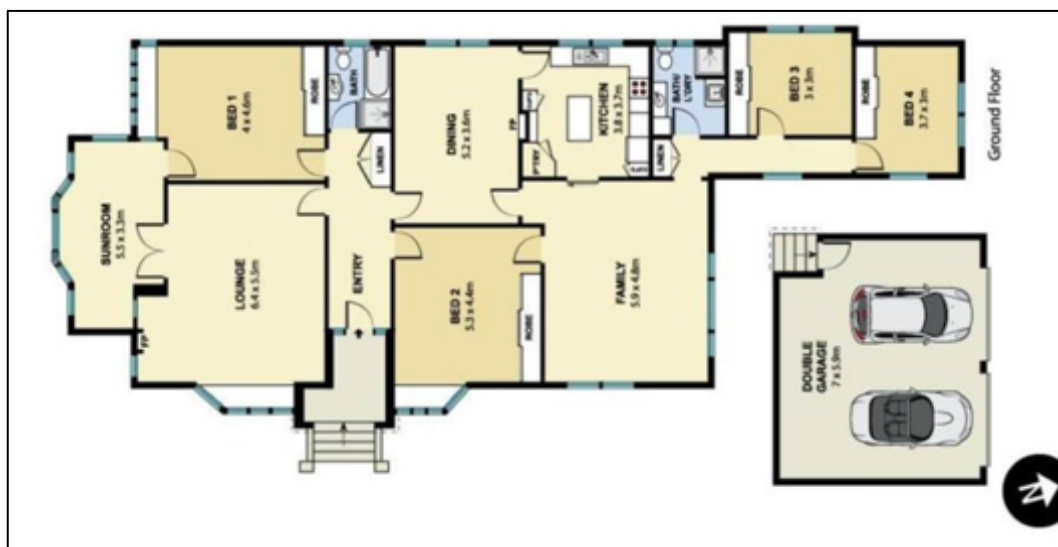
Figure 17: Layout of No. 12 Ponsonby Parade.
Real Estate

The interior of the dwelling is accessed from the entry porch on the eastern elevation. It opens into a hallway with bedrooms and living spaces to the north and south, as well as a bathroom to the west. The hallway has a timber floor, rendered masonry walls, splayed timber architraves and plate rail, timber skirting boards and a decorative plaster ceiling with moulded cornices.

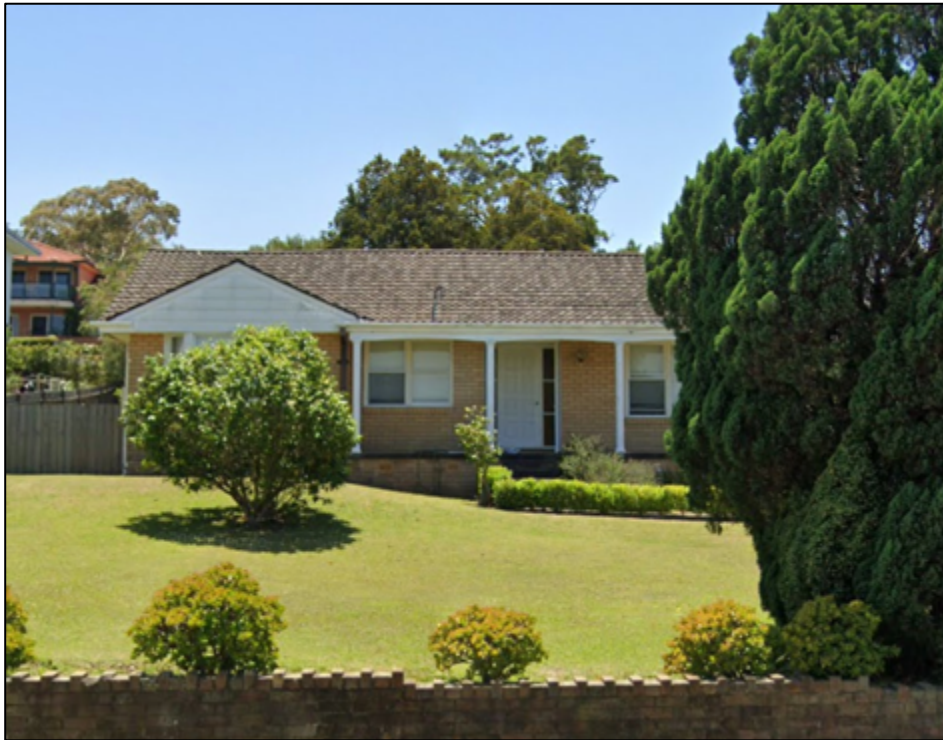
No. 14 Ponsonby Parade presents as a single-storey c. 1970s dwelling. It is constructed from face brick and has a hipped and gabled roof clad in concrete tiles. There is an existing approval for the demolition of this dwelling which is not described further for the purposes of this statement.

Figure 30: The front elevation of No. 14 Ponsonby Parade as viewed from the street.

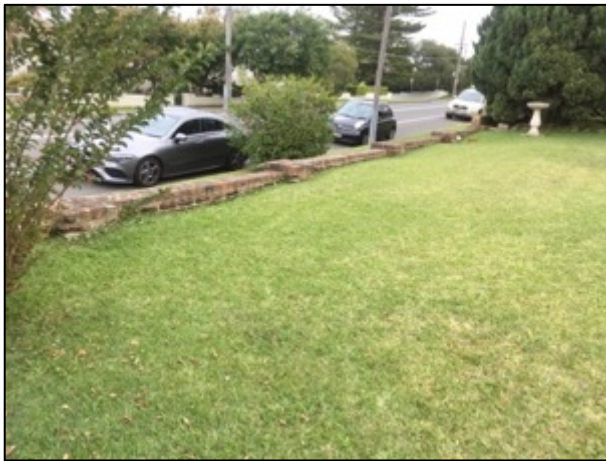
Element	Materials/ Comments	Integrity
Fence	Low brick wall with metal gate.	Original.
Paving	Brick.	Not original.
Vegetation	Small plantings along the base of the front elevation. Lawn.	
Other Features

Figure 44: Looking towards Ponsonby Parade from the front garden.

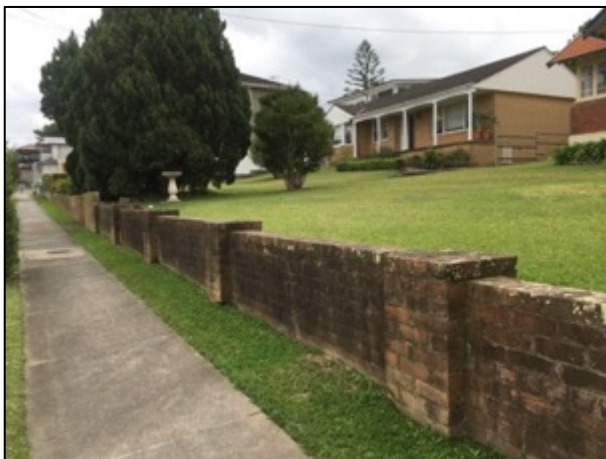
Figure 45: Looking towards the front fence from outside on Ponsonby Parade.

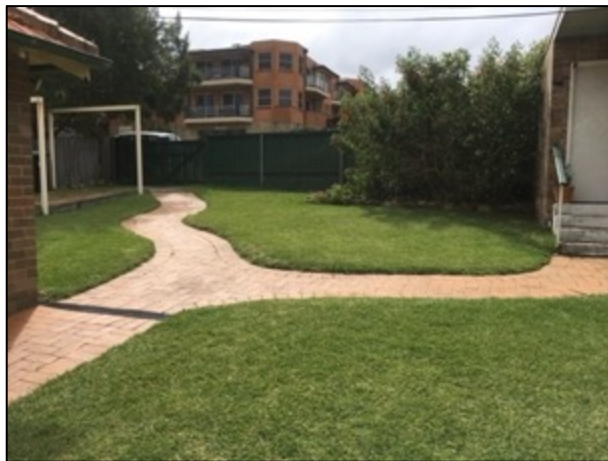
Element	Materials/ Comments	Integrity
Fence	Lapped and capped timber fence.	Not original.
Paving	Brick paving.	Not original.
Vegetation	Small plantings. Lawn, natural and artificial.	
Other Features	Brick garage with roof clad in corrugated metal and separate metal roller doors.	Not original.

Figure 46: Rear garden, looking north.

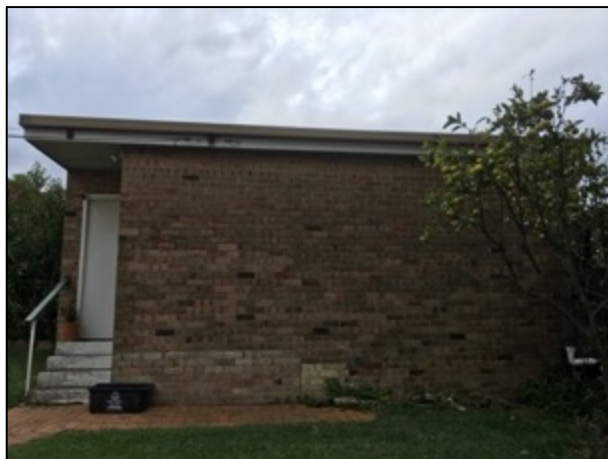
Figure 47: Brick garage at rear.

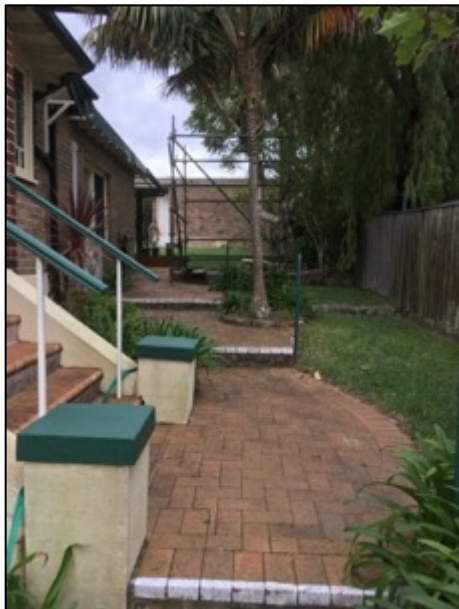
Element	Materials/ Comments	Integrity
Fence	Timber paling fence.	Not original.
Paving	Brick paving with raised stone walls.	Not original.
Vegetation	Lawn.	
Other Features

Figure 48: Looking north along the eastern boundary.

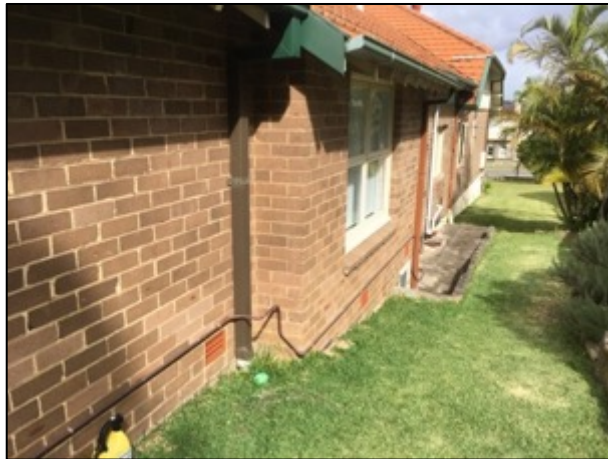
Element	Materials/ Comments	Integrity
Fence	Timber paling fence.	Not original.
Paving		
Vegetation	Lawn.	
Other Features

Figure 49: Looking south along the western boundary.

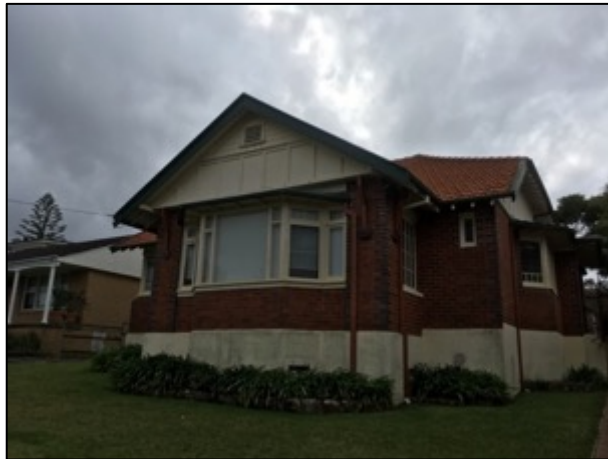
Element	Materials/ Comments	Integrity
Roof	Unglazed terracotta tiles.	The cladding has been replaced.
Walls	Tuckpointed face brick with a painted brick base. FC battens to gable and timber vent.	Original.
Doors		
Other Features	Services on wall including plumbing. Subfloor wall vents. Subfloor access.	Not original.

Figure 50: Front elevation.

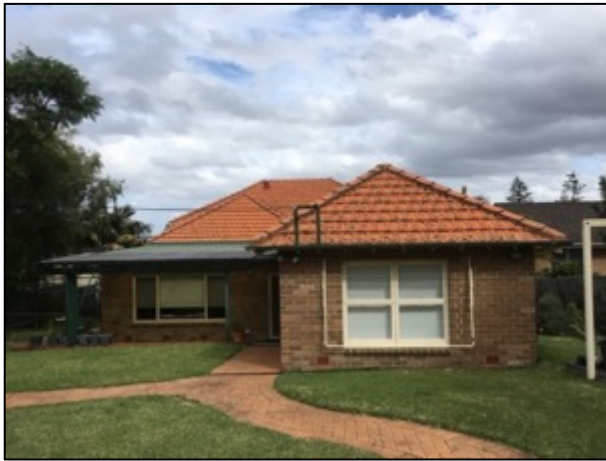
Element	Materials/ Comments	Integrity
Roof	Unglazed terracotta tiles and polycarbonate roof.	The cladding has been replaced.
Walls	Common brick.	Not original.
Doors	Modern security gate and door.	Not original.
Other Features	Modern verandah.	Not original.

Figure 51: Rear elevation showing principal building form to the left and rear wing to the right.

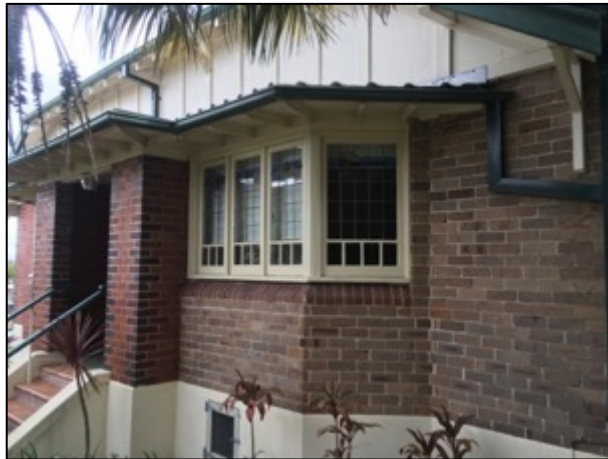
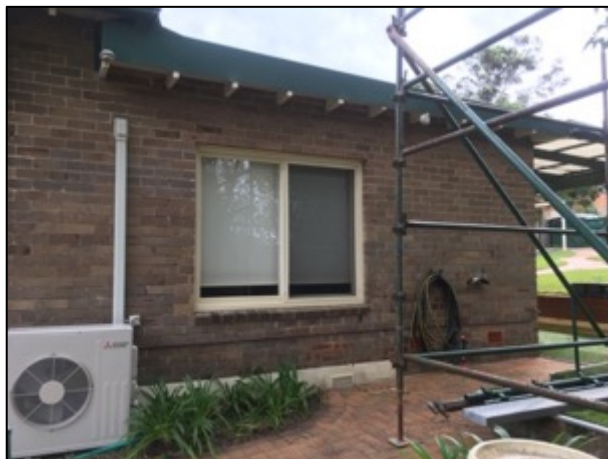
Element	Materials/ Comments	Integrity
Roof	Unglazed terracotta tiles.	The cladding has been replaced.
Walls	Tuckpointed face brick with quoining and painted brick base. Common brick to the north of entry.	Original.
Doors	Entry door with concrete skirting, threshold terrazzo and timber entry handrail.	Not original.
Other Features	<ol style="list-style-type: none"> 1. Entry stair tiled with brick pavers. 2. Gable/widows peak lined with FC and battens. 	<ol style="list-style-type: none"> 1. Not original. 2. Original.

Figure 52: Looking towards the entry on the eastern elevation.

Figure 53: Looking towards the rear of the eastern elevation.

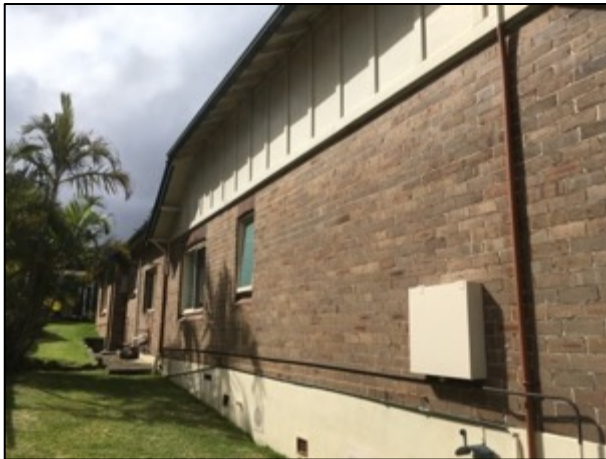
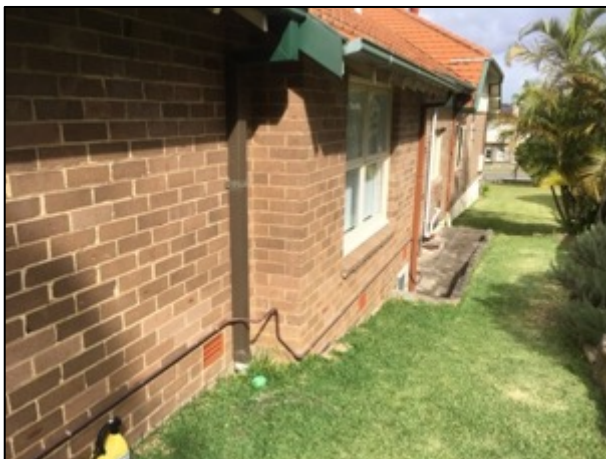
Element	Materials/ Comments	Integrity
Roof	Unglazed terracotta tiles	The cladding has been replaced.
Walls	Common brick.	Original to the principal building, but not the modern rear wing.
Doors		
Other Features	Services and plumbing on wall. Subfloor wall vents.	Original.

Figure 56: Looking towards the rear of the western elevation.

Figure 57: Looking towards the front of the western elevation

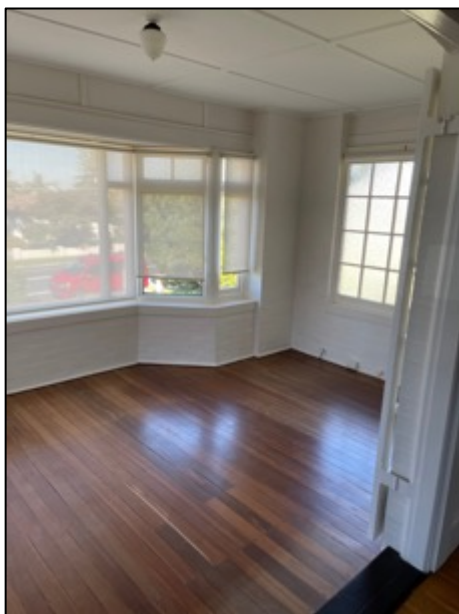
Element	Materials/ Comments	Integrity
Floor	Timber. Appears to be Western Red Cedar.	Replacement.
Skirting	Quarter round timber.	Not original.
Walls	Painted brickwork.	Original.
Doors	Timber-framed multi-paned French door.	Original.
Windows	Infill glazing to verandah.	Not original.
Cornice	Quarter round plaster cornices.	Original.
Ceiling	Battened fibre cement.	Original.
Wall Vents	Plaster	Original.
Fireplace		
Lights		
Other Features

Figure 58: Sunroom at the front of the dwelling.

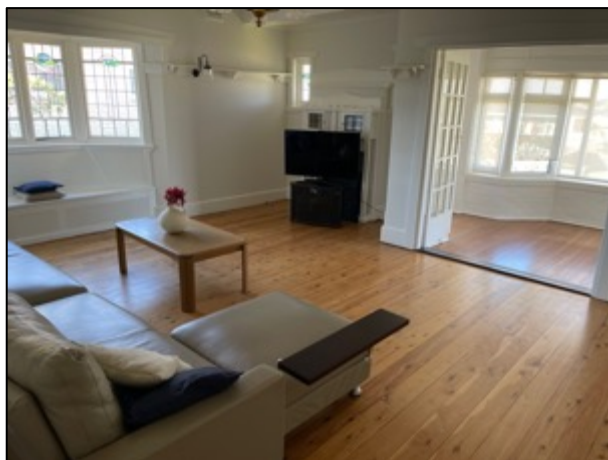
Figure 59: Living room.

Element	Materials/ Comments	Integrity
Floor	Timber. Appears to be Kauri Pine.	Original.
Skirting	Cedar chamfer.	Original.
Walls	Painted rendered masonry. Plate rail.	Original.
Doors	Four panel solid door and painted hardware.	Original.
Windows	Bay window with leadlight.	Original.
Cornice	Decorative plaster.	Original.
Ceiling	Decorative plaster ceiling.	Original.
Architrave	Timber.	Original.
Wall Vents	Plaster.	Original.
Fireplace	fireplace with painted timber and blue tile floor with leadlight door cupboard.	Original.
Lights	Gas bayonette and light with light pull.	Not original.
Other Features	Window seat with storage.	Original.

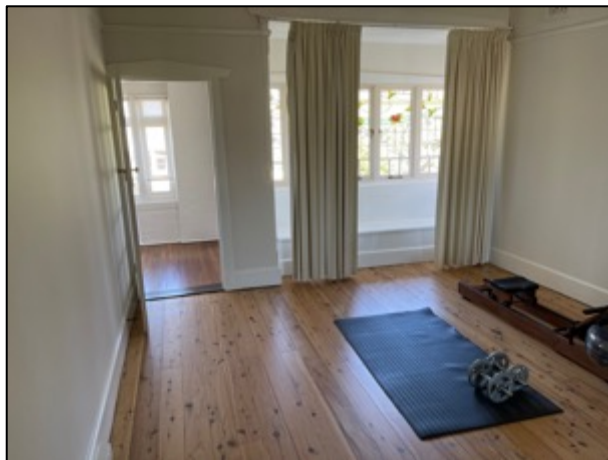
Figure 60: Bedroom 1, currently used as a gym.

Element	Materials/ Comments	Integrity
Floor	Timber. Appears to be Kauri Pine.	Original.
Skirting	Cedar chamfer.	Original.
Walls	Painted rendered masonry with timber picture rail.	Original.
Doors	Four panel solid door and hardware.	Original.
Windows	Timber-framed casement bay window with leadlight.	Original.
Cornice	Decorative plaster.	Original.
Ceiling	Decorative plaster ceiling.	Original.
Architrave	Timber.	Original.
Wall Vents	Plaster.	Original.
Fireplace		Original.
Lights	Lighting with light pull.	Not original.
Other Features	<ol style="list-style-type: none"> 1. Window seat with storage. 2. Wardrobe 	<ol style="list-style-type: none"> 1. Original. 2. Not original.

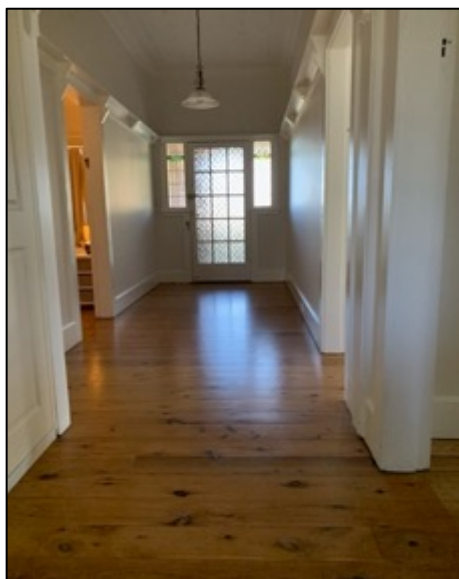
Figure 62: Hallway, looking towards the front.

Element	Materials/ Comments	Integrity
Floor	Timber. Appears to be Kauri Pine.	Original.
Skirting	Cedar chamfer.	Original.
Walls	Painted rendered masonry with plate rail.	Original.
Doors	Entry door multi-paned and glazed with leadlight both sides.	Original.
Windows		
Cornice	Decorative plaster.	Original.
Ceiling	Decorative plaster ceiling.	Original.
Architrave	Timber.	Original.
Wall Vents	Plaster.	Original.
Fireplace		
Lights	Lighting with switch.	Not original.
Other Features	Modern storage.	Not original.

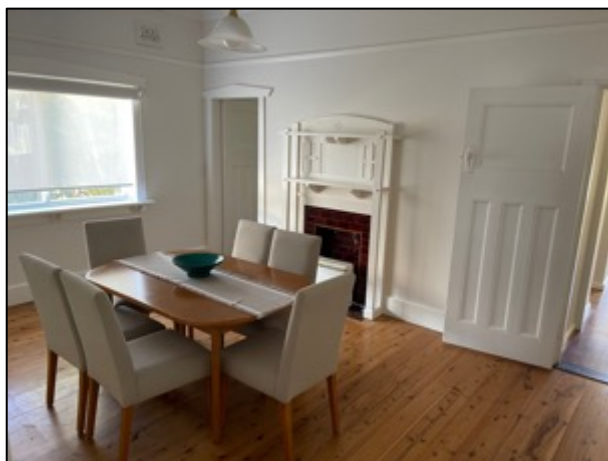
Figure 63: Dining room.

Element	Materials/ Comments	Integrity
Floor	Timber. Appears to be Kauri Pine.	Original.
Skirting	Cedar chamfer.	Original.
Walls	Painted rendered masonry with timber picture rail.	Original.
Doors	Four panel solid door and hardware.	Original.
Windows	Timber-framed sliding window.	Not original.
Cornice	Decorative plaster.	Original.
Ceiling	Decorative plaster ceiling.	Original.
Architrave	Timber.	Original.
Wall Vents	Plaster.	Original.
Fireplace	Fireplace with brown tiles and painted timber surrounds.	Original.
Lights	Lighting with light pull.	Not original.
Other Features

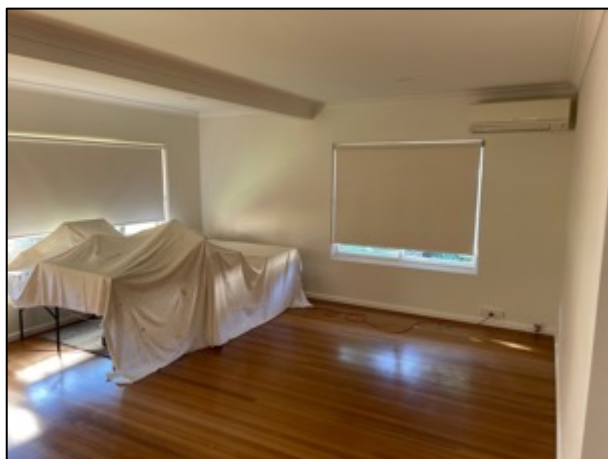
Element	Materials/ Comments	Integrity
Floor	Timber.	Not original.
Skirting	Timber.	Not original.
Walls	Painted rendered masonry.	Original.
Doors	Timber panelled.	Not original.
Windows	Timber-framed awning windows.	Not original.
Cornice	Plasterboard	Not original.
Ceiling	Plasterboard	Not original.
Architrave	Timber	Not original.
Wall Vents		
Fireplace		
Lights	Modern lighting.	Not original.
Other Features

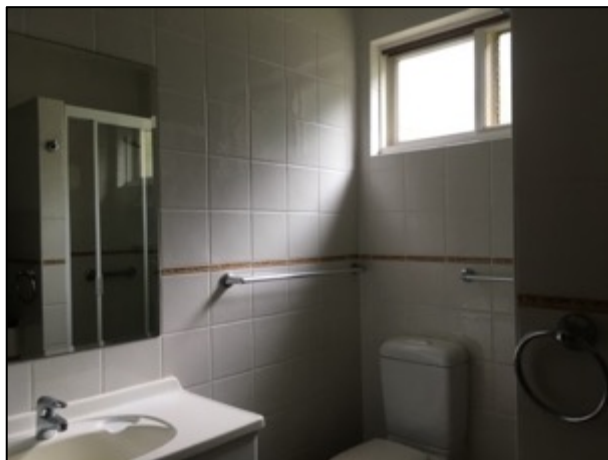
Element	Materials/ Comments	Integrity
Floor	Tiled.	Not original.
Skirting		
Walls	Tiled.	Not original.
Doors	Timber.	Not original.
Windows	Timber-framed sliding window.	Not original.
Cornice	Plasterboard.	Not original.
Ceiling	Plasterboard.	Not original.
Architrave	Timber.	Not original.
Wall Vents		
Fireplace		
Lights	Lighting with switch.	Not original.
Other Features	Modern fixtures and joinery.	Not original.

Figure 66: Detail, fittings in laundry plus bathroom.

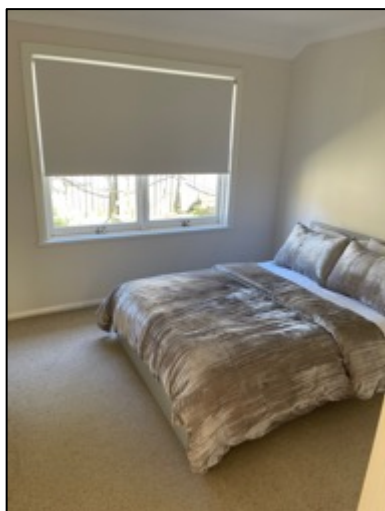
Figure 68: Bedroom 3.

Element	Materials/ Comments	Integrity
Floor	Timber with carpet cladding.	Not original.
Skirting	Timber.	Not original.
Walls	Plasterboard stud walls.	Not original.
Doors	Timber.	Not original.
Windows	Timber-framed awning window in set of four.	Not original.
Cornice	Plasterboard.	Not original.
Ceiling	Plasterboard.	Not original.
Architrave	Timber.	Not original.
Wall Vents		
Fireplace		
Lights	Lighting with switch.	Not original.
Other Features	Wardrobe.	Not original.

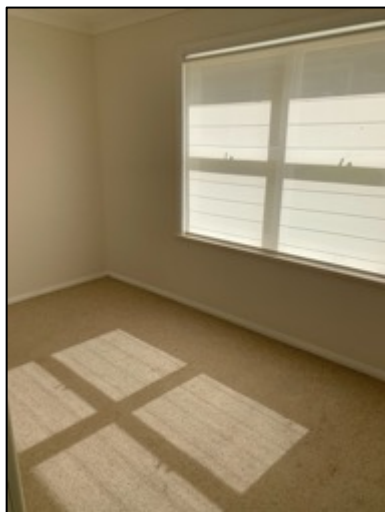
Figure 69: Bedroom 4.

Element	Materials/ Comments	Integrity
Floor	Timber with carpet cladding.	Not original.
Skirting	Timber.	Not original.
Walls	Plasterboard stud walls.	Not original.
Doors	Timber	Not original.
Windows	1 x timber-framed awning window in set of four. 1 x timber-framed window in set of two.	Not original.
Cornice	Plasterboard.	Not original.
Ceiling	Plasterboard.	Not original.
Architrave	Timber.	Not original.
Wall Vents		
Fireplace		
Lights	Lighting with switch.	Not original.
Other Features	Wardrobe.	Not original.
