Species Impact Statement

PMHC Rawdon Island Bridge – Stage 2 Repairs

Prepared for: Port Macquarie – Hastings Council
© GeoLINK, 2022

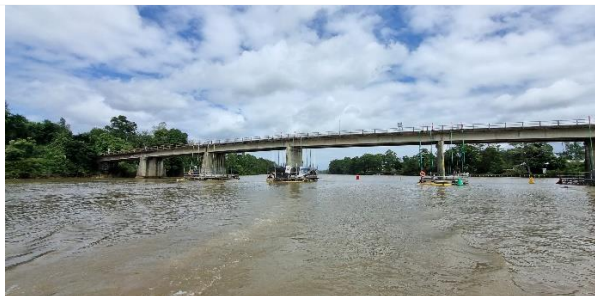
Plate 2.1 – Rawdon Island Bridge

The Rawdon Island Bridge occurs over the Hastings River on Rawdon Island Road (known as B159 Rawdon Island Bridge) north-east of Wauchope. The existing bridge is an 8-span concrete bridge structure with an approximate length of 164 m. The bridge was constructed in 1961. The bridge is a significant asset in the PMHC LGA providing a critical link between Rawdon Island and the mainland, and is utilised by residents, businesses and primary producers located on the island. The bridge provides the only road access to the community of Rawdon Island and there is no other access on or off the island.

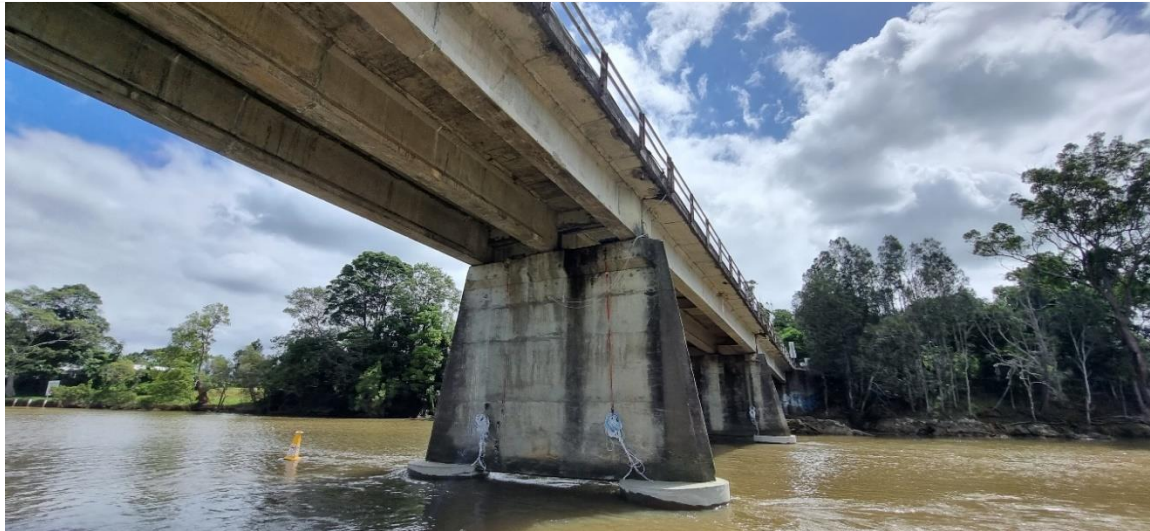
Plate 4.1 – Rawdon Island Bridge (Pier 6)

Rawdon Island Bridge is a beam and slab concrete bridge, approximately 164m long and 6.5m wide, with seven piers. Previous ecological assessments of the entire bridge identified several small open cavities within the bridge that provide habitat for cave-dwelling microbat species (Wolfpeak, 2021). The highest potential roosting habitat was identified in deck expansion joints above Pier 2 and Pier 6 (Echo Ecology and Surveying, 2021b, 2021c; Wolfpeak, 2021). The deck expansion joint above Pier 5 provides structurally similar habitat but without a seal. The Pier 5 expansion joint is being repaired as part of the Stage 1 works and may provide potential habitat upon completion. The main roosting habitat, which has been seen utilised by microbats (both Little Bent-winged Bat and Southern Myotis) occurs within Pier 6 (**Plate 4.1**) (Echo Ecology and Surveying, 2021c, 2021b). Regarding Little Bent-winged Bat, it is likely that Rawdon Island Bridge only provides roosting habitat for individuals whilst foraging in the locality and unlikely to act as a breeding site. Only a small number of Little Bent-winged Bats (<10) have previously been recorded at the bridge (Dr Anna McConville, pers. comms, March 2022). Little Bent-winged Bats are known to prefer breeding in maternity colonies associated with cave systems that maintain certain stable temperatures, of which only five nursery/maternity colonies are known in Australia (Environment Energy and Science, 2022c). Significant over-wintering

Rawdon Island Bridge provides the highest value habitat opportunities for Southern Myotis. As stated previously, the bridge provides several small open cavities, of which, Pier 6 expansion joint is known to provide roosting for approximately 120-199 individuals (Echo Ecology and Surveying, 2021b, 2021c; Wolfpeak, 2021; Dr Anna McConville, pers. comms, March 2022) (**Plate 4.2, Plate 4.4 and Plate 4.5**). Previous ecological surveys across entire bridge only identified Pier 6 being utilised by the species, with some potential/ similar habitat values identified in Pier 2. The deck expansion joint above Pier 5 provides structurally similar habitat but without a seal. The Pier 5 expansion joint is being repaired as part of the Stage 1 works and may provide potential habitat upon completion. Given the presence of a relatively large colony roosting within Pier 6 expansion joint and evidence of long-term use, it is likely that the roosting habitat is also used for breeding by the species.

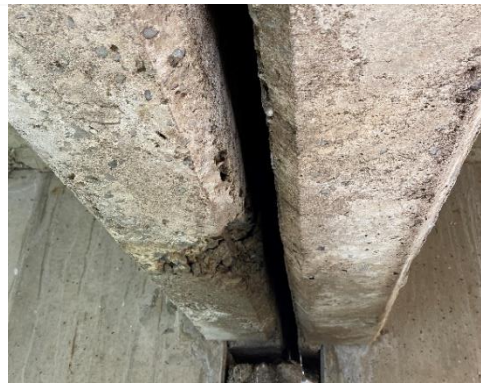
Plate 4.5 – Pier 6 roosting habitat in concrete expansion gap (photo: Will Steggall)

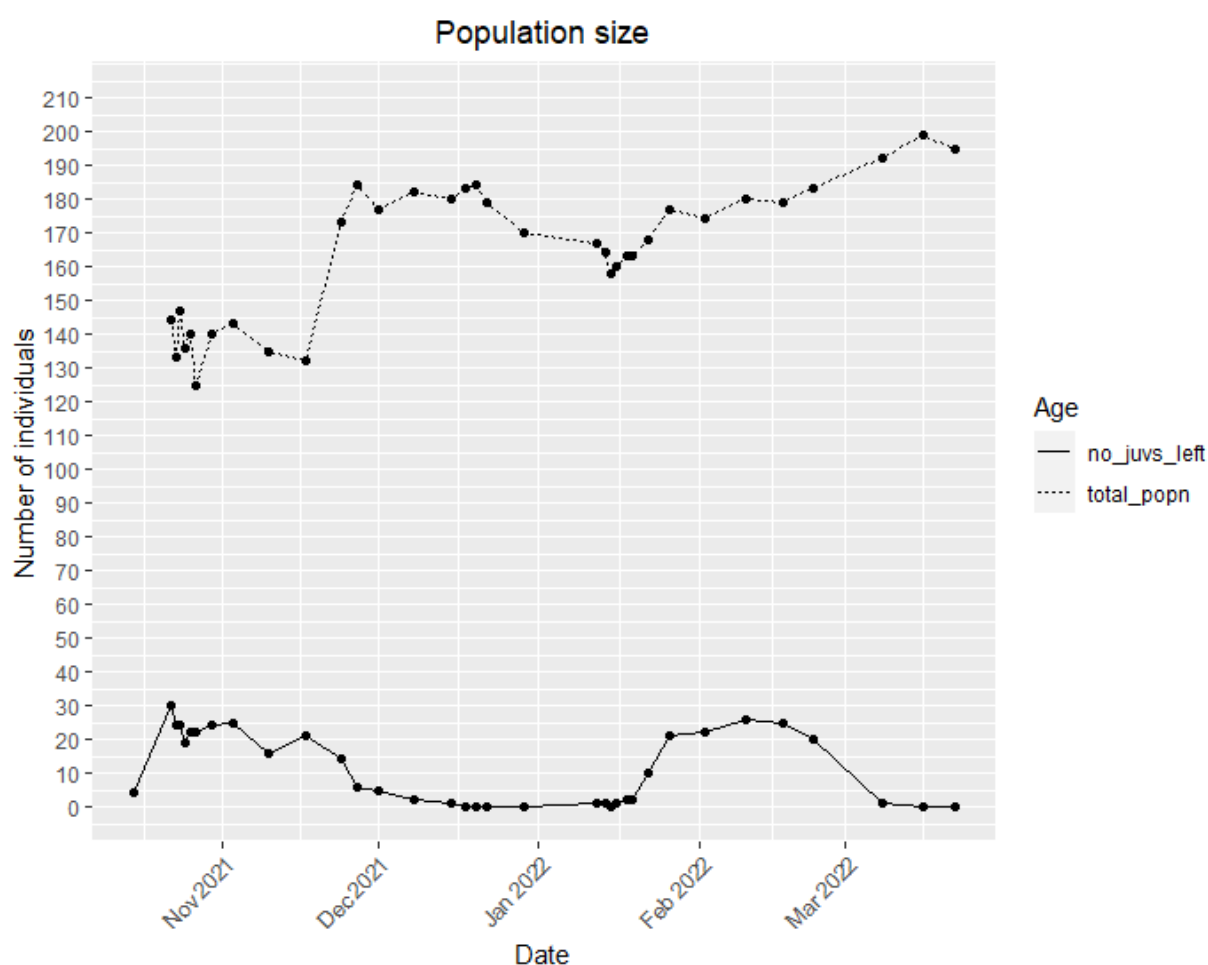
Figure 5.1 Southern Myotis numbers at Rawdon Island Bridge during Stage 1 Monitoring
(source: Echo Ecology and Surveying, 4/04/2022)

- Rawdon Island Bridge supports a locally significant Southern Myotis population, of approximately 120-199 individuals (Echo Ecology and Surveying, 2021b; Dr Anna McConville, pers. comms, March 2022; **Figure 5.1**)
- the Subject site is important to the long-term survival of the species in the locality.

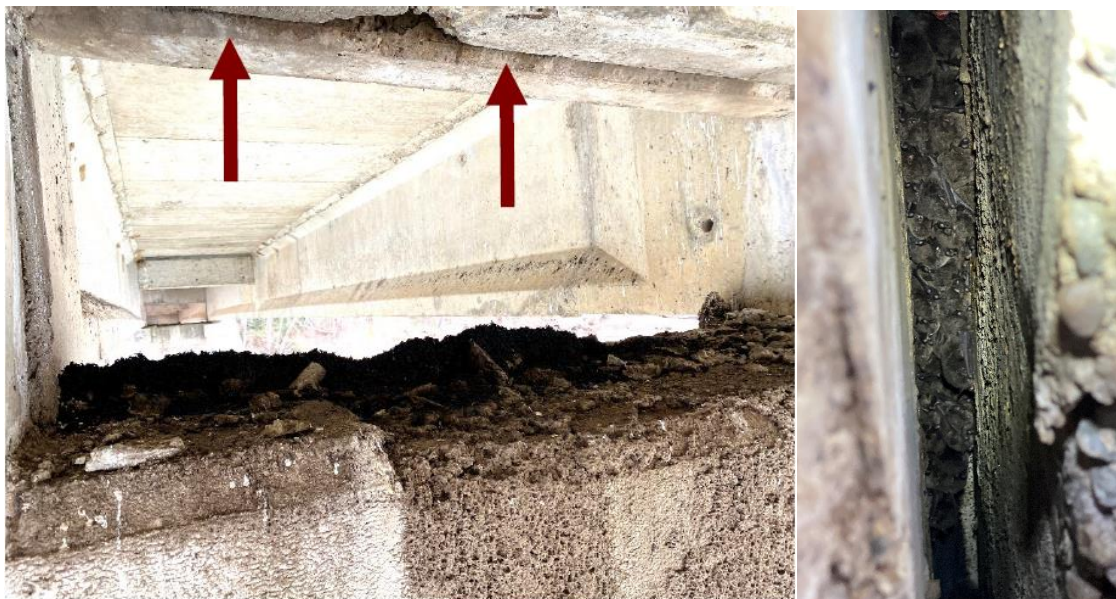
Plate 5.1 – Rawdon Island Bridge - Pier 6 eastern expansion joint and Southern Myotis roosting (Photos: Will Steggall)

The main microbat roosting area in Rawdon Island bridge is in the expansion joint above Pier 6. Inspections undertaken by Wolf Peak (September 2021) identified approximately 100-120 Southern Myotis in the eastern end of the expansion joint in Pier 6 (**Plate 5.1**) and approximately 20 individuals identified in the western end of the expansion joint. Large guano deposits and staining were identified on top of the blade wall on the eastern section of Pier 6, indicating that the eastern section roost is the main roosting location for individuals (Echo Ecology and Surveying, 2021). From September 2021 to March 2022, the Southern Myotis population has been estimated to range between 120 and 199 individuals.

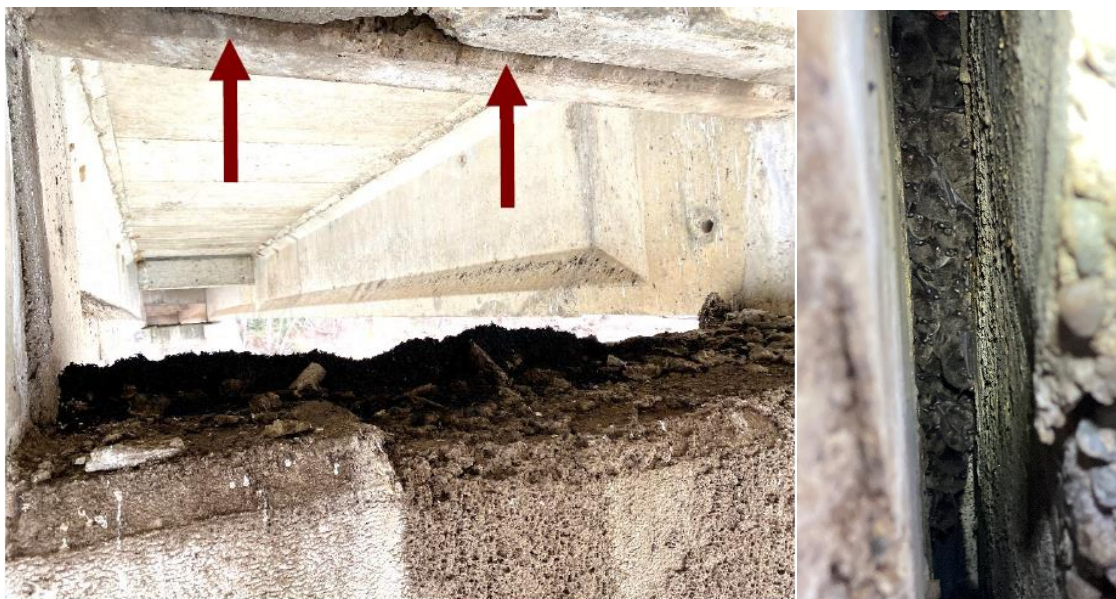
Plate 1.1 – Rawdon Island Bridge - Pier 6 eastern end of expansion joint and Southern Myotis roosting (Photos: Will Steggall)

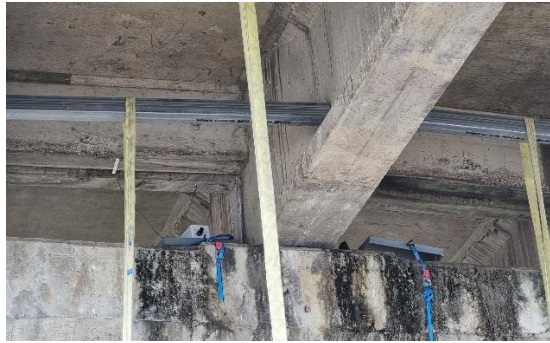
Plate 1.2 – Pier 2 potential microbat habitat with monitoring cameras

Other roosting opportunities for microbats occur in the bridge in small cracks and gaps in the concrete. The most suitable alternative roost location is the deck expansion joint at Pier 2 (**Plate 1.2** and **Plate 1.3**) that is similar to the expansion joint at Pier 6 (**Figure 1.2**). However, no evidence of use was observed (no bats present, guano or staining) during the inspection by the Wolf Peak (Wolfpeak 2021) or monitoring at Pier 2 as part of the Stage 1 works (Echo Ecology and Survey 2021b). Pier 5 will also provide similar structured habitat upon completion of the Stage 1 works.

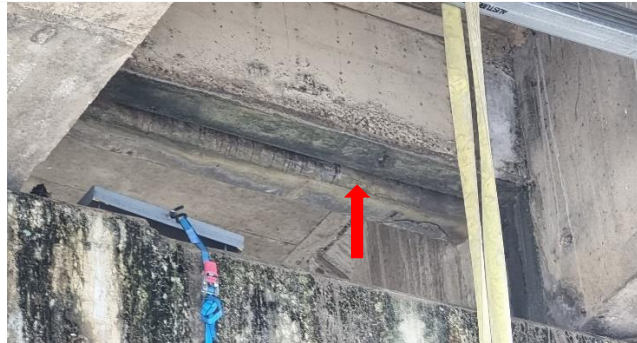
Plate 1.3 – Pier 2 microbat habitat in expansion joints

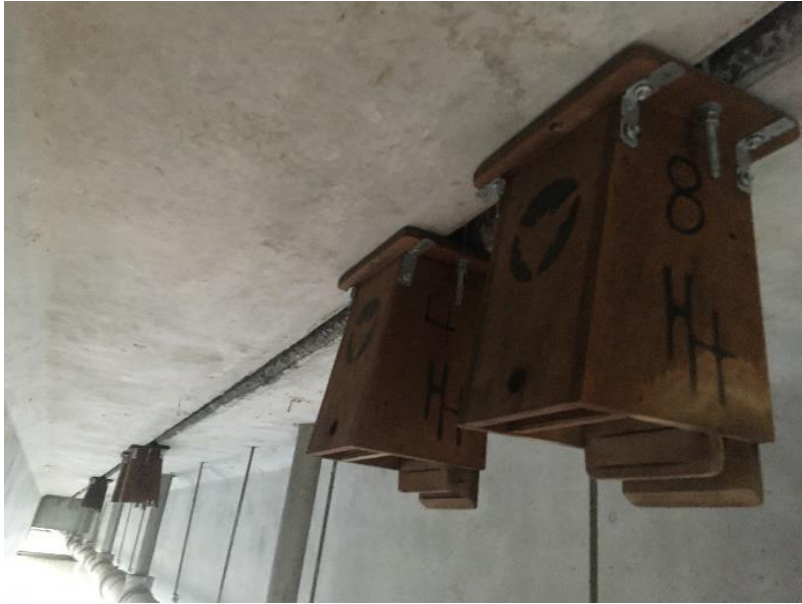
Plate 2.1 Example of alternative microbat boxes secured with anchor bolts into insitu slab (between expansion joint) on a super-T bridge. The microbat boxes are re-enforced with galvanised steel brackets securing the lid to the side.

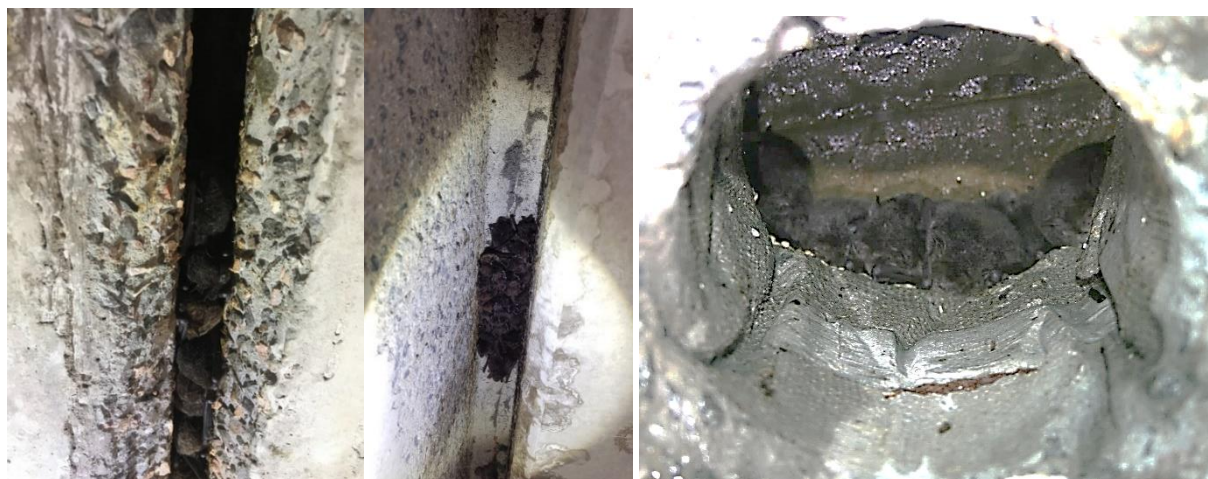
Plate 2.2 Examples of concrete texturing on bridge and culvert structures to create/enhance microbat roost habitat values.
