Heritage Impact Statement

Demolition of a heritage item
10 Forbes Street Grenfell

November 2021
EHC2020/0156

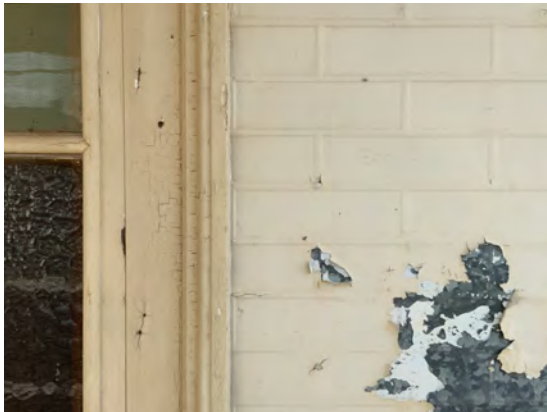
Figure 7: View of the front masonry pattern tin cladding.

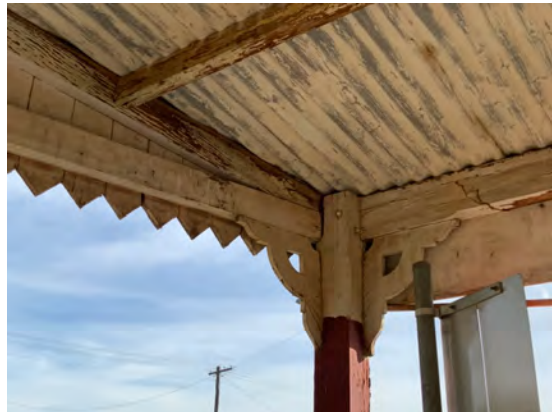
Figure 8: Detail of the front awning, showing decorative timber brackets and timber valance.

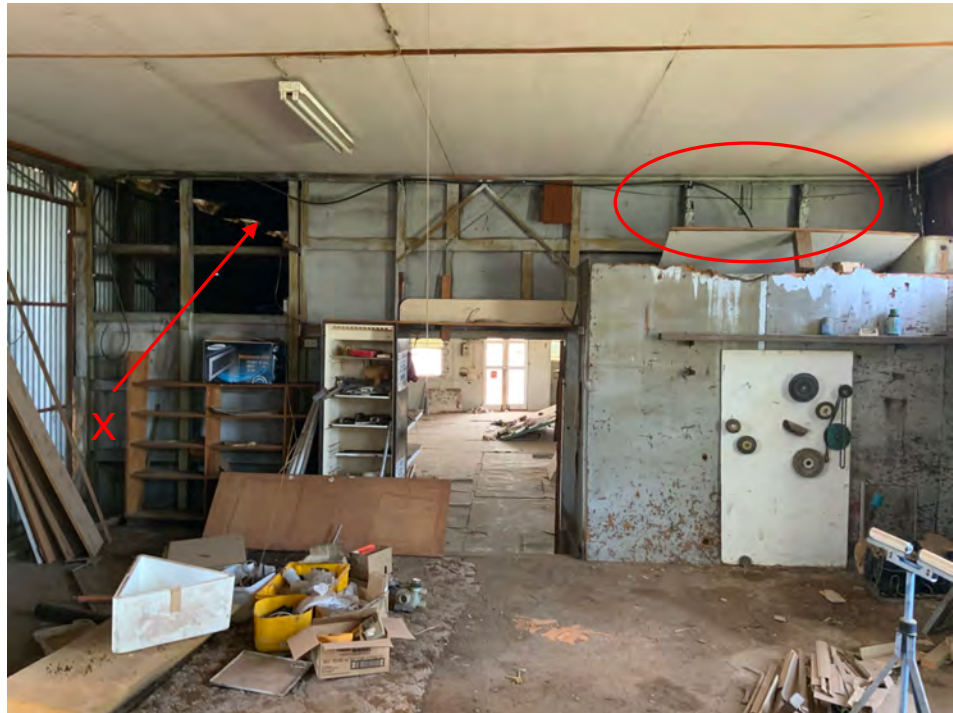
During the visual inspection of the building by EHC in October 2020, evidence of extensive fire damage was discovered to the timber truss framing of the roof and the upper portions of timber wall framing. The existing damage was most extensive within the roof space, largely concealed from view by the existing ceiling and limited access to the roof space.

Figure 34: View of the building facing towards Forbes Street, showing the areas of visible deterioration. The charred timber framing (painted silver) is shown. Note: due to safety concerns, access to the roof void was not obtained, but observations made from standing at the location marked 'X' and facing in the direction of the arrow as shown.

- a) Removal of non-original partition walls and general tidy;
- b) Wholesale removal of subfloor bearers and joists and inspect footings;
- c) Replacement of flooring system throughout, with new bearers, joists, floorboards and appropriate termite protection;
- d) Investigate and remove hazardous material (ie lead based paint and asbestos) as identified and required;
- e) Remove internal and external wall cladding and inspect wall framing;
- f) Replace fire damaged wall framing as required;
- g) Remove existing roof cladding and ceiling lining;
- h) Wholesale replacement of timber roof trusses to original footprint of the building;
- i) Reinstate roof sheeting and / or replace as necessary;
- j) Rewire all electricals throughout;
- k) Replace / repair damaged external timber and repaint as required.

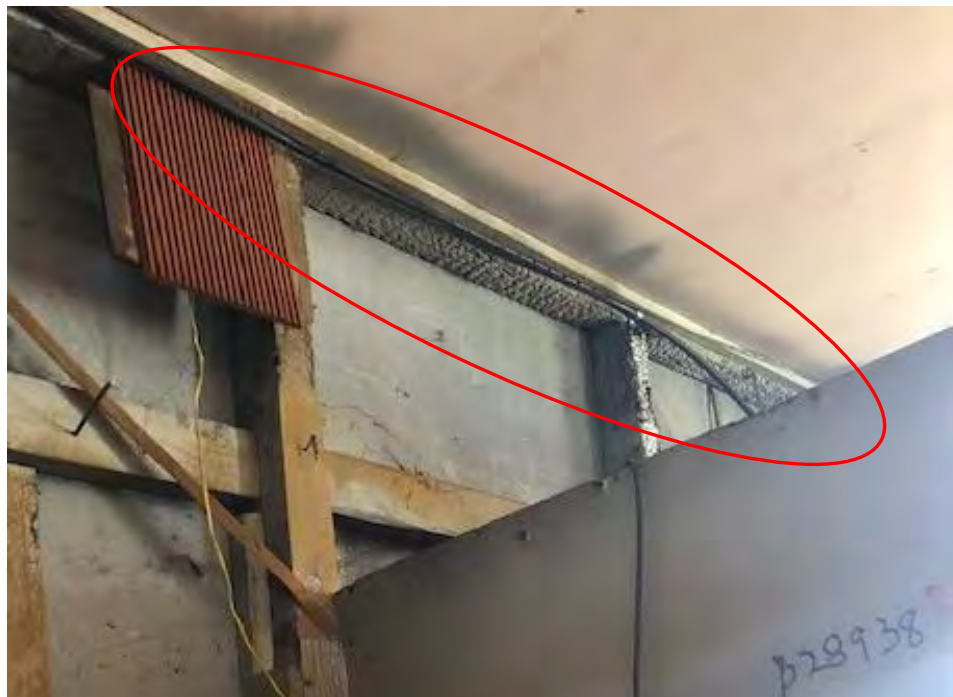
The fire damage was likely sustained during a significant fire event, with subsequent works undertaken that involved likely recladding of the roof, internal ceilings and walls, effectively concealing the severely dilapidated structural timber framing of the walls and roof. The fire and subsequent works predate the Client's ownership of the site in 2012.

Figure 35: Evidence of some of the more visible fire damage to the building.

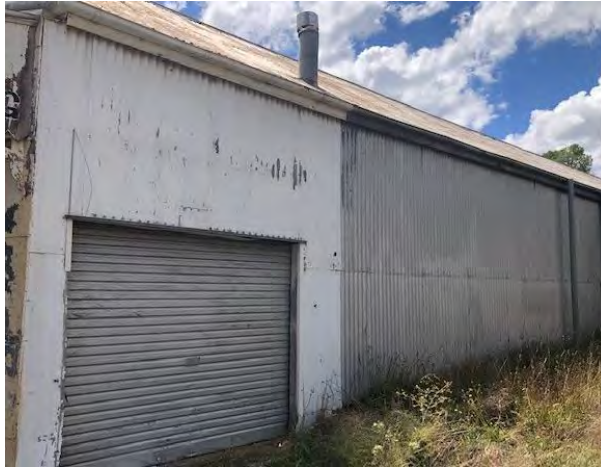
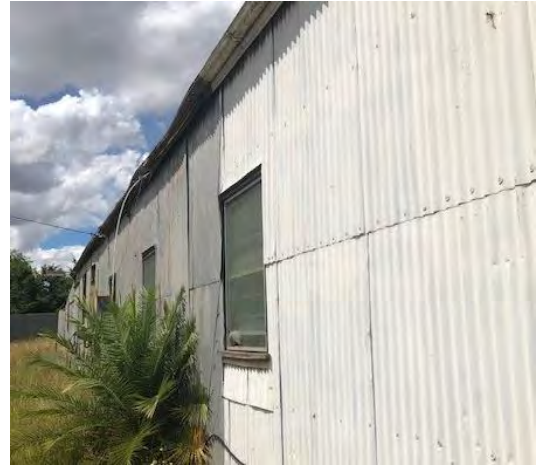
Roof iron and roof drainage generally was in poor condition at the time of our inspection.

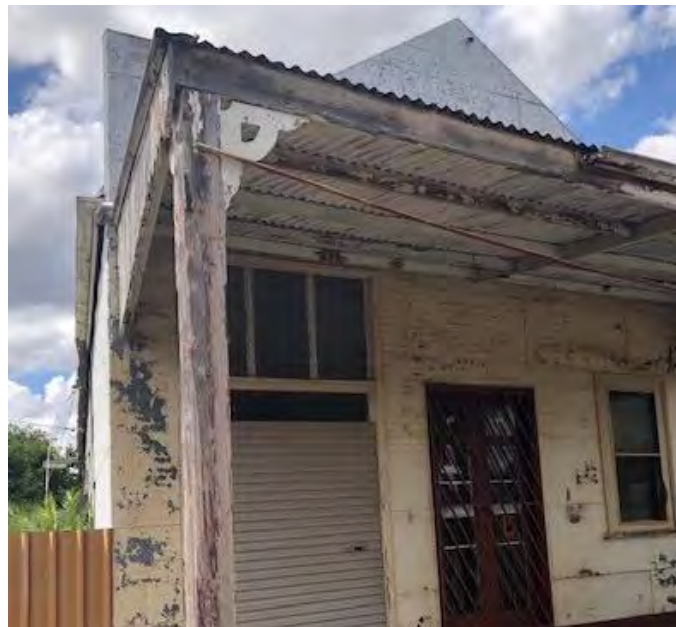
Exposed timber elements were in poor condition at the time of our inspection, including structural posts and beams, all non-structural external elements.

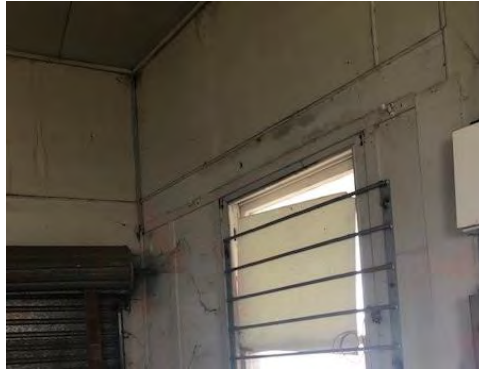
The internal inspection revealed extensive damage throughout due to general deterioration, moisture ingress, and insufficient maintenance.

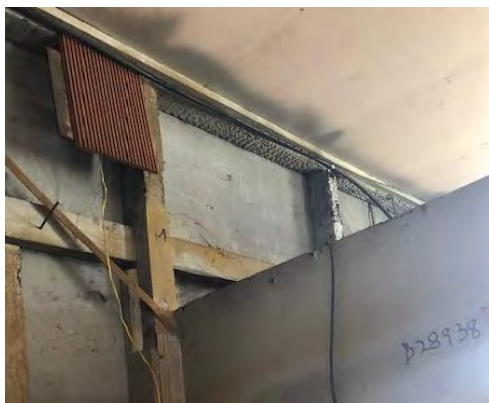
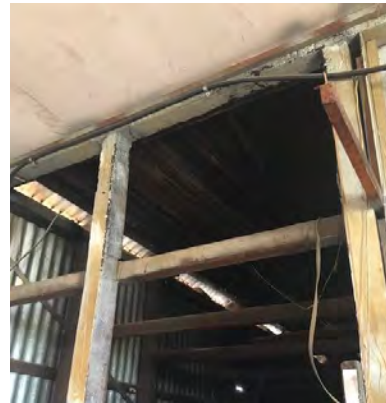
Our inspection revealed evidence of a previous fire, with significant smoke damage and charring of roof elements.

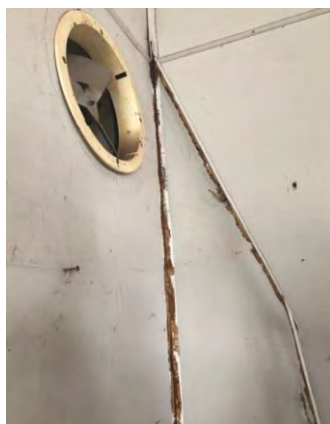
Evidence of termite activity and damage was noted during our inspection.

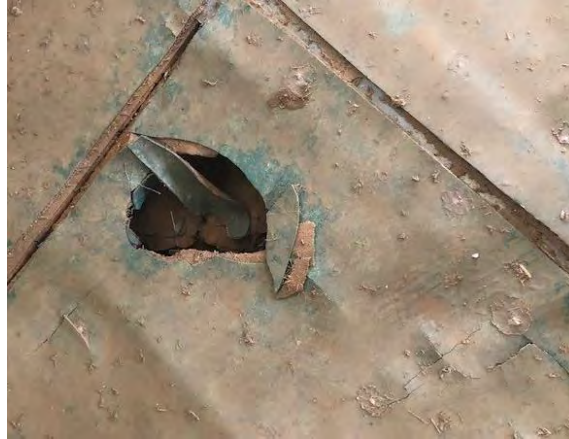
There was major structural damage observed for the suspended timber floor portion of the building. The pest report describes the damage in detail.
