# Geotechnical Investigation

10-16 Pacific Drive, Port Macquarie, NSW

**Report No:** E24947.G03\_Rev1

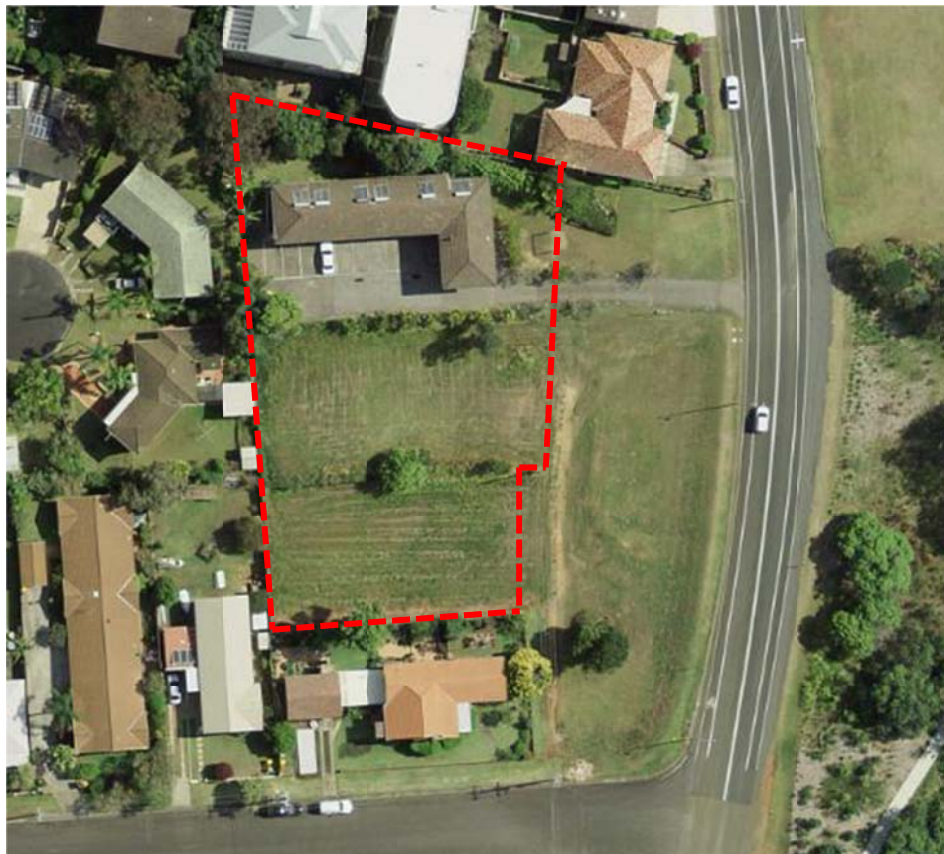
**Plate 1:** Aerial photograph of the site (source: SIX Maps, accessed 14/12/2020)

| Information | Detail |
|---|---|
| Brief Site Description | At the time of our investigation, the site was occupied by a two-storey brick residential building located within the north-western portion. The building structure appeared to be in fair condition based on a cursory inspection of the exterior walls. The areas towards the south of the residential building were concrete paved and connected with the Pacific Drive by a driveway. The concrete pavement was in fair condition. The remaining area of the site was vacant and covered with grass. |
| Site Area | The site area is approximately 2990m <sup>2</sup> (based on the provided survey plan referenced above). |
