ENVIRONMENTAL ASSESSMENT

LEVEL 2 - MINOR WORKS

East Seaham Road Guardrail Installation

23 May 2024

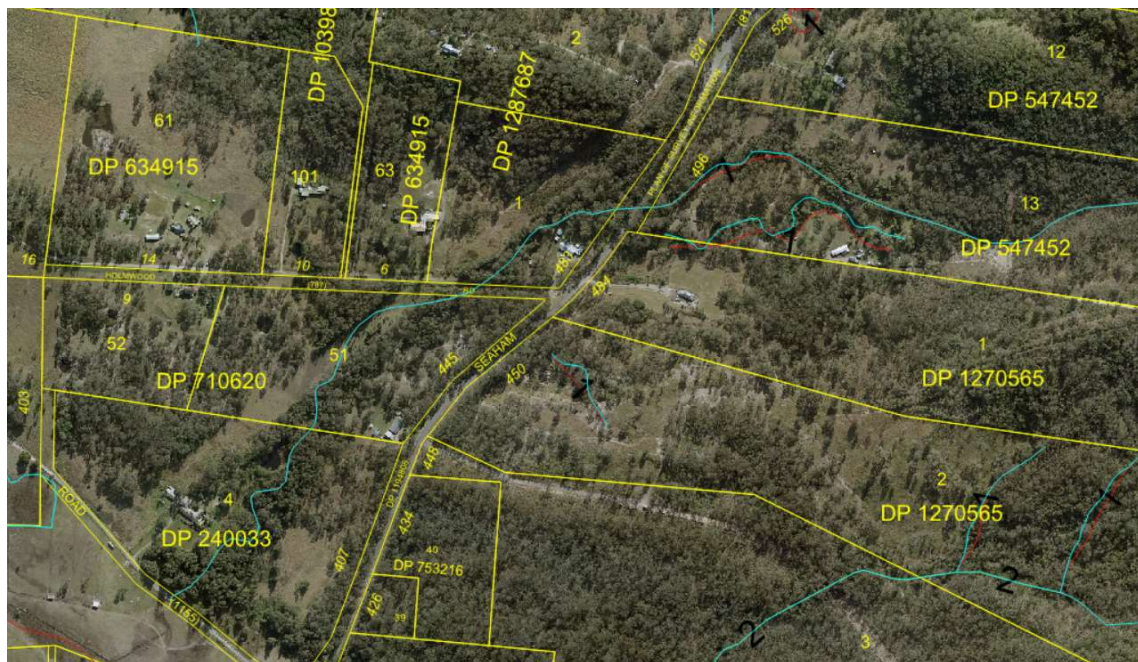
Figure: Waterways

There is a watercourse with a stream order of 1 to the north of the site, and two stormwater culverts (pipes) under East Seaham Road within the works area assisting water to drain westwards towards the watercourse and to the Williams River, approximately 1.5km downstream from the site,

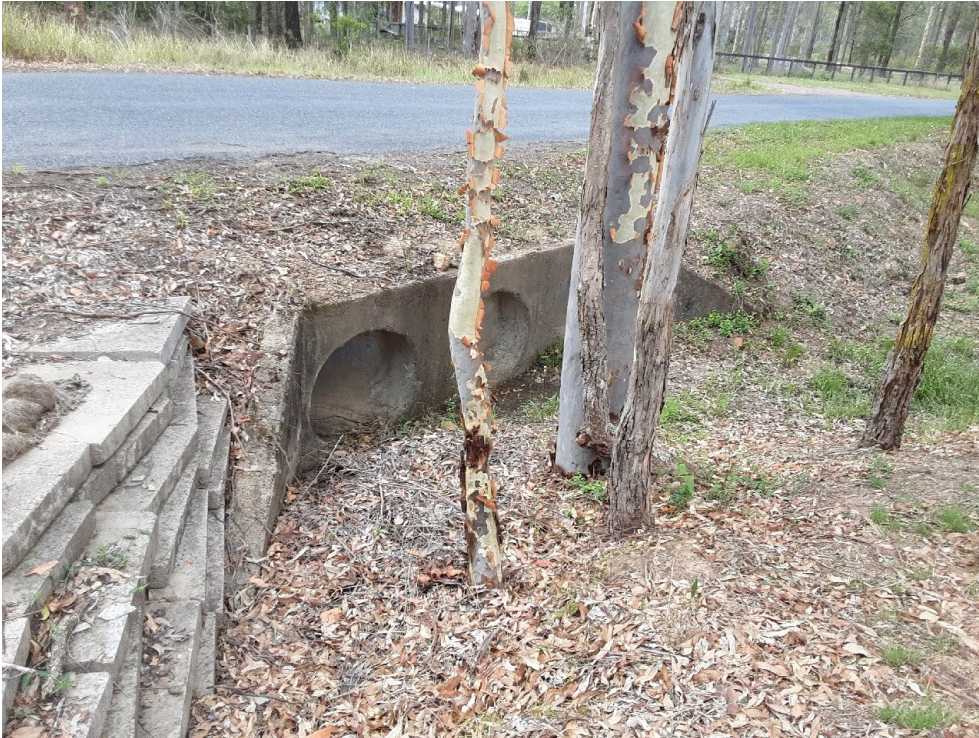
and electricity which are visible throughout the study area (Photo 14, Photo 15, Photo 16). Disturbance of this nature is characterised as high. The excavation undertaken to construct the road would have displaced the soils and thus completely disturbed that region resulting in high disturbance levels. Disturbances of this nature would likely result in the limited preservation of intact archaeological deposits in subsurface layers.

Photo 14 Example of drainage structures located throughout the study area, photo taken facing south-east

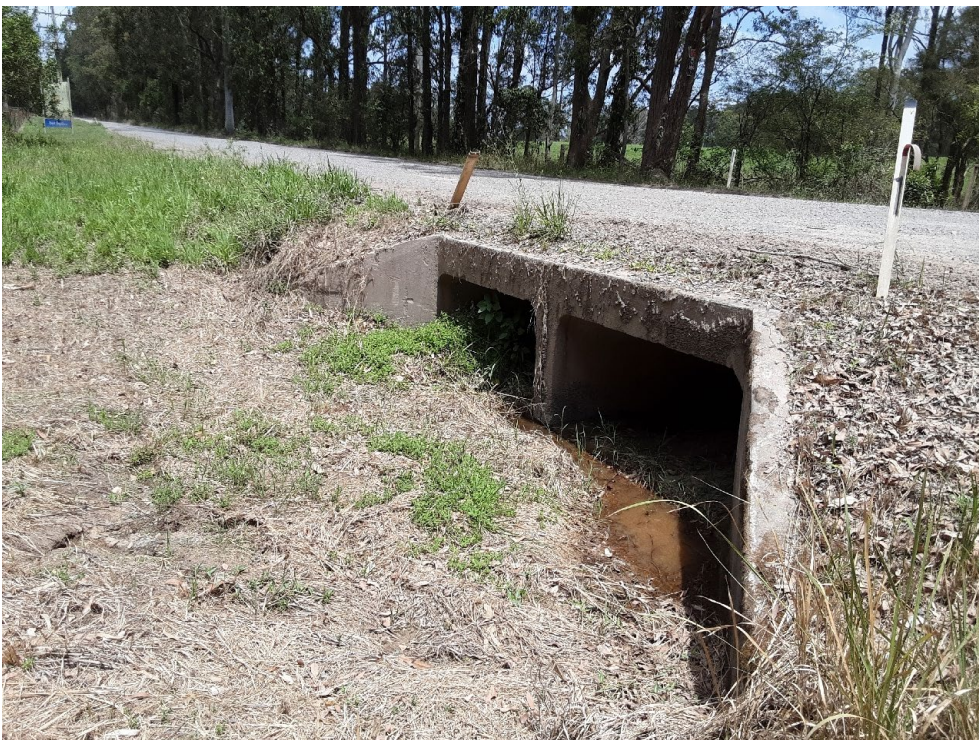
Photo 15 Example of drainage structures located throughout the study area. Photo taken facing northeast

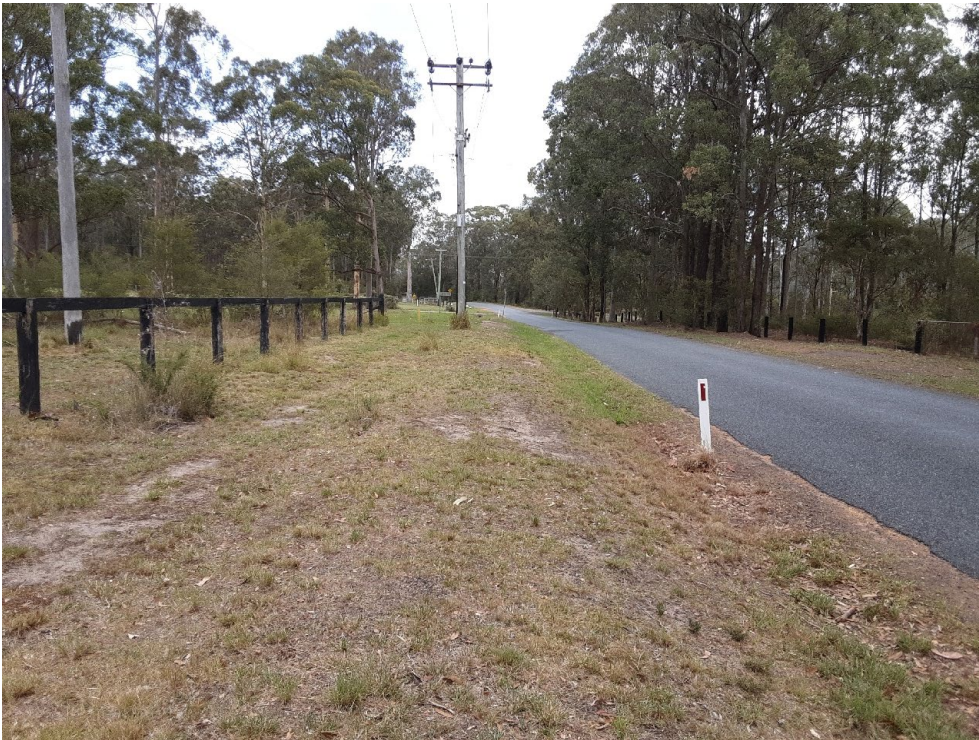
Photo 16 Disturbance associated with electricity installation and fence line. Photo taken facing north

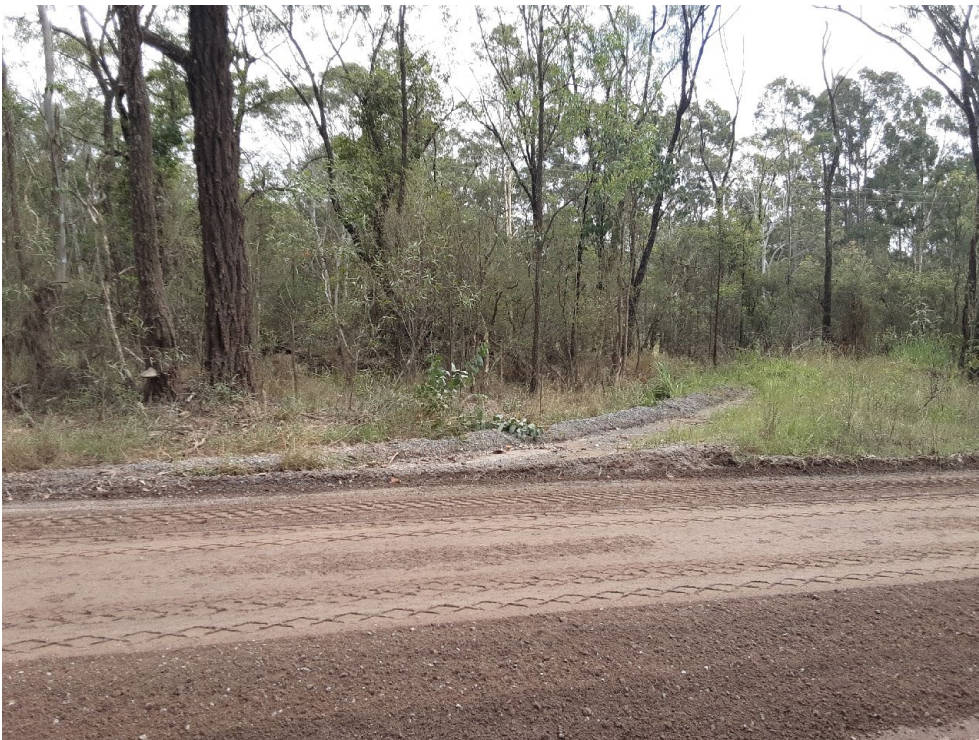
Photo 17 Disturbance associated with road grading and construction. Photo taken facing east

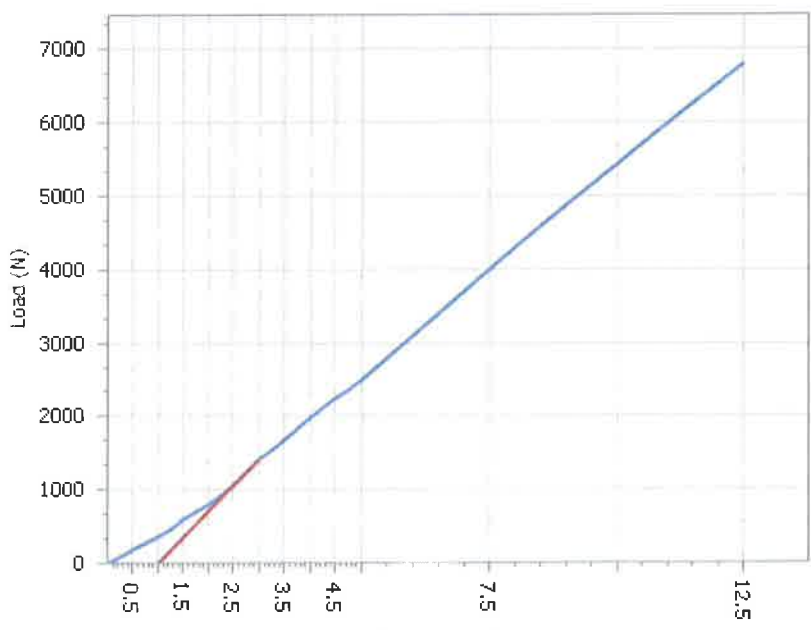
Maximum Dry Density (t/m³):	1.95	<p style="text-align: center;">CBR PENETRATION PLOT</p>

Optimum Moisture Content (%):	11.0	
Field Moisture Content (%):	6.7	
Sample Percent Oversize (%):	4.0	
Oversize Included / Excluded	Excluded	
Target Density Ratio (%):	100	
Target Moisture Ratio (%):	100	
Placement Dry Density (t/m³):	1.95	
Placement Dry Density Ratio (%):	100.0	
Placement Moisture Content (%):	11.2	
Placement Moisture Ratio (%):	101.0	
Test Condition / Soaking Period:	Soaked / 4 Days	
CBR Surcharge (kg)	4.5	
Dry Density After Soak (t/m³):	1.95	
Total Curing Time (hrs)	n/a	
Liquid Limit Method	Estimation	
Moisture (top 30mm) After Soak (%)	11.5	
Moisture (remainder) After Soak (%)	11.1	
CBR Swell (%):	0.0	
Minimum CBR Specification (%):	-	
CBR Value @ 5.0mm (%):	16

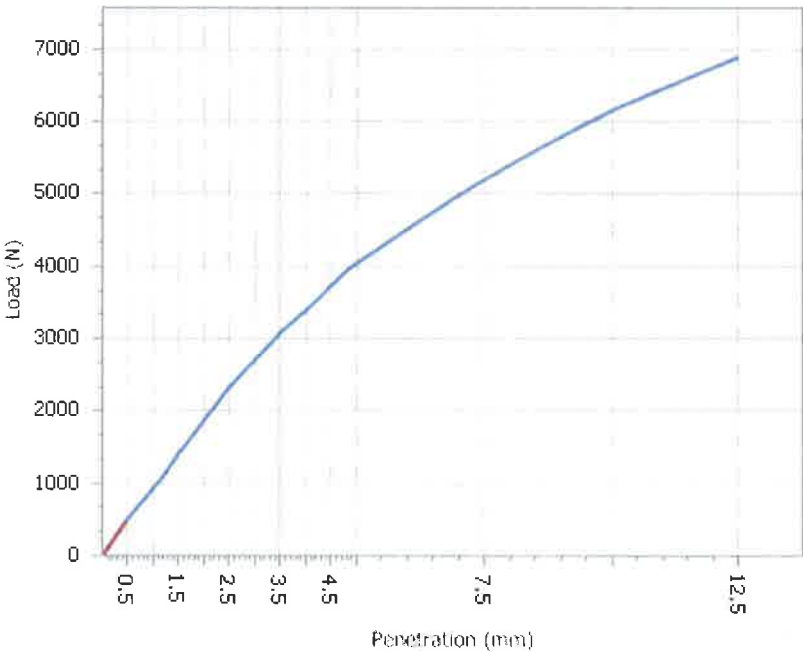
Material Description	Clayey Sandy SILT, brown-grey		
Maximum Dry Density (t/m³):	1.93	<div style="text-align: center;"> CBR PENETRATION PLOT

</div>	
Optimum Moisture Content (%):	11.0		
Field Moisture Content (%):	6.7		
Sample Percent Oversize (%)	2.0		
Oversize Included / Excluded	Excluded		
Target Density Ratio (%):	100		
Target Moisture Ratio (%):	100		
Placement Dry Density (t/m³):	1.93		
Placement Dry Density Ratio (%):	100.0		
Placement Moisture Content (%):	10.9		
Placement Moisture Ratio (%):	97.5		
Test Condition / Soaking Period:	Soaked / 4 Days		
CBR Surcharge (kg)	4.5		
Dry Density After Soak (t/m³):	1.92		
Total Curing Time (hrs)	n/a		
Liquid Limit Method	Estimation		
Moisture (top 30mm) After Soak (%)	15.1		
Moisture (remainder) After Soak (%)	12.0		
CBR Swell (%):	0.0		
Minimum CBR Specification (%):	-		
CBR Value @ 5.0mm (%):	20
