East Seaham Road, East Seaham

Aboriginal Due Diligence Assessment

FINAL REPORT

Prepared for Port Stephens Council

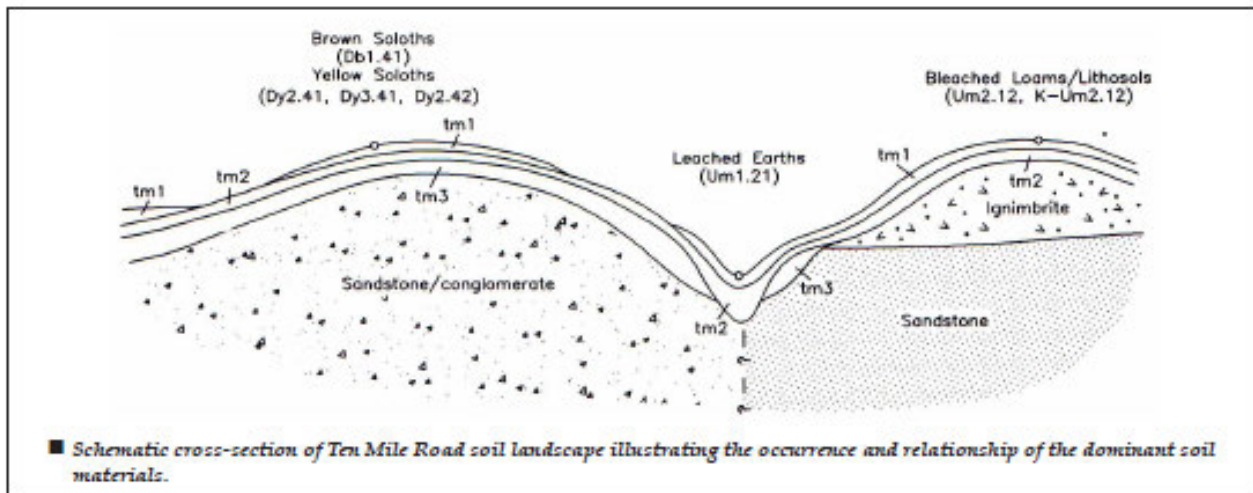
Photo 2 Schematic cross-section of Ten Mile Road soil landscape illustrating the occurrence and relationship of the dominant soil materials (Department of Planning, Industry and Environment 2023b).

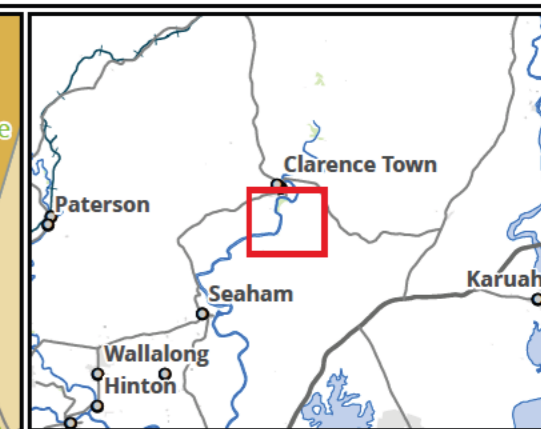
Figure 4 Geological units in the vicinity of the study area

- Legend**
- Study area
 - Geological units**
 - Cgin, Newtown Formation
 - Cginv, Vacy Ignimbrite Member
 - Cugw, Wallaringa Formation
 - Curim, Martins Creek Ignimbrite Member
 - Cutj, Mount Johnstone Formation
 - QH_af, Alluvial floodplain deposits
 - QP_at, Alluvial terrace deposits
 - Q_a, Alluvium
 - Q_ab, Alluvial backswamp deposits
 - Q_acw, Alluvial channel deposits - subaqueous
 - Q_al, Alluvial levee/overbank deposits
 - Q_ap, Alluvial palaeochannel deposits
 - Q_av, Alluvial valley deposits
 - Q_avf, Alluvial fan deposits

The study area is overlapping several geological units made complex due to the association with a dense network of hydrological structures stemming from Williams River. Figure 4 reveals alluvial valley deposits to be located throughout the southern portion of the study area where first and third order tributaries cut through. The geological formations include the Wallaringa Formation which is located in the in the northern most 150 metres of the study area. The Newtown Formation is located from the extent of the Wallaringa Formation to 200 metres south. The Vacy Ignimbrite Member is located from the extent of the Newtown Formation and encompasses approximately 200 metres within the southern extent. Lastly, there is a small portion of the Newtown Formation which is located in the southern 200 metres of the study area. Descriptions of each of these units can be found in Table 1.

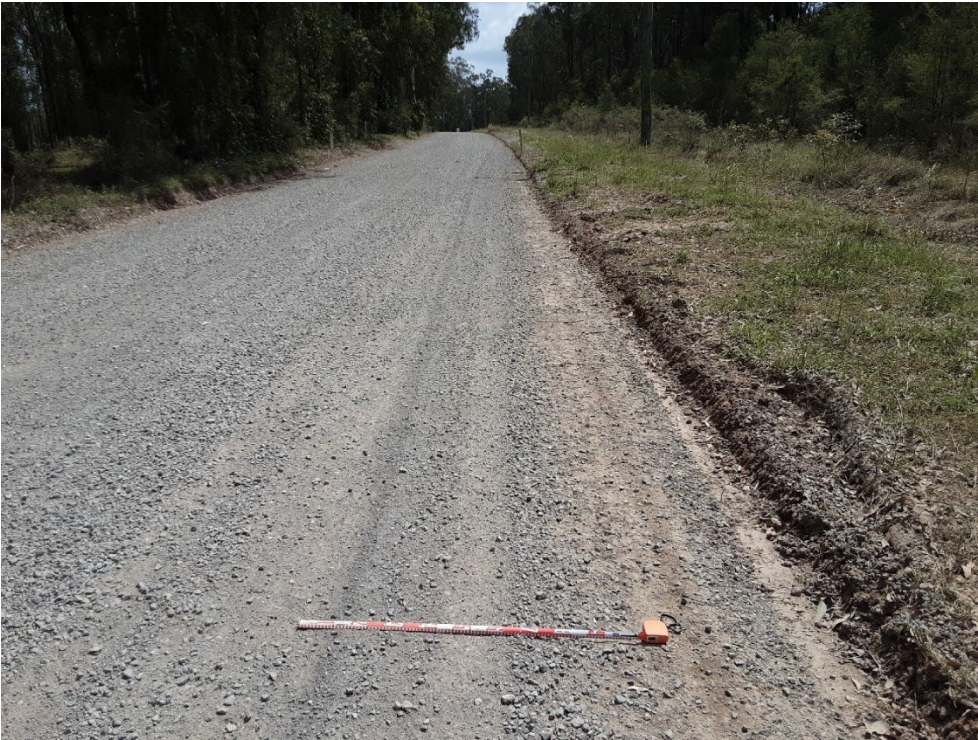
Photo 9 Southern portion of East Seaham Road, facing east depicting 20% visibility of the study area

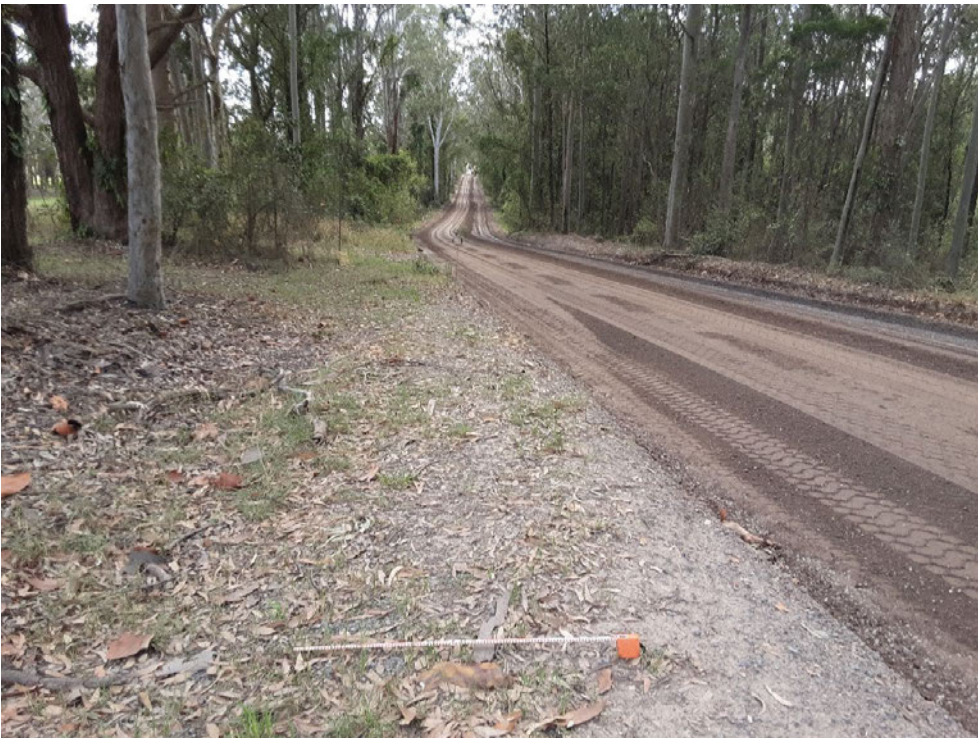
GSV remained the same for the central portion of the study area (Photo 10). The road continued to consist of a gravel road, however it was less densely tree lined in comparison to the southern portion due to the powerlines and services. Cleared shoulders are also visible due to access to residential properties and access to Wallaroo Nature Reserve. There is also a cleared access road on the eastern side of the road corridor which provides access to the cleared area in which pylons exist which runs parallel to Wallaroo National Park. GSV within this area was moderate (10-50%) in areas subjected to high levels of ground disturbances and vegetation clearance in the central portions of the study area (Photo 11).

Photo 10 Central portion of East Seaham Road, facing north depicting 20% GSV associated with middle portion of road

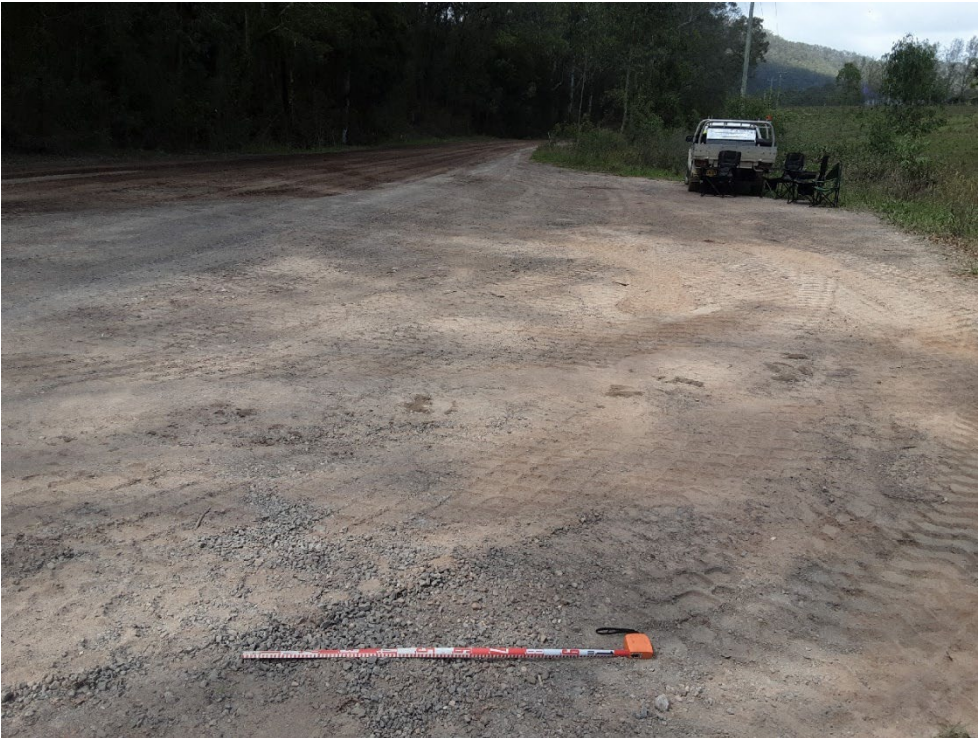
Photo 11 Central section of East Seaham Road, facing south east depicting 50% GSV due to cleared shoulder

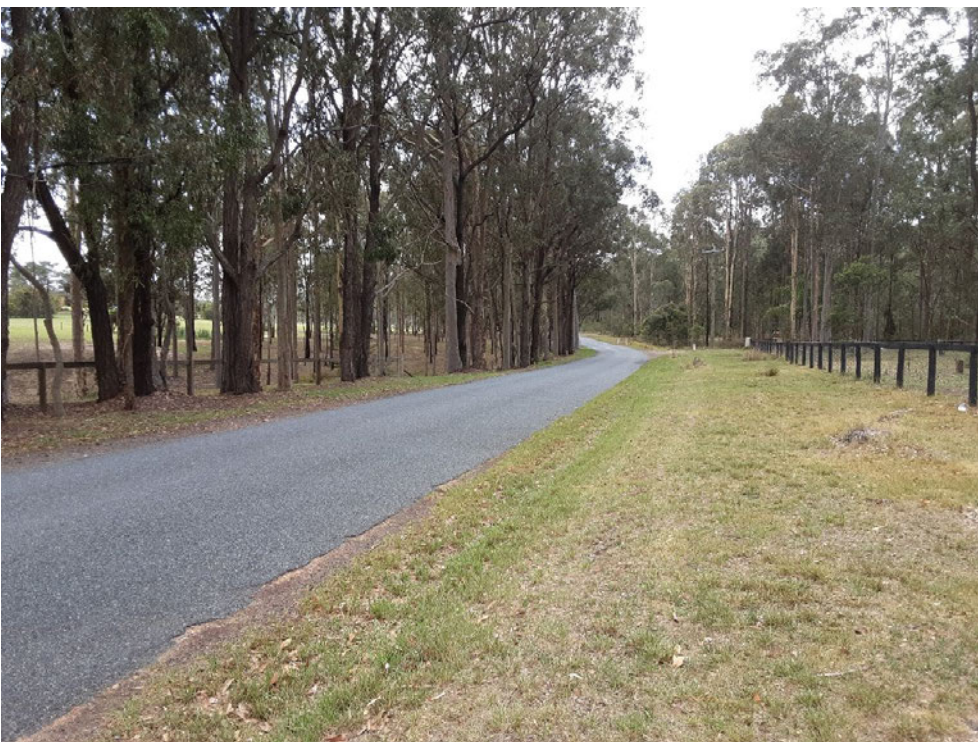
Photo 12 Northern section of East Seaham Road, facing north west depicting 30% GSV due to road and grass coverage

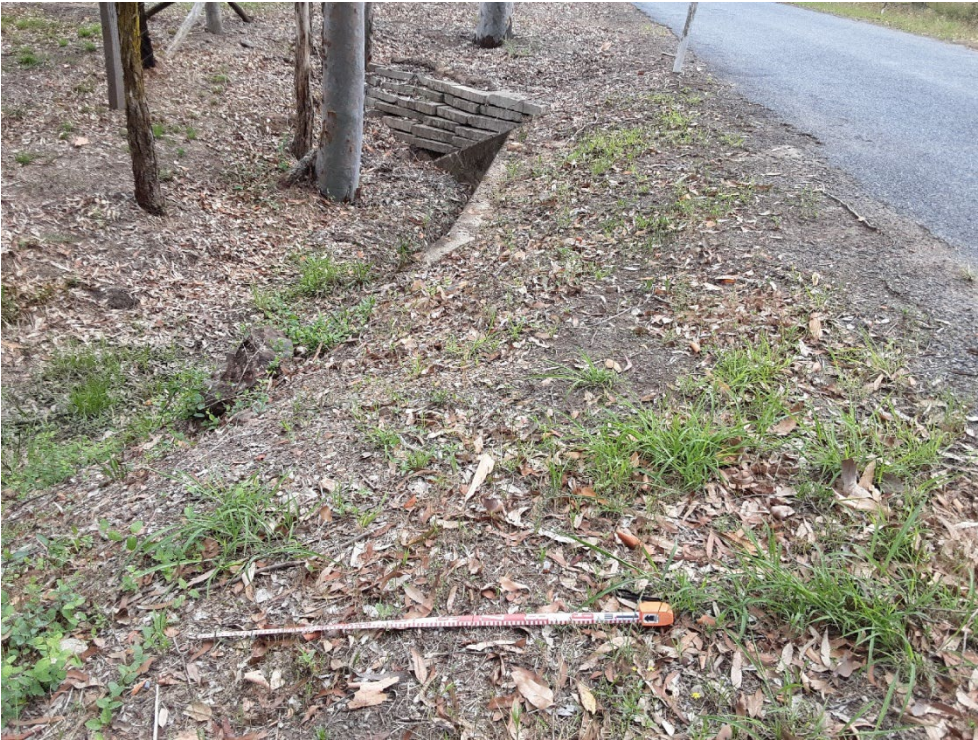
The northern portion of the study area exhibits the highest level of visibility due to the high amount of cleared vegetation due to the existing powerlines and services on the eastern side of the road (Photo 12). GSV within the northern portion was low to moderate (10-50%) with higher areas of GSV due to the high levels of ground disturbance and vegetation clearance. The western road corridor remains heavily tree lined except for some cleared areas which exhibit dense grass coverage, cleared shoulders, driveways or culverts (Photo 13).

Photo 13 Northern portion of East Seaham Road, portraying a culvert located in the road corridor displaying 10% GSV

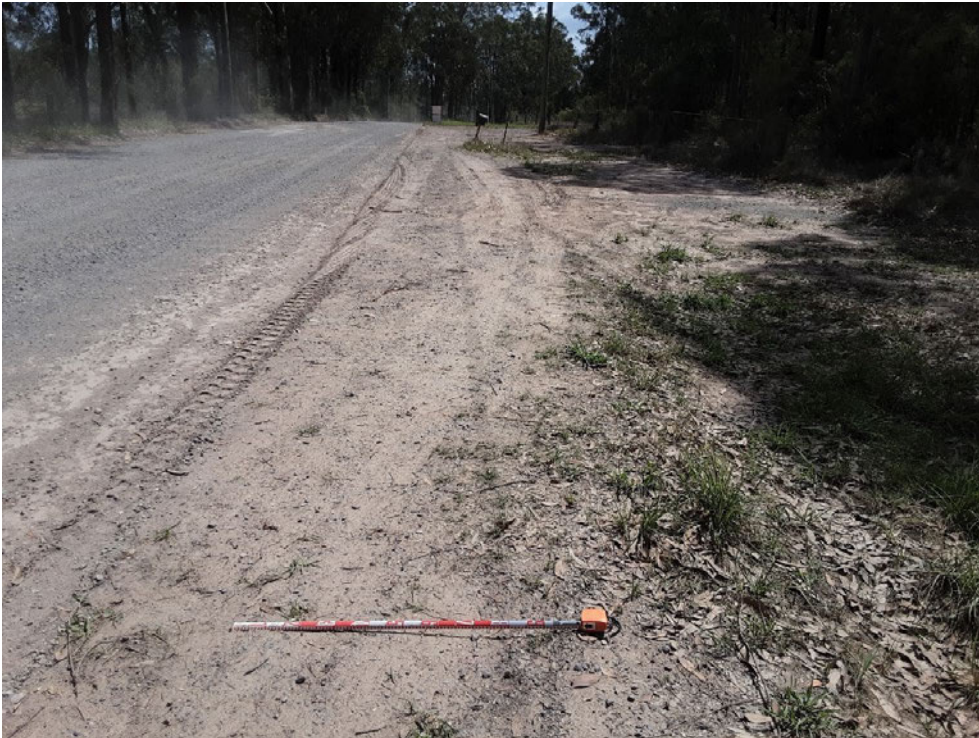
Overall, the study area displayed limited areas of exposure, ranging between 0–10% on the road corridors. The central section of the study area had the highest levels of exposure, due to ground disturbances from the pre-existing exposed gravel road (Photo 14). In the shoulders on the boundary of the road, exposure was minimal (0–5%) and was limited by areas that were densely vegetated (Photo 15).

Photo 14 Moderate exposure (10%) associated with vehicular use, facing north

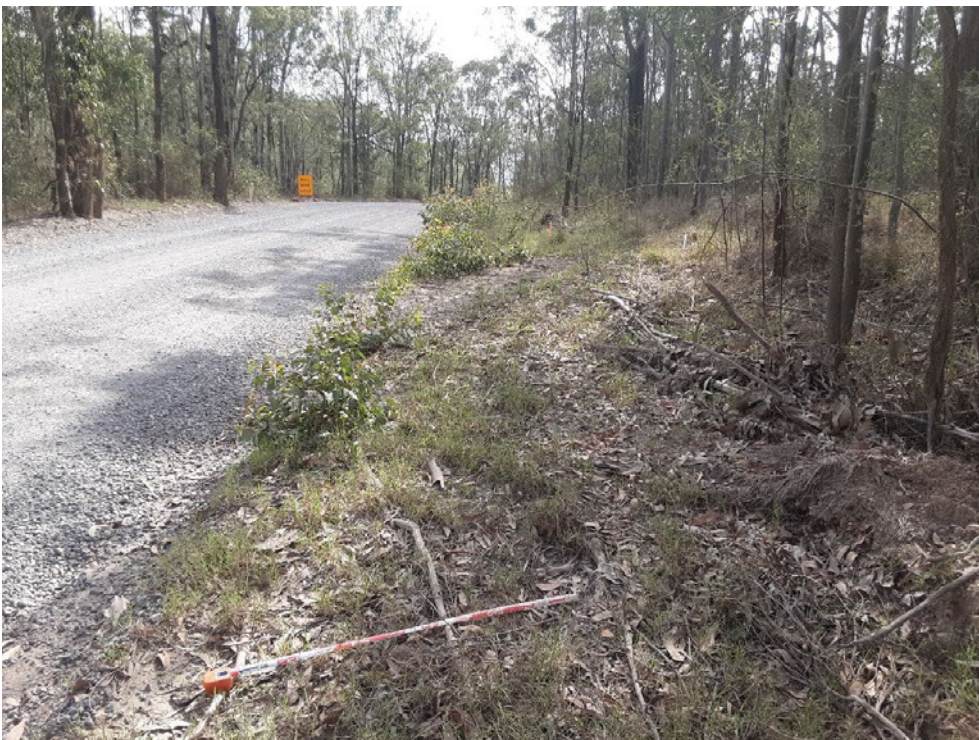
Photo 15 0% exposure associated with road shoulder, dense vegetation coverage and leaf litter, facing north

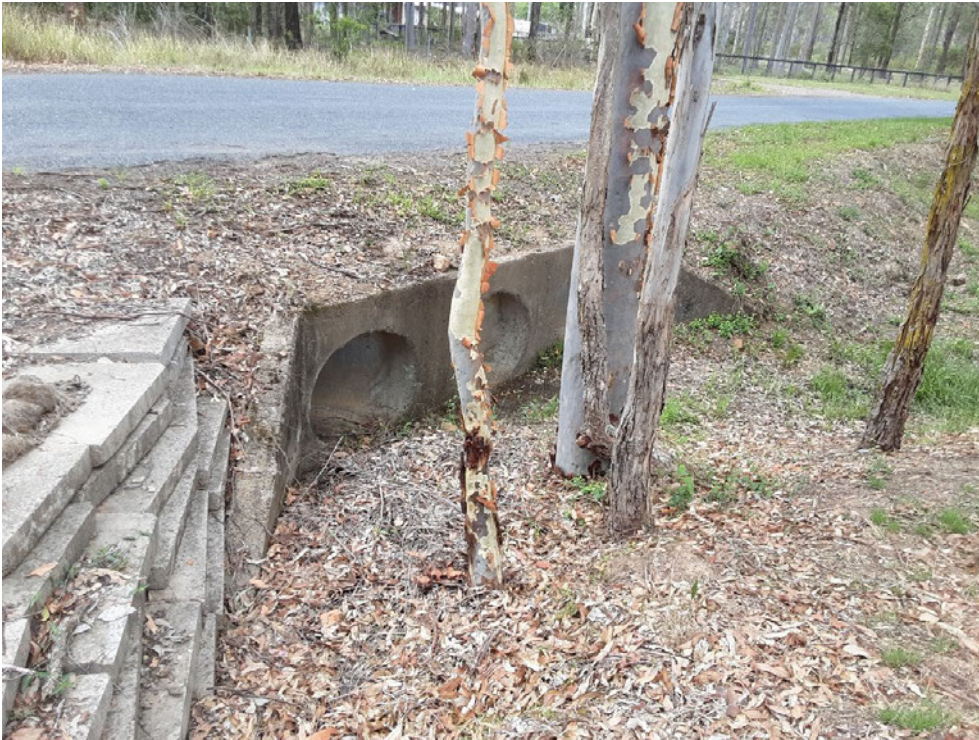
Photo 16 Example of drainage structures located throughout the study area, photo taken facing south-east

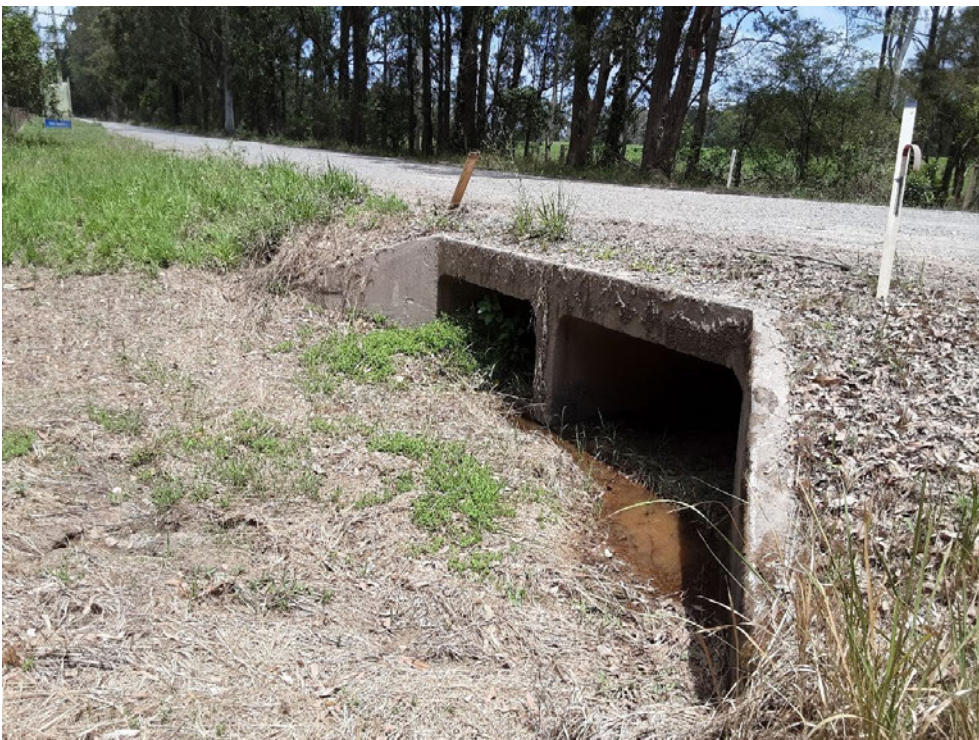
Photo 17 Example of drainage structures located throughout the study area; photo taken facing north-east

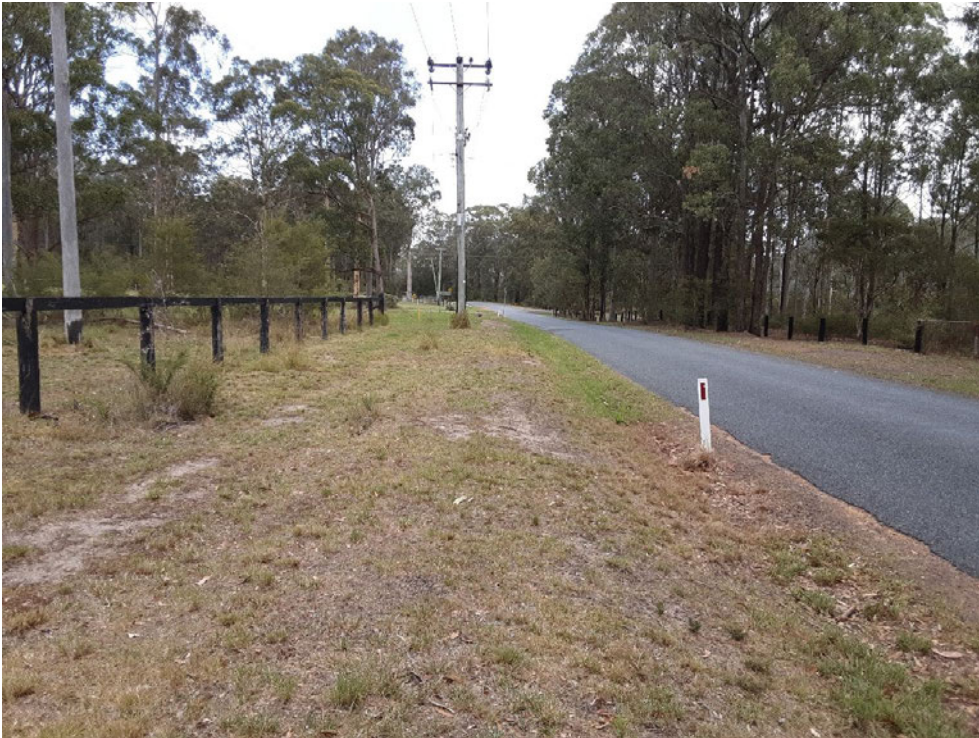
Disturbance throughout the study area would have impacted both surface and subsurface deposits. Soils at locations of vegetation clearing experience higher levels of displacements and re-deposition in shallow layers. The development of East Seaham Road involved the modification of the landform for utilities, sewer, water and electricity which are visible throughout the study area (Photo 16, Photo 17, Photo 18). Disturbance of this nature is characterised as high. The excavation undertaken to construct the road would have displaced the soils and thus completely disturbed that region resulting in high disturbance levels. Disturbances of this nature would likely result in the limited preservation of intact archaeological deposits in subsurface layers.

Photo 18 Disturbance associated with electricity installation and fence line; photo taken facing north

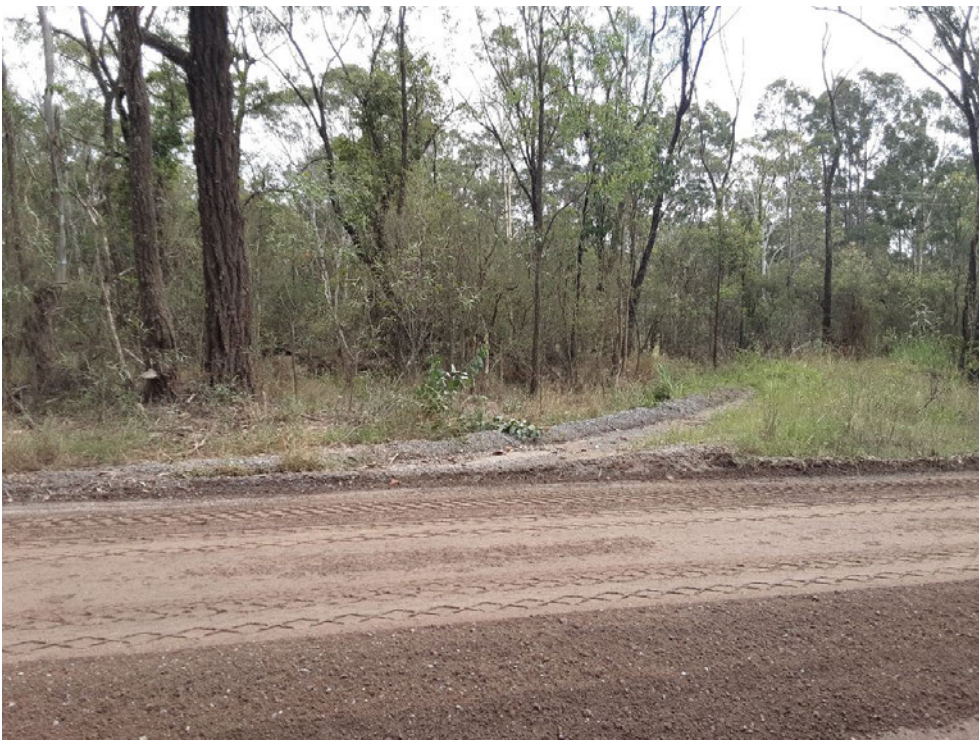
Photo 19 Disturbance associated with road grading and construction; photo taken facing east

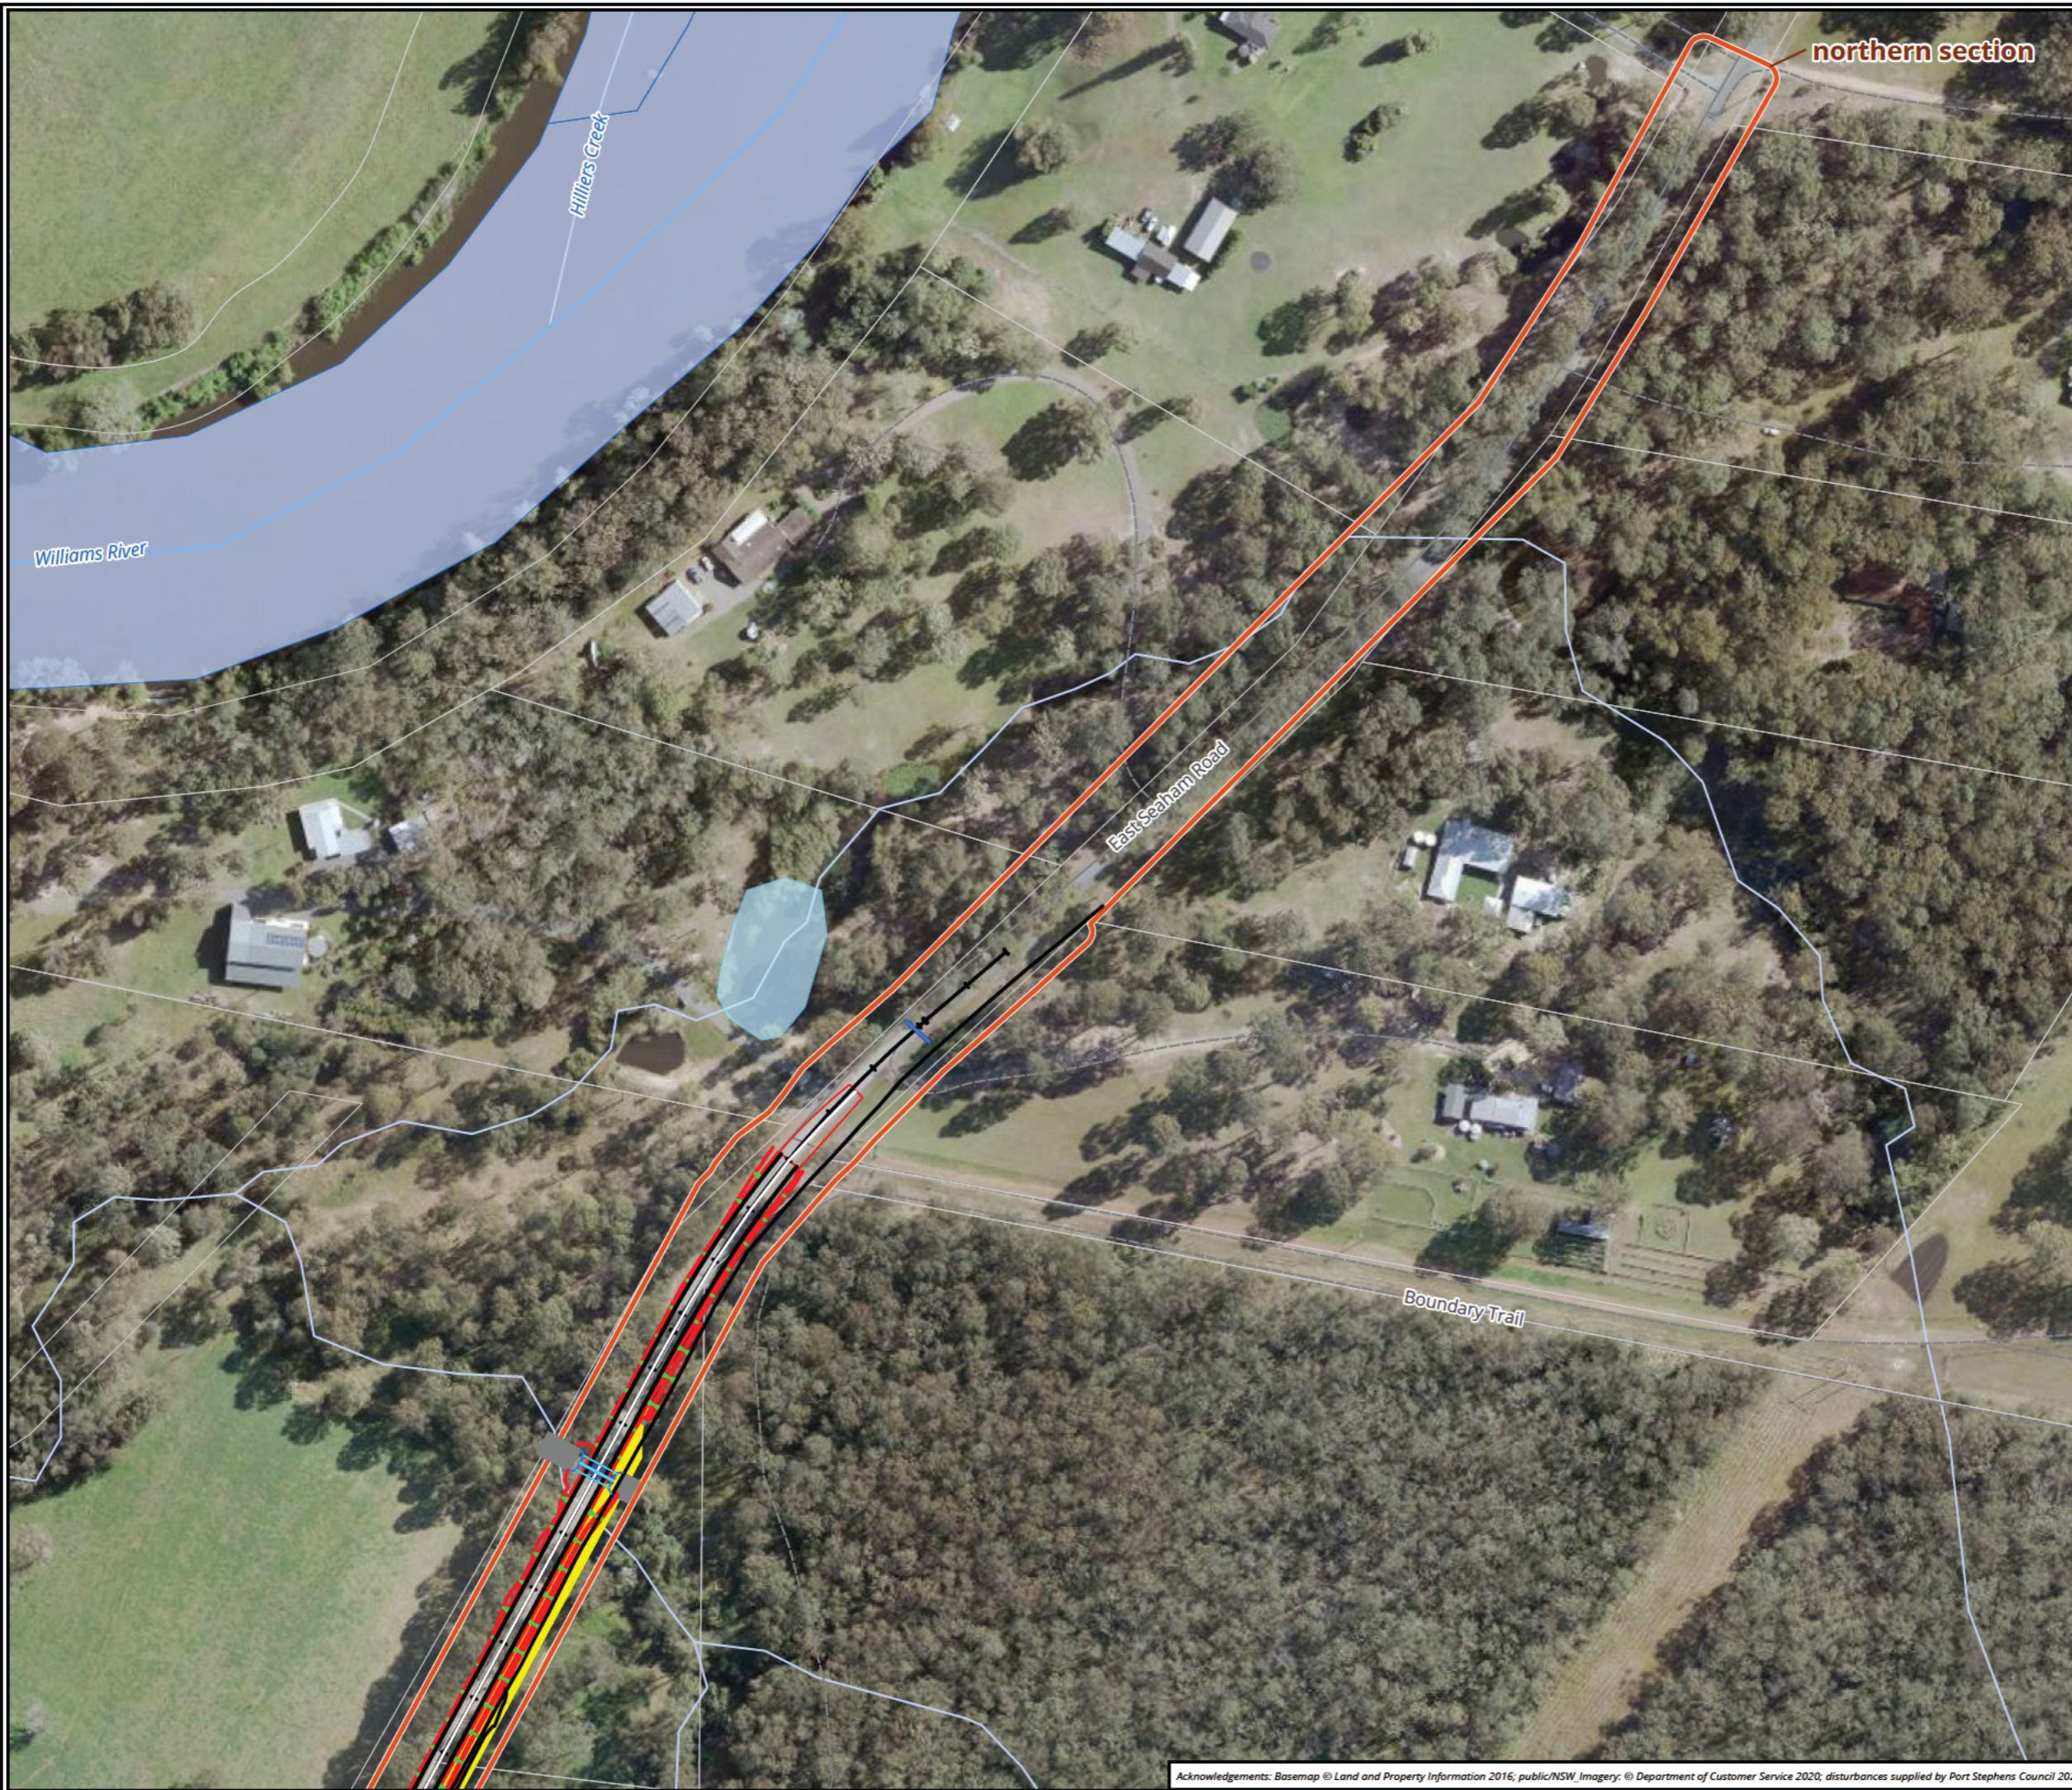
Figure 8.1 Disturbances

- Legend**
- Study area section
 - Lot
- Disturbances**
- Cleared vegetation
 - Culvert
 - 1
 - 2
 - Extent of works
 - Batter
 - Communications
 - 6
 - Culvert
 - Culvert
 - Culvert

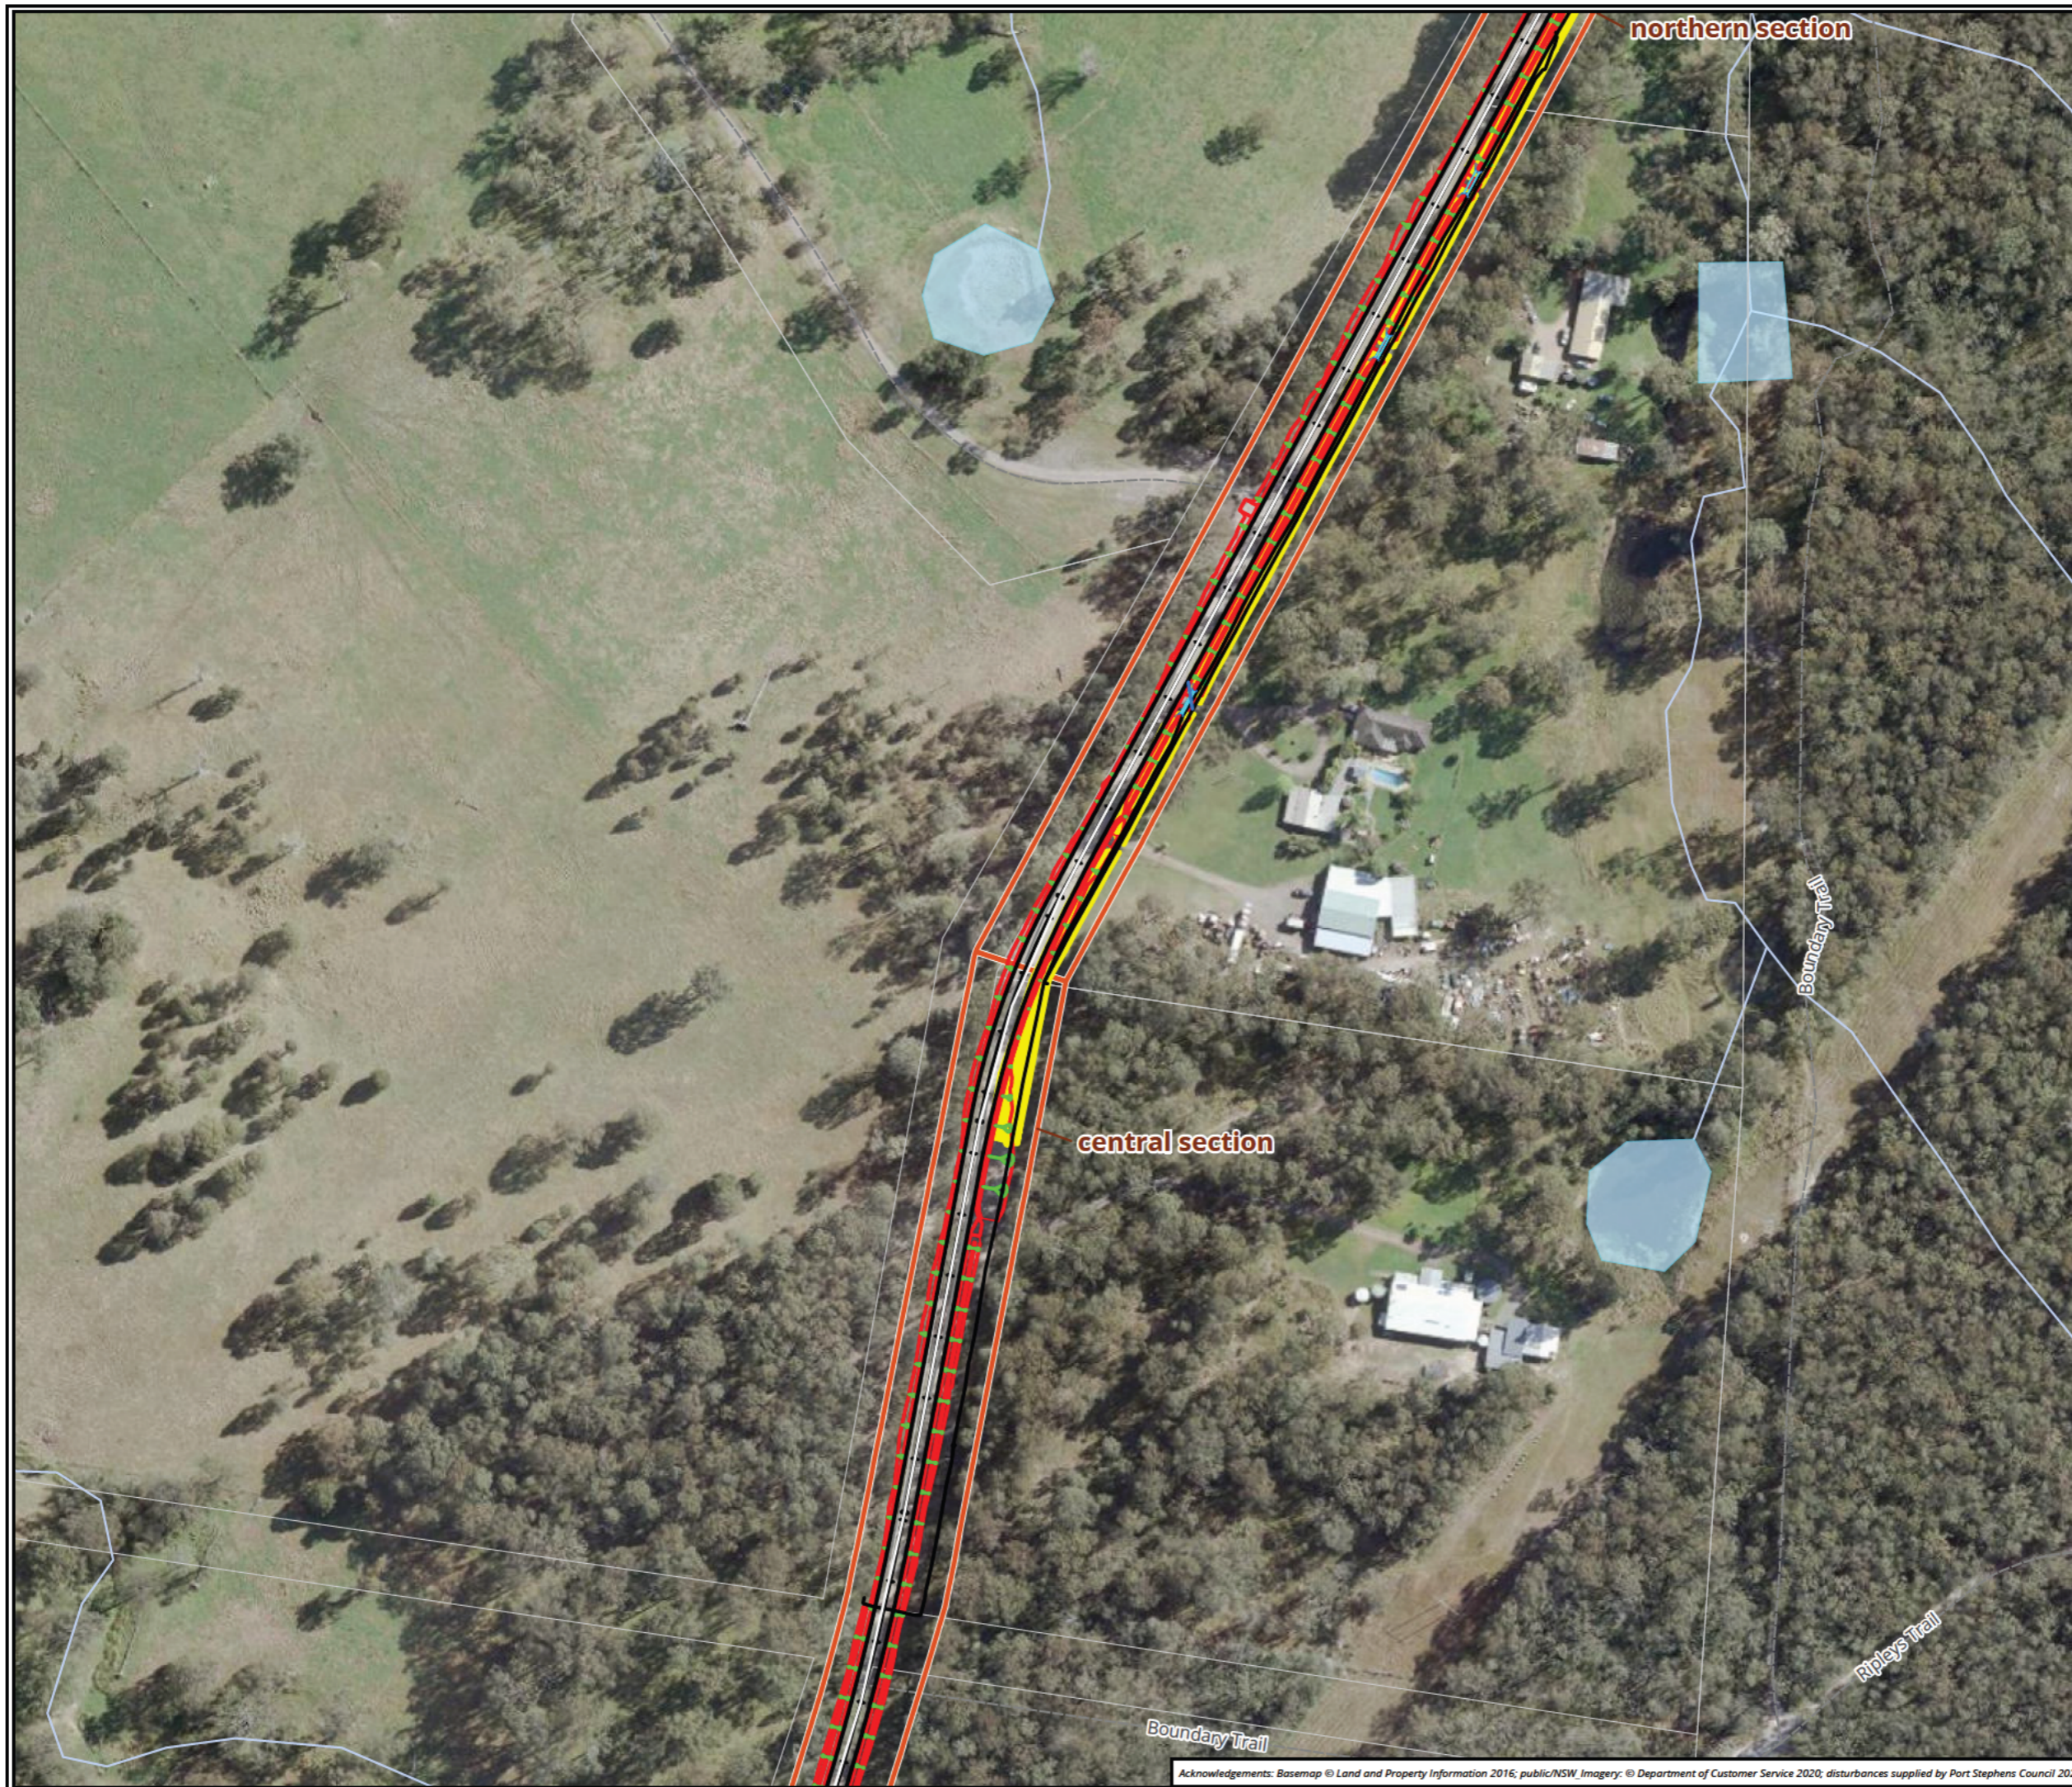
Figure 8.2 Disturbances

- Legend**
- Study area section
 - Lot
- Disturbances**
- Cleared vegetation
 - 1
 - 2
 - Extent of works
 - Batter
 - Communications
 - 6
 - Culvert
 - Culvert
 - Culvert

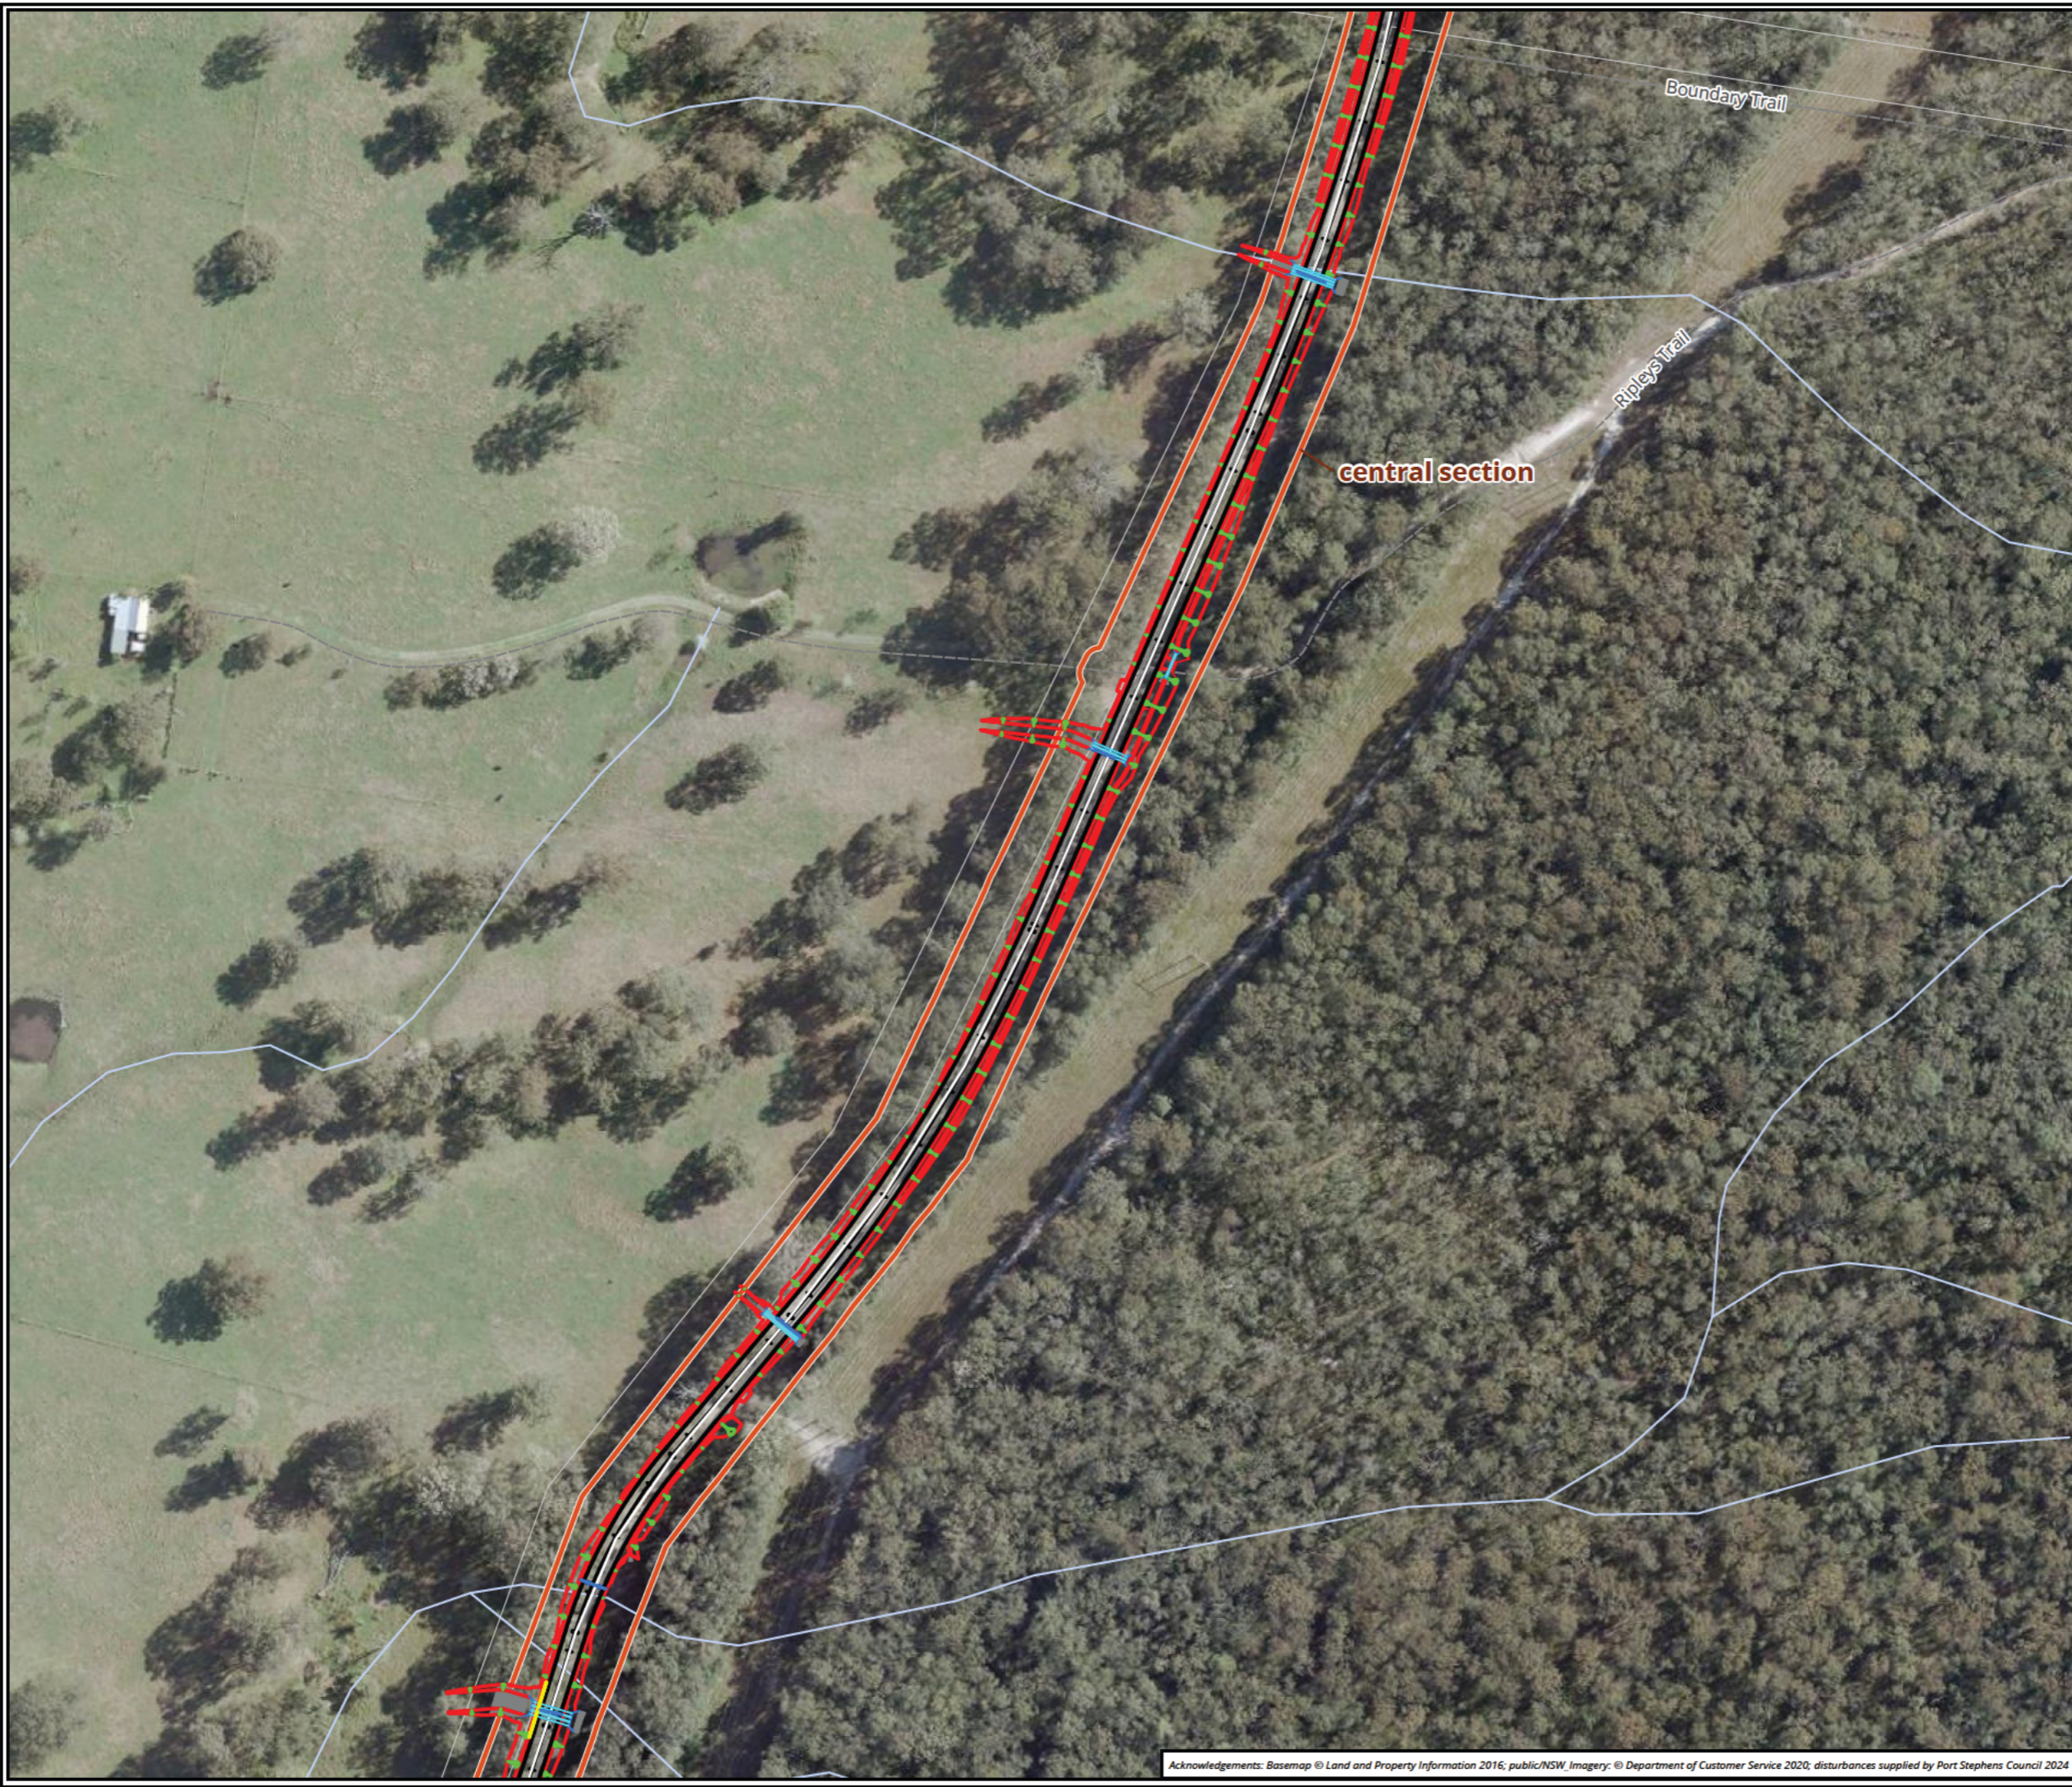
Figure 8.3 Disturbances

- Legend**
- Study area section
 - Lot
- Disturbances**
- Culvert
 - 1
 - 2
 - Extent of works
 - Batter
 - Communications
 - 6
 - Culvert
 - 9
 - Culvert
