East Seaham Road, East Seaham

Aboriginal Due Diligence Assessment

FINAL REPORT

Prepared for Port Stephens Council

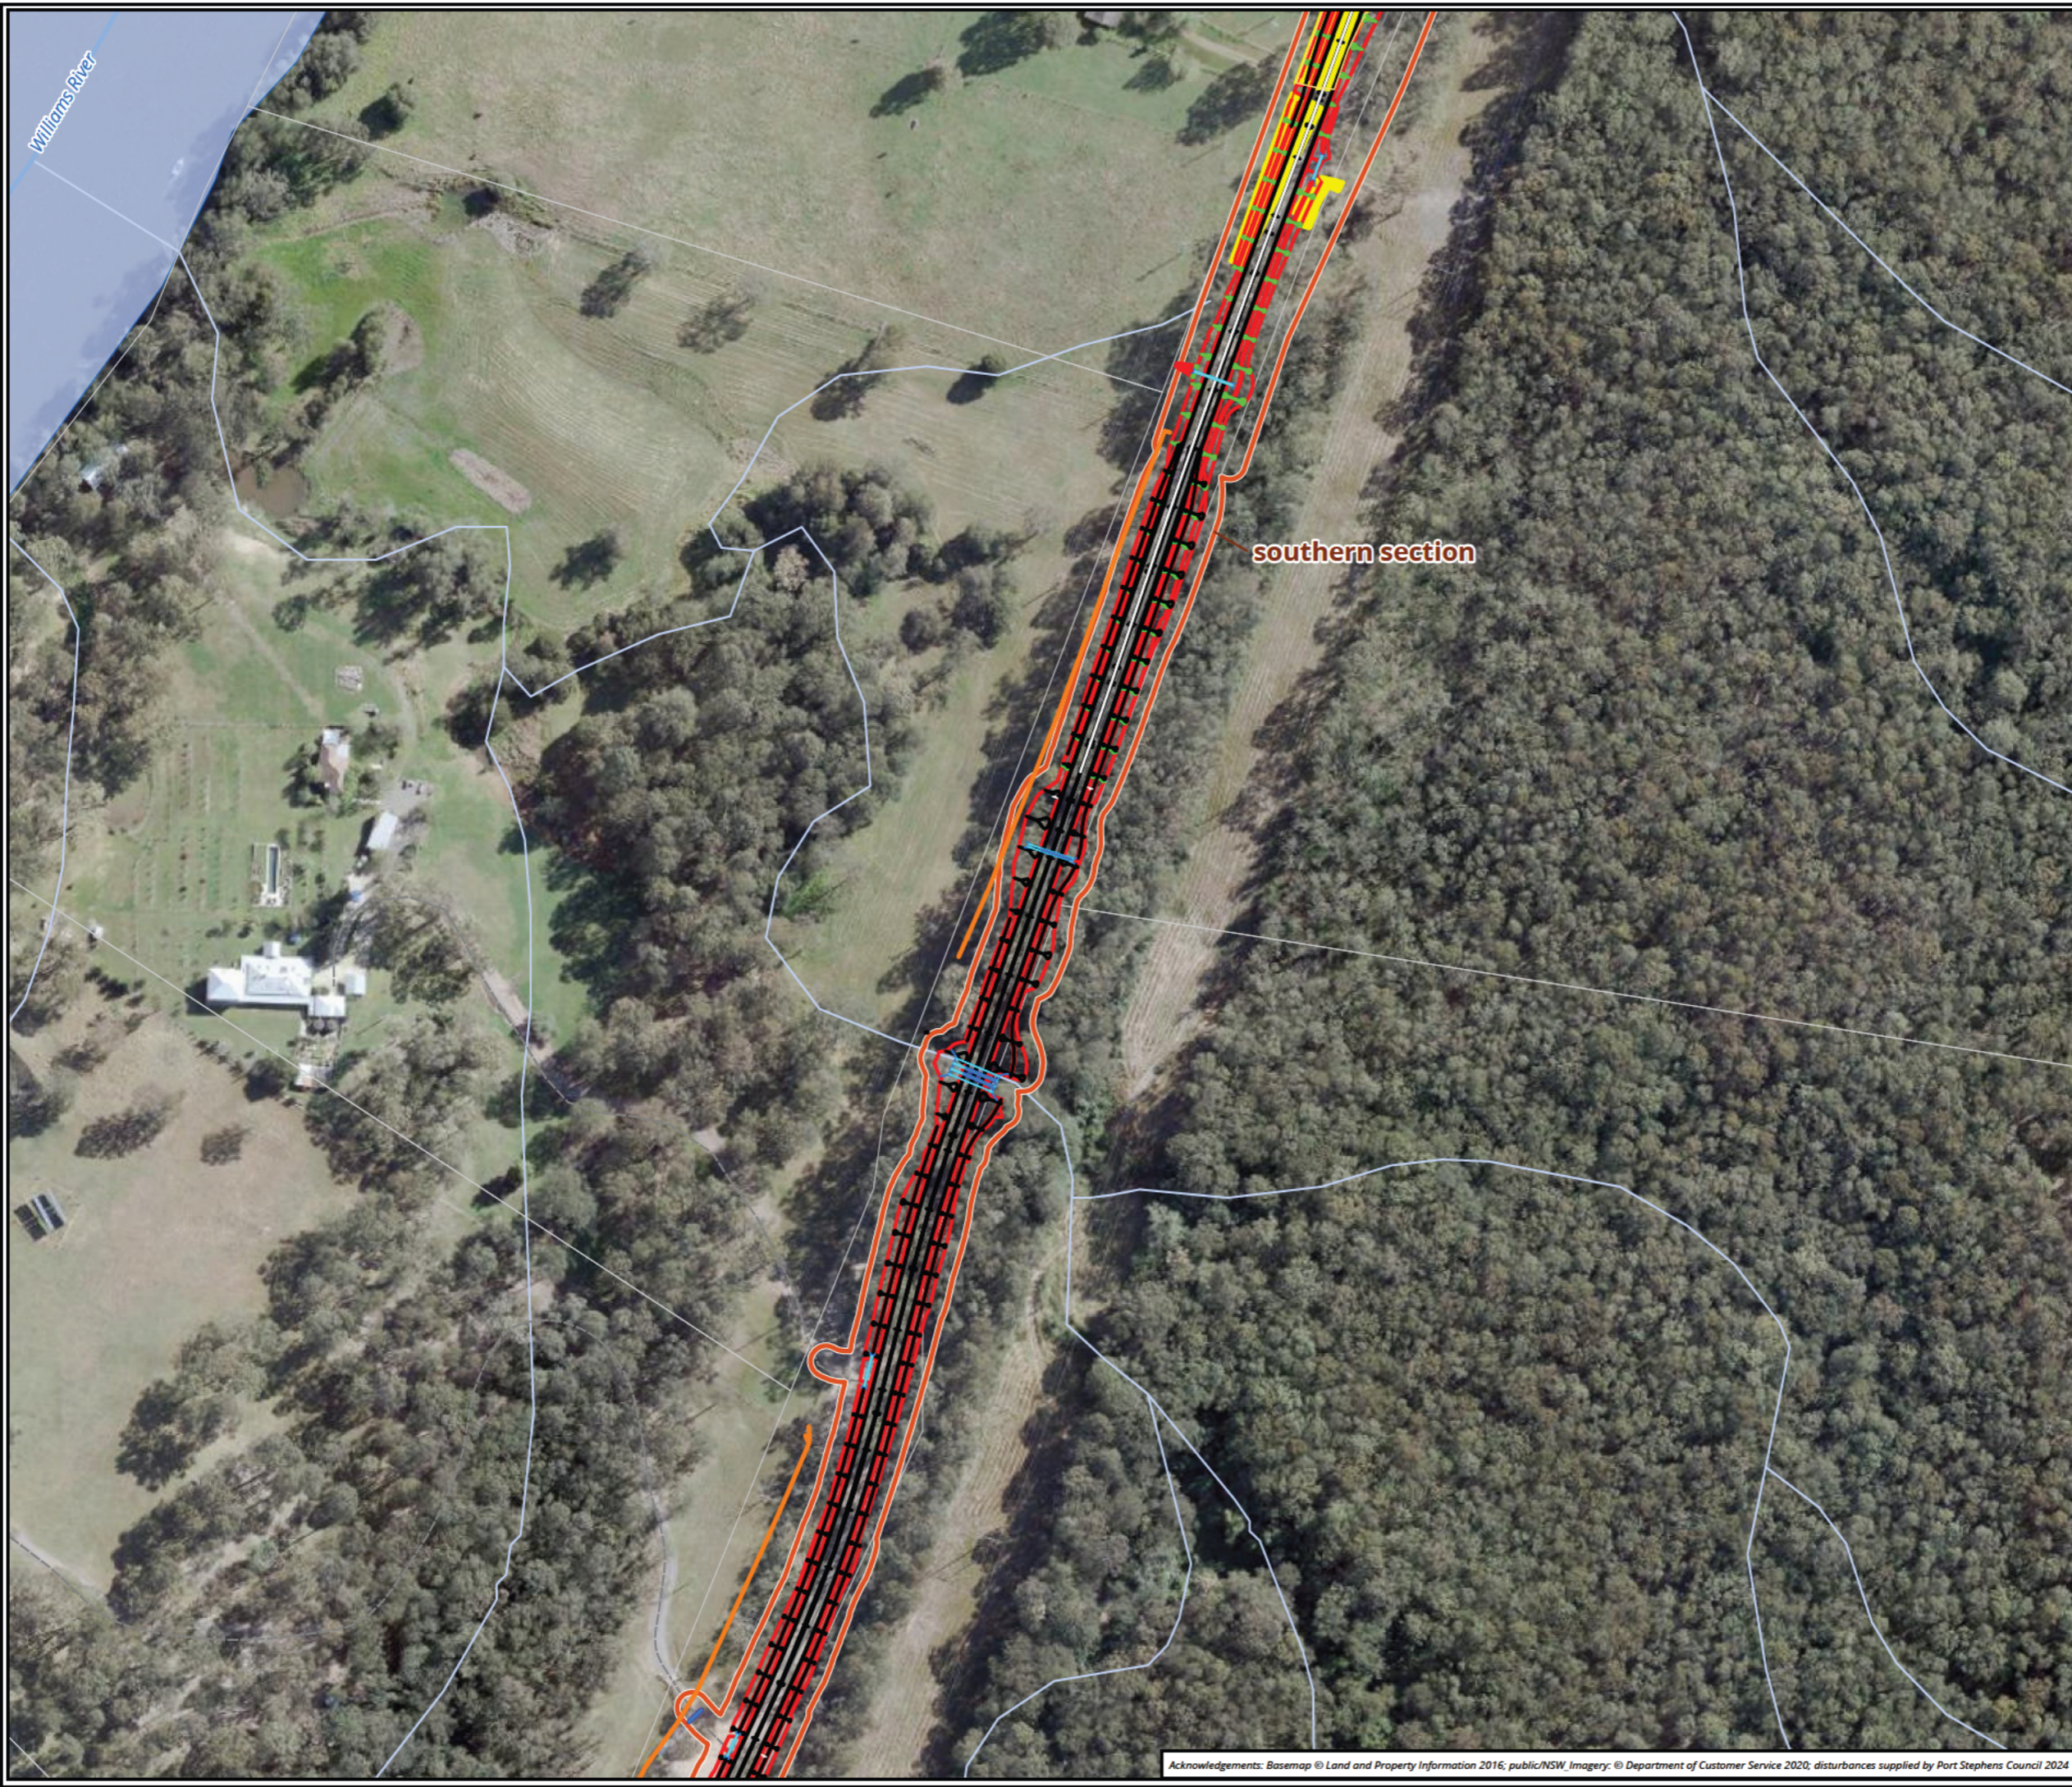
Figure 8.5 Disturbances

- Legend**
- Study area section
 - Lot
- Disturbances**
- Cleared vegetation
 - Culvert
 - 1
 - 2
 - Extent of works
 - Batter
 - Communications
 - 6
 - Culvert
 - Culvert
 - 10
 - Telstra
 - Culvert
